**BIODIVERSITY AND WATER RESOURCE
ASSESSMENT FOR THE PROPOSED
DECOMMISSIONING OF THE TRANSNET
DURBAN TO JOHANNESBURG PIPELINE
(DJP)**

Gauteng, Free State and KwaZulu Natal

Date
December 2019

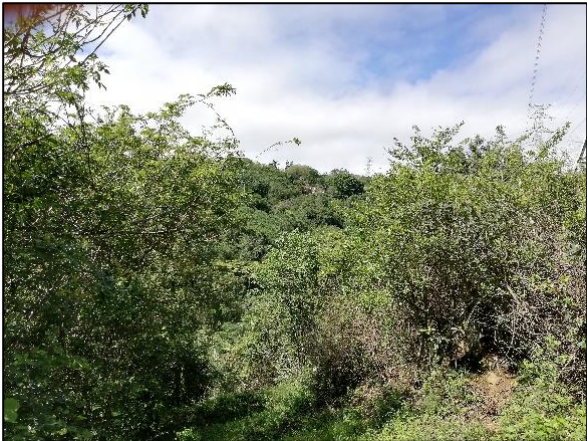
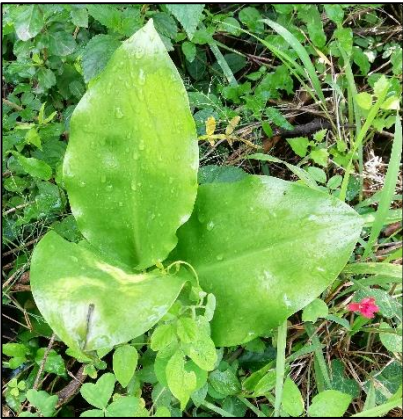
Table 23: Summary of terrestrial features of site 535

<p style="text-align: center;"><i>Scadoxus puniceus</i></p>			
Habitat Type	Thicket, Riparian				
Habitat features	Although degraded along the servitude and urban edge, vegetation interior consists primarily of indigenous flora. <i>Scadoxus puniceus</i> and <i>Freesia laxa</i> occurs in the servitude.				
Sensitivity	Low	Moderate	Moderate-High	High	
Current Impacts	Erosion, Alien vegetation , Vegetation Clearing , Powerlines , Litter and Dumping				
Discussion:	<i>Scadoxus puniceus</i> and <i>Freesia laxa</i> is protected provincially under schedule 11 and Schedule 8 of KZN, respectively. A 300m buffer was placed around this project area due to the protected species in the project area.

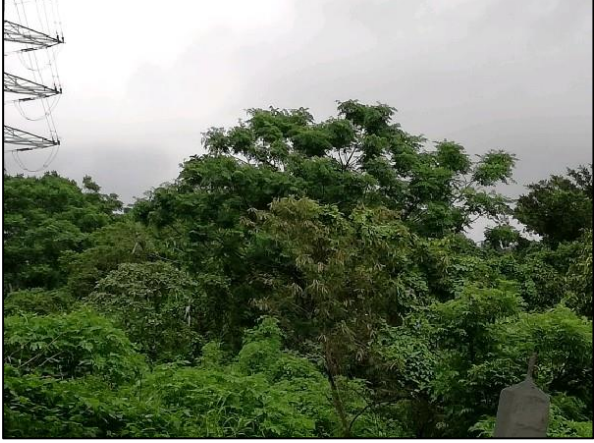
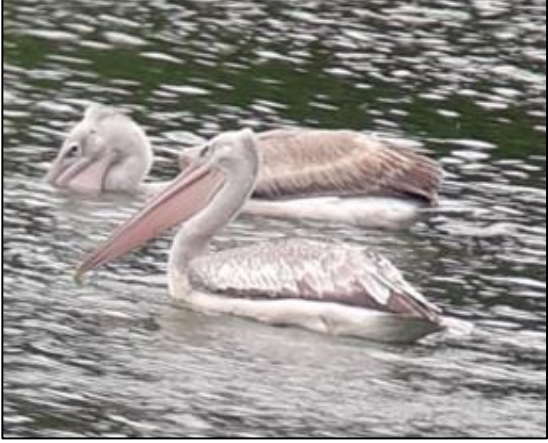
Table 24: Summary of terrestrial features of site 545

<p><i>Pink-backed pelican (Pelecanus rufescens)</i></p>			
Habitat Type	Thicket with an artificial dam				
Habitat features	Pink-backed pelican (<i>Pelecanus rufescens</i>) were found in an artificial dam close to the project area. The habitat is mainly thicket vegetation.				
Sensitivity	Low	Moderate	Moderate-High	High	
Current Impacts	Alien vegetation, Vegetation Clearing , Powerlines , Urban development				
Discussion:	Pink-backed pelican (<i>Pelecanus rufescens</i>) is VU on a regional scale (SANBI, 2016) and although parts of the habitat is disturbed, this species is very sensitive to disturbance and a 500m buffer were given to the area surrounding the dam.

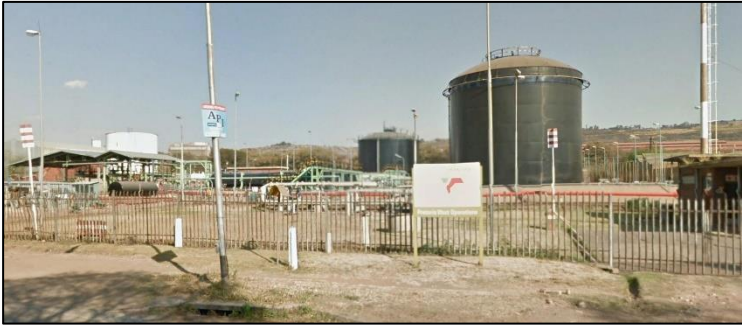
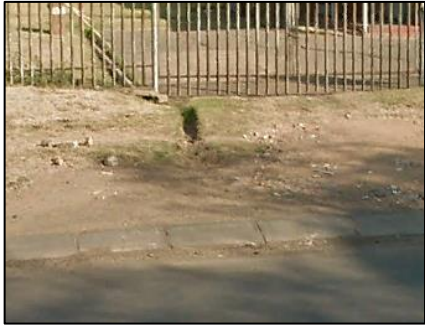
Table 25: Summary of terrestrial features of the Pretoria West depot.

Habitat Type	Transformed, with a park across the road				
Sensitivity	Low	Moderate	Moderate-High	High	
Current Impacts	Industrial area, footpaths, road and litter

Invasive plant species present	<p><i>Arundo donax</i> (Across the road)</p> <p><i>Jacaranda mimosifolia</i> (Across the road)</p> <p><i>Pennisetum clandestinum</i> (Kikuyu)</p>
Plant species suggested to be used in rehabilitation	<p><i>Elionurus muticus</i></p> <p><i>Eragrostis lehmanniana</i></p> <p><i>Pogonarthria squarrosa</i></p> <p><i>Searsia lancea</i></p> <p><i>Searsia pyroides</i></p> <p><i>Themeda triandra</i></p> <p><i>Vachellia karroo</i></p>

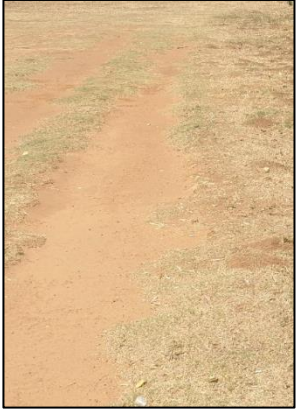
Table 26: Summary of terrestrial features of the Elardus Park depot.

<p>Footpath adjacent to fence</p>	
Habitat Type	Transformed adjacent to an urban greenbelt				
Sensitivity	Low	Moderate	Moderate-High	High	
Current Impacts	Erosion, footpaths, Urban area, roads				
Invasive plant species present	<p><i>Pennisetum clandestinum</i> (Kikuyu)</p> <p><i>Verbena bonariensis</i></p>				
Plant species suggested to be used in rehabilitation	<p><i>Cymbopogon caesius</i></p> <p><i>Elephantorrhiza elephantina</i></p> <p><i>Elionurus muticus</i></p>

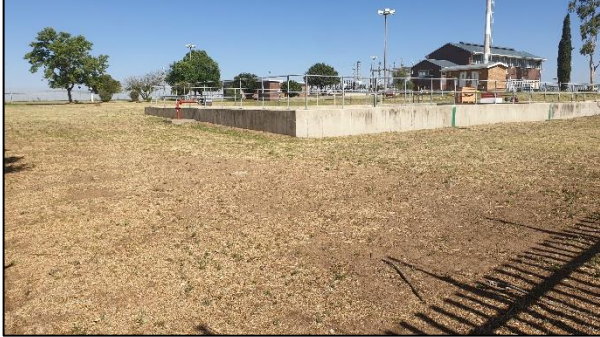
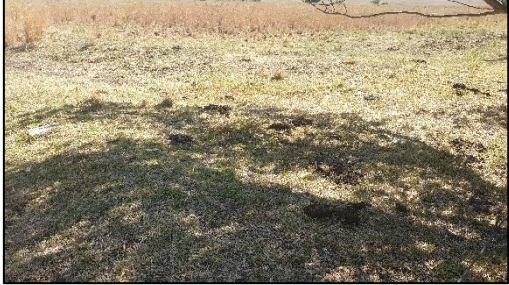
Table 27: Summary of terrestrial features of the Magdala depot.

<p>Cattle dung</p>	
Habitat Type	Secondary Grassland surrounds the station, the habitat within the station is transformed.		
Sensitivity	Low	Moderate	Moderate-High High
Current Impacts	Livestock, Vegetation Clearing, Powerlines and Roads		
Invasive plant species present	<i>Pennisetum clandestinum</i> (Kikuyu)		
Plant species suggested to be used in rehabilitation	<p><i>Themeda triandra</i></p> <p><i>Elionurus muticus</i></p> <p><i>Cymbopogon caesius</i></p>

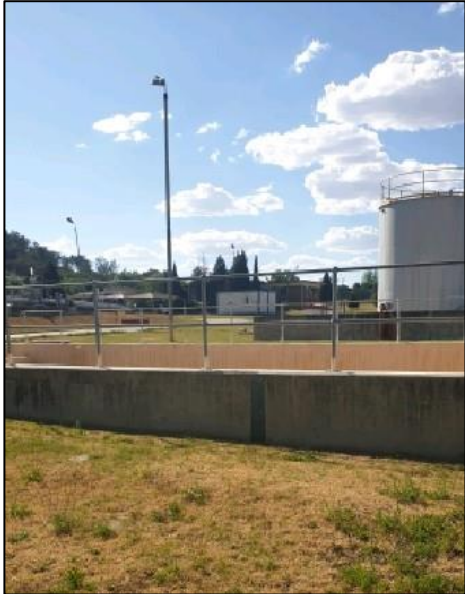
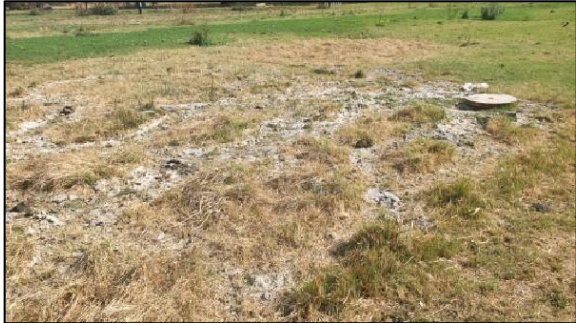
Depot Name	Bethlehem			Sample Date	2019/04/11
Site photo		Feature

<p>Sewage spilling out.</p>			
Habitat Type	Degraded and Transformed				
Sensitivity	Low	Moderate	Moderate-High	High	
Current Impacts	Livestock, Alien vegetation, Powerlines, Litter and Dumping, Roads, Urban development, Sewage				
Invasive plant species present	<i>Acacia mearnsii</i> (Black Wattle) <i>Eucalyptus camaldulensis</i> <i>Melia azedarach</i> <i>Pennisetum clandestinum</i> (Kikuyu) <i>Verbena bonariensis</i>				
Plant species suggested to be used in rehabilitation	<i>Aristida congesta</i> (Grass) <i>Aristida junciformis</i> (Grass) <i>Cynodon dactylon</i> (Grass) <i>Eragrostis chloromelas</i> (Grass) <i>Themeda triandra</i> (Grass)

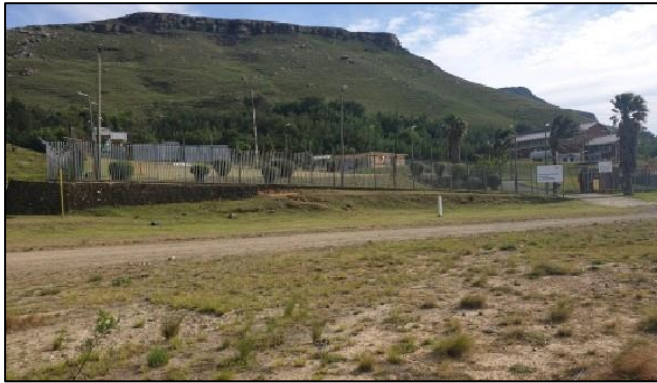
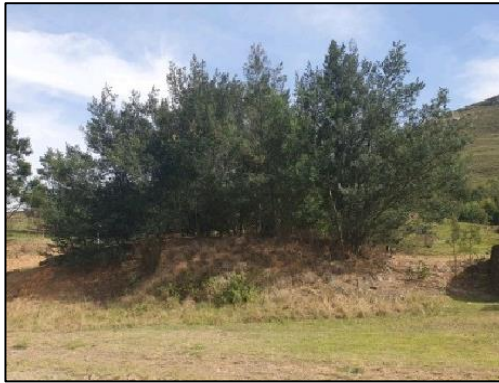
Table 29: Summary of terrestrial features of the Van Reenen depot.

<p><i>Acacia mearnsii</i> (Black Wattle)</p>		
Habitat Type	Degraded surrounding habitat whereas the area within the station is transformed. Topography is sensitive, erosion control mitigations will be crucial.				
Sensitivity	Low	Moderate	Moderate-High	High	
Current Impacts	Livestock, Alien vegetation, Powerlines, Litter and Dumping and Roads				
Invasive plant species present	<p><i>Acacia mearnsii</i> (Black Wattle) (Dominated) all individuals within and surrounding the station must be eradicated.</p> <p><i>Pennisetum clandestinum</i> (Kikuyu)</p> <p>Palm species</p>				
Plant species suggested to be used in rehabilitation	<p><i>Aristida diffusa</i> (Grass)</p> <p><i>Buddleja salviifolia</i> (Tree)</p> <p><i>Diospyros whyteana</i> (Tree)</p> <p><i>Elionurus muticus</i> (Grass)</p> <p><i>Eragrostis chloromelas</i> (Grass)</p> <p><i>Eragrostis curvula</i> (Grass)</p> <p><i>Leucosidea sericea</i> (Tree)</p> <p><i>Pennisetum sphacelatum</i> (Grass)</p>

Rehabilitation	<p>The existing slope of the area is inclining, and if left un-rehabilitated, severe soil erosion will exist; Geojute netting and Geojute logs are suggested.</p> <p>Seeds for plants:</p> <p>Lifestyle Seeds (https://lifestyleseeds.co.za/)</p> <p>Silverhill Seeds (http://www.silverhillseeds.co.za/default.asp)</p>

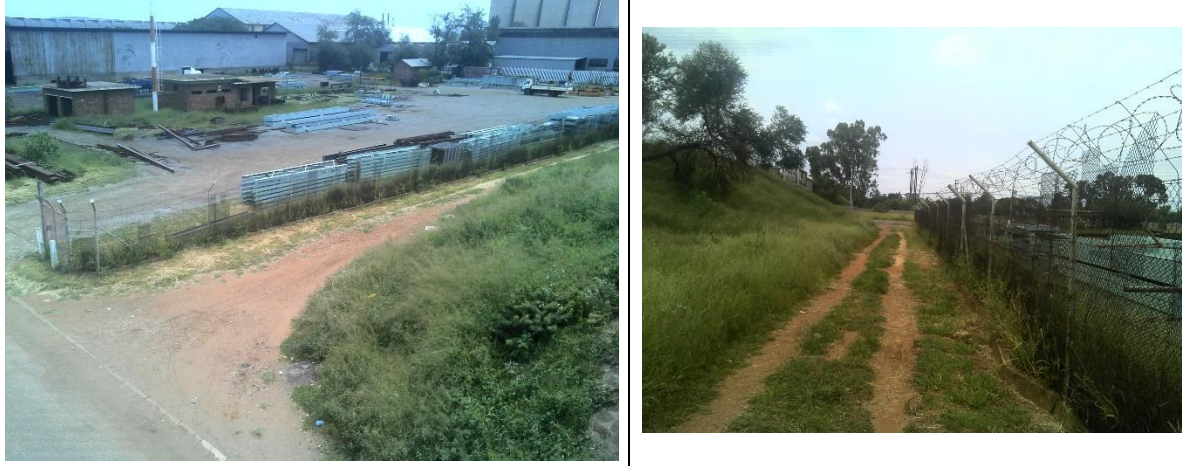
Depot Name	Potchefstroom			Sample Date	02/18/2020
Site photo

Habitat Type	Transformed, with storage of metal on site				
Sensitivity	Low X	Moderate	Moderate-High	High	
Current Impacts	Industrial area, dust, oil spills, road and metal storage				
Invasive plant species present	<i>Ipomoea purpurea</i> (On fence) <i>Pennisetum clandestinum</i> (Kikuyu) <i>Solanum mauritianum</i> <i>Bidens pilosa</i>				
Plant species suggested to be used in rehabilitation	<i>Elionurus muticus</i> <i>Eragrostis lehmanniana</i> <i>Eragrostis curvula</i> <i>Pogonarthria squarrosa</i> <i>Searsia lancea</i> <i>Searsia pyroides</i> <i>Themeda triandra</i> <i>Vachellia karroo</i>				
Rehabilitation	All materials stored on the area must be removed, all soil affected by oil must be removed and replaced with topsoil. Alien management must be made a priority as surrounding area has large numbers of alien invasive species.

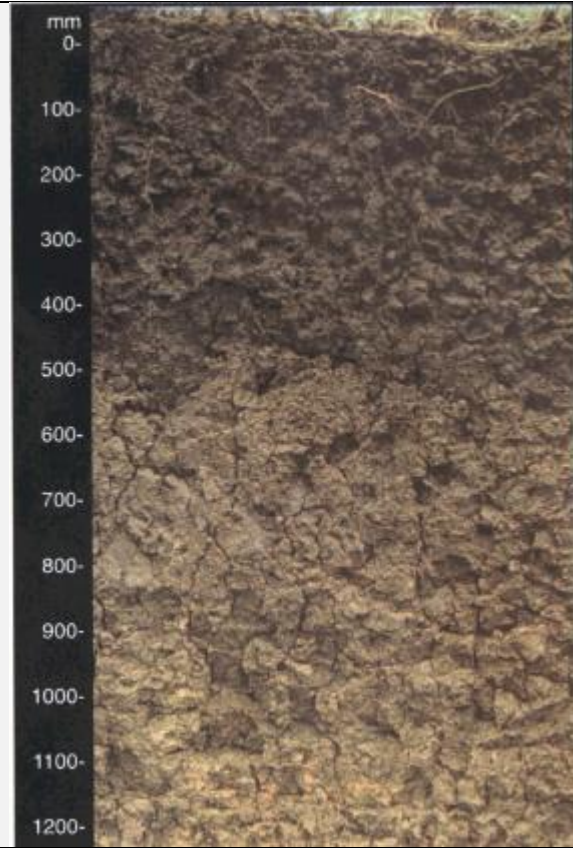
Table 32: Examples and descriptions of the dominant soil forms encountered on site (SASA, 1991)

<p>These soils were predominantly encountered between Bethlehem and Van Reenen. They typically occurred on mid-slope to channel topographies and were associated with permanent to seasonal conditions. They showed a melanic topsoil overlying a G horizon. The Melanic clays are very similar to that of the vertic clays in saturated conditions. Melanic clays have extremely good structure, which therefore allows for rapid infiltration and percolation without the possibility of precipitation accumulating within the first 50cm. Melanic clays will have a blocky structure which are approximately 5cm in diameter with extremely dark colours being present.</p>
Westleigh

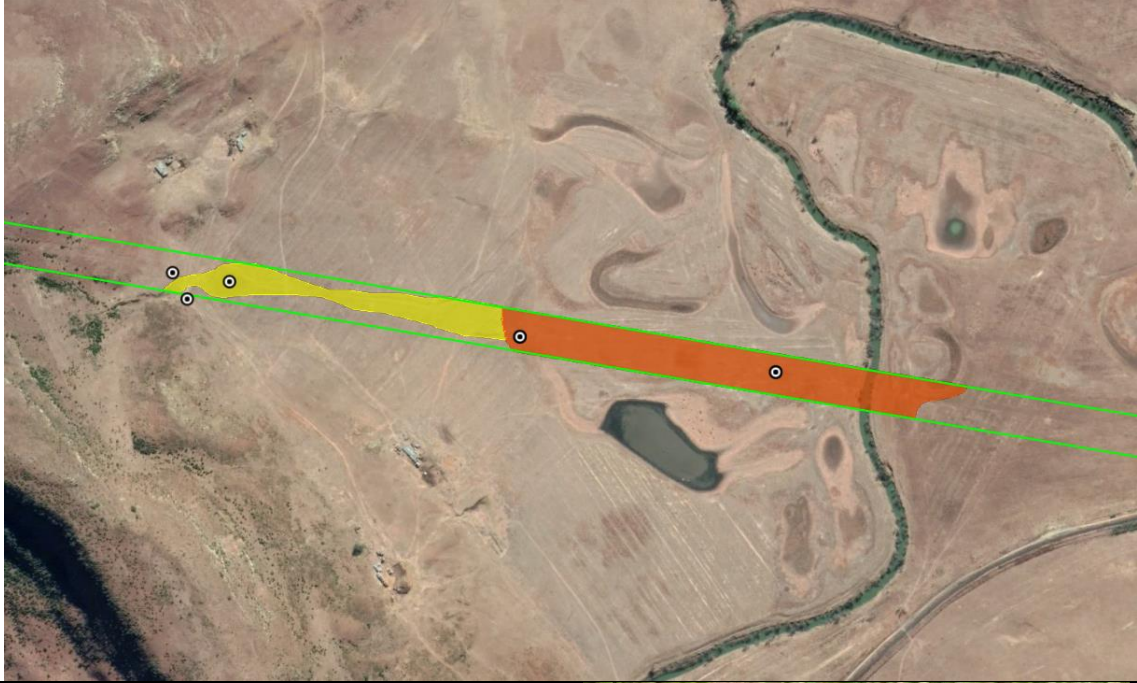
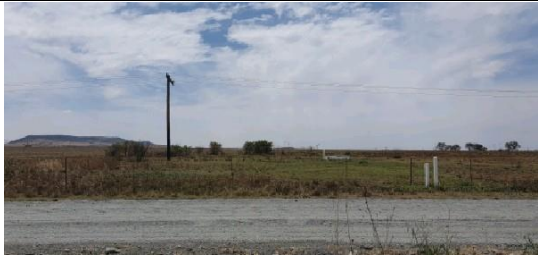
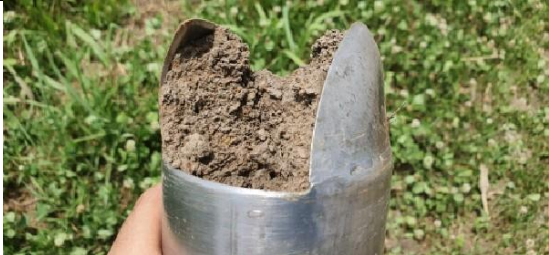
Table 35: Summary of the wetland system sampled at site 15

HGM Type	Floodplain	Site Code	15
Location	-28.349571, 29.214173	Priority	Very High

Wetland		Katspruit	
Wetland FEPA	No	River FEPA	FEPA Code 1
Description	Very Intermittently inundated system, hydrophytic indicators few, bed covered by grass (<i>Themeda triandra</i> dominated). Deep alluvial deposits with feint signs of mottling.		
Impacts	Powerlines, road crossings, alien and invasive plants present but minor and restricted to road verge. Mild grazing pressure from game.		
Assessment Rating	PES	EIS	Ecosystem Services
	B: Largely Modified	Moderate	Very High

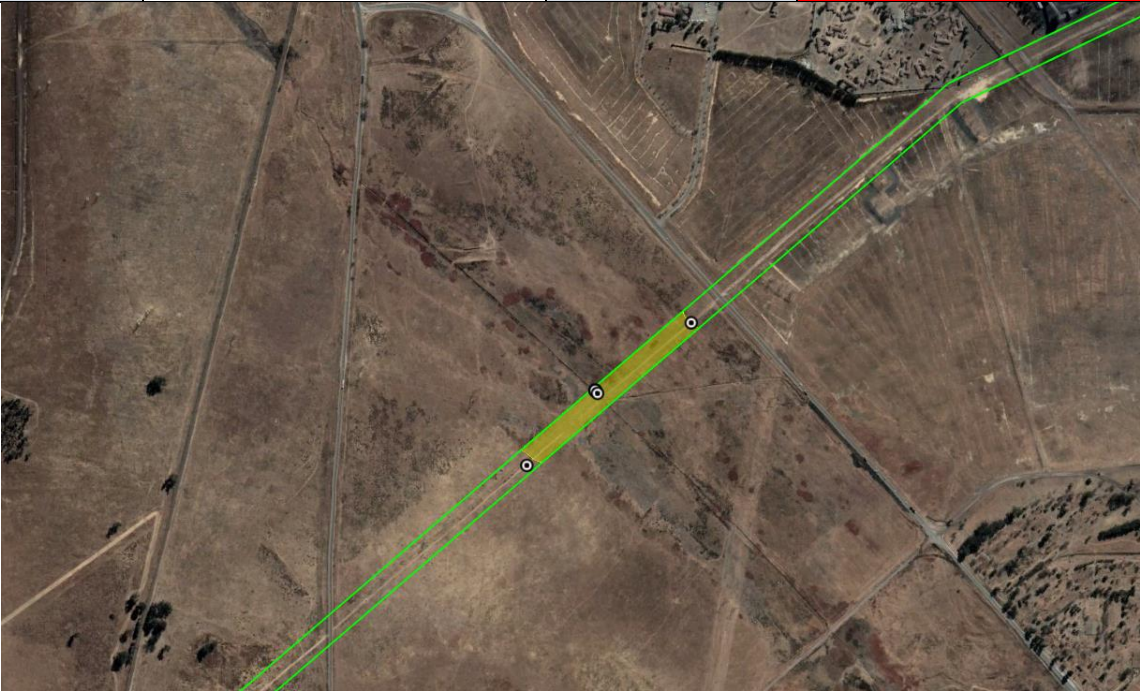
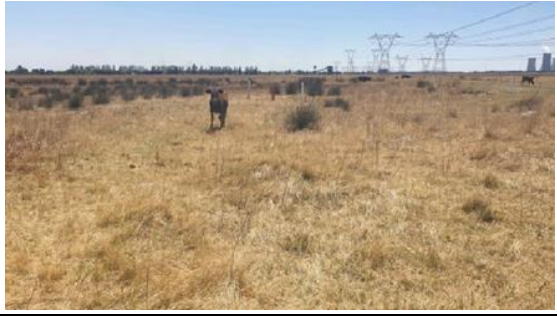
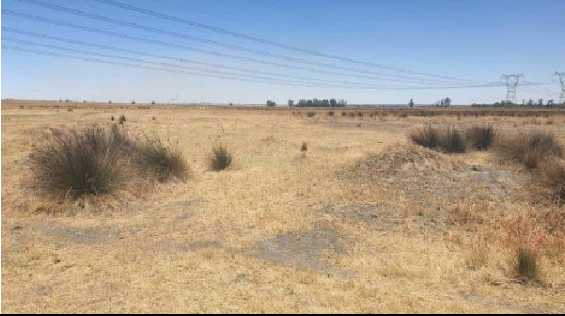
HGM Type	Flat	Site Code	87
Location	-26.750481, 27.926415	Priority	Very High

Wetland		<i>Scirpoides</i> spp on edge of temporary zone	
Wetland FEPA	No	River FEPA	No
Description	Degraded area with several wetlands. Fragmented from surrounding areas.		
Impacts	Livestock, Alien vegetation, Powerlines, Roads. Old degraded Grassland due to livestock mainly		
Assessment Rating	PES	EIS	Ecosystem Services
	C: Moderately Modified	High	Moderately High

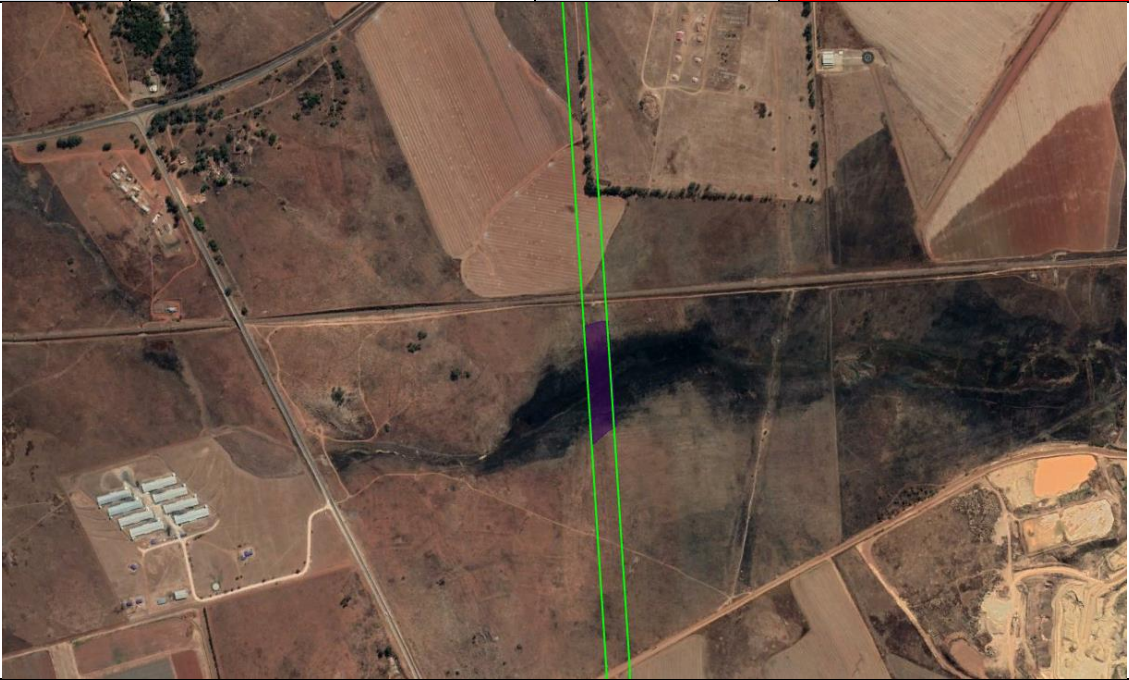
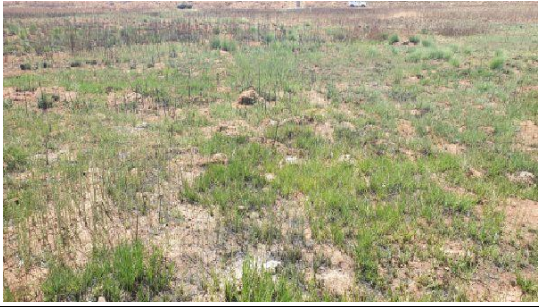
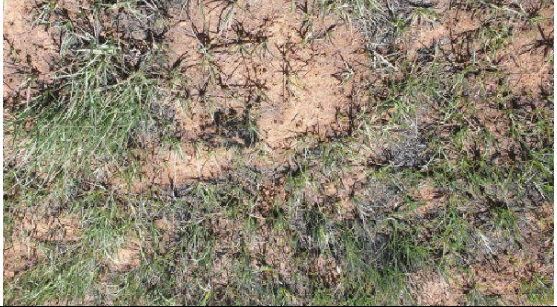
HGM Type	Unchanneled valley-bottom	Site Code	82
Location	-26.024605, 28.321810	Priority	Very High

Wetland		Dundee Soils	
Wetland FEPA	FEPA Code 1	River FEPA	No
Description	Large system, wide system, shallow cross-sectional profile. Relatively intact vegetation.		
Impacts	Livestock, Railway decreased roughness. Burning		
Assessment Rating	PES	EIS	Ecosystem Services
	B: Largely natural	Very High	Moderately High

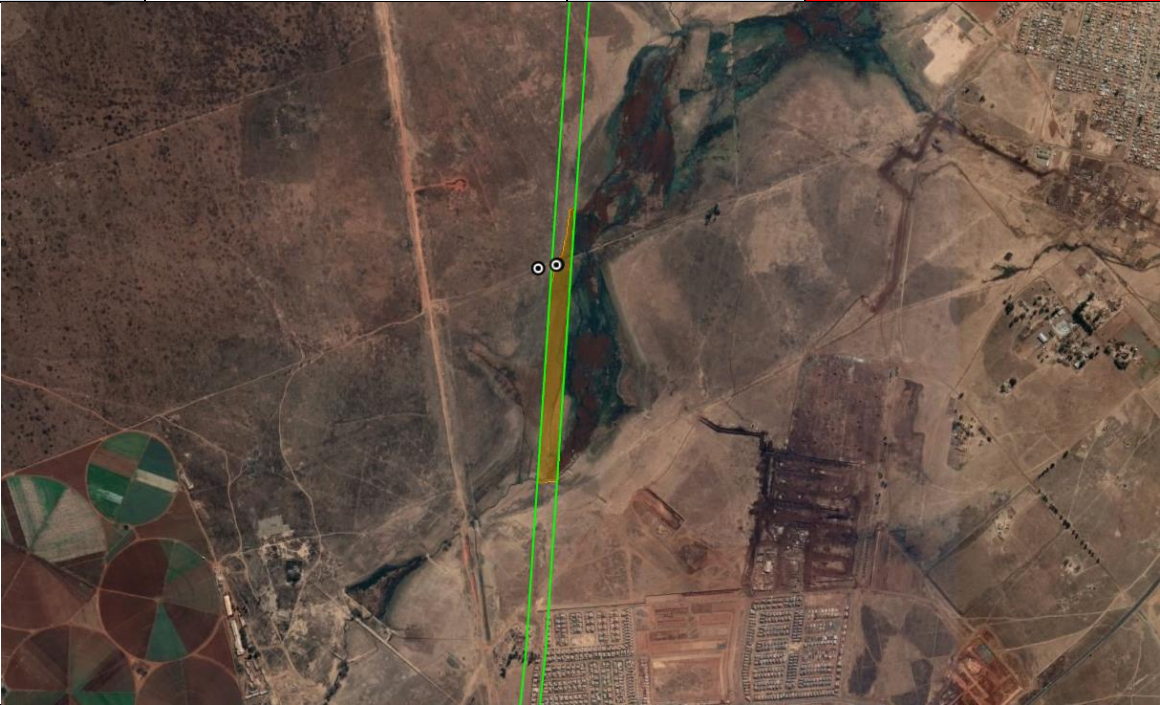
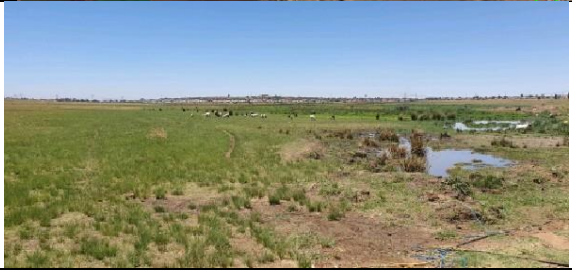
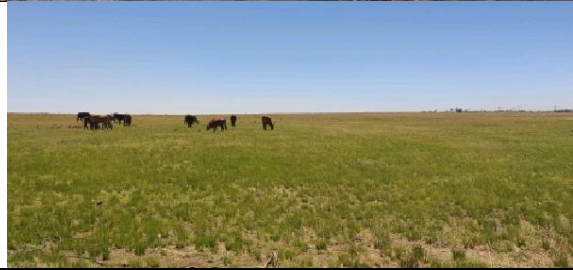
Table 39: Summary of the wetland system sampled at site 19

HGM Type	Floodplain	Site Code	19
Location	-26.399984, 28.109348	Priority	Very High

Wetland		Livestock	
Wetland FEPA	No	River FEPA	No
Description	Large wetland maintains much of its functionality although vegetation roughness has been significantly reduced by livestock grazing.		
Impacts	Livestock, Alien vegetation, Litter and Dumping, Roads		
Assessment Rating	PES	EIS	Ecosystem Services
	C: Moderately modified	Very High	High

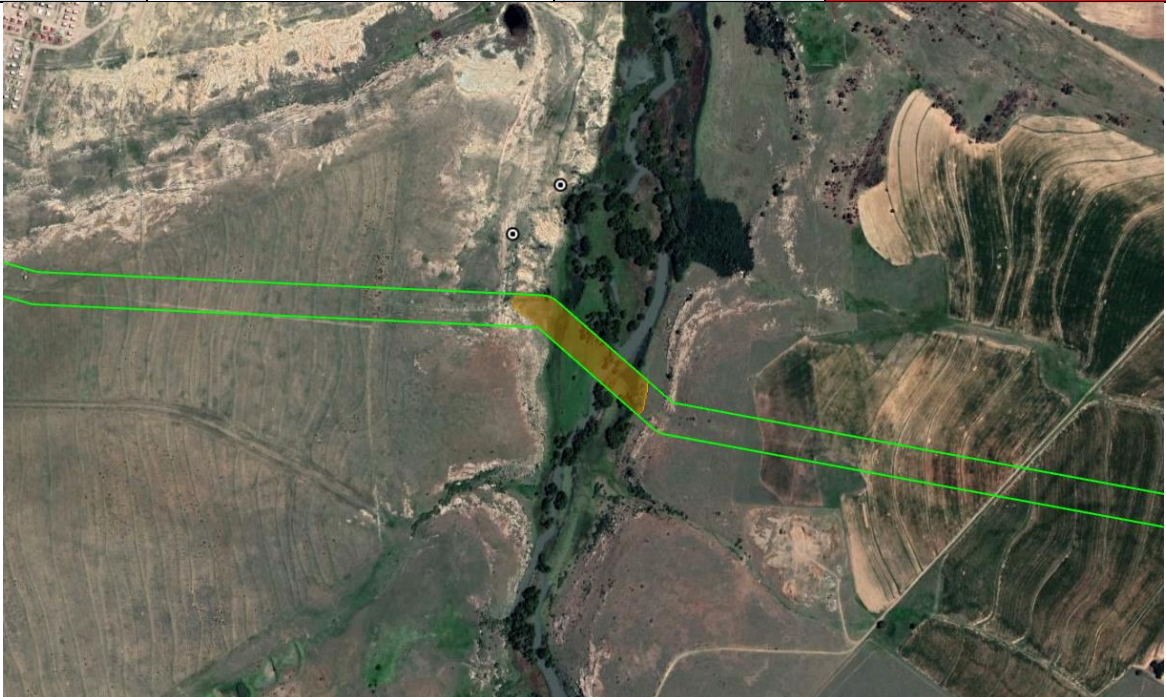
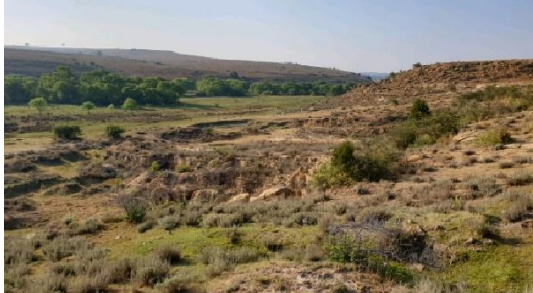
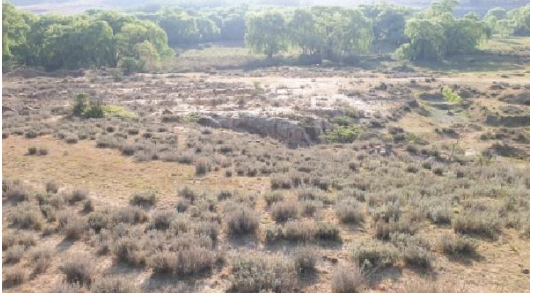
Table 40: Summary of the wetland system sampled at site 14

HGM Type	Floodplain	Site Code	14
Location	-28.204761, 28.362827	Priority	Very High

Wetland		<i>Serisium vulgare</i>	
Wetland FEPA	No	River FEPA	No
Description	Impacted area due to proximity of urban area. Avoid riparian and rocky outcrop area.		
Impacts	Erosion, livestock, alien vegetation, litter and dumping, Roads, urban development		
Assessment Rating	PES	EIS	Ecosystem Services
	C: Moderately Modified	Very High	High

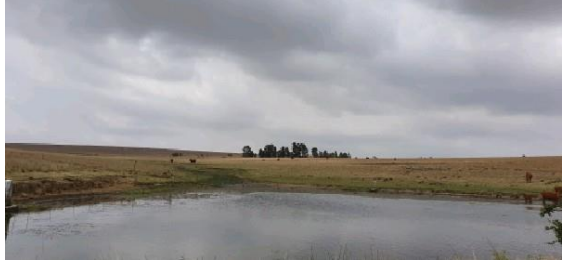
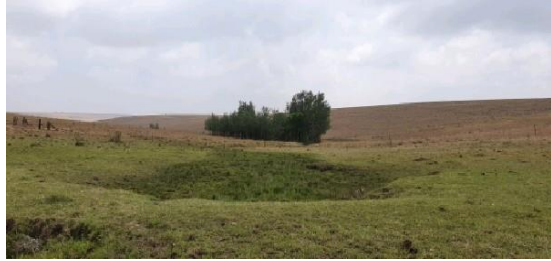
Table 41: Summary of the wetland system sampled at site 54

HGM Type	Channelled valley-bottom	Site Code	54
Location	-28.329719, 29.112475	Priority	Very High

Wetland		View looking downstream, <i>Eucalyptus camaldulensis</i> in background.	
Wetland FEPA	No	River FEPA	No
Description	Small yet permanently saturated system with vegetation in a largely natural state.		
Impacts	Alien vegetation and dams (minor).		
Assessment Rating	PES	EIS	Ecosystem Services
	C: Moderately modified	High	High

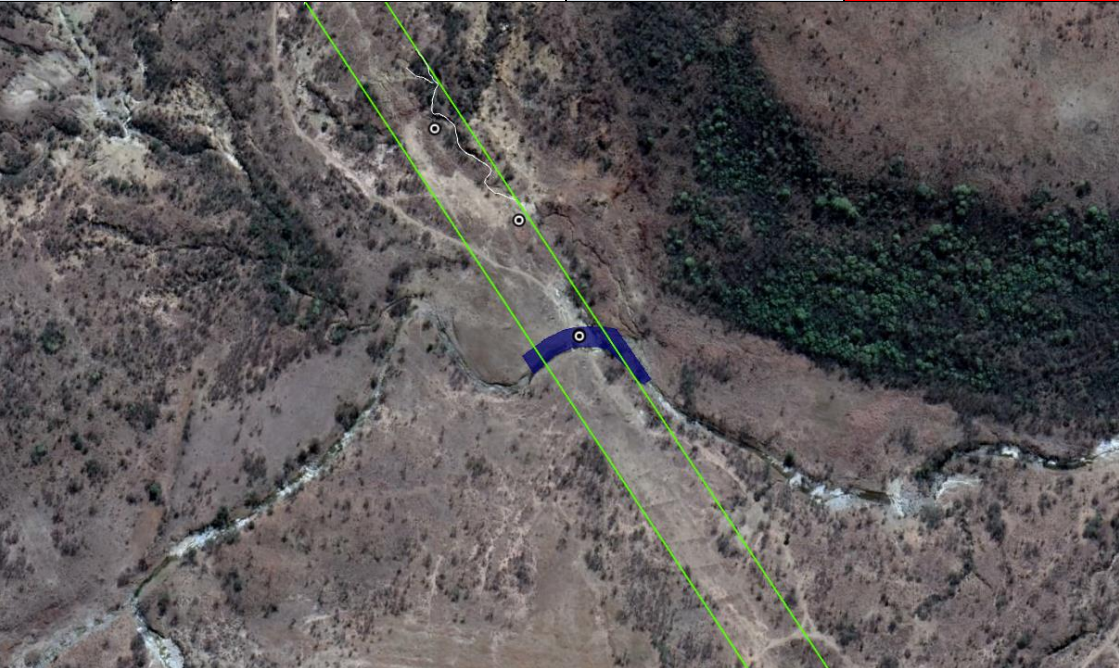
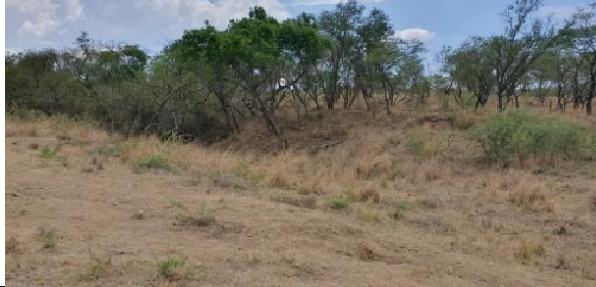
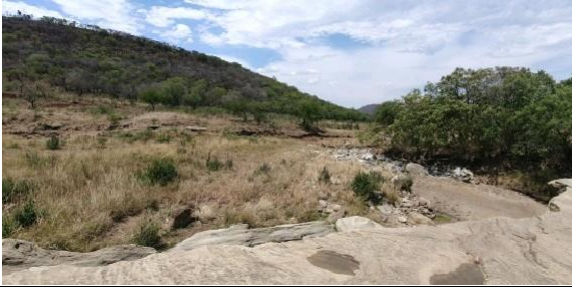
Table 42: Summary of the wetland system sampled at site 57

HGM Type	Channelled valley-bottom	Site Code	57
Location	-28.951001, 29.886447	Priority	Very High

Wetland		Downstream showing exposed bedrock	
Wetland FEPA	No	River FEPA	No
Description	Large intact channelled valley-bottom system in nature reserve. Extensive sheets of exposed bedrock.		
Impacts	Slight erosion from overgrazing by game.		
Assessment Rating	PES	EIS	Ecosystem Services
	C: Moderately modified	Very High	Moderately High

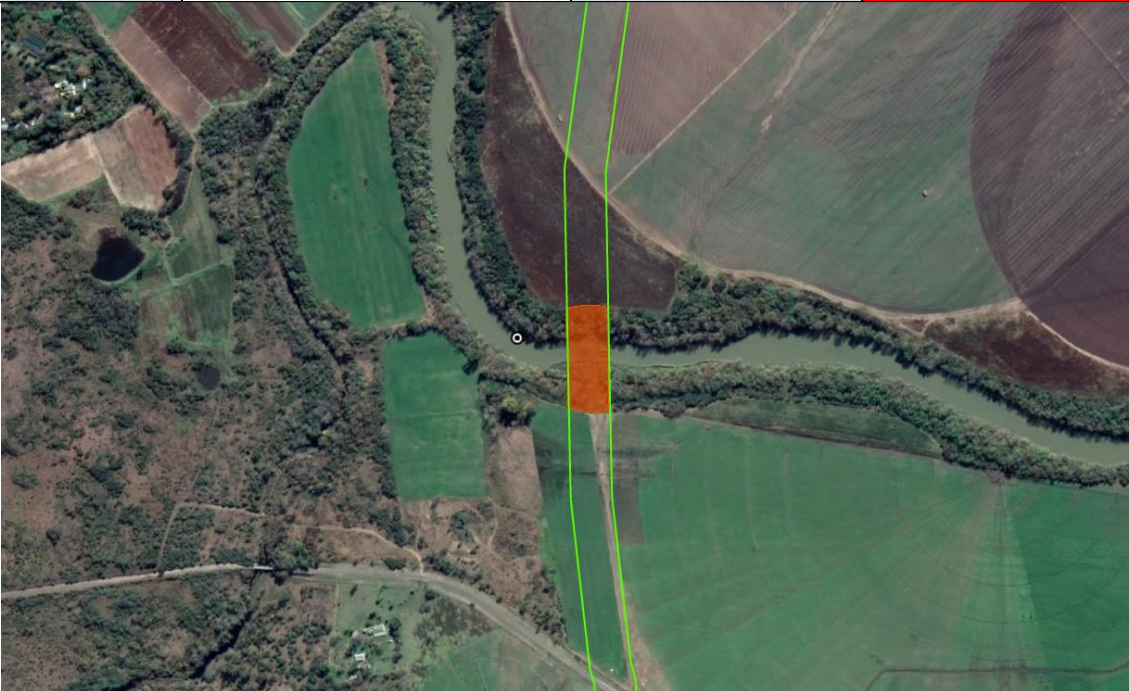
HGM Type	Floodplain	Site Code	12
Location	28°44'32.69"S, 29°48'12.41"E	Priority	Very High

Wetland FEPA	FEPA Code 1	River FEPA	FEPA Code 4
Description	Thukela River. Large floodplain with distinct channel. Moderate to high channel sinuosity.		
Impacts	Alien vegetation has replaced natural riparian zone. Crop cultivation.		
Assessment Rating	PES	EIS	Ecosystem Services
	D: Largely modified	High	High

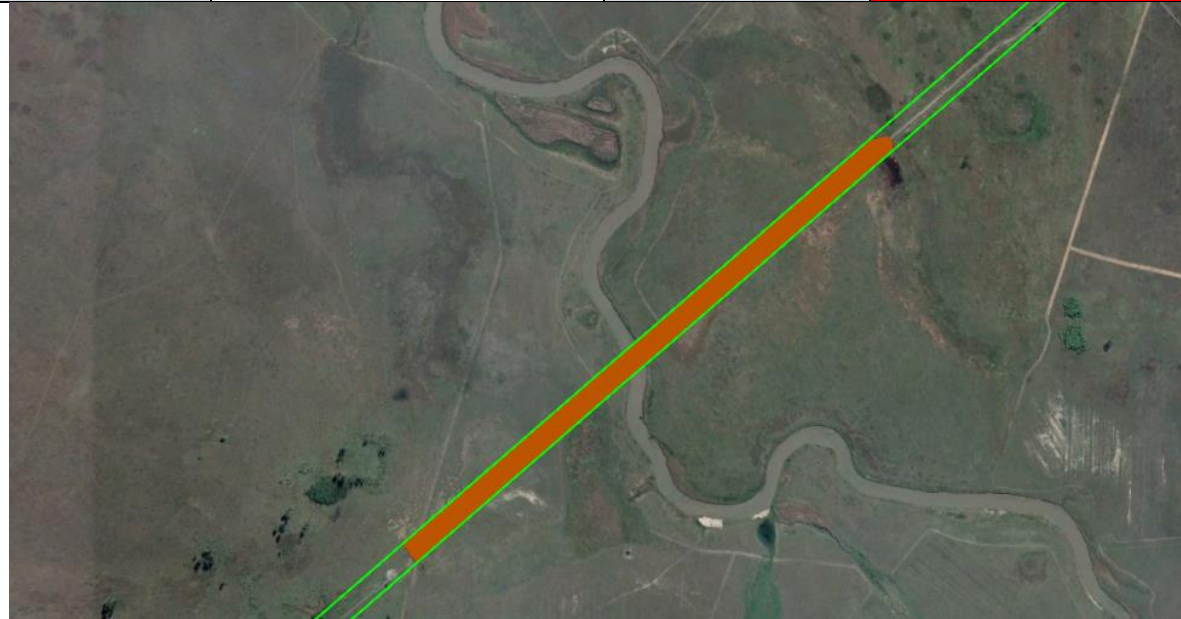
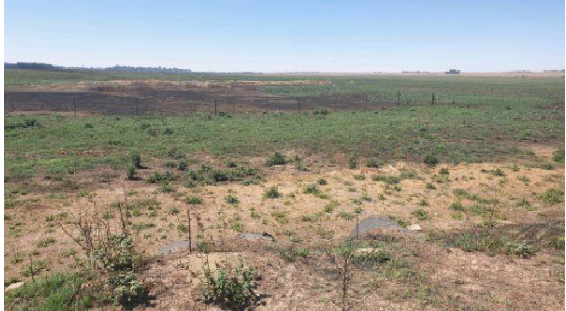
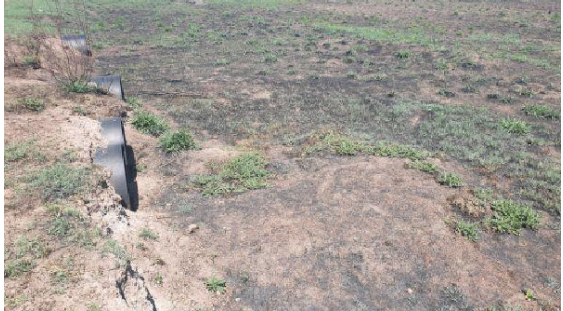
HGM Type	Floodplain	Site Code	17
Location	-26.773718, 27.896160	Priority	Very High

Wetland		Pipe culverts for dirt road crossings	
Wetland FEPA	No	River FEPA	No
Description	Taaibospruit. Particularly large, wide, low gradient floodplain. Vegetation cover low. Deep alluvial Dundee soils. Signs of past cultivation.		
Impacts	Burning, weedy annuals, culvert, livestock, farming, alien vegetation, roads.		
Assessment Rating	PES	EIS	Ecosystem Services
	C: Moderately modified	High	Intermediate

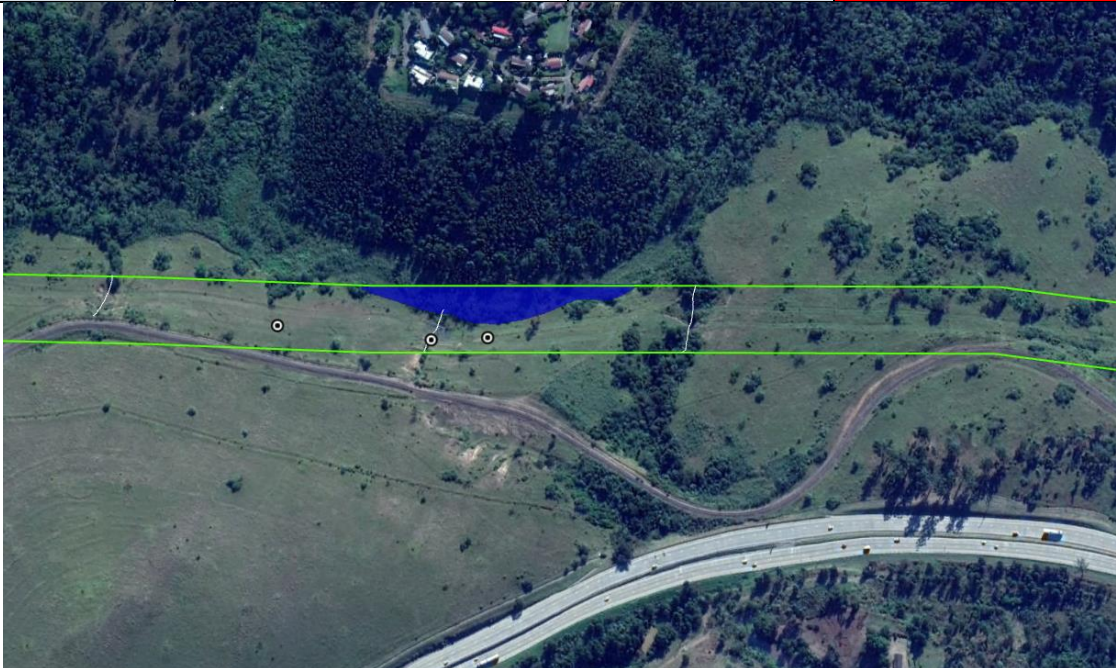
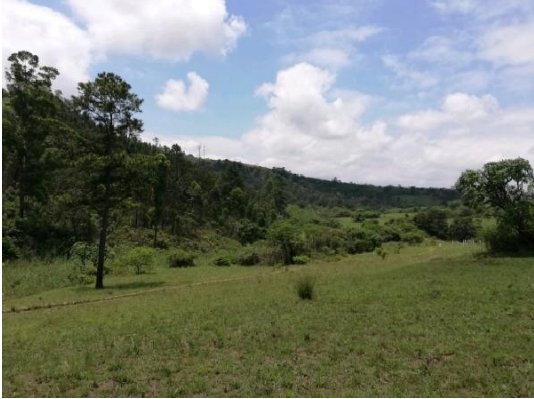
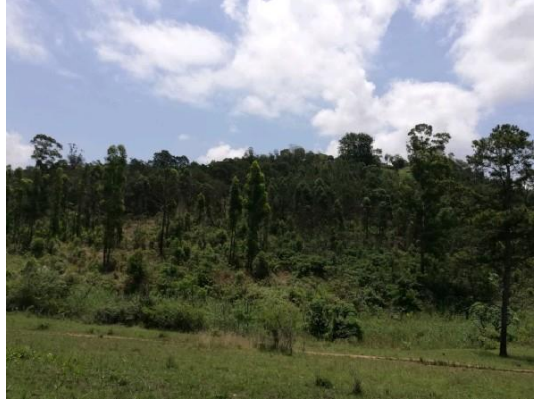
HGM Type	Channelled valley-bottom	Site Code	59
Location	29°44'5.43"S, 30°38'31.38"E	Priority	Very High

Wetland		Encroachment by <i>Pinus</i> spp.	
Wetland FEPA	No	River FEPA	Np
Description	Livestock grazing limited to grassland. Alien and invasive plant species tended to occur in more intensive growth on south-facing slope. Sand could be sourced locally from surrounding grassland. No SCC or protected species observed.		
Impacts	Erosion, Livestock, Alien vegetation		
Assessment Rating	PES	EIS	Ecosystem Services
	C: Moderately modified	High	Intermediate

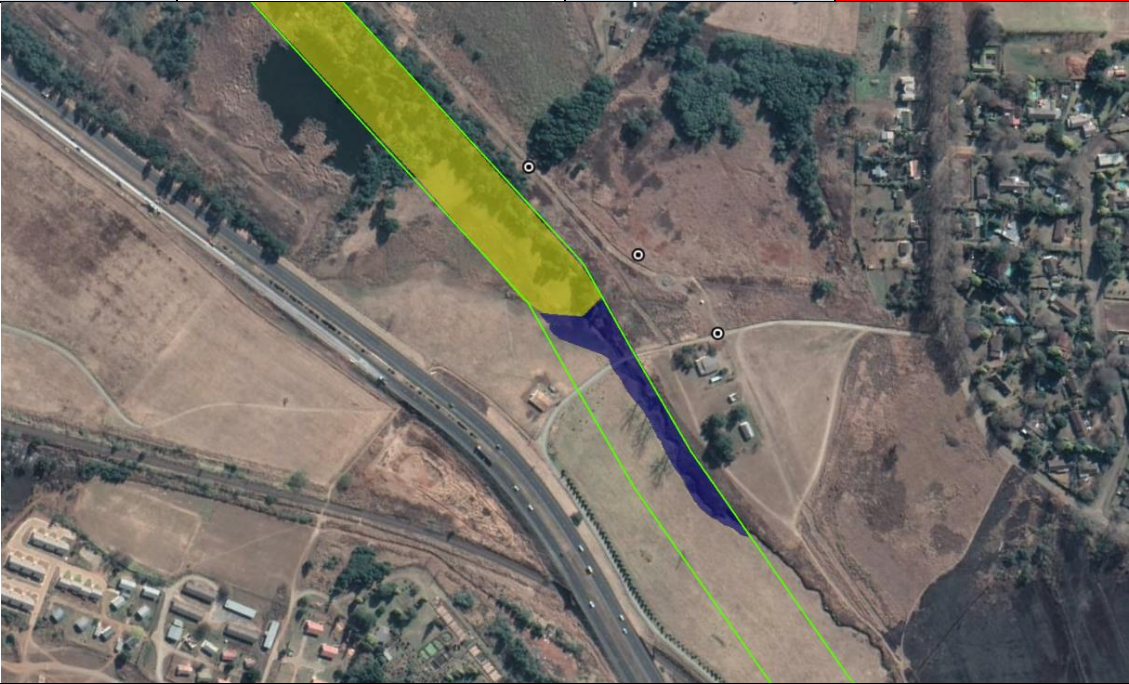
Table 46: Summary of the wetland system sampled at site 58

HGM Type	Channelled valley-bottom	Site Code	58
Location	29°29'3.74"S, 30°12'11.36"E	Priority	Very High

Wetland showing young <i>Phragmites australis</i>		Soil ped showing coarse sandy Katspruit soils	
Wetland FEPA	FEPA Code 1	River FEPA	No
Description	A large permanently saturated system with signs of channel erosion.		
Impacts	Altered surface roughness, alien vegetation.		
Assessment Rating	PES	EIS	Ecosystem Services
	D: Largely modified	Moderate	Intermediate

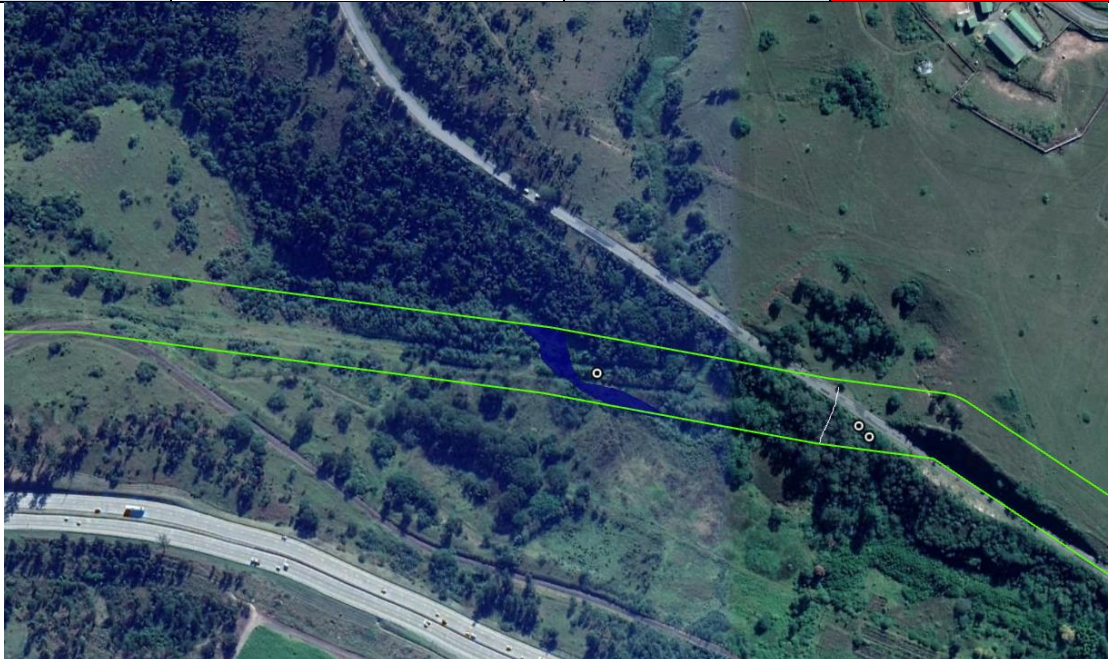
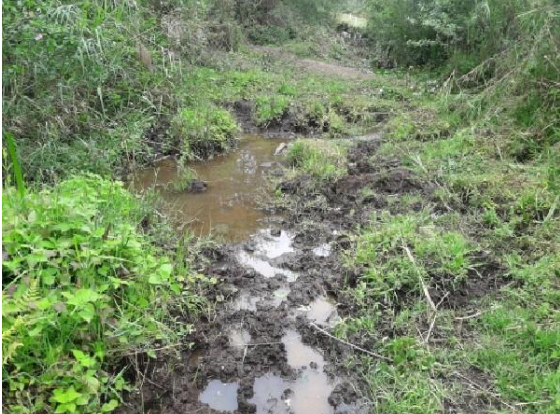
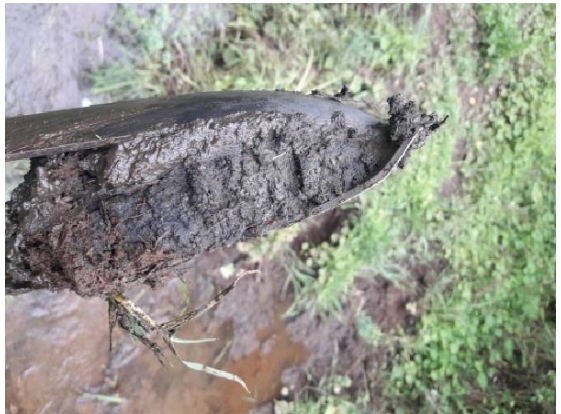
Table 47: Summary of the wetland system sampled at site 53

HGM Type	Channelled valley-bottom	Site Code	53
Location	29°44'6.57"S, 30°39'6.88"E	Priority	Very High

Wetland showing signs of soil poaching by livestock		G horizon in Katspruit soil form	
Wetland FEPA	No	River FEPA	No
Description	A relatively intact channelled valley-bottom system in incised terrain.		
Impacts	Alien vegetation.		
Assessment Rating	PES	EIS	Ecosystem Services
	B: Largely Natural	High	High

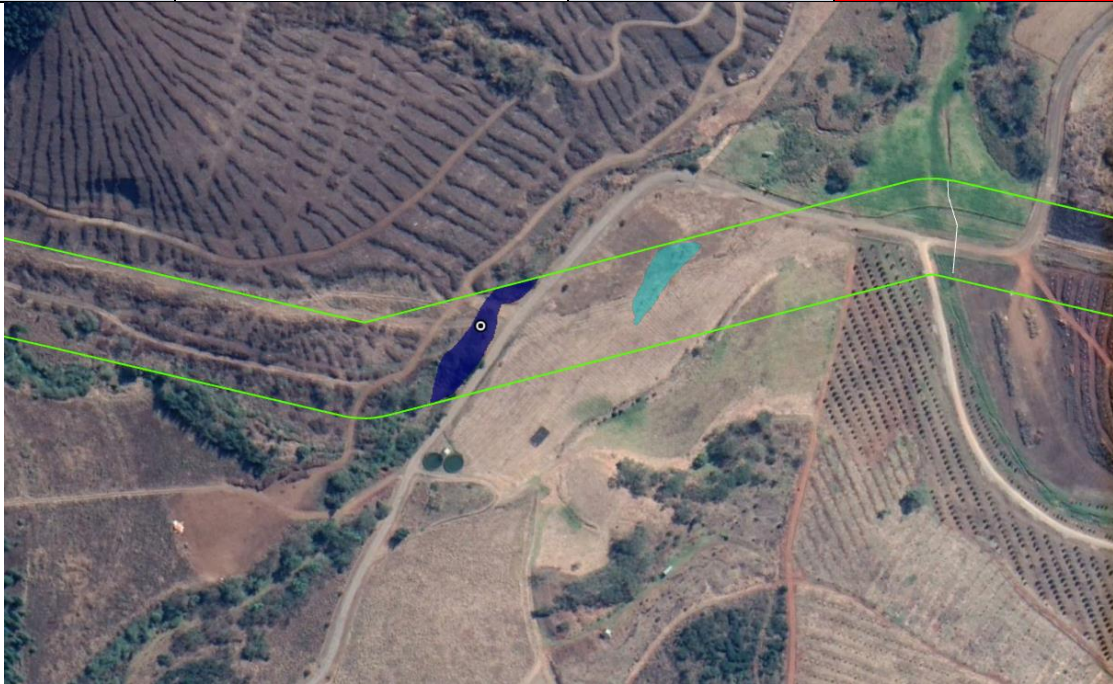
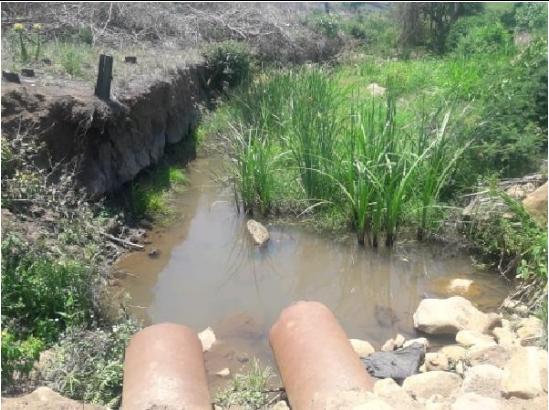
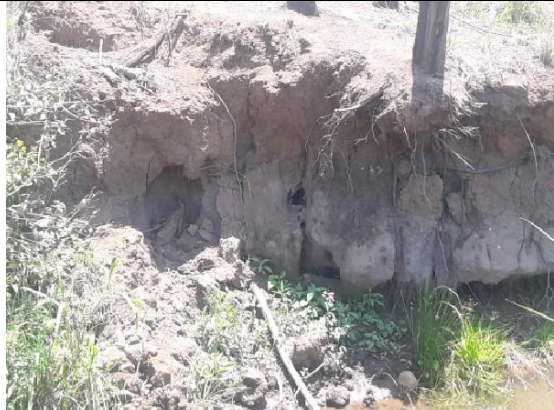
Table 48: Summary of the wetland system sampled at site 51

HGM Type	Channelled valley-bottom	Site Code	51
Location	-29.5223, 30.3276	Priority	Very High

Wetland showing pipe culverts		Erosion downstream of culverts	
Wetland FEPA	No	River FEPA	No
Description	A small yet permanently saturated channelled valley-bottom wetland. The presence of two small pipe culverts serves to funnel and direct flows which has led to notable erosion of the bed and banks.		
Impacts	Erosion, culverts, farming, alien vegetation, roads		
Assessment Rating	PES	EIS	Ecosystem Services
	D: Largely modified	Moderate	Intermediate

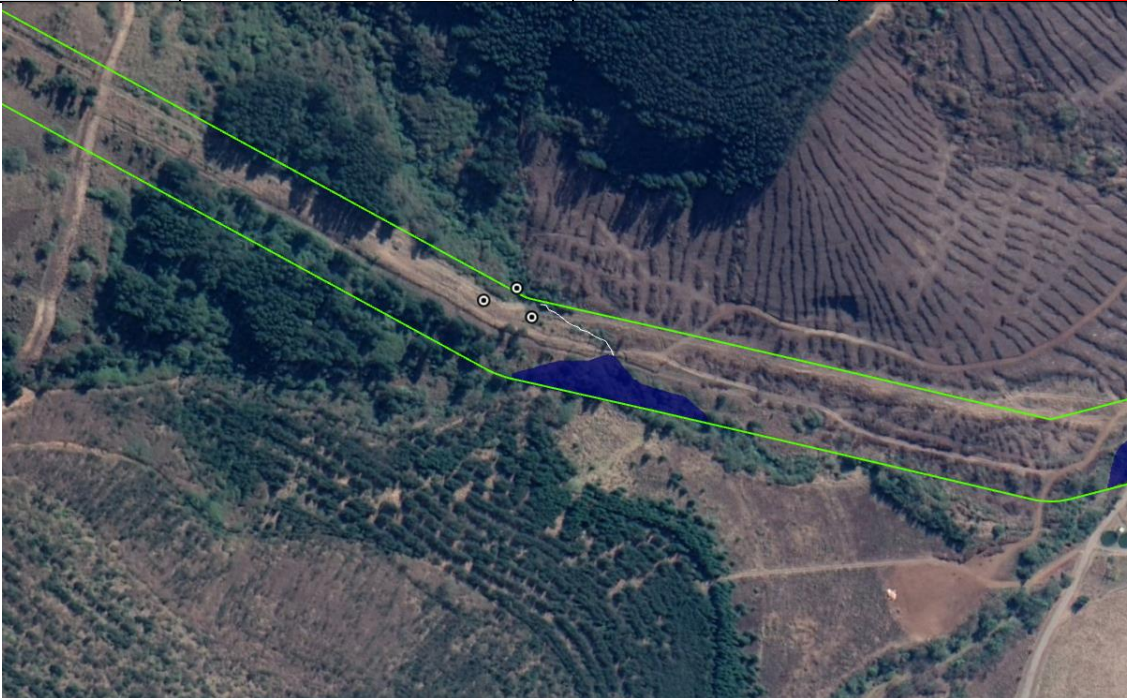
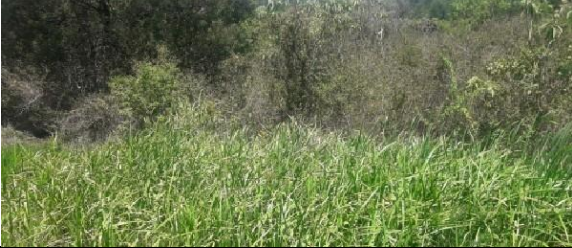
Table 49: Summary of the wetland system sampled at site 50

HGM Type	Channelled valley-bottom		Site Code	50
Location	-29.5216, 30.3226		Priority	Very High

Wetland				
Wetland FEPA	No	River FEPA	No	
Description	Small, permanently inundated channelled valley-bottom wetland surrounded by farming.			
Impacts	Erosion, alien vegetation, farming.			
Assessment Rating	PES	EIS	Ecosystem Services	
	D: Largely modified	Moderate	Intermediate
