**BIODIVERSITY AND WATER RESOURCE
ASSESSMENT FOR THE PROPOSED
DECOMMISSIONING OF THE TRANSNET
DURBAN TO JOHANNESBURG PIPELINE
(DJP)**

Gauteng, Free State and KwaZulu Natal

Date
December 2019

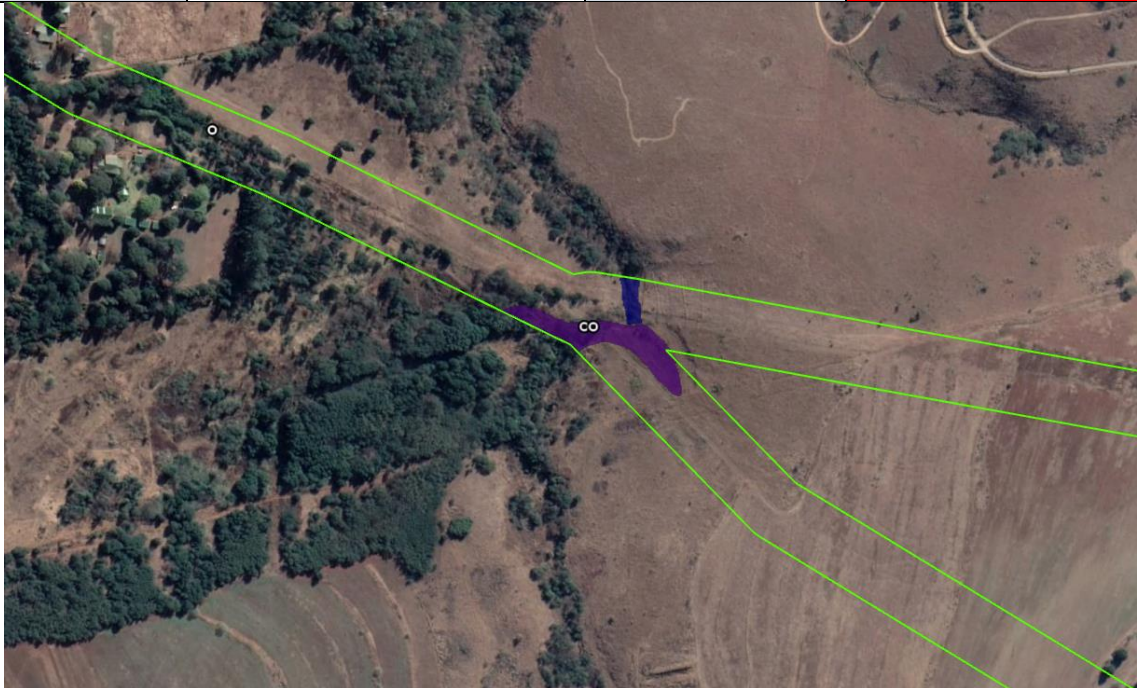
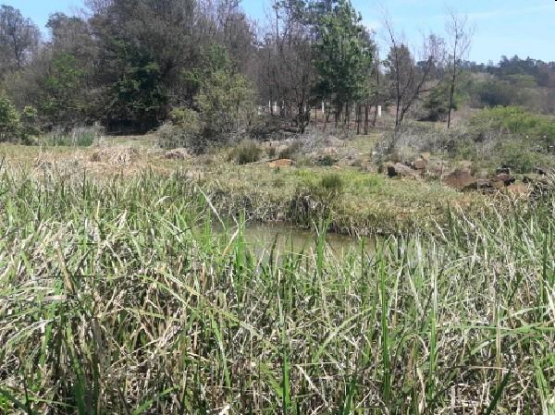
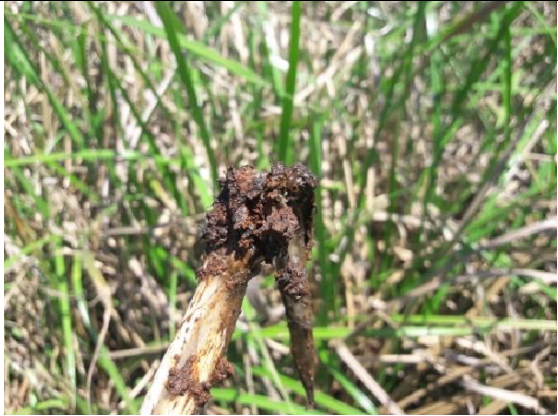
Table 50: Summary of the wetland system sampled at site W131CBI

HGM Type	Channelled valley-bottom	Site Code	W131CBI
Location	-29.5123, 30.2661	Priority	Very High

Wetland		Root mottling.	
Wetland FEPA	Fepa Code 1	River FEPA	No
Description	Small permanently inundated system with dense hydromorphic vegetation cover.		
Impacts	Livestock, alien vegetation.		
Assessment Rating	PES	EIS	Ecosystem Services
	C: Moderately modified	High	Intermediate

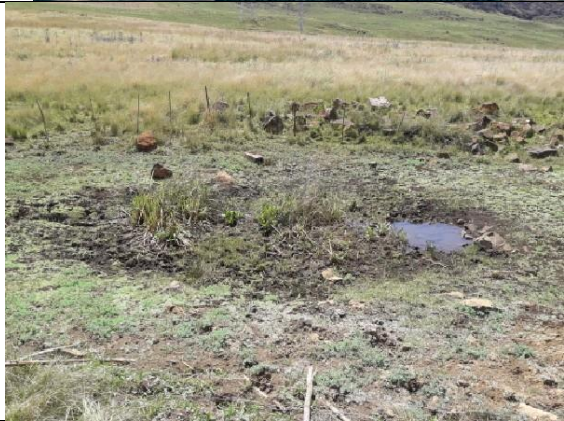
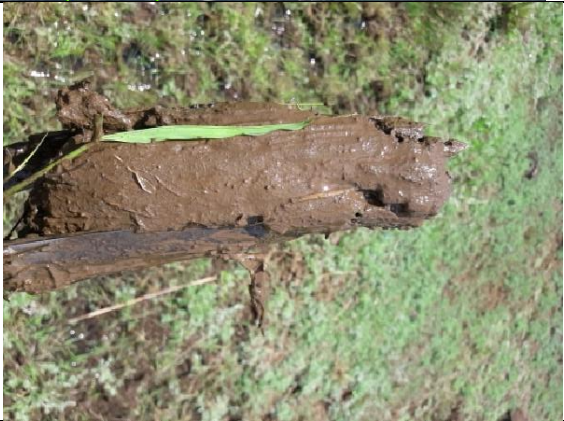
Table 51: Summary of the wetland system sampled at site 46

HGM Type	Channelled valley-bottom	Site Code	46
Location	29°23'33.12"S, 30° 9'10.15"E	Priority	Very High

Wetland		Katspruit soils	
Wetland FEPA	No	River FEPA	No
Description	Small permanently inundated system, remote largely intact.		
Impacts	Erosion, livestock, alien vegetation		
Assessment Rating	PES	EIS	Ecosystem Services
	D: Largely modified	Moderate	Moderately Low

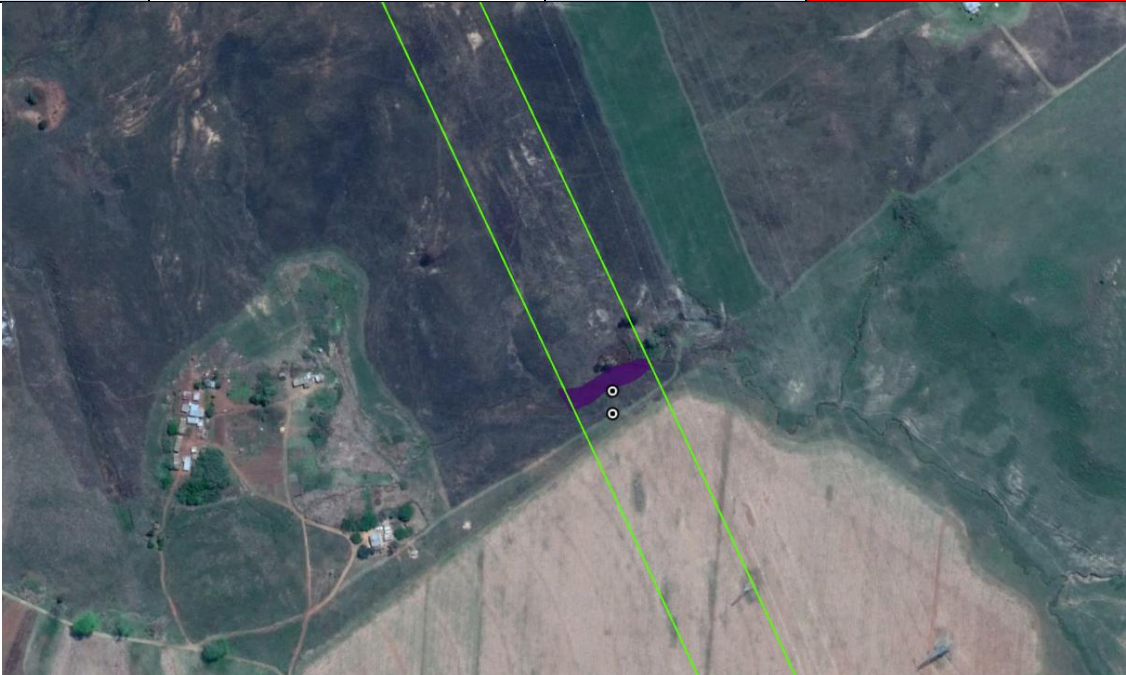
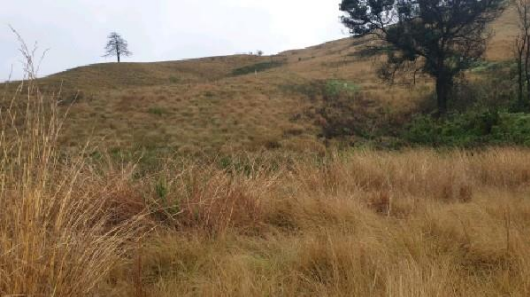
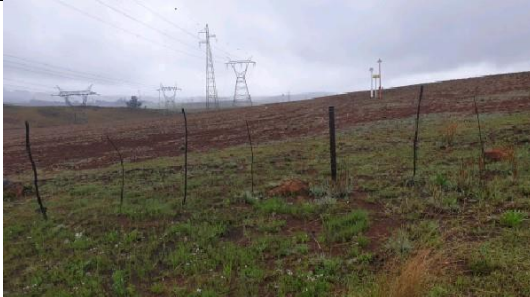
Table 52: Summary of the wetland system sampled at site 83

HGM Type	Unchanneled valley-bottom	Site Code	83
Location	-29.4047, 30.1597	Priority	Very High

Wetland		Other	
Wetland FEPA	No	River FEPA	No
Description	Intact mountain grassland to the north. Agriculture to the south. Pump from agriculture		
Impacts	Farming, powerlines, adjacent impacts		
Assessment Rating	PES	EIS	Ecosystem Services
	C: Moderately modified	High	High

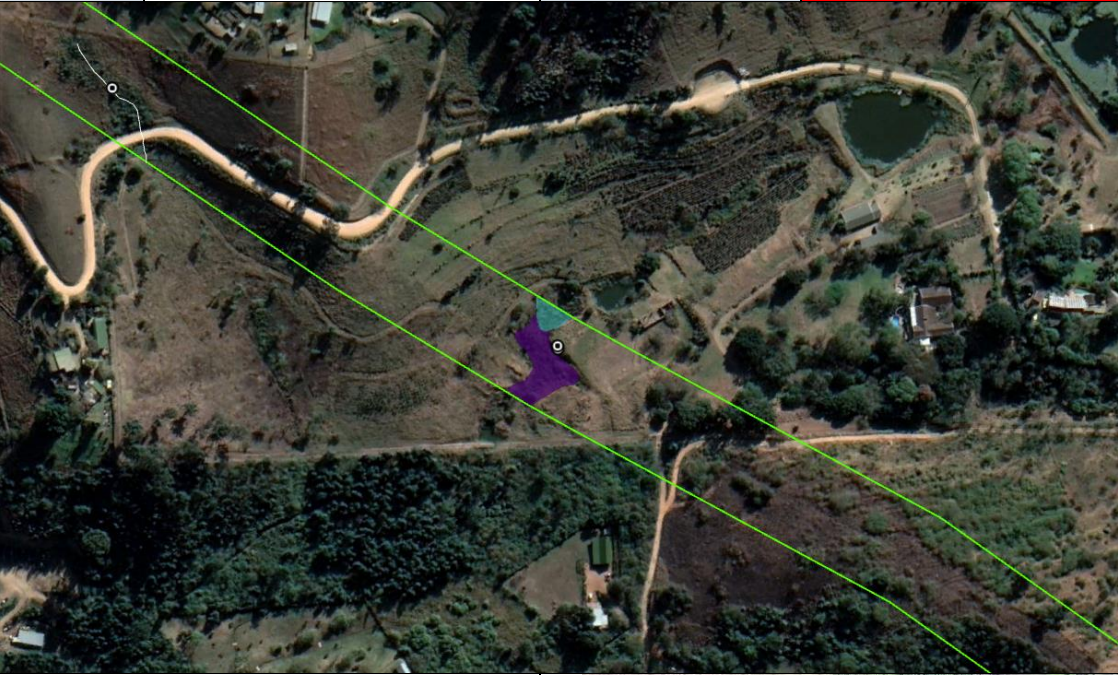
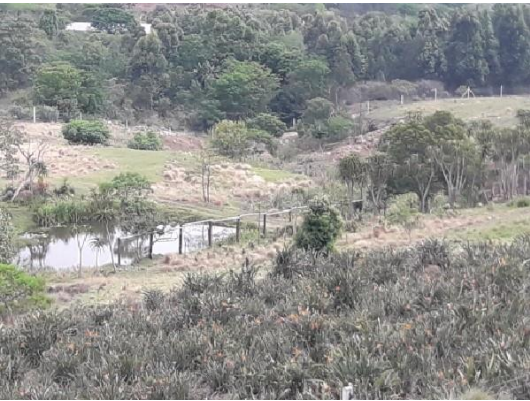
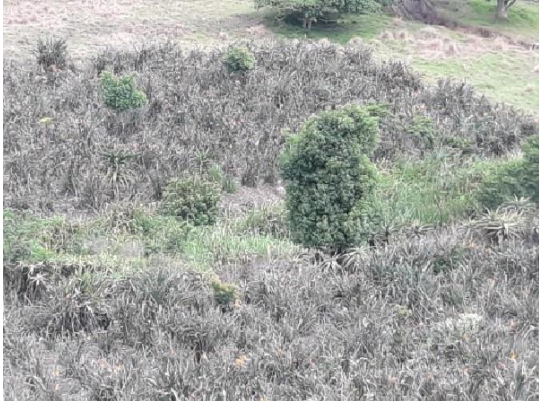
Table 53: Summary of the wetland system sampled at site 78

HGM Type	Unchanneled valley-bottom		Site Code	78	
Location	-29.7663, 30.7045		Priority	Very High

Wetland			<i>Acacia melanoxylon</i> encroaching om wetland		
Wetland FEPA	No		River FEPA	No	
Description	Moderate to small, permanent system with dense hydrophytic vegetation.				
Impacts	Dams, past cultivation.				
Assessment Rating	PES		EIS		Ecosystem Services
	C: Moderately modified		High		High

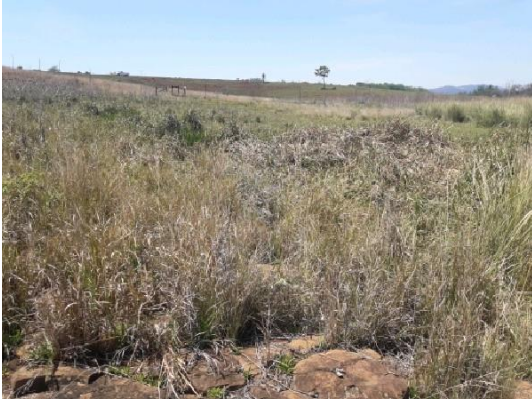
Table 54: Summary of the wetland system sampled at site 76

HGM Type	Unchanneled valley-bottom	Site Code	76
Location	-29.5123, 30.2661	Priority	Very High

View downstream			
Wetland FEPA	No	River FEPA	No
Description	Small system that still retains an intact wetland vegetation although impacted further upstream by <i>Acacia mearnsii</i> bushclumps.		
Impacts	Livestock, Alien vegetation		
Assessment Rating	PES	EIS	Ecosystem Services
	C: Moderately modified	Moderate	High

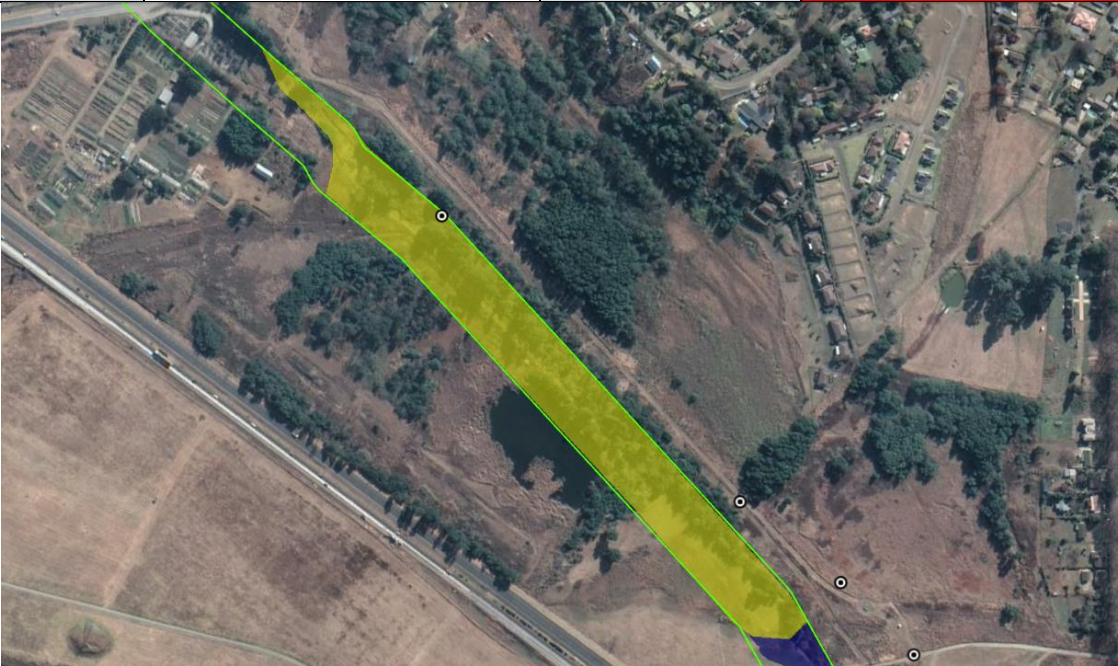
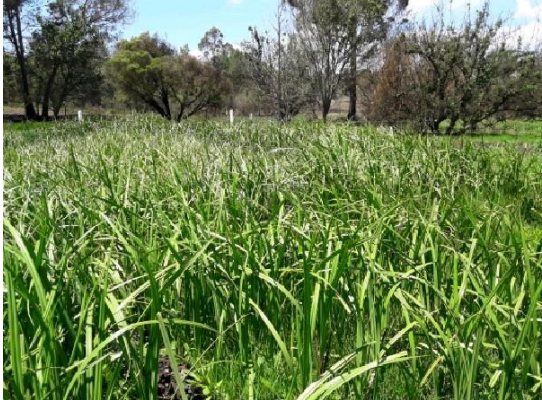
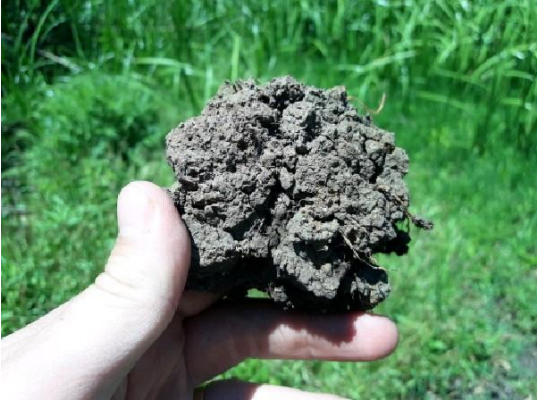
Table 56: Summary of the wetland system sampled at site 85

HGM Type	Flat	Site Code	85
Location	-29.4799, 30.1989	Priority	Very High

Wetland showing <i>Cyperus dives</i>		Willowbrook soil form	
Wetland FEPA	No	River FEPA	No
Description	Large permanently inundated flat wetland		
Impacts	Alien vegetation, Roads, Urban development		
Assessment Rating	PES	EIS	Ecosystem Services
	C: Moderately modified	High	High

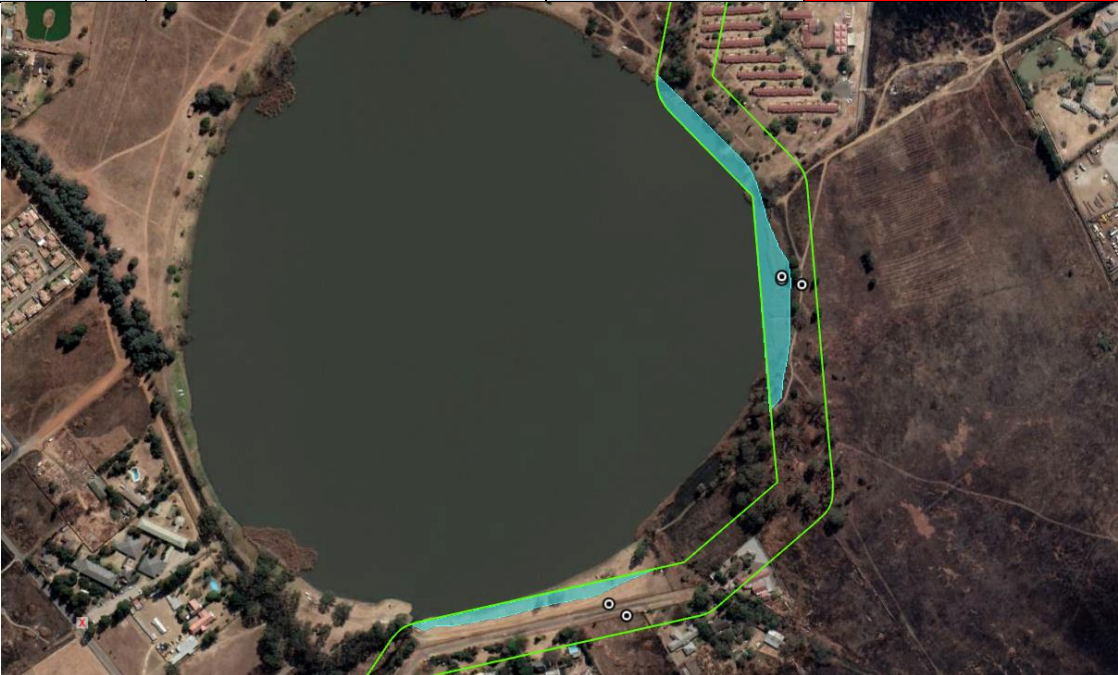
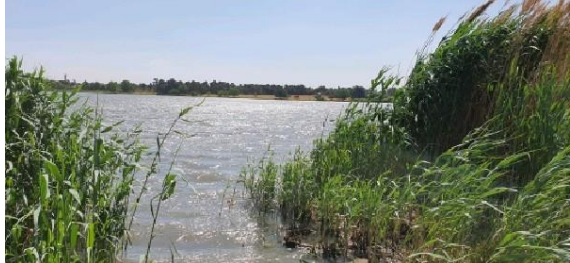
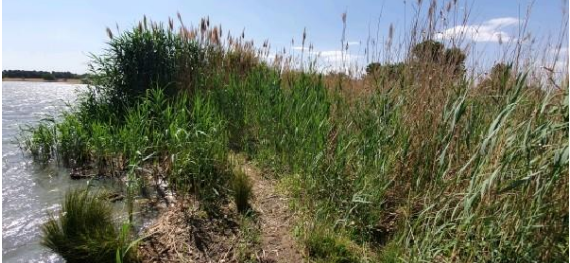
Table 57: Summary of the wetland system sampled at site 90

HGM Type	Depression	Site Code	90
Location	-26.123640, 28.273442	Priority	Very High

Wetland		Other	
Wetland FEPA	No	River FEPA	No
Description	Large permanent pan, high inundation levels during survey. Only a narrow belt of associated hydrophytic vegetation persist along margin		
Impacts	Alien vegetation, litter and Dumping, roads, urban development		
Assessment Rating	PES	EIS	Ecosystem Services
	B: Largely natural	Very High	Moderately High

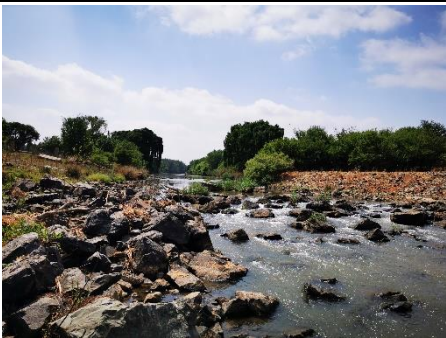
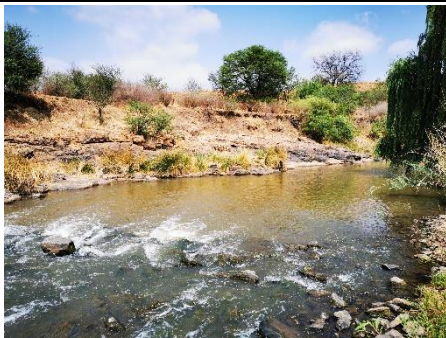
Table 58: Summary of the aquatic system sampled at site 56

Site Code	56	Priority	1	Sample Date	01/11/2019
Upstream			Downstream

Coordinates		26°40'12.50"S		28° 0'33.24"E	
Desktop data for the Sub-Quaternary Reach: C21G-1692			River Name	Suikerbosrand River	
Strahler Order	3		Modifications Dryland agriculture, Vereeniging, Rand Water – treatment works, Suikerbosrand treatment plant, Alien invasive species		
Present Ecological State	Class D				
Ecological Importance	High				
Ecological Sensitivity	High				
Water Quality					
pH	Conductivity (µS/cm)		DO (mg/l)	Temperature (°C)

7.86	1249		4.81	20.1	
Habitat					
Geoclass	Class F – Lowland river	WMA	Vaal	Ecoregion	Highveld
Habitat integrity (IHIA)	Riparian		Instream		
	Class D		Class D		
Biotope Rating X/45	22.5		Comment		
			Site dominated by stones in current, with limited marginal and aquatic vegetation.		
Macroinvertebrate Assessment					
SASS5 Score	No. of Taxa		ASPT	Ecological category (Dallas 2007)	
95	21		4.5	Class B	
Fish Community Assessment					
Species collected (IUCN Status)			Species of Conservational Concern	1	
<i>Labeo capensis</i> (LC) <i>Labeobarbus aeneus</i> (LC) <i>Labeobarbus kimberleyensis</i> (NT)					
Discussion					
The state of the Suikerbosrand River was found to be in a moderately modified state. This was attributed to habitat and water quality modifications. A largely intact biotic macroinvertebrate community was observed during the study. A single fish species of conservational concern was collected during the survey and identified according to (Skelton, 2001), <i>Labeobarbus kimberleyensis</i> (NT). Access point to the pipeline should be located outside the recommended buffer for the riparian zone.

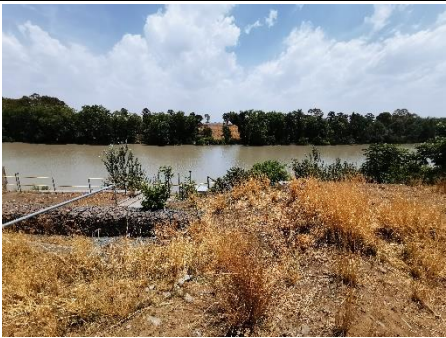
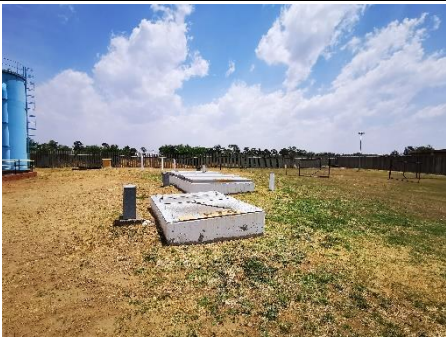
Table 59: Summary of the aquatic system sampled at site 57

Site Code	57	Priority	1	Sample Date	01/11/2019
Upstream			Downstream

Coordinates			26°41'43.42"S	27°59'56.57"E	
Desktop data for the Sub-Quaternary Reach: C22F-1737			River Name	Vaal River	
Strahler Order	4		Modifications <ul style="list-style-type: none"> • Agriculture • Power station, • Mining • Methabo weir 		
Present Ecological State	Class C				
Ecological Importance	High				
Ecological Sensitivity	High				
Water Quality					
pH	Conductivity (µS/cm)		DO (mg/l)	Temperature (°C)	
Not assessed					
Habitat					
Geoclass	Class F – Lowland river	WMA	Vaal	Ecoregion	Highveld
Habitat integrity (IHIA)	Riparian		Instream		
	Class C		Class D		
Biotope Rating X/45	-		Comment		
			Slow deep moving waters, marginal vegetation		
Macroinvertebrate Assessment					
SASS5 Score	No. of Taxa		ASPT	Ecological category (Dallas 2007)	
Not assessed					
Fish Community Assessment					
Species collected (IUCN Status)			Species of Conservational Concern	1

<i>Labeo capensis</i> (LC) <i>Labeobarbus aeneus</i> (LC) <i>Labeobarbus kimberleyensis</i> (NT)					
Discussion					
The access point to the pipeline falls within the Rand Water treatment works. Should the access point be within the Rand Water property, and negligible risk is assessed for the Vaal system. The desktop state of the Vaal is classed as moderately modified.

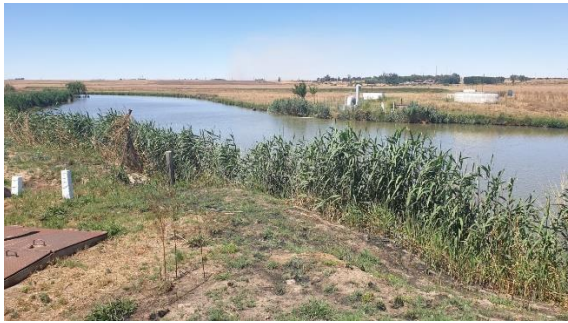
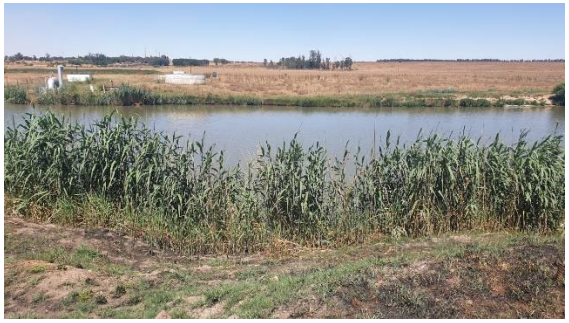
Table 60: Summary of the aquatic system sampled at site 61

Site Code	61	Priority	1	Sample Date	01/11/2019
Upstream			Downstream

Coordinates			26°46'43.70"S	27°53'22.49"E	
Desktop data for the Sub-Quaternary Reach: C22K-1795			River Name	Taaibospruit	
Strahler Order	3		Modifications <ul style="list-style-type: none"> • Impacts from discharge from industries, • Agriculture from run-of-river, • back water from Barrage in lower reach 		
Present Ecological State	Class D				
Ecological Importance	High				
Ecological Sensitivity	High				
Water Quality					
pH	Conductivity (µS/cm)		DO (mg/l)	Temperature (°C)	
Not assessed					
Habitat					
Geoclass	Class F – Lowland river	WMA	Vaal	Ecoregion	Highveld
Habitat integrity (IHIA)	Riparian		Instream		
	Class C		Class D		
Biotope Rating X/45	-		Comment		
			Slow deep moving waters, marginal vegetation		
Macroinvertebrate Assessment					
SASS5 Score	No. of Taxa		ASPT	Ecological category (Dallas 2007)	
Not assessed

Fish Community Assessment					
Species collected (IUCN Status)			Species of Conservational Concern	1	
<i>Labeo capensis</i> (LC) <i>Labeobarbus aeneus</i> (LC) <i>Labeobarbus kimberleyensis</i> (NT)					
Discussion					
A large floodplain occurs either side of the river channel, and therefore the wetland delineation and buffer should be followed.

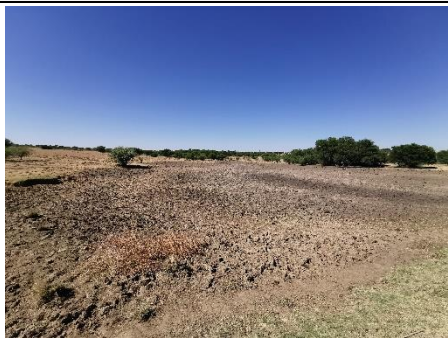
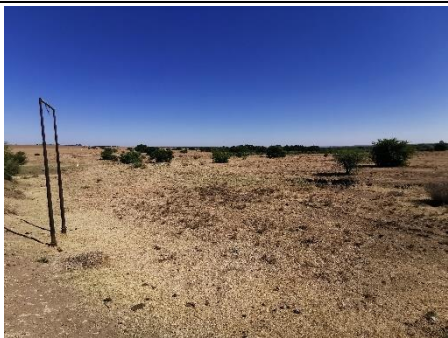
Table 61: Summary of the aquatic system sampled at site 61

Site Code	69	Priority	3	Sample Date	01/11/2019
Upstream			Downstream

Coordinates			27°44'2.35"S	27°17'58.10"E	
Desktop data for the Sub-Quaternary Reach: C60D-2472			River Name	Unnamed Tributary of the Vals River	
Strahler Order	1		Modifications <ul style="list-style-type: none"> Erosion Livestock Instream impoundment 		
Present Ecological State	Class D				
Ecological Importance	Moderate				
Ecological Sensitivity	Moderate				
Water Quality					
pH	Conductivity (µS/cm)		DO (mg/l)	Temperature (°C)	
DRY					
Habitat					
Geoclass	Class D – Lowland river	WMA	Vaal	Ecoregion	Highveld
Habitat integrity (IHIA)	Riparian		Instream		
	Class D		Class D		
Biotope Rating X/45	N/A		Comment		
			Dry dam		
Macroinvertebrate Assessment					
SASS5 Score	No. of Taxa		ASPT	Ecological category (Dallas 2007)	
Dry					
Fish Community Assessment					
Species collected (IUCN Status)			Species of Conservational Concern	0

Dry					
Discussion					
Site was dry, proposed activities pose a low risk to aquatic system. Follow wetland delineation and buffer. Due to the ephemeral nature a lower priority assigned.

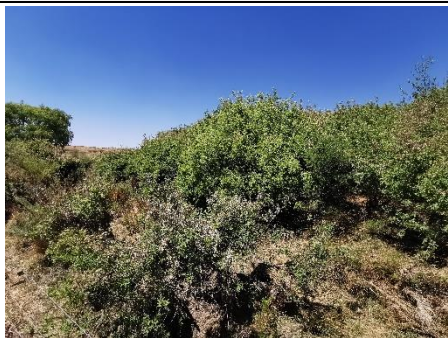
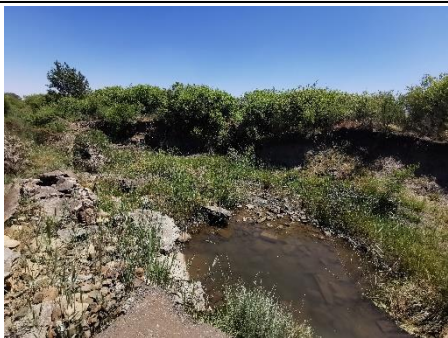
Table 62: Summary of the aquatic system sampled at site 84

Site Code	84	Priority	1	Sample Date	04/11/2019
Upstream			Downstream

Coordinates			27°49'43.36"S	27°30'14.98"E	
Desktop data for the Sub-Quaternary Reach: C60D-2507			River Name	Unnamed Tributary of the Vals River	
Strahler Order	1		Modifications <ul style="list-style-type: none"> • Erosion • Livestock • Abstraction • Alien vegetation 		
Present Ecological State	Class C				
Ecological Importance	Moderate				
Ecological Sensitivity	Moderate				
Water Quality					
pH	Conductivity (µS/cm)		DO (mg/l)	Temperature (°C)

8.16	1052		3.84	23.3	
Habitat					
Geoclass	Class E – Lowland river	WMA	Vaal	Ecoregion	Highveld
Habitat integrity (IHIA)	Riparian		Instream		
	Class C		Class B		
Biotope Rating X/45	10		Comment		
			Site dominated by stones in current, with limited marginal and aquatic vegetation.		
Macroinvertebrate Assessment					
SASS5 Score	No. of Taxa		ASPT	Ecological category (Dallas 2007)	
107	24		4.5	Class B	
Fish Community Assessment					
Species collected (IUCN Status)			Species of Conservational Concern	0	
<i>Enteromius anoplus</i> (LC)					
Discussion					
Limited flow within the reach. Largely intact macroinvertebrate community, a single species of fish collected, listed as Least Concern. Modified instream and riparian habitat, however, largely intact macroinvertebrates community. Follow wetland delineation and prescribed buffer.

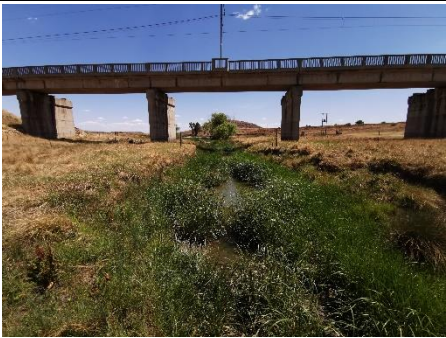
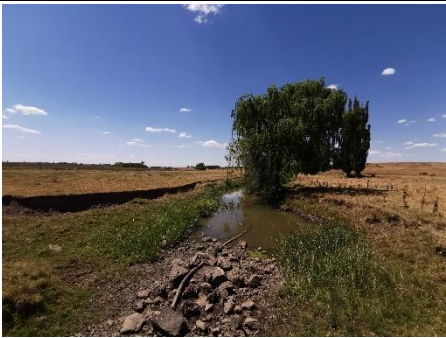
Table 63: Summary of the aquatic system sampled at site 126

Site Code	125/126	Priority	1	Sample Date	04/11/2019
Upstream			Downstream

Coordinates			28° 8'27.37"S	28° 6'48.67"E	
Desktop data for the Sub-Quaternary Reach: C60A-2607			River Name	Vals River	
Strahler order	2		Modifications		
Present Ecological State	Class C		<ul style="list-style-type: none"> • Roads • instream dam • dams in tributaries • agriculture • Eutrophication 		
Ecological Importance	High				
Ecological Sensitivity	High				
Water Quality					
pH	Conductivity (µS/cm)	DO (mg/l)	Temperature (°C)

7.79	905	4.67	23.1		
Habitat					
Geoclass	Class E – Lowland river	WMA	Vaal	Ecoregion	Highveld
Habitat integrity (IHIA)	Riparian		Instream		
	Class D		Class D		
Biotope Rating X/45	12.5		Comment		
			Site dominated by mud, marginal vegetation, undercut banks, and limited stones out of current		
Macroinvertebrate Assessment					
SASS5 Score	No. of Taxa	ASPT	Ecological category (Dallas 2007)		
78	18	4.3	Class C		
Fish Community Assessment					
Species collected (IUCN Status)			Species of Conservational Concern	0	
No fish collected at site					
Discussion					
Limited flow at site due to upstream impoundment. Moderately modified biotic community. Largely modified habitat integrity due to flow, sedimentation and water quality modifications. Meandering system with large floodplain, follow wetland delineation and prescribed buffer.

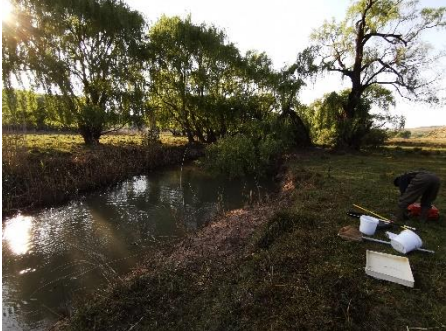
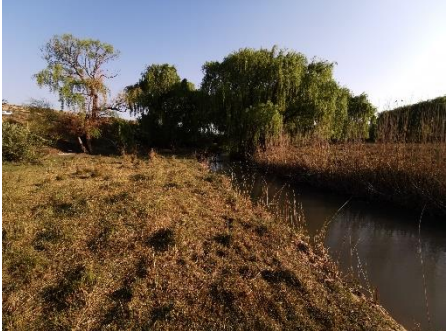
Table 64: Summary of the aquatic system sampled at site 144

Site Code	144	Priority	1	Sample Date	05/11/2019
Upstream			Downstream

Coordinates			28°12'27.97"S	28°21'48.61"E	
Desktop data for the Sub-Quaternary Reach: C83C-2847			River Name	Liebenbergsvlei River	
Strahler Order	3		Modifications		
Present Ecological State	Class E		<ul style="list-style-type: none"> • Erosion • Livestock • Sewage • Alien vegetation • Increased flows 		
Ecological Importance	Low				
Ecological Sensitivity	High				
Water Quality					
pH	Conductivity (µS/cm)		DO (mg/l)	Temperature (°C)

*	110		4.75	18.4	
Habitat					
Geoclass	Class E – Lowland river	WMA	Upper Vaal	Ecoregion	Eastern Escarpment Mountains
Habitat integrity (IHIA)	Riparian		Instream		
	Class C		Class D		
Biotope Rating X/45	8		Comment		
			Site dominated by sand and marginal vegetation.		
Macroinvertebrate Assessment					
SASS5 Score	No. of Taxa		ASPT	Ecological category (Dallas 2007)	
54	14		3.9	Class D	
Fish Community Assessment					
Species collected (IUCN Status)			Species of Conservational Concern	0	
No Fish collected					
Discussion					
Extensive channel modification and erosion has limited instream habitat diversity. Modified habitat integrity and biotic community. Follow wetland delineation and prescribed buffer.

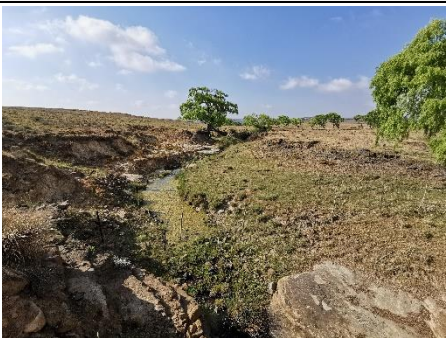
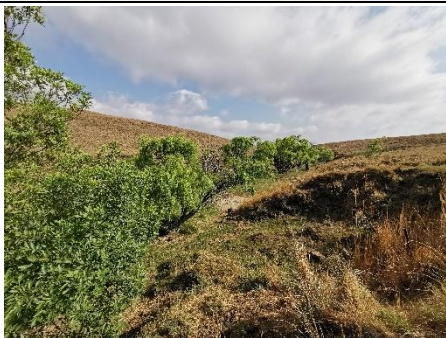
Table 65: Summary of the aquatic system sampled at site 158

Site Code	158	Priority	3	Sample Date	05/11/2019
Upstream			Downstream

Coordinates		28°13'27.93"S		28°32'29.91"	
Desktop data for the Sub-Quaternary Reach: C83D-2806			River Name	Kalkoenspruit River	
Strahler Order	1		Modifications <ul style="list-style-type: none"> • Small area cultivation, • Excessive nutrients, • abandoned lands, • road crossings 		
Present Ecological State	Class C				
Ecological Importance	Moderate				
Ecological Sensitivity	High				
Water Quality					
pH	Conductivity (µS/cm)		DO (mg/l)	Temperature (°C)

*	341		3.82	20.2	
Habitat					
Geoclass	Class D – Lowland river	WMA	Upper Vaal	Ecoregion	Eastern Escarpment Mountains
Habitat integrity (IHIA)	Riparian		Instream		
	Class B		Class B		
Biotope Rating X/45	11.5		Comment		
	Site dominated by stones out of current current, with marginal and aquatic vegetation.				
Macroinvertebrate Assessment					
SASS5 Score	No. of Taxa		ASPT	Ecological category (Dallas 2007)	
123	24		5.1	Class C	
Fish Community Assessment					
Species collected (IUCN Status)			Species of Conservational Concern	0	
<i>Enteromius anoplus</i> (LC)					
Discussion					
No flow observed during the survey within the reach. Habitat limited to a standing pool with stones and mud substrate. No access to site, sampled upstream at road crossing. Channelled valley-bottom wetland, follow wetland delineation and prescribed buffer. Kalkoenspruit runs parallel and classed unchanneled valley-bottom wetland (Sites 156 and 157).

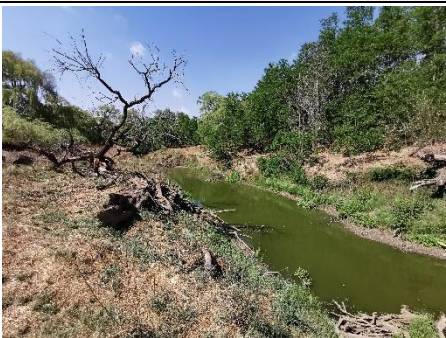
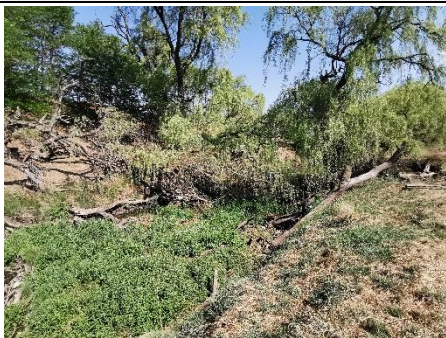
Table 66: Summary of the aquatic system sampled at site 177

Site Code	177	Priority	1	Sample Date	05/11/2019
Upstream			Downstream

Coordinates				28°16'47.18"S	28°51'54.78"E
Desktop data for the Sub-Quaternary Reach: C81H-2894				River Name	Elands River
Strahler order	3		Modifications <ul style="list-style-type: none"> • Erosion • Livestock • Alien vegetation • Agriculture 		
Present Ecological State	Class B				
Ecological Importance	High				
Ecological Sensitivity	High				
Water Quality					
pH	Conductivity (µS/cm)		DO (mg/l)	Temperature (°C)

*	509		4.8	22.0	
Habitat					
Geoclass	Class E – Lowland river	WMA	Upper Vaal	Ecoregion	Eastern Escarpment Mountains
Habitat integrity (IHIA)	Riparian		Instream		
	Class C		Class C		
Biotope Rating X/45	7		Comment		
			Site dominated by marginal and aquatic vegetation, no observable flow, mud substrate		
Macroinvertebrate Assessment					
SASS5 Score	No. of Taxa		ASPT	Ecological category (Dallas 2007)	
46	12		3.8	Class D	
Fish Community Assessment					
Species collected (IUCN Status)			Species of Conservational Concern	0	
No fish collected					
Discussion					
Barely perceptible flow at site. Eroded banks and eutrophic conditions as indicated by excess algae. Combination of channelled valley-bottom and a large floodplain adjacent to the Elands River. Follow wetland delineation and prescribed buffer.

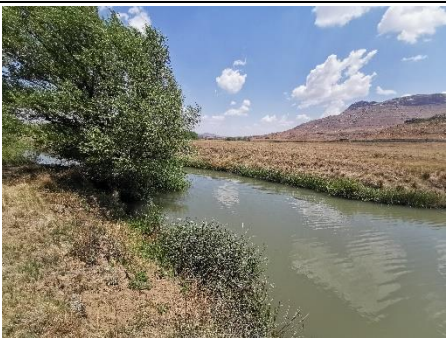
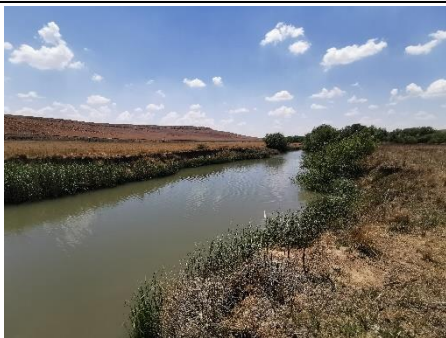
Table 67: Summary of the aquatic system sampled at site 189

Site Code	189	Priority	1	Sample Date	05/11/2019
Upstream			Downstream

Coordinates			28° 19'36.56"S	29° 5'32.96"E	
Desktop data for the Sub-Quaternary Reach: C81E-2930			River Name	Nuwejaarspuit River	
Strahler Order	2		Modifications <ul style="list-style-type: none"> • Channelization • Inundation • Livestock • Alien vegetation 		
Present Ecological State	Class C				
Ecological Importance	Moderate				
Ecological Sensitivity	High				
Water Quality					
pH	Conductivity (µS/cm)		DO (mg/l)	Temperature (°C)

*	111		4.26	25.4	
Habitat					
Geoclass	Class E – Lowland river	WMA	Vaal	Ecoregion	Highveld
Habitat integrity (IHIA)	Riparian		Instream		
	Class C		Class D		
Biotope Rating X/45	7		Comment		
			Site characterised as slow deep moving waters with marginal vegetation, substrate was limited to mud and detritus		
Macroinvertebrate Assessment					
SASS5 Score	No. of Taxa		ASPT	Ecological category (Dallas 2007)	
118	23		5.1	Class B	
Fish Community Assessment					
Species collected (IUCN Status)			Species of Conservational Concern	0	
<i>Cyprinus carpio</i>					
Discussion					
Channelized system, and pushback from downstream impoundment has flooded instream habitat. A large floodplain occurs either side of the channel. A largely intact (class B) macroinvertebrate community was collected, however, taxa with a preference to cobbles and flow were absent from the site. A single exotic fish species was collected. Due to the large floodplain, a low risk to the riverine system is expected.

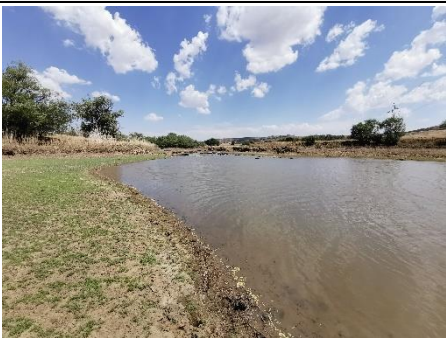
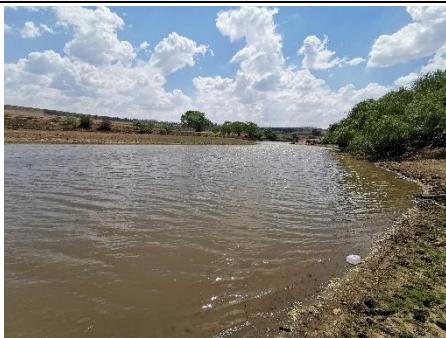
Table 68: Summary of the aquatic system sampled at site 192

Site Code	192	Priority	1	Sample Date	05/11/2019
Upstream			Downstream

Coordinates			28°20'6.34"S	29° 8'29.15"E	
Desktop data for the Sub-Quaternary Reach: C81B-2864			River Name	Wilge River	
Strahler Order	2		Modifications <ul style="list-style-type: none"> • Erosion • Livestock • Alien vegetation • Sedimentation 		
Present Ecological State	Class D				
Ecological Importance	High				
Ecological Sensitivity	High				
Water Quality					
pH	Conductivity (µS/cm)		DO (mg/l)	Temperature (°C)

*	190.7		5.44	27.4	
Habitat					
Geoclass	Class F – Lowland river	WMA	Vaal	Ecoregion	Highveld
Habitat integrity (IHIA)	Riparian		Instream		
	Class D		Class D		
Biotope Rating X/45	5		Comment		
			No flow, dominated by bedrock and mud substrate. Limited habitat diversity.		
Macroinvertebrate Assessment					
SASS5 Score	No. of Taxa		ASPT	Ecological category (Dallas 2007)	
34	10		3.4	Class E/F	
Fish Community Assessment					
Species collected (IUCN Status)			Species of Conservational Concern		0
<i>Cyprinus carpio</i> (Exotic) <i>Labeo capensis</i> (LC) <i>Labeobarbus aeneus</i> (LC) <i>Clarias gariepinus</i> (LC)					
Discussion					
Modified riparian and instream habitat was observed during the survey. No flow and limited instream habitat diversity limited the macroinvertebrate community, resulting in a seriously modified ecological category. Four fish species were collected, however, no species of conservational concern.

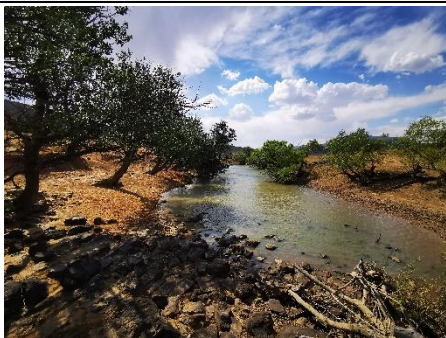
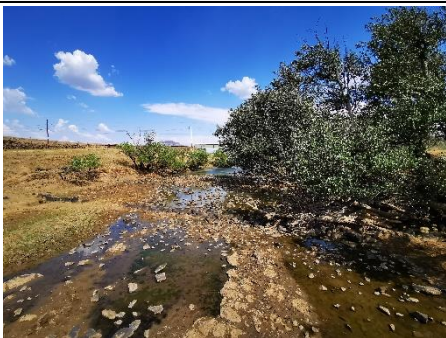
Table 69: Summary of the aquatic system sampled at site 204

Site Code	204	Priority	1	Sample Date	05/11/2019
Upstream			Downstream

Co-ordinate			28°20'57.70"S	29°12'57.25"E	
Desktop data for the Sub-Quaternary Reach: C81B-2864			River Name	Wilge River	
Strahler Order	2		Modifications <ul style="list-style-type: none"> • Erosion • Excessive algae • Livestock • Alien vegetation • No flow 		
Present Ecological State	Class D				
Ecological Importance	High				
Ecological Sensitivity	High				
Water Quality					
pH	Conductivity (µS/cm)		DO (mg/l)	Temperature (°C)

*	127		4.97	27.2	
Habitat					
Geoclass	Class F – Lowland river	WMA	Vaal	Ecoregion	Highveld
Habitat integrity (IHIA)	Riparian		Instream		
	Class C		Class B		
Biotope Rating X/45	18		Comment		
	Site dominated by stones out of current and mud, with limited marginal and aquatic vegetation. Undercut banks with root systems provide diverse habitat				
Macroinvertebrate Assessment					
SASS5 Score	No. of Taxa		ASPT	Ecological category (Dallas 2007)	
183	32		5.7	Class A	
Fish Community Assessment					
Species collected (IUCN Status)			Species of Conservational Concern	0	
No Fish					
Discussion					
Diverse biotopes were available within the reach, despite absence of flow. A natural macroinvertebrate community was collected at the site, with 32 taxa collected. Flow modifications within the river resulted in the absence of flow in the reach. Livestock and agricultural activities have resulted in a modified riparian and instream habitat integrity. A large floodplain with oxbow lakes occurs within the reach. Follow wetland delineation and prescribed buffer.

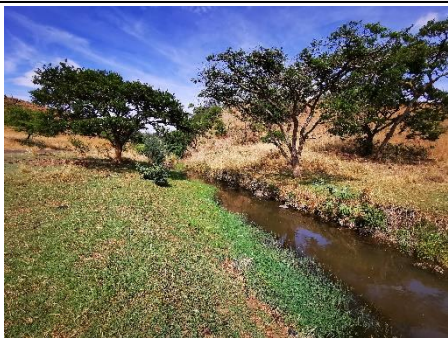
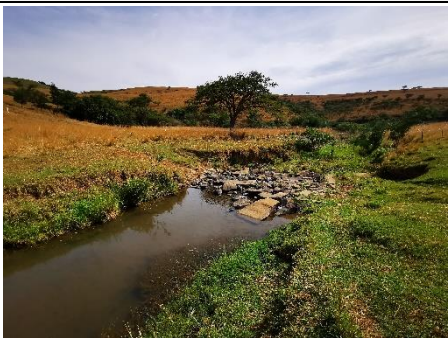
Table 70: Summary of the aquatic system sampled at site 230

Coordinates			28°24'22.81"S	29°25'56.97"E	
Desktop data for the Sub-Quaternary Reach: V12D-2987			River Name	Unnamed Tributary of the Sandspruit	
Strahler Order	2		Modifications <ul style="list-style-type: none"> • Erosion • Livestock and agriculture • Instream impoundments • Sedimentations 		
Present Ecological State	Class C				
Ecological Importance	High				
Ecological Sensitivity	High				
Water Quality					
pH	Conductivity (µS/cm)		DO (mg/l)	Temperature (°C)

6.27	151		3.86	24.2	
Habitat					
Geoclass	Class D – Lowland river	WMA	Pongola-Mtamvuna	Ecoregion	North Eastern Uplands
Habitat integrity (IHIA)	Riparian		Instream		
	Class C		Class B		
Biotope Rating X/45	18		Comment		
			Diverse stones in and out of current, diverse marginal and aquatic vegetation.		
Macroinvertebrate Assessment					
SASS5 Score	No. of Taxa		ASPT	Ecological category (Dallas 2007)	
232	40		5.8	Class A	
Fish Community Assessment					
Species collected (IUCN Status)			Species of Conservational Concern	0	
<i>Enteromius anoplus</i> (LC)					
Discussion					
Moderate to largely natural habitat integrity. Good water quality and instream habitat diversity resulted in a natural macroinvertebrate community. A single fish species was collected. The narrow channel and size of the system resulted in a priority rating of 2.

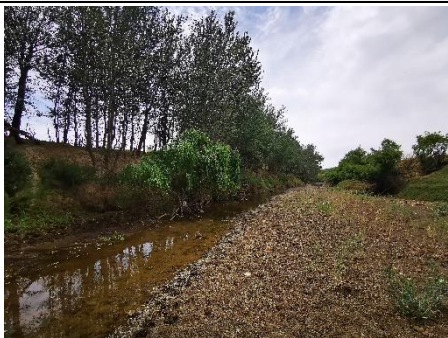
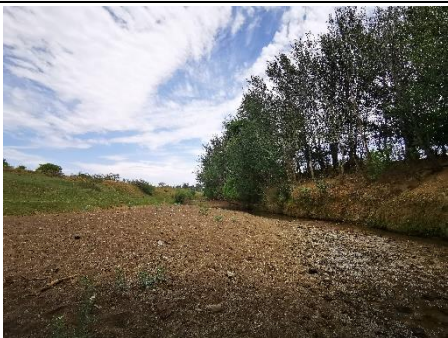
Table 71: Summary of the aquatic system sampled at site 261

Co-ordinate			28°30'54.20"S	29°43'46.24"	
Desktop data for the Sub-Quaternary Reach: V12F-3125			River Name	Klip River	
Strahler Order	3		Modifications <ul style="list-style-type: none"> Flow modifications Livestock Alien vegetation Windsor dam 		
Present Ecological State	Class C				
Ecological Importance	High				
Ecological Sensitivity	High				
Water Quality					
pH	Conductivity (µS/cm)		DO (mg/l)	Temperature (°C)

8.08	331		5.06	29.8	
Habitat					
Geoclass	Class E – Lowland river	WMA	Pongola-Mtamvuna	Ecoregion	South Eastern Uplands
Habitat integrity (IHIA)	Riparian			Instream	
	Class C			Class B	
Biotope Rating X/45	10.5		Comment		
	Site dominated by gravel substrate, limited marginal vegetation				
Macroinvertebrate Assessment					
SASS5 Score	No. of Taxa		ASPT	Ecological category (Dallas 2007)	
179	31		5.8	Class A	
Fish Community Assessment					
Species collected (IUCN Status)			Species of Conservational Concern		0
<i>Labeobarbus natalensis</i> (LC) <i>Enteromius anoplus</i> (LC) <i>Clarias gariepinus</i> (LC) <i>Pseudocrenilabrus philander</i> (LC)					
Discussion					
Flow, riparian and instream modifications have resulted in a lower desktop PES of class C, however, according to biological bands, a natural macroinvertebrate community was collected. No fish species of conservational concern were collected in the reach.

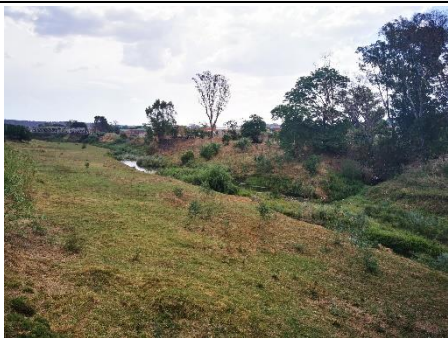
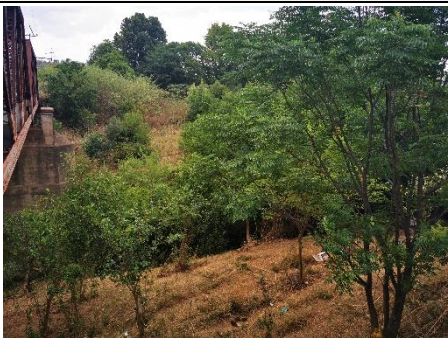
Site Code	270	Priority	1	Sample Date	06/11/2019
Upstream			Downstream

Co-ordinate			28°30'54.20"S	29°43'46.24"	
Desktop data for the Sub-Quaternary Reach: V12F-3125			River Name	Klip River	
Strahler Order	3		Modifications <ul style="list-style-type: none"> • Flow modifications • Livestock • Alien vegetation • Sewage • Urban runoff 		
Present Ecological State	Class C				
Ecological Importance	High				
Ecological Sensitivity	High				
Water Quality					
pH	Conductivity (µS/cm)		DO (mg/l)	Temperature (°C)	
Not assessed					
Habitat					
Geoclass	Class E – Lowland river	WMA	Pongola-Mtamvuna	Ecoregion	South Eastern Uplands
Habitat integrity (IHIA)	Riparian		Instream		
	Class D		Class D		
Biotope Rating X/45	-		Comment		
			Site dominated by sand substrate		
Macroinvertebrate Assessment					
SASS5 Score	No. of Taxa	ASPT		Ecological category (Dallas 2007)	
Not assessed					
Fish Community Assessment

Species expected (IUCN Status)			Species of Conservational Concern	0	
<i>Labeobarbus natalensis</i> (LC) <i>Enteromius anoplus</i> (LC) <i>Clarias gariepinus</i> (LC) <i>Pseudocrenilabrus philander</i> (LC)					
Discussion					
No access to crossing point. Visual observation of reach. Riparian vegetation dominated by alien invasive species. Large amount of solid waste within the channel and deteriorated water quality due to urban runoff of a sewage. Follow wetland delineation and prescribed buffer.

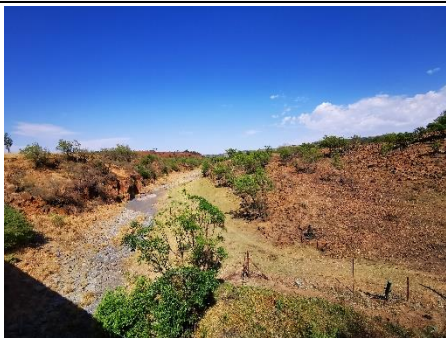
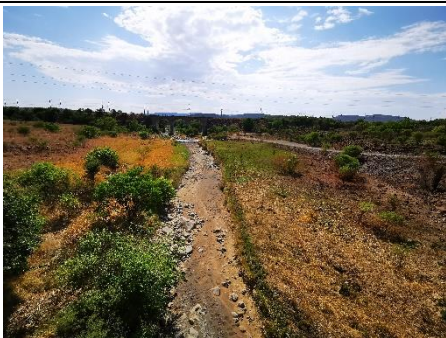
Table 73: Summary of the aquatic system sampled at site 298

Co-ordinate			28°41'58.56"S	29°48'37.06"E	
Desktop data for the Sub-Quaternary Reach: V14B-3296			River Name	Unnamed Tributary of the Thukela	
Strahler Order	3		Modifications <ul style="list-style-type: none"> • Erosion • Alien invasive vegetation 		
Present Ecological State	Class B				
Ecological Importance	High				
Ecological Sensitivity	High				
Water Quality					
pH	Conductivity (µS/cm)	DO (mg/l)	Temperature (°C)		
Dry					
Habitat					
Geoclass	Class E – Lowland river	WMA	Pongola-Mtamvuna	Ecoregion	South Eastern Uplands
Habitat integrity (IHIA)	Riparian		Instream		
	Class B		Class B		
Biotope Rating X/45	-		Comment		
			Habitat dominated by bedrock and sand		
Macroinvertebrate Assessment					
SASS5 Score	No. of Taxa	ASPT	Ecological category (Dallas 2007)		
Dry					
Fish Community Assessment					
Species collected (IUCN Status)			Species of Conservational Concern	0

Dry					
Discussion					
System was dry during the survey. Within a nature reserve. Priority 1, follow wetland delineation and prescribed buffer.

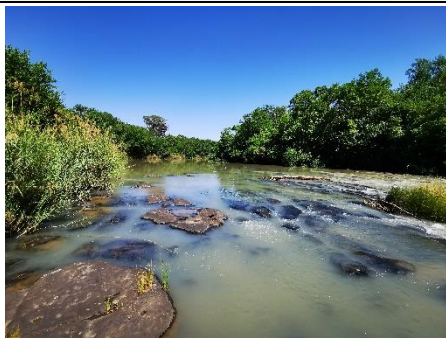
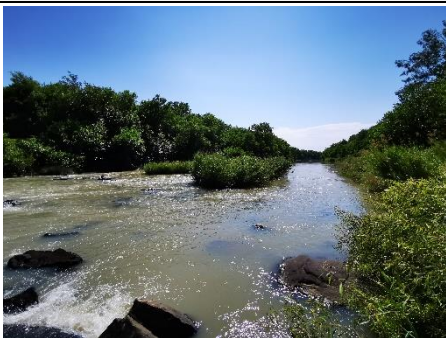
Table 74: Summary of the aquatic system sampled at site 306

Co-ordinate			28°44'33.59"S	29°48'16.47"E	
Desktop data for the Sub-Quaternary Reach: V14B-3296			River Name	Thukela	
Strahler Order	4		Modifications <ul style="list-style-type: none"> • Road crossings • agriculture from canal • gauging weir • small sand mining operations 		
Present Ecological State	Class C				
Ecological Importance	High				
Ecological Sensitivity	High				
Water Quality					
pH	Conductivity (µS/cm)		DO (mg/l)	Temperature (°C)

7.11	81.2		5.5	25.2	
Habitat					
Geoclass	Class F – Lowland river	WMA	Pongola-Mtamvuna	Ecoregion	North Eastern Uplands
Habitat integrity (IHIA)	Riparian		Instream		
	Class C		Class B		
Biotope Rating X/45	25		Comment		
			Diverse biotopes within the system.		
Macroinvertebrate Assessment					
SASS5 Score	No. of Taxa		ASPT	Ecological category (Dallas 2007)	
200	34		5.9	B	
Fish Community Assessment					
Species collected (IUCN Status)			Species of Conservational Concern	0	
No fish collected					
Discussion					
Large lowland river with diverse instream habitat. Largely natural macroinvertebrate community. Riparian vegetation dominated by alien invasive species. Extensive agricultural activities within the reach. Follow riparian delineation and buffer.

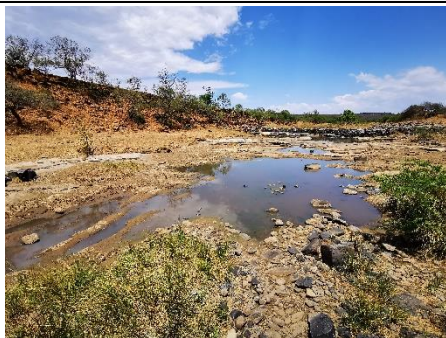
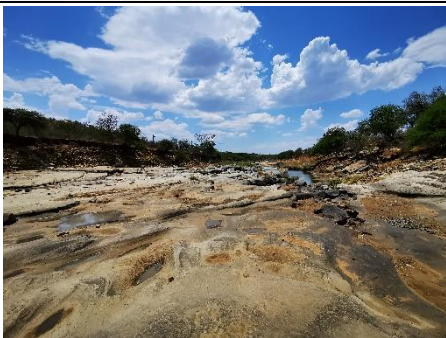
Table 75: Summary of the aquatic system sampled at site 315

Co-ordinate			28°51'38.08"S	29°49'2.96"E	
Desktop data for the Sub-Quaternary Reach: V14D-3374			River Name	Bloukrans	
Strahler Order	2		Modifications <ul style="list-style-type: none"> • Road crossings, • sediments from upper reaches, • dams in tributaries. 		
Present Ecological State	Class B				
Ecological Importance	High				
Ecological Sensitivity	High				
Water Quality					
pH	Conductivity (µS/cm)		DO (mg/l)	Temperature (°C)

8.43	674		4.8	32.4	
Habitat					
Geoclass	Class D – Upper Foothills	WMA	Pongola-Mtamvuna	Ecoregion	North Eastern Uplands
Habitat integrity (IHIA)	Riparian		Instream		
	Class B		Class B		
Biotope Rating X/45	9		Comment		
			Site dominated by bedrock and mud substrate		
Macroinvertebrate Assessment					
SASS5 Score	No. of Taxa		ASPT	Ecological category (Dallas 2007)	
68	16		4.13	E/F	
Fish Community Assessment					
Species collected (IUCN Status)			Species of Conservational Concern		1
<i>Clarias gariepinus</i> <i>Labeo rubromaculatus</i> (VU)					
Discussion					
Characterised as a channelled valley-bottom with adjacent floodplain. A largely natural instream and riparian habitat occurs within the reach, however the biotic community was rated as seriously modified, likely due to flow modifications within the reach. A single fish species of conservational concern was collected, <i>Labeo rubromaculatus</i> , which is listed as Vulnerable. The proposed activities pose a risk a low to the fish community within the Bloukransriver.

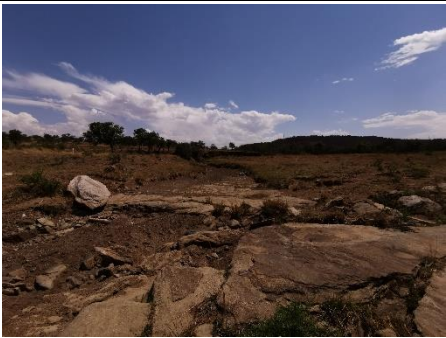
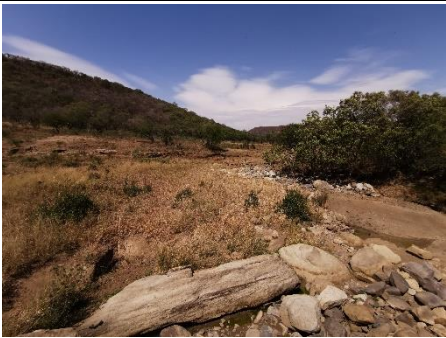
Table 76: Summary of the aquatic system sampled at site 332

Co-ordinate			28°59'1.05"S	29°54'36.38"E	
Desktop data for the Sub-Quaternary Reach: V70F-3623			River Name	Unnamed Tributary of the Boesmans	
Strahler Order	2		Modifications <ul style="list-style-type: none"> • Bank erosion • Livestock • Instream sedimentation 		
Present Ecological State	Class C				
Ecological Importance	High				
Ecological Sensitivity	High				
Water Quality					
pH	Conductivity (µS/cm)		DO (mg/l)	Temperature (°C)

7.92	745		6.17	28.1	
Habitat					
Geoclass	Class E – Lower foothills	WMA	Pongola-Mtamvuna	Ecoregion	South Eastern Uplands
Habitat integrity (IHIA)	Riparian		Instream		
	Class B		Class B		
Biotope Rating X/45	23		Comment		
			Site characterised by a single standing pool, substrate gravel and sand		
Macroinvertebrate Assessment					
SASS5 Score	No. of Taxa		ASPT	Ecological category (Dallas 2007)	
76	15		5.1	E/F	
Fish Community Assessment					
Species collected (IUCN Status)			Species of Conservational Concern	0	
Discussion					
Ephemeral system. Standing pools present during the survey. Largely natural habitat integrity within the reach. However, seriously modified macroinvertebrate community, predominantly tolerant taxa collected within refuge areas.

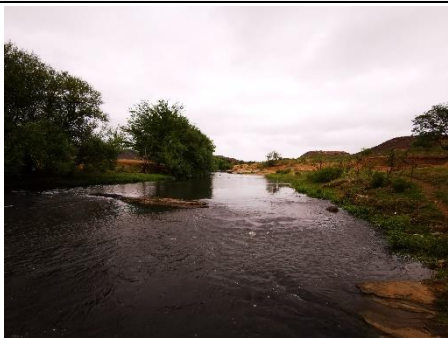
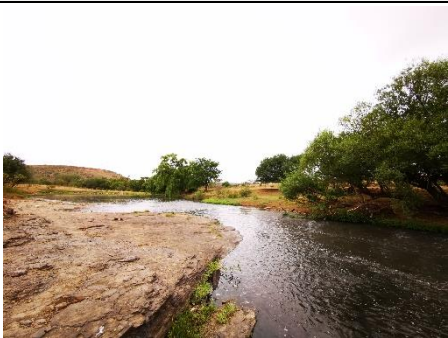
Table 77: Summary of the aquatic system sampled at site 339

Co-ordinate			28°41'58.56"S	29°48'37.06"E	
Desktop data for the Sub-Quaternary Reach: V14B-3296			River Name	Boesmans River	
Strahler Order	4		Modifications <ul style="list-style-type: none"> • Estcourt WWTWs, Alien invasive plants, • road crossing, • small sand mining operation, • irrigation in lower reaches 		
Present Ecological State	Class C				
Ecological Importance	High				
Ecological Sensitivity	High				
Water Quality					
pH	Conductivity (µS/cm)		DO (mg/l)	Temperature (°C)

-	127.2		3.74	19.5	
Habitat					
Geoclass	Class E – Lower foothills	WMA	Pongola-Mtamvuna	Ecoregion	North Eastern Uplands
Habitat integrity (IHIA)	Riparian		Instream		
	Class C		Class C		
Biotope Rating X/45	14		Comment		
			Site dominated by bedrock and marginal vegetation in current		
Macroinvertebrate Assessment					
SASS5 Score	No. of Taxa		ASPT	Ecological category (Dallas 2007)	
44	12		3.7	E/F	
Fish Community Assessment					
Species collected (IUCN Status)			Species of Conservational Concern	0	
No fish collected					
Discussion					
Extensive sewage present at the site resulting in modified water quality and critically modified biotic community. Modified instream and habitat integrity within the reach.

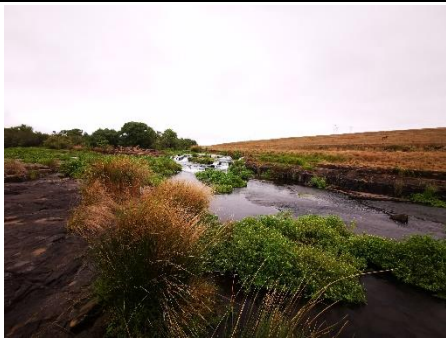
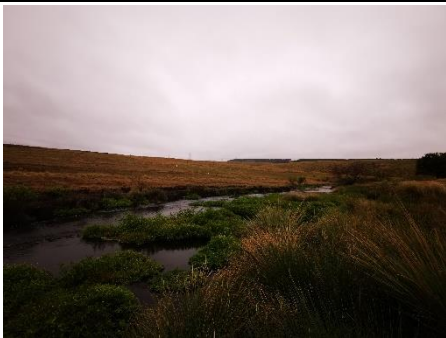
Table 78: Summary of the aquatic system sampled at site 371

Co-ordinate			29°11'1.91"S	30° 3'4.14"E	
Desktop data for the Sub-Quaternary Reach: V20E-3884			River Name	Mooi River	
Strahler Order	4		Modifications <ul style="list-style-type: none"> • Start in Mearns weir, • irrigation, • roads, • textile factory • WWTWs, • gauging weir, • urban (Moorriver & surrounding), • dairy farming 		
Present Ecological State	Class C				
Ecological Importance	High				
Ecological Sensitivity	Very High				
Water Quality					
pH	Conductivity (µS/cm)		DO (mg/l)	Temperature (°C)

-	136.6		6.35	17.5	
Habitat					
Geoclass	Class E – Lower foothills	WMA	Pongola-Mtamvuna	Ecoregion	North Eastern Uplands
Habitat integrity (IHIA)	Riparian		Instream		
	Class C		Class B		
Biotope Rating X/45	22		Comment		
			Diverse instream habitat. Diverse stones in current, aquatic and marginal vegetation		
Macroinvertebrate Assessment					
SASS5 Score	No. of Taxa		ASPT	Ecological category (Dallas 2007)	
192	38		5.1	B	
Fish Community Assessment					
Species collected (IUCN Status)			Species of Conservational Concern	0	
<i>Micropterus salmoides</i> <i>Lepomis macrochirus</i>					
Discussion					
Diverse instream habitat was present at the site. Modifications to the reach included water quality and alien invasive vegetation within marginal and riparian zones. A largely intact macroinvertebrate community was collected, and two exotic fish species.
