**BIODIVERSITY AND WATER RESOURCE
ASSESSMENT FOR THE PROPOSED
DECOMMISSIONING OF THE TRANSNET
DURBAN TO JOHANNESBURG PIPELINE
(DJP)**

Gauteng, Free State and KwaZulu Natal

Date
December 2019

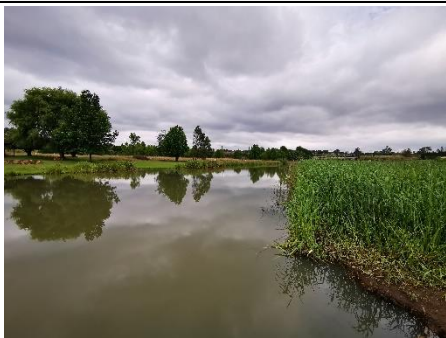
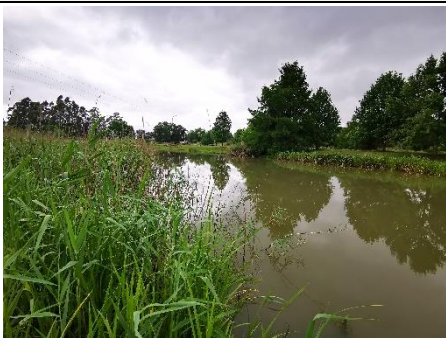
Table 79: Summary of the aquatic system sampled at site 420

Co-ordinate			29°29'24.81"S	30°12'26.00"E	
Desktop data for the Sub-Quaternary Reach: U20E-4340			River Name	Umgeni	
Strahler Order	3		Modifications <ul style="list-style-type: none"> Upper part in Midmar Dam, Howick, industrial, Howick falls, Howick WWTW, AIP in riparian zone, informal areas, dryland agric. Sakabula Stream and Riet not digitised. 		
Present Ecological State	Class C				
Ecological Importance	High				
Ecological Sensitivity	High Very				
Water Quality					
pH	Conductivity (µS/cm)		DO (mg/l)	Temperature (°C)

74.6		5.11	16.9	
Habitat					
Geoclass	Class E – Lower foothills	WMA	Pongola-Mtamvuna	Ecoregion	South Eastern Uplands
Habitat integrity (IHIA)	Riparian		Instream		
	Class C		Class D		
Biotope Rating X/45	6.5		Comment		
			Sampling limited to marginal vegetation and mud substrate.		
Macroinvertebrate Assessment					
SASS5 Score	No. of Taxa		ASPT	Ecological category (Dallas 2007)	
65	14		4.6	E/F	
Fish Community Assessment					
Species collected (IUCN Status)			Species of Conservational Concern		0
<i>Gambusia affinis</i> (Exotic)					
Discussion					
Channelized reach of the Umgeni River. Sampling limited to marginal zones. Seriously modified macroinvertebrate community collected. Habitat integrity rated as moderately to largely modified. Extensive wetlands adjacent to the channel, follow wetland delineation and prescribed buffer.

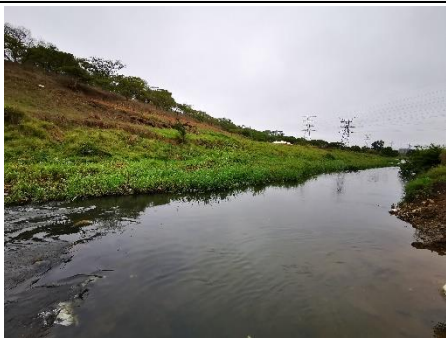
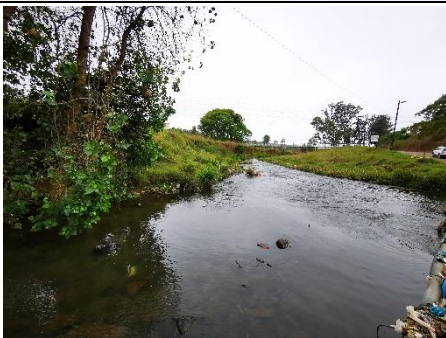
Table 80: Summary of the aquatic system sampled at site 437

Co-ordinate		29°36'6.06"S		30°24'28.75"E	
Desktop data for the Sub-Quaternary Reach: U20J-4364			River Name		uMnsunduze
Strahler Order	4		Modifications <ul style="list-style-type: none"> Campsdrift, weir without fish ladder, industries, stormwater runoff, urban, road crossings, Dorpspruit, settlements, WWTW (Darvill) return flows, Bainspruit (pollution), oil industry, chicken farms 		
Present Ecological State	Class E				
Ecological Importance	Moderate				
Ecological Sensitivity	Very High				
Water Quality					
pH	Conductivity (µS/cm)		DO (mg/l)		Temperature (°C)

-	242		5.34		22.9
Habitat					
Geoclass	Class E – Lower foothills	WMA	Pongola-Mtamvuna	Ecoregion	South Eastern Uplands
Habitat integrity (IHIA)	Riparian			Instream	
	Class C			Class B	
Biotope Rating X/45	23		Comment		
	Site dominated by stones in current, with limited marginal and aquatic vegetation.				
Macroinvertebrate Assessment					
SASS5 Score	No. of Taxa		ASPT		Ecological category (Dallas 2007)
37	9		4.1		E/F
Fish Community Assessment					
Species collected (IUCN Status)			Species of Conservational Concern		0
No fish collected					
Discussion					
modifications to the reach include urban runoff, solid waste disposal and alien vegetation encroachment into the riparian zone. Diverse instream habitat was present at the site, indicating water quality deterioration has impacted on the biotic integrity of the reach, resulting in a class E/F ecological category.

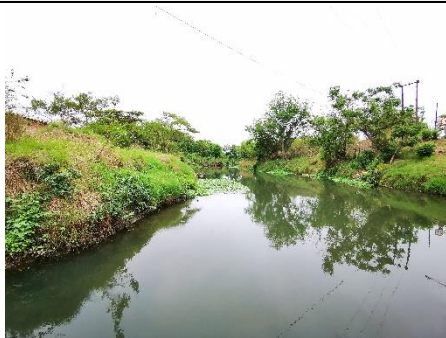
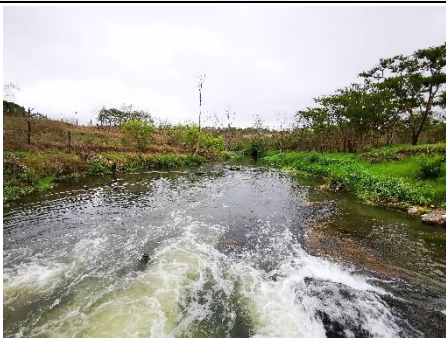
Table 81: Summary of the aquatic system sampled at site 468

Co-ordinate			29°37'7.24"S	30°27'14.66"E	
Desktop data for the Sub-Quaternary Reach: V14B-3296			River Name	uMnsunduze	
Strahler Order	4		Modifications <ul style="list-style-type: none"> Campsdrift, weir without fish ladder, industries, stormwater runoff, urban, road crossings, Dorpspruit, settlements, WWTW (Darvill) return flows, Bainspruit (pollution), oil industry, chicken farms 		
Present Ecological State	Class E				
Ecological Importance	Moderate				
Ecological Sensitivity	Very High				
Water Quality					
pH	Conductivity (µS/cm)		DO (mg/l)	Temperature (°C)

-	388		4.38	23.5	
Habitat					
Geoclass	Class E – Lowland river	WMA	Pongola-Mtamvuna	Ecoregion	South Eastern Uplands
Habitat integrity (IHIA)	Riparian		Instream		
	Class C		Class B		
Biotope Rating X/45	23		Comment		
			Site dominated by stones in current, with limited marginal and aquatic vegetation.		
Macroinvertebrate Assessment					
SASS5 Score	No. of Taxa		ASPT	Ecological category (Dallas 2007)	
26	8		3.3	Class E/F	
Fish Community Assessment					
Species collected (IUCN Status)			Species of Conservational Concern	0	
No fish collected					
Discussion					
Site 468 was sampled upstream at the road crossing. Water quality deterioration within the reach has resulted in a critically modified macroinvertebrate community. Several instream impoundments have resulted in flow and habitat modifications. Pipeline access should follow the riparian delineation and applicable buffer.

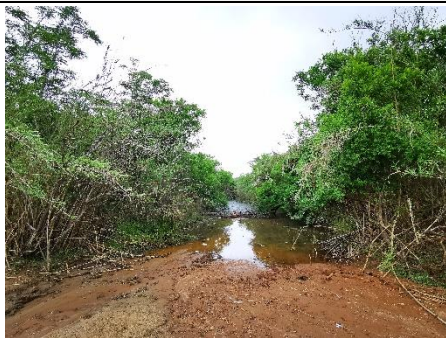
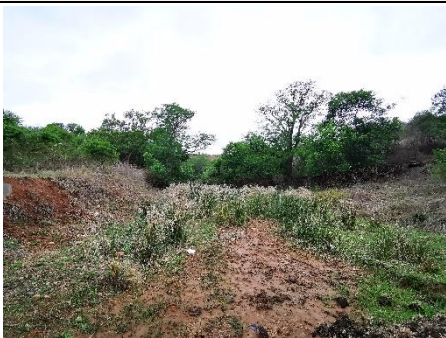
Table 82: Summary of the aquatic system sampled at site 471

Co-ordinate			28°41'58.56"S	29°48'37.06"E	
Desktop data for the Sub-Quaternary Reach: U20J-4488			River Name	Unnamed Tributary of the uMnsunduze	
Strahler Order	3		Modifications <ul style="list-style-type: none"> • Erosion • Livestock • Sewage • Alien vegetation 		
Present Ecological State	Class C				
Ecological Importance	High				
Ecological Sensitivity	High				
Water Quality					
pH	Conductivity (µS/cm)		DO (mg/l)	Temperature (°C)

-	857		2.75	21.2	
Habitat					
Geoclass	Class E – Lowland river	WMA	Pongola-Mtamvuna	Ecoregion	South Eastern Uplands
Habitat integrity (IHIA)	Riparian		Instream		
	Class C		Class C		
Biotope Rating X/45	9		Comment		
			Site dominated by stones in current, with limited marginal and aquatic vegetation.		
Macroinvertebrate Assessment					
SASS5 Score	No. of Taxa		ASPT	Ecological category (Dallas 2007)	
87	22		4.0	E/F	
Fish Community Assessment					
Species collected (IUCN Status)			Species of Conservational Concern	0	
No fish collected					
Discussion					
Ephemeral system, characterised by a standing pool during the survey. Reach dominated by sandy substrate and aquatic vegetation. Seriously modified macroinvertebrate community collected.

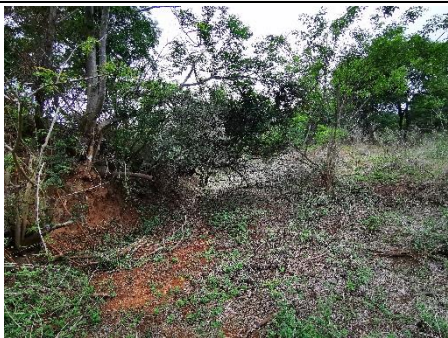
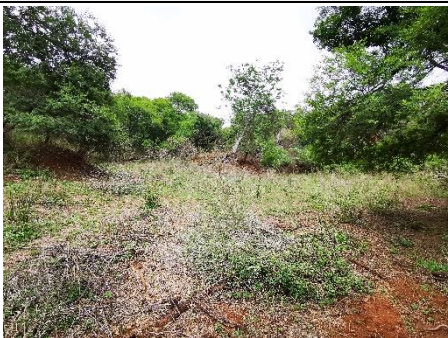
Table 83: Summary of the aquatic system sampled at site 480

Co-ordinate			29°41'27.03"S	30°30'50.26"E	
Desktop data for the Sub-Quaternary Reach: U20J-4488			River Name	Unnamed Tributary of the Mshwati	
Strahler Order	3		Modifications <ul style="list-style-type: none"> • Erosion • Alien vegetation 		
Present Ecological State	Class B				
Ecological Importance	High				
Ecological Sensitivity	Very High				
Water Quality					
pH	Conductivity (µS/cm)		DO (mg/l)	Temperature (°C)	
DRY					
Habitat					
Geoclass	Class E – Lowland river	WMA	Pongola-Mtamvuna	Ecoregion	South Eastern Uplands
Habitat integrity (IHIA)	Riparian		Instream		
	Class B		Class B		
Biotope Rating X/45	N/A		Comment		
			Dry ephemeral system		
Macroinvertebrate Assessment					
SASS5 Score	No. of Taxa		ASPT	Ecological category (Dallas 2007)	
DRY					
Fish Community Assessment					
Species collected (IUCN Status)			Species of Conservational Concern	0

DRY					
Discussion					
Ephemeral system. No water present during the survey. Instream and riparian habitat integrity rated as largely natural.

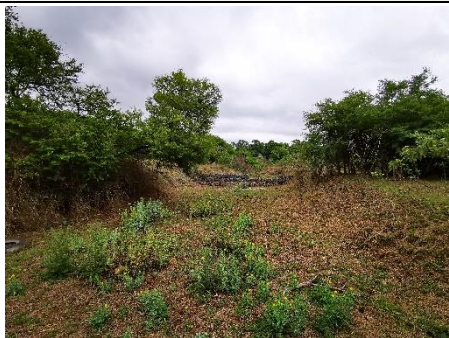
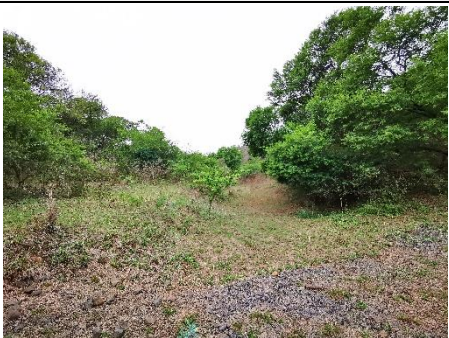
Table 84: Summary of the aquatic system sampled at site 483

Co-ordinate			29°41'27.03"S	30°30'50.26"E	
Desktop data for the Sub-Quaternary Reach: U20J-4488			River Name	Unnamed Tributary of the Mshwati	
Strahler Order	3		Modifications <ul style="list-style-type: none"> • Erosion • Alien vegetation 		
Present Ecological State	Class B				
Ecological Importance	High				
Ecological Sensitivity	Very High				
Water Quality					
pH	Conductivity (µS/cm)		DO (mg/l)	Temperature (°C)	
DRY					
Habitat					
Geoclass	Class E – Lowland river	WMA	Pongola-Mtamvuna	Ecoregion	South Eastern Uplands
Habitat integrity (IHIA)	Riparian		Instream		
	Class B		Class B		
Biotope Rating X/45	N/A		Comment		
			Dry ephemeral system		
Macroinvertebrate Assessment					
SASS5 Score	No. of Taxa		ASPT	Ecological category (Dallas 2007)	
DRY					
Fish Community Assessment					
Species collected (IUCN Status)			Species of Conservational Concern	0

DRY					
Discussion					
Ephemeral system. No water present during the survey. Instream and riparian habitat integrity rated as largely natural.

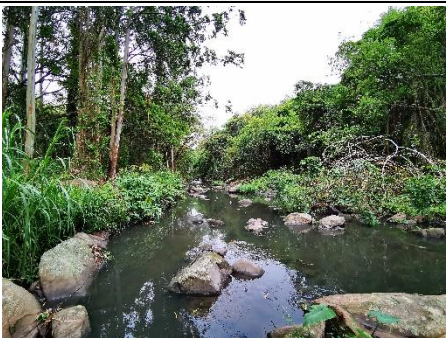
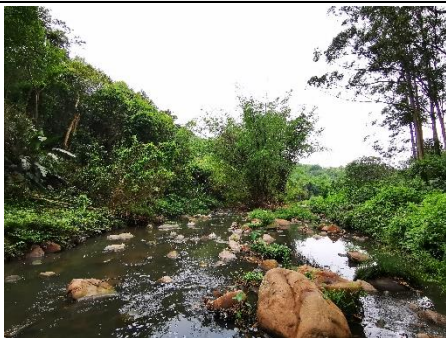
Site Code	530		Sample Date	09/11/2019	
Upstream			Downstream

Co-ordinate			29°51'28.53"S	30°53'55.50"E	
Desktop data for the Sub-Quaternary Reach: U60F-4632			River Name	Umbilo	
Strahler Order	2		Modifications <ul style="list-style-type: none"> Residential (Pinetown), industrial area, Paradise Valley Nature Reserve, Alien invasive plants in riparian zone, quarry, into estuary. Mkhumbane River not digitised. 		
Present Ecological State	Class D				
Ecological Importance	High				
Ecological Sensitivity	Very High				
Water Quality					
pH	Conductivity (µS/cm)		DO (mg/l)	Temperature (°C)	
	328		5.02	23.1	
Habitat					
Geoclass	Class E – Lowland river	WMA	Pongola-Mtamvuna	Ecoregion	North Eastern Coastal Belt
Habitat integrity (IHIA)	Riparian			Instream	
	Class B			Class B	
Biotope Rating X/45	16		Comment		
			Site dominated by stones in current, with diverse marginal vegetation.		
Macroinvertebrate Assessment

SASS5 Score	No. of Taxa		ASPT	Ecological category (Dallas 2007)	
14	5		2.8	E/F	
Fish Community Assessment					
Species collected (IUCN Status)			Species of Conservational Concern	0	
<i>Poecilia reticulata</i> (Exotic)					
Discussion					
Perennial system. Instream and riparian habitat integrity rated as largely natural, however, extensive water quality deterioration due to sewage discharge resulted in a critically modified biotic integrity of the system.

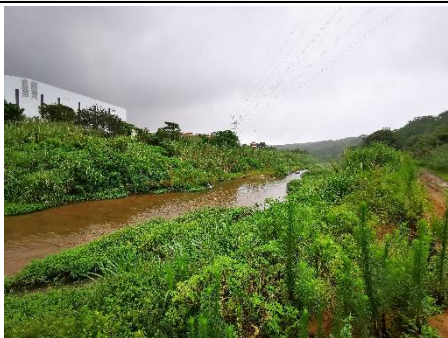
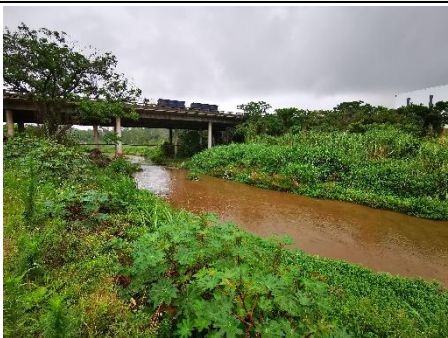
Table 86: Summary of the aquatic system sampled at site 537

Co-ordinate			28°41'58.56"S	29°48'37.06"E	
Desktop data for the Sub-Quaternary Reach: U60F-4632			River Name	Umbilo	
Strahler Order	3		Modifications <ul style="list-style-type: none"> Residential (Pinetown), industrial area, Paradise Valley Nature Reserve, AIP in riparian zone, quarry, into estuary. Mkhumbane River not digitised. 		
Present Ecological State	Class D				
Ecological Importance	High				
Ecological Sensitivity	Very High				
Water Quality					
pH	Conductivity (µS/cm)		DO (mg/l)	Temperature (°C)	
	455		4.97	21.3	
Habitat					
Geoclass	Class E – Lowland river	WMA	Pongola-Mtamvuna	Ecoregion	North Eastern Coastal Belt
Habitat integrity (IHIA)	Riparian		Instream		
	Class C		Class C		
Biotope Rating X/45	12		Comment		
			Substrate dominated by sand. Diverse marginal vegetation		
Macroinvertebrate Assessment					
SASS5 Score	No. of Taxa		ASPT	Ecological category (Dallas 2007)

46	11		4.2	E/F	
Fish Community Assessment					
Species collected (IUCN Status)			Species of Conservational Concern	0	
<i>Poecilia reticulata</i> (Exotic)					
Discussion					
Instream habitat dominated by sand substrate, with diverse marginal vegetation. Low biotope diversity and water quality modifications have contributed to the seriously modified state of the macroinvertebrate community. A single fish species was collected at the site.
