## *Geohydrological Impact Assessment - Calvinia Abattoir, Northern Cape.*

GEOSS Report No: 2017/08-25

*21 August 2017*

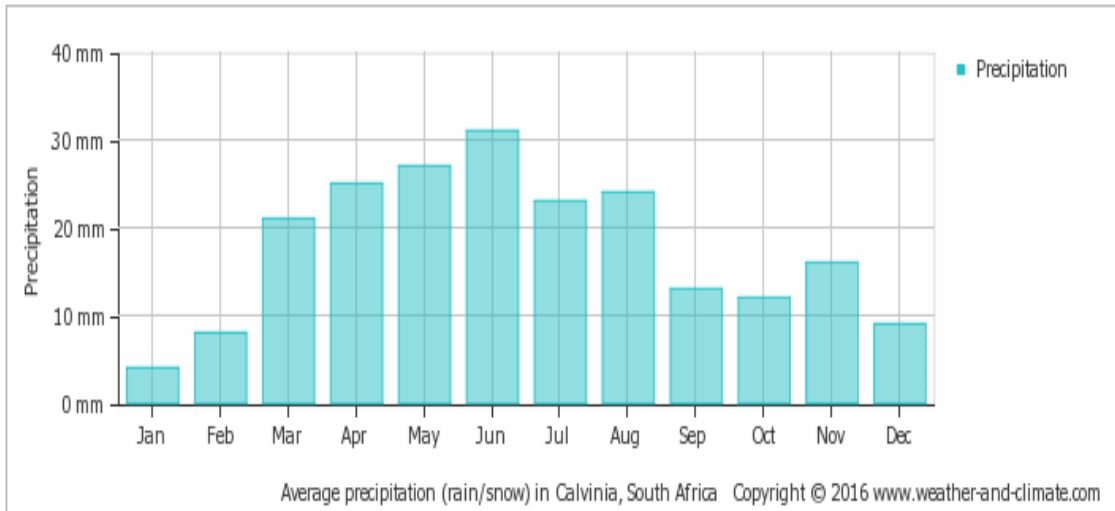
**Figure 1: Average monthly rainfall Calvinia**  
(www.weather-and-climate.com)

Calvinia receives approximately 216 mm of rainfall per year and because it receives most of its rainfall during winter it has a Mediterranean climate. It receives the lowest rainfall in January and the highest in June. The monthly distribution of average daily maximum temperatures shows that the hottest time of the year in the area is during the months of January and February. The region is the coldest during June and July. The implication of the highest rainfall occurring during the winter time of the year is that more of the rainfall will become groundwater recharge due to the lower evaporation rates.

Figure 1 and Figure 2 show the long term monthly rainfall and temperature distribution respectively.

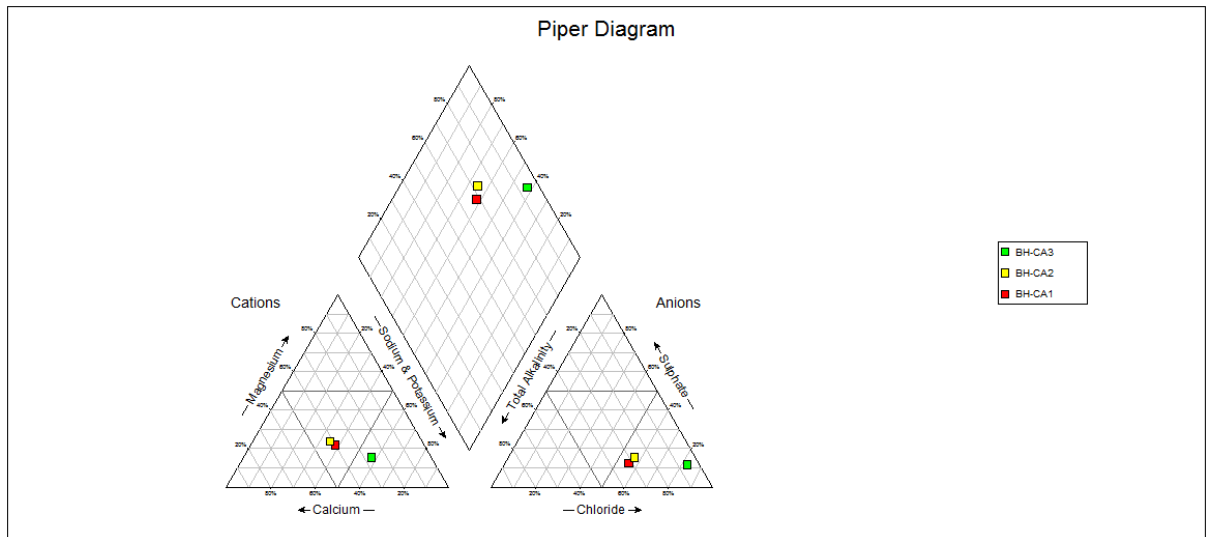
From **Figure 3** (central diamond) the production borehole groundwater samples are classified as having a sodium – chloride (BH-CA3) and calcium - chloride hydrofacies.

**Figure 3: Piper diagram of the production borehole groundwater samples**

A number of chemical diagrams have been plotted for the proposed production borehole groundwater samples and these are useful for chemical characterisation of the water. The chemistry of the sample has been plotted on a tri-linear diagram known as a Piper diagram (**Figure 3**). This diagram indicates the distribution of cations and anions in separate triangles and then a combination of the chemistry in the central diamond. Water with similar chemical signatures will plot in close proximity to one another on the diagram.

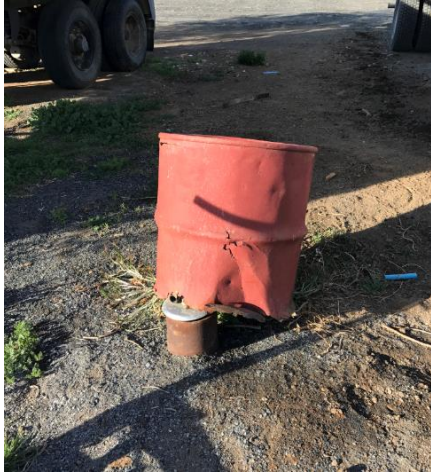
Photo 1: BH\_CA\_P1

<i>Parameter</i>	<i>Description</i>	
<i>Borehole Number</i>	BH_CA_P1 (GEOSS)	Production Borehole
<i>Co-ordinates</i>	31.46840 S 19.75577 E 975 mamsl	
<i>Borehole Depth (mbgl)</i>	?	
<i>WL (mbgl)</i>	Covered by base plate	
<i>Comments</i>	<ul style="list-style-type: none"> <li>• Low yield 1000 L/hr</li> <li>• Water pumped into collection JoJo Tanks and used for cleaning</li> <li>• Equipped with pump</li> </ul>

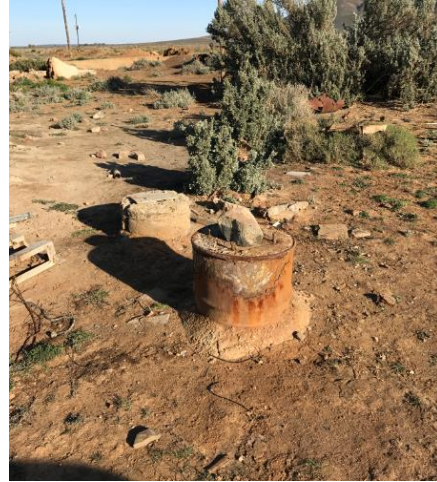
Photo 2: BH\_CA1

<b>Parameter</b>	<b>Description</b>	
<i>Borehole Number</i>	BH_CA1(GEOSS)	Abandoned Borehole
<i>Co-ordinates</i>	31.468661S 19.754416E 973 mamsl	
<i>Borehole Depth (mbgl)</i>	?	
<i>WL (mbgl)</i>	7.15	
<i>Quality</i>	EC: 365 mS/m TDS: 2229 mg/L pH: 7	
<i>Comments</i>	<ul style="list-style-type: none"> <li>• Not in use</li> <li>• Assumed to be an old windpump</li> </ul>

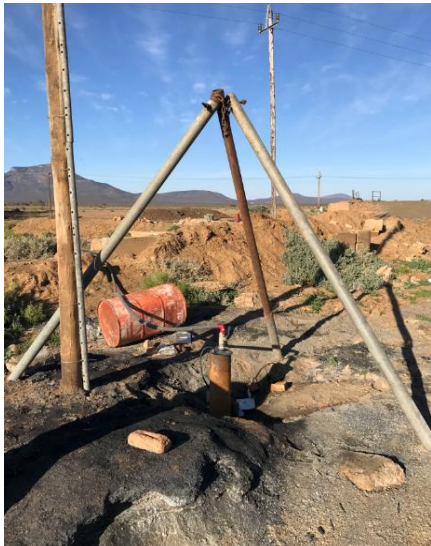
Photo 3: BH\_CA\_P2

<b>Parameter</b>	<b>Description</b>	
<i>Borehole Number</i>	BH_CA_P2 (GEOSS)	Newly drilled (2017)
<i>Co-ordinates</i>	31.46868 S 19.75409 E 973 mamsl	
<i>Borehole Depth (mbgl)</i>	?	
<i>WL (mbgl)</i>	Covered by base plate	
<i>Comments</i>	<ul style="list-style-type: none"> <li>• Equipped with pump but now power supply present.</li> <li>• Reported as very low yielding according to property owner</li> <li>• Drilled in Shale</li> </ul>

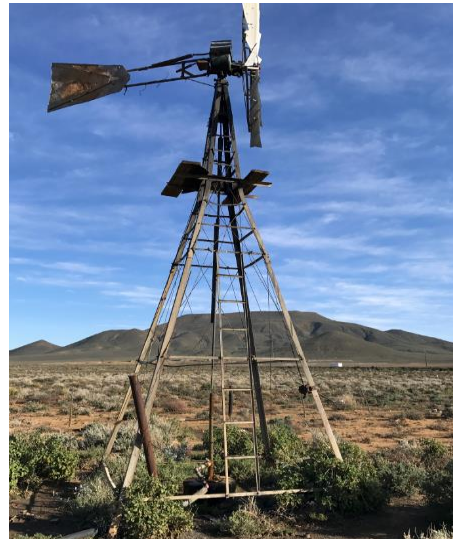
Photo 4: BH\_CA\_WP1

<i>Parameter</i>	<i>Description</i>	
<i>Borehole Number</i>	BH_CA_WP1 (GEOSS)	Windpump
<i>Co-ordinates</i>	31.46855 S 19.75067 E 973 mamsl	
<i>Borehole Depth (mbgl)</i>	?	
<i>WL (mbgl)</i>	Covered by base plate	
<i>Comments</i>	<ul style="list-style-type: none"> <li>• Water is piped to collection JoJo tanks, same as BH_CA_P1</li> <li>• Sample not collected as main source could not be collected before been mixed into collection tanks</li> </ul>

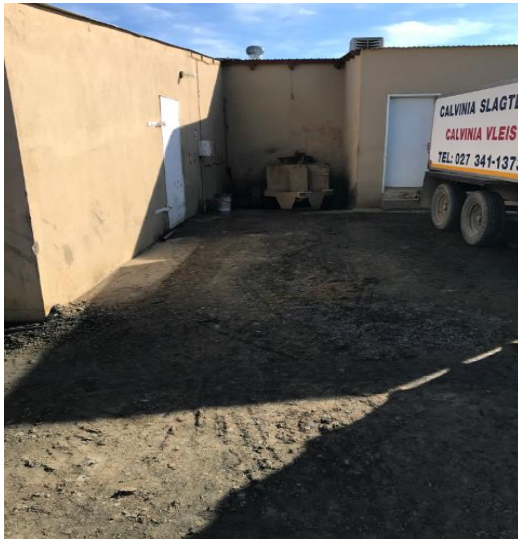
<b>Parameter</b>	<b>Description</b>	
<i>Borehole Number</i>	BH_CA2 (GEOSS)	Production Borehole
<i>Co-ordinates</i>	31.46862 S 19.75409 E 968 mamsl	
<i>Borehole Depth (mbgl)</i>	?	
<i>WL (mbgl)</i>	Borehole is buried underground	
<i>Quality</i>	EC: 365 mS/m TDS: 2336 mg/L pH: 7.5	
<i>Comments</i>	<ul style="list-style-type: none"> <li>• Borehole is used for cleaning the factory floors</li> <li>• Drinking water for livestock</li> <li>• Waste water is channelled into drains which feed a storage tank</li> <li>• Waste water is pumped to WWTW</li> </ul>

Photo 5: BH\_CA2, Buried underground

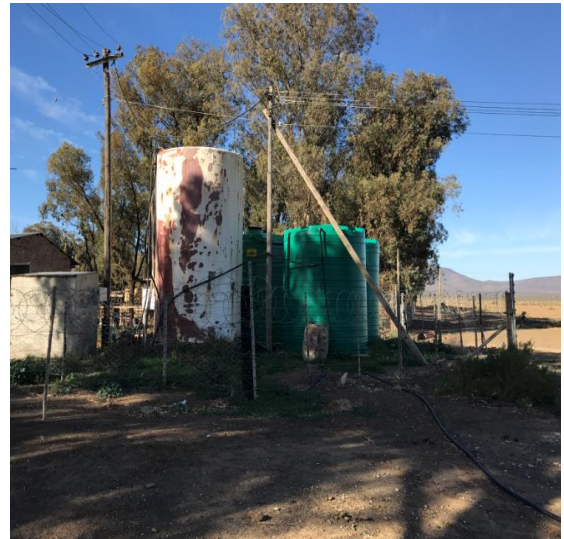
The site was inspected for any potential risks that may lead to groundwater contamination. Groundwater was found to be used to clean off carcasses, the groundwater is chlorinated on site to disinfect. Groundwater was also found to be used to clean out the holding pens. The holding pens and washing zones are within cement bunding walls. The effluent water is channelled into a storage tank where it is transferred to a Waste Water Treatment Works.

Photo 6: Collection JoJo tanks

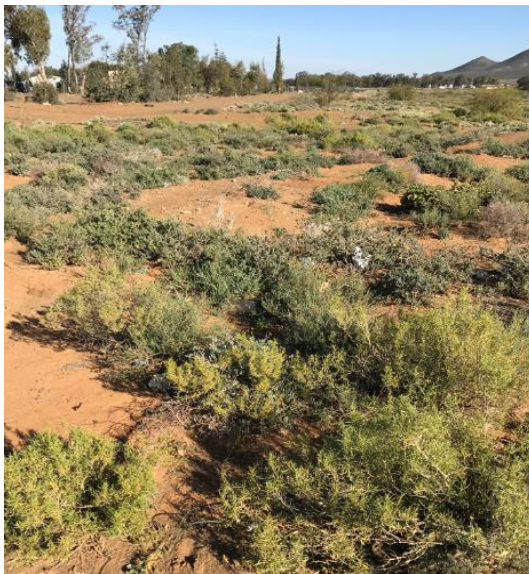
There were Three NGA boreholes within the one kilometre search radius surrounding the Abattoir site. None of the NGA sites could be located during the field visit as they do not exist or have been destroyed.

Photo 7: NGA site, no borehole
