Report on the floristic and ecological assessment of the proposed establishment of a service/delivery access road adjacent to the Northridge Mall, Bloemfontein, Free State Province.

October 2016

Prepared for:
MDA Environmental Consultants
9 Barnes Street
Westdene
9301

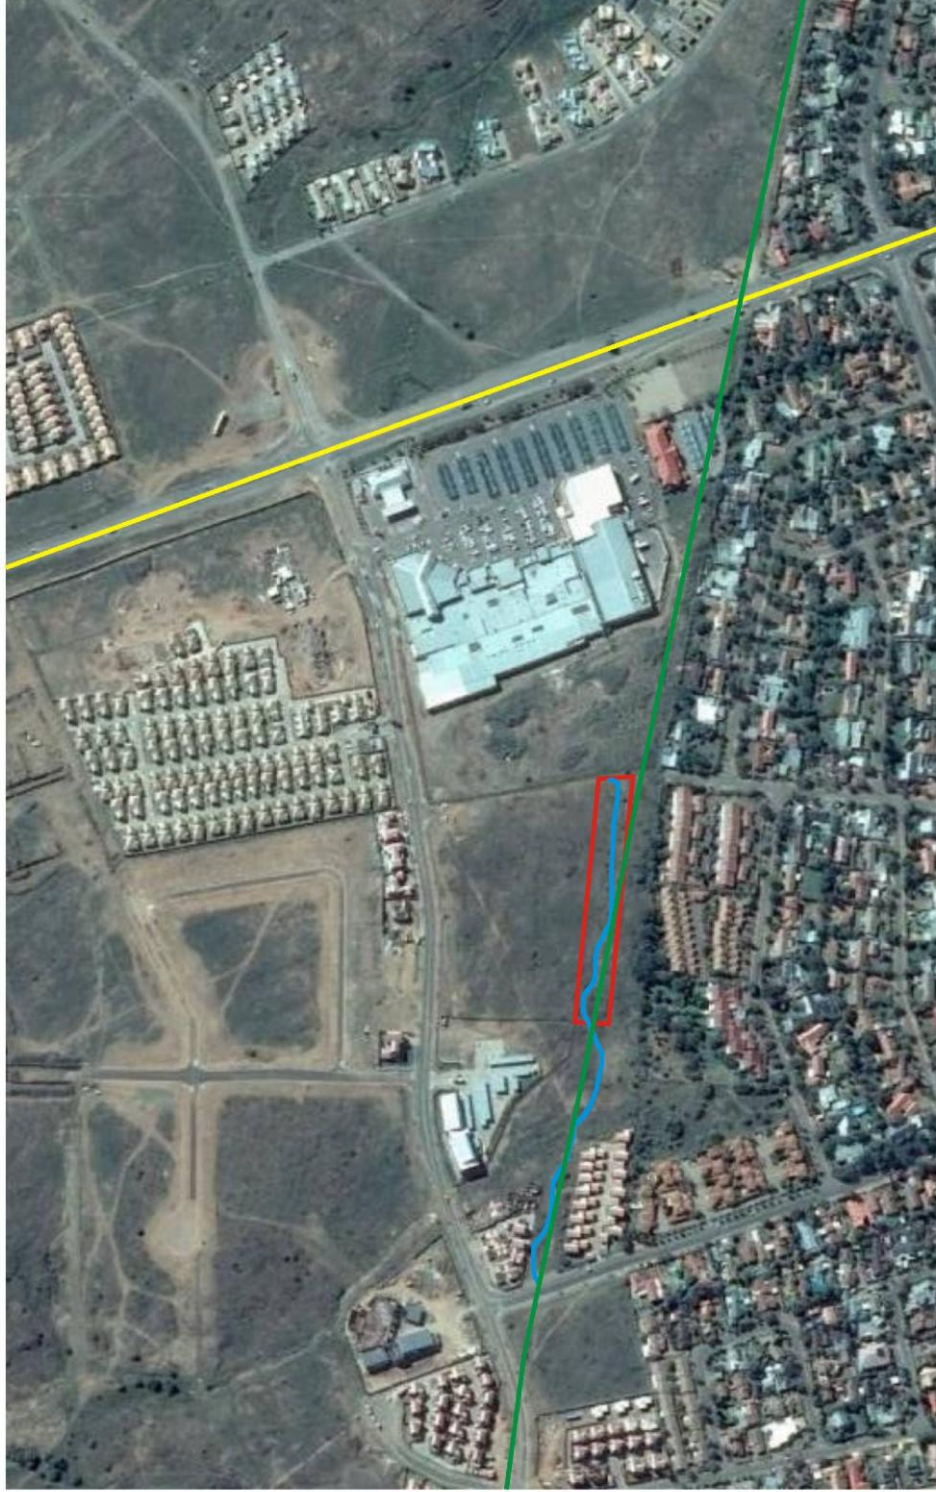
Map 1: Location of the proposed establishment of an access road adjacent to the Northridge Mall. The dirt track and power line causing degradation of the site is also indicated. Note also the surrounding construction and urban areas.

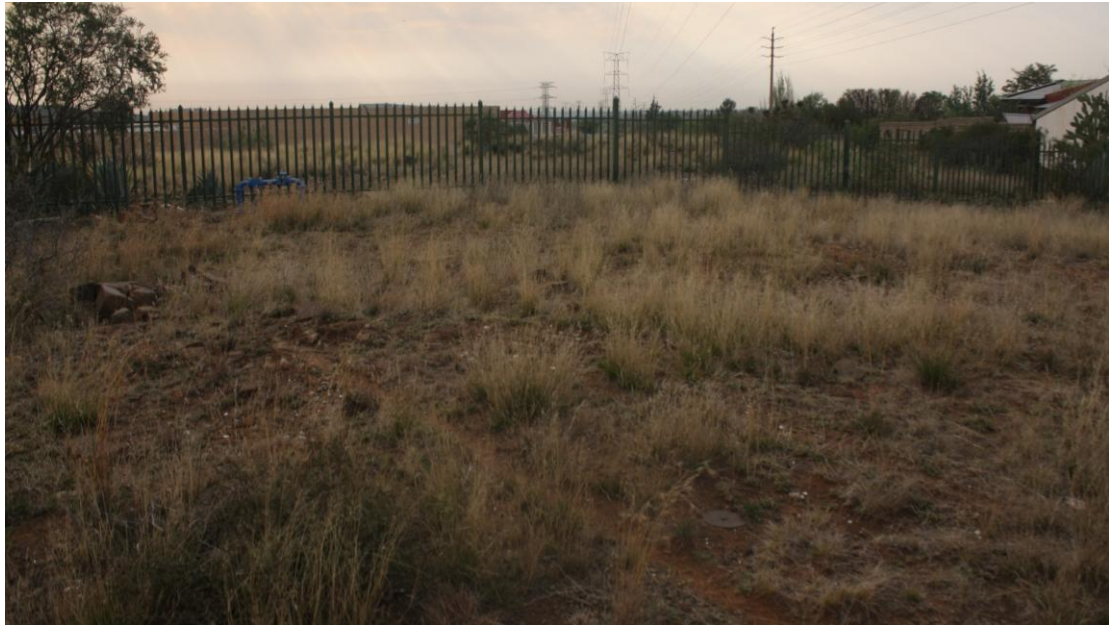
Figure 1: View of the eastern end of the propose road.

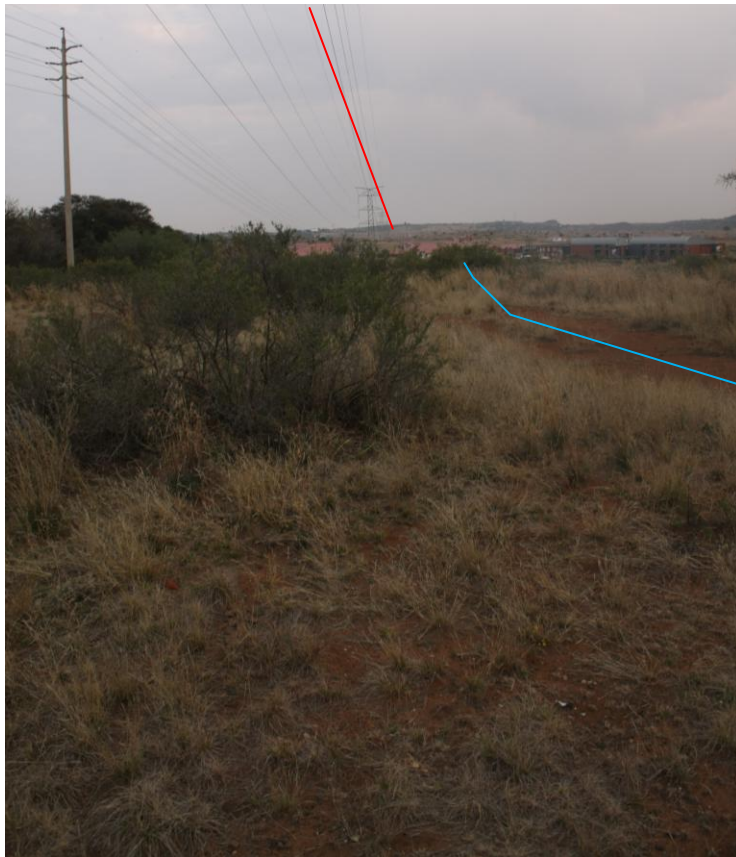
Figure 2: View of the proposed road from the east toward the west.
The overhead powerline and dirt track is indicated.

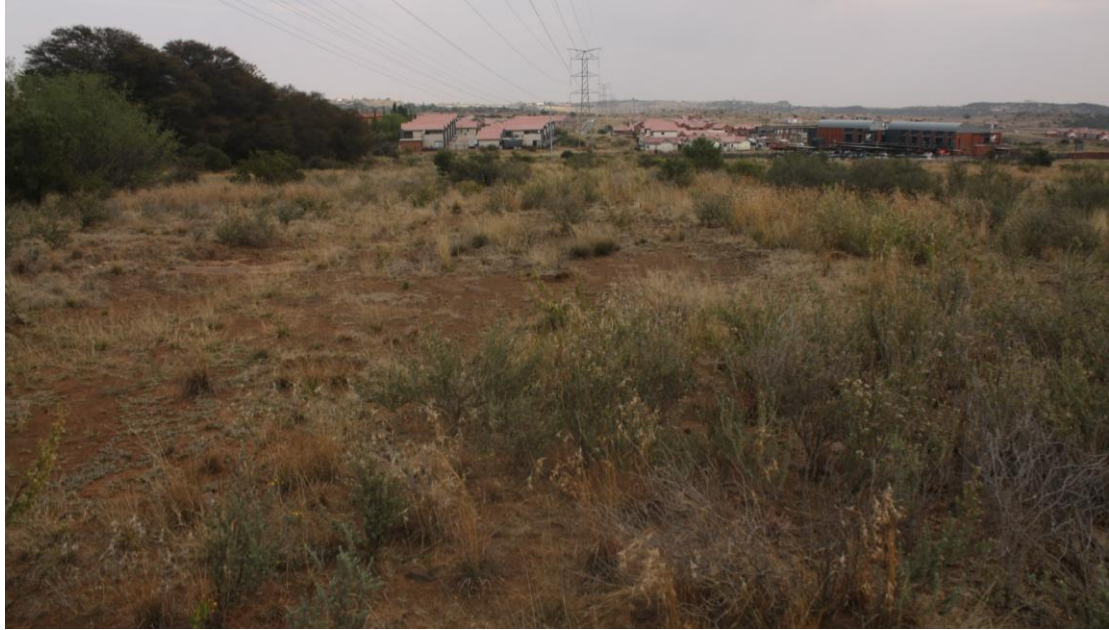
Figure 3: View of the site. Note areas devoid of vegetation. Although the vegetation type contains rock sheets where cover is low this area is not of this type and has been degraded.
