Ecological Report

Report on the ecological and wetland assessment of the proposed construction of a bulk water transfer pipeline from the Cyferfonteindam to the town of Senekal, Free State Province.

March 2019

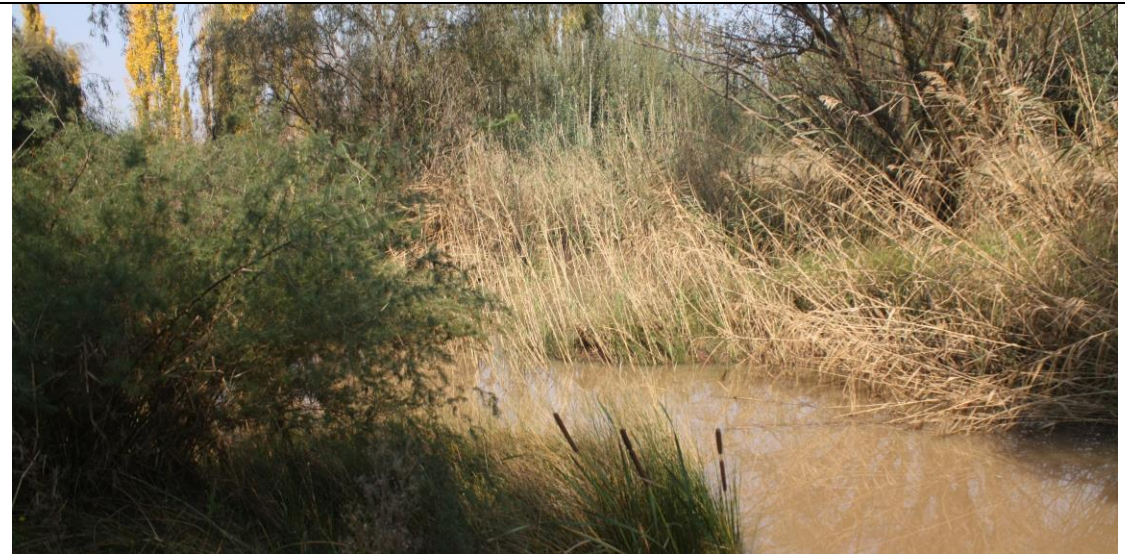
<p>View of the main channel of the Sand River.</p>

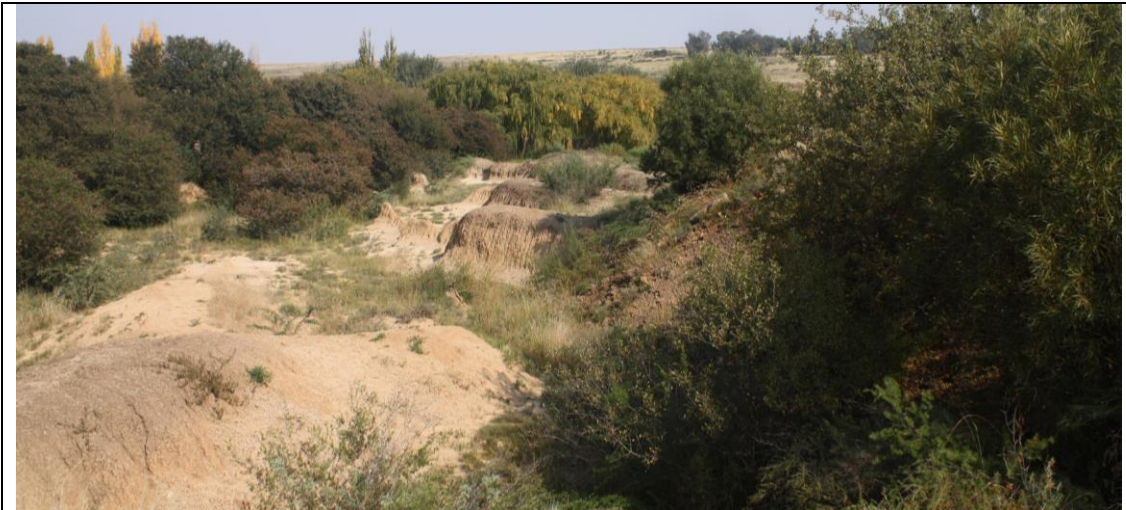
View of the floodplain of the Sand River. Note the extensive erosion gullies, considered to be mostly natural.

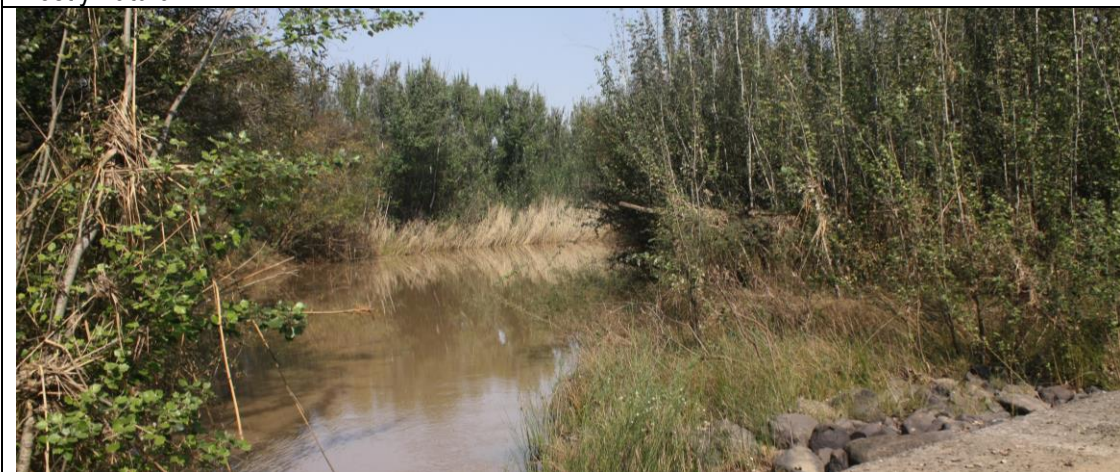
View of the main channel of the Sand River. Note that riparian trees in this area is dominated by exotic *Populus x canescens*.

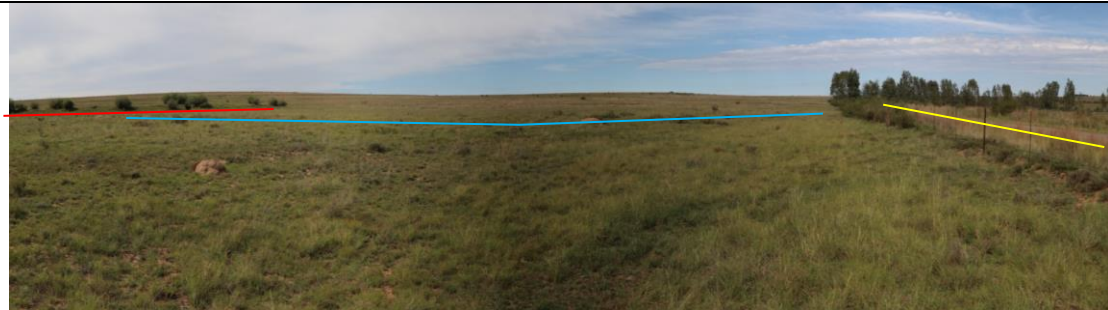
The drainage line contains a few obligate wetland species including grasses and sedges and indicates that although it is small, some wetland conditions do occur. The drainage line is devoid of a clearly defined channel although wetland conditions are clearly present and is therefore considered a valley-bottom wetland without a channel.

View of the drainage line (blue). It is clearly indistinct without a defined main channel. The impoundment (red) and gravel road (yellow) is also indicated.

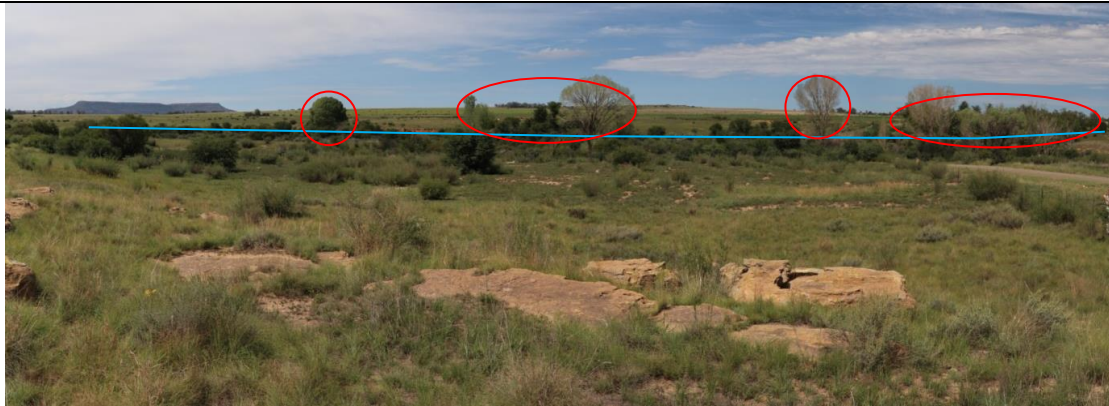
The stream has a clearly defined main channel and the floodplain contains a clear floodbench which simplifies determination of the border of the floodplain. Significant erosion was noted in the floodplain but is considered mostly natural though somewhat exacerbated by surrounding land use. Obligate wetland vegetation is dominant along the main channel but mostly confined to it and absent from the floodplain.

View of the Sandspruit (blue). Riparian thicket is clearly visible. Note also exotic trees (red).

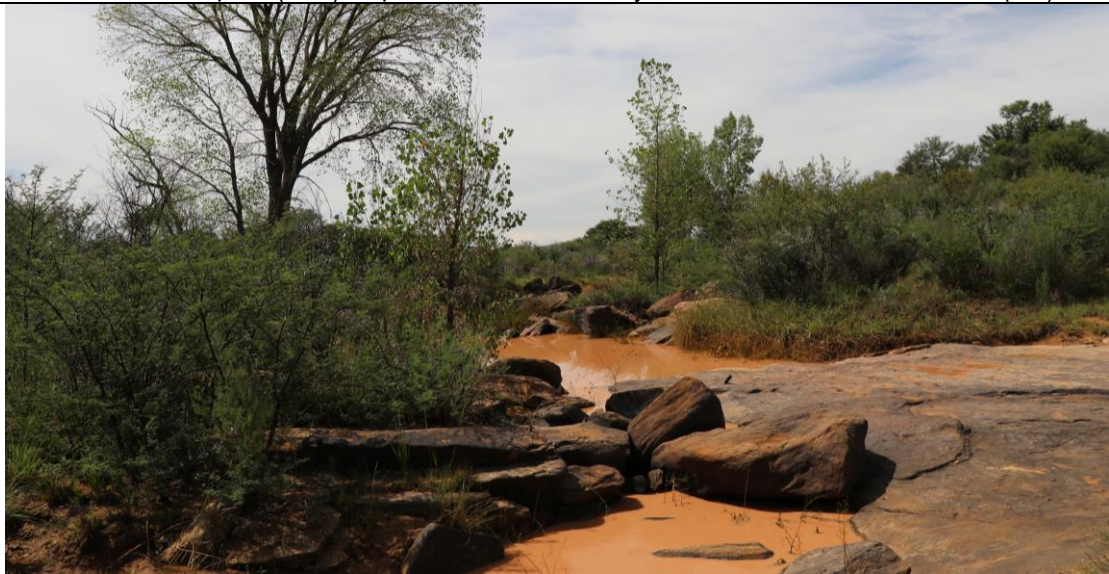
The main channel of the Sandspruit clearly indicates that it is a large and significant watercourse. Note the large exotic tree in the background.

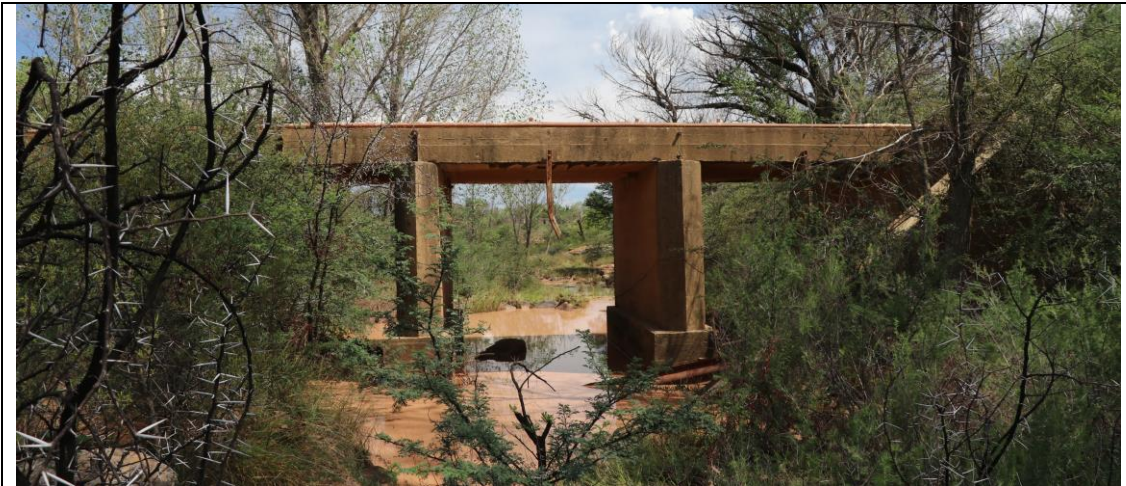
View of the gravel road and bridge over the Sandspruit. This will clearly have some impact in terms of flooding and scouring.

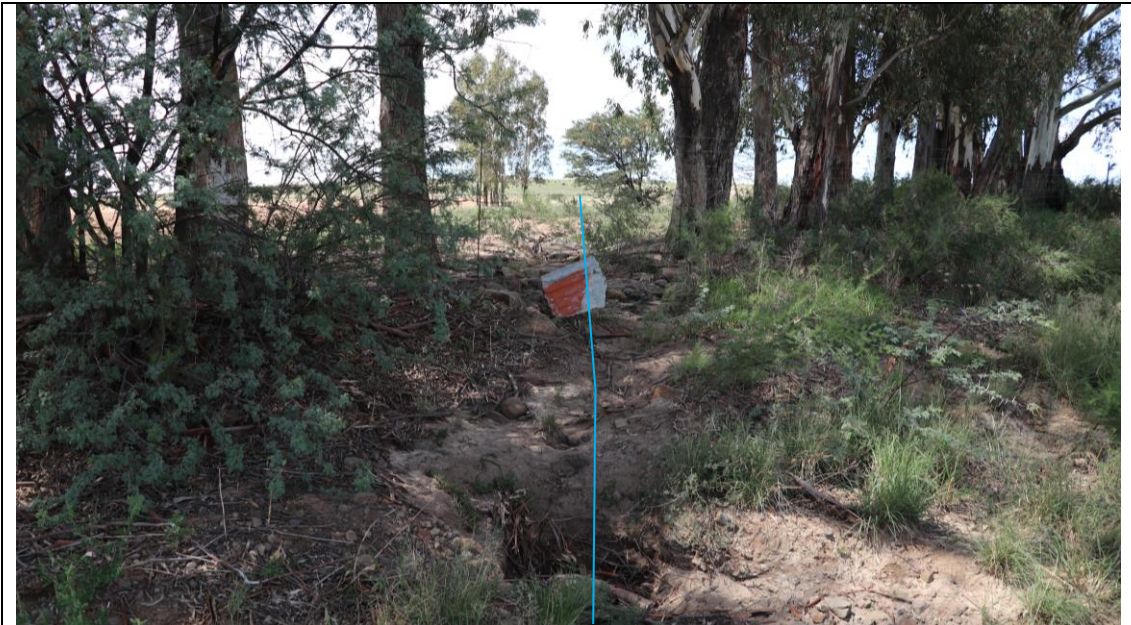
The drainage line is heavily modified and clearly affected by numerous significant impacts. The catchment of the drainage line is situated within agricultural cropfields which affects it heavily in terms of increased runoff velocity which in turn increases erosion and sedimentation of watercourses. Also associated with this is fertiliser, pesticide and herbicide runoff and its effect on water quality. A road crossing and the small holdings also cause flow barriers and alter the flow regime considerably. These also cause some diversion of the flow pattern of this drainage line.

The drainage line is dominated by terrestrial species with a few facultative wetland grasses and indicates that wetland conditions are largely absent. It also indicates the small size of the drainage line. It does contain a clearly defined, though small, main channel.

View of the drainage line (blue). It is clearly heavily degraded. Note row of exotic *Eucalyptus camaldulensis* trees.

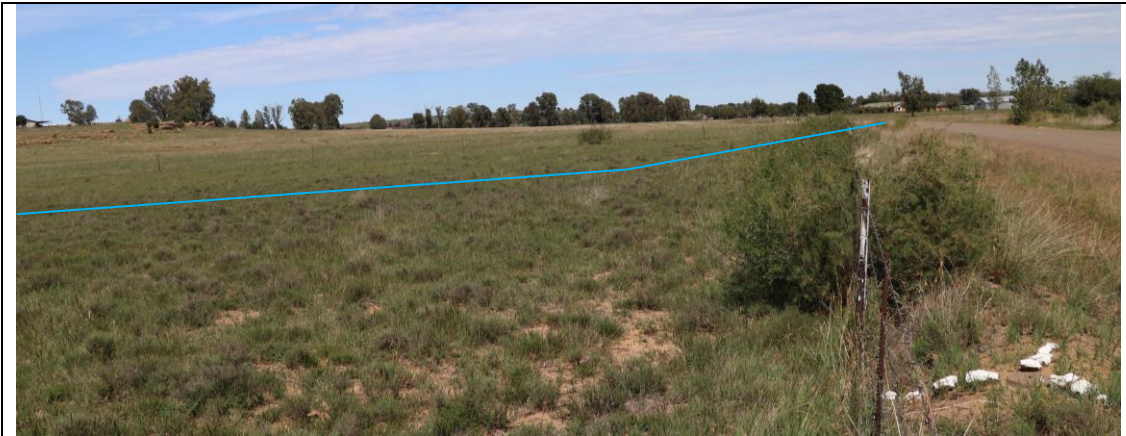
The drainage line is modified to a large degree by a few large impacts. The catchment of the drainage line is situated in the portion of remaining natural grassland and therefore the impacts of erosion, surface runoff and contribution of any fertilisers would be absent. However, several artificial impoundments immediately upstream of the point of crossing causes significant modification of the flow- and flooding regime of the drainage line. These impoundments also modify the geomorphology of the drainage line. The crossing of the gravel road also leads to significant modification of the drainage line. This causes retardation of flow and modifies the flow- and flooding regime further.

The drainage line contains a few obligate wetland species including grasses and sedges and indicates that although it is small, some wetland conditions do occur. The drainage line is devoid of a clearly defined channel although wetland conditions are clearly present and is therefore considered a valley-bottom wetland without a channel.

View of the drainage line (blue). It is clear that a defined channel is absent.

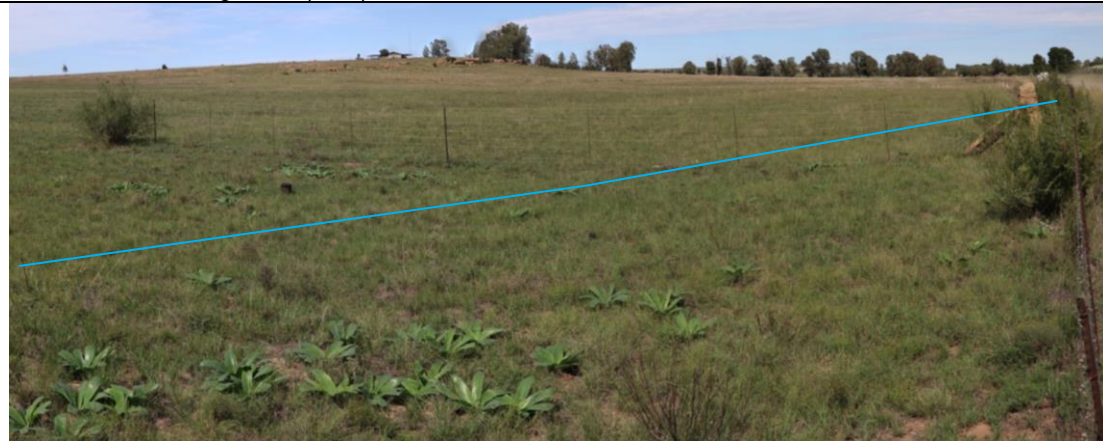
View of the drainage line (blue). Note a significant colony of the protected geophyte, *Amocharis coranica*.

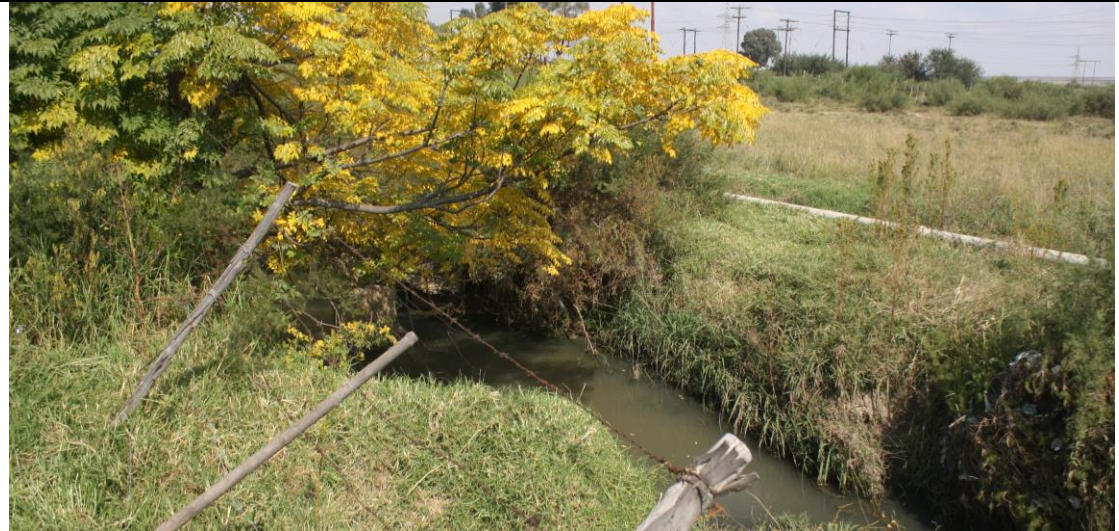
The stream is clearly defined with a prominent main channel and as a result of increased effluent is anticipated to have an almost perennial flow. Being dominated by exotic vegetation obligate wetland vegetation is largely absent although it is still highly likely that wetland conditions will be present although artificial to a large extent due to the increased baseflow.

View of the seasonal stream which has clearly been degraded.

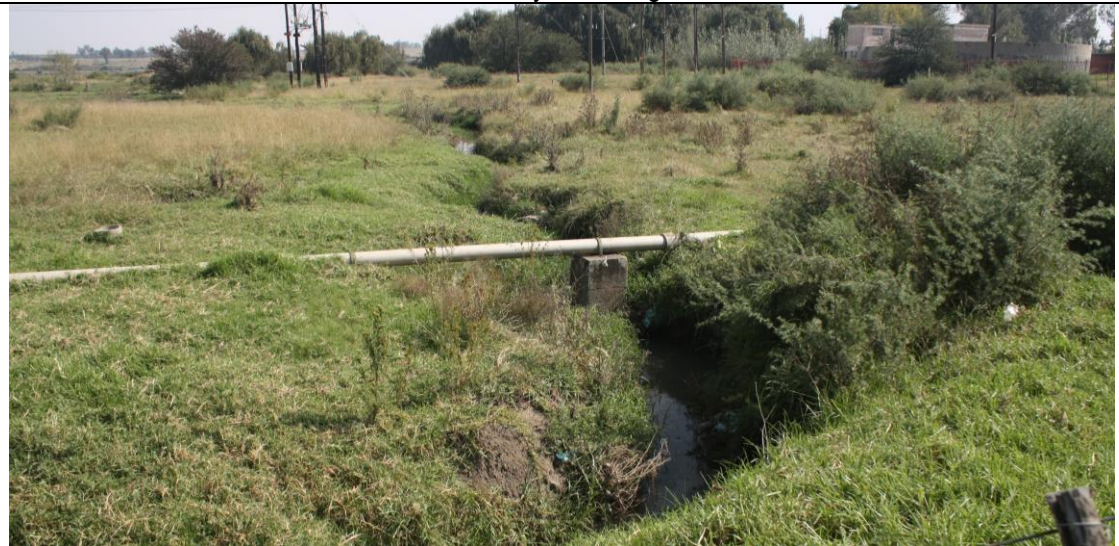
View of the main channel of the stream which is clearly modified by increased effluent. Note also the crossing by existing pipeline.

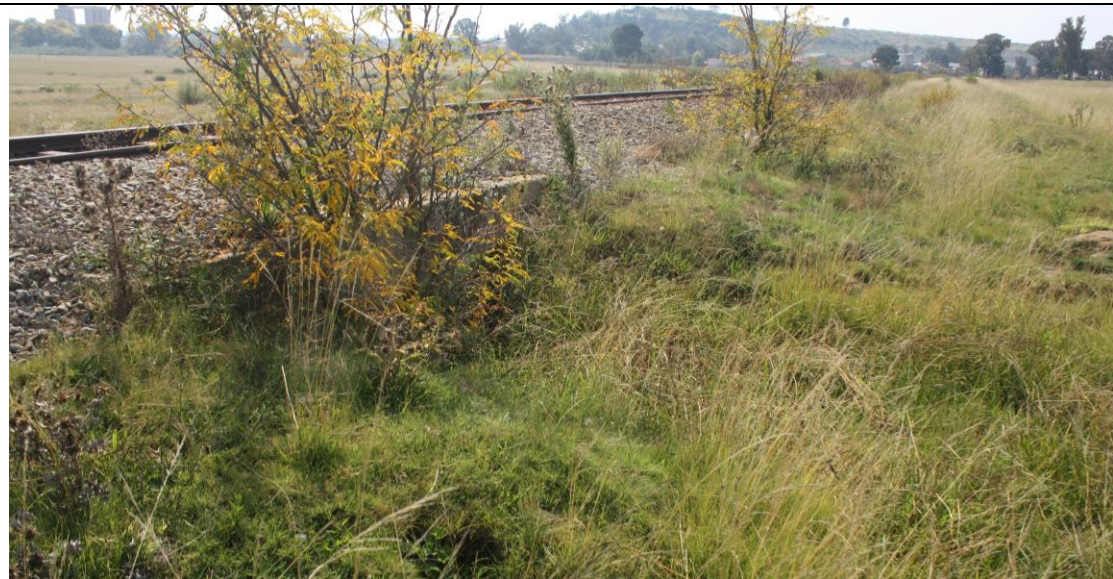
View of the artificial wetland area and accumulation of moisture adjacent to the railway line.

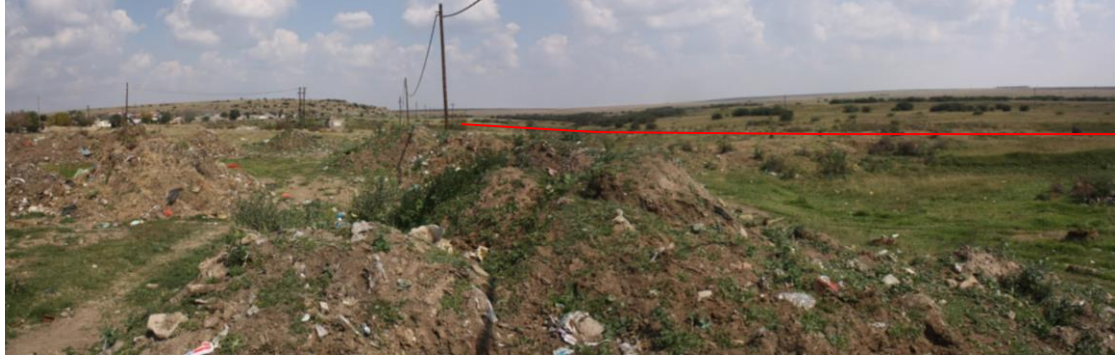
The river contains a clearly defined main channel and floodbench although activities such as illegal dumping and erosion complicates the boundary of the floodplain. Significant erosion gullies occur in the floodplain which is considered a natural feature of this river although visibly exacerbated by the current impacts. Exotic vegetation is abundant and dominates in some areas. Obligate wetland vegetation is dominant along the main channel but mostly confined to it and absent from the floodplain.

View of the illegal dumping in the floodplain. The location of the river is indicated (red).

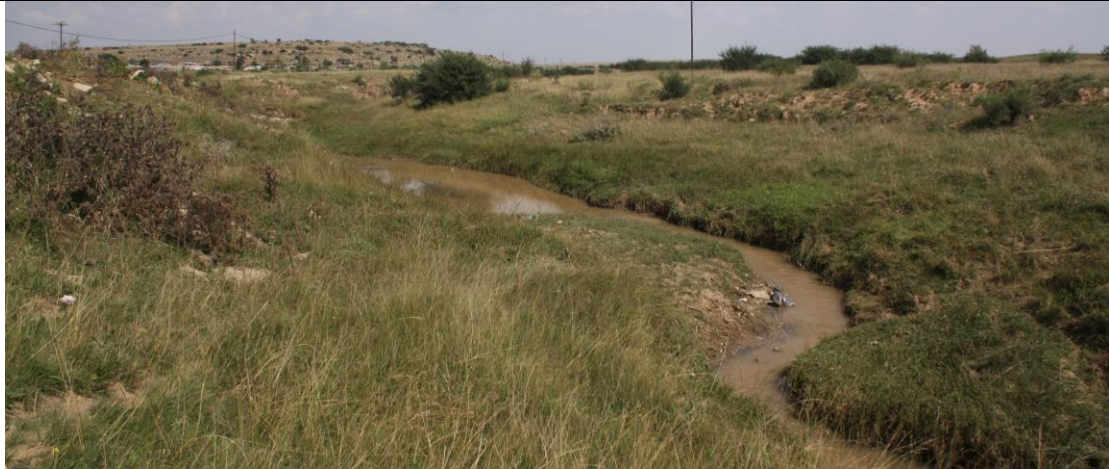
View of the main channel of the river.

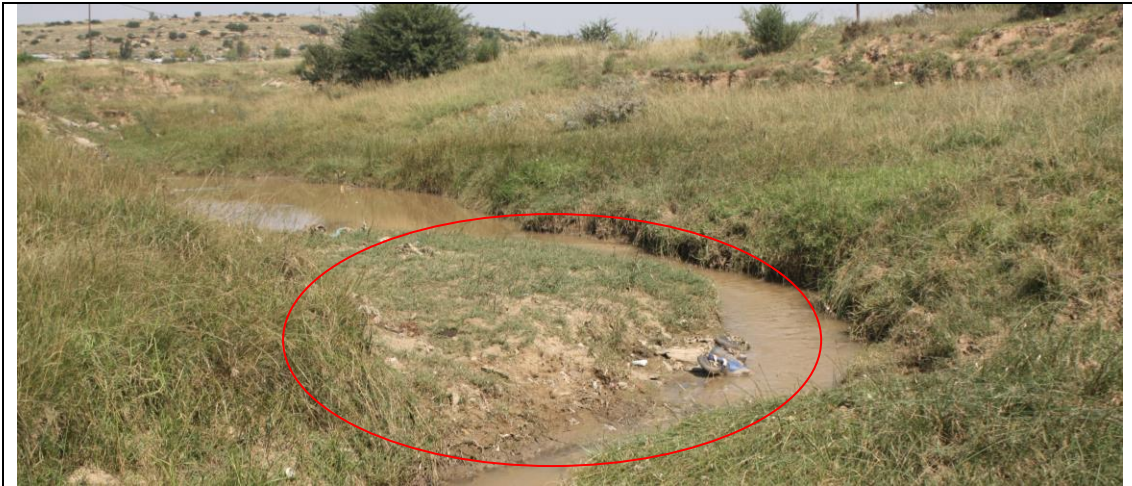
Trampling and refuse is evident along the riverbank (red).

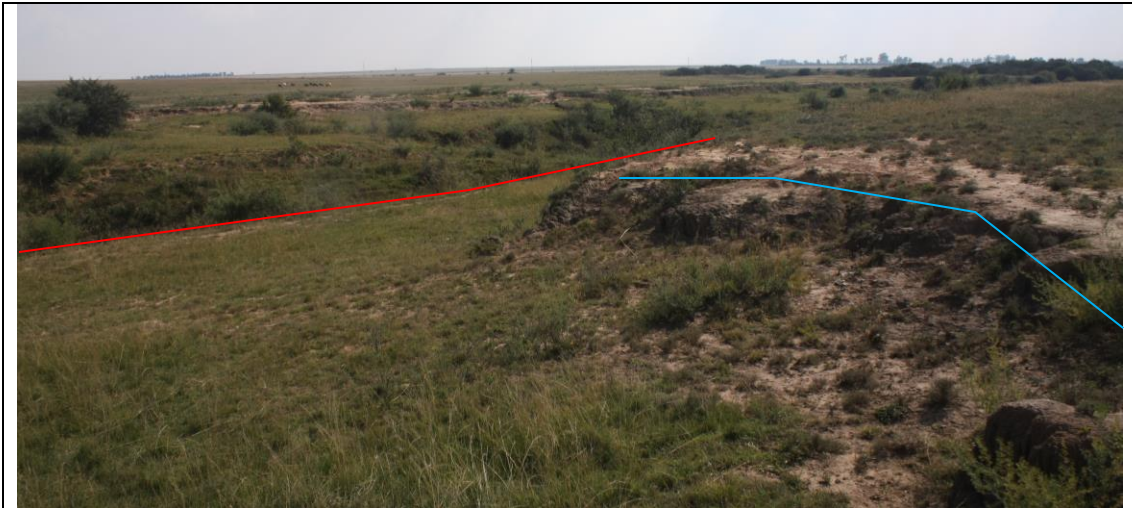
The river contains a clearly defined main channel and the floodplain contains a clear floodbench which simplifies determination of the border of the floodplain. Significant erosion gullies occur in the floodplain which is considered a natural feature of this river although visibly exacerbated by overgrazing and trampling. Exotic vegetation is abundant but do not dominate. Obligate wetland vegetation is dominant along the main channel but mostly confined to it and absent from the floodplain.

View of the river (red) with the floodbench clearly visible (blue).

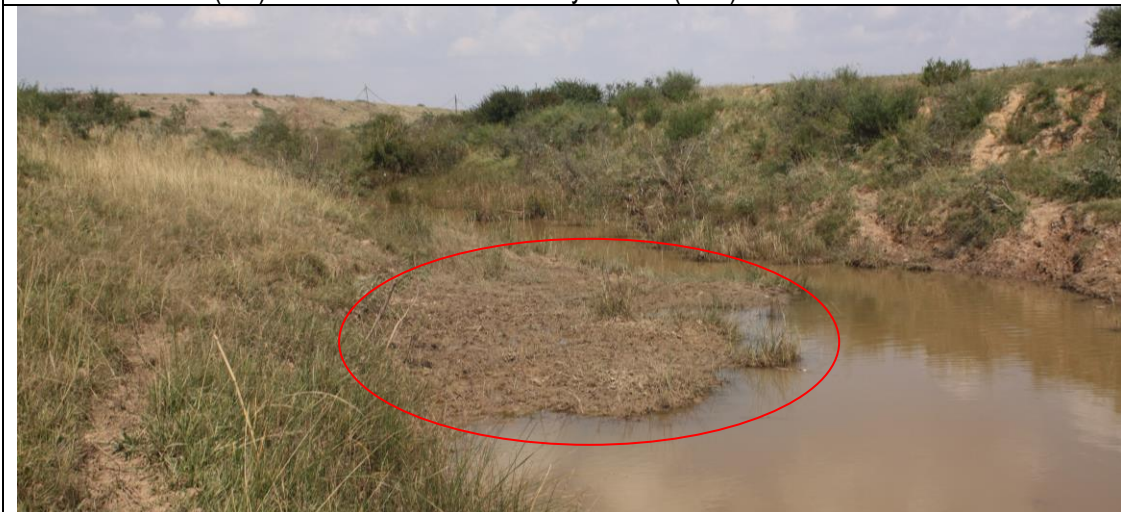
View of the main channel of the river. High levels of trampling is clearly present (red).

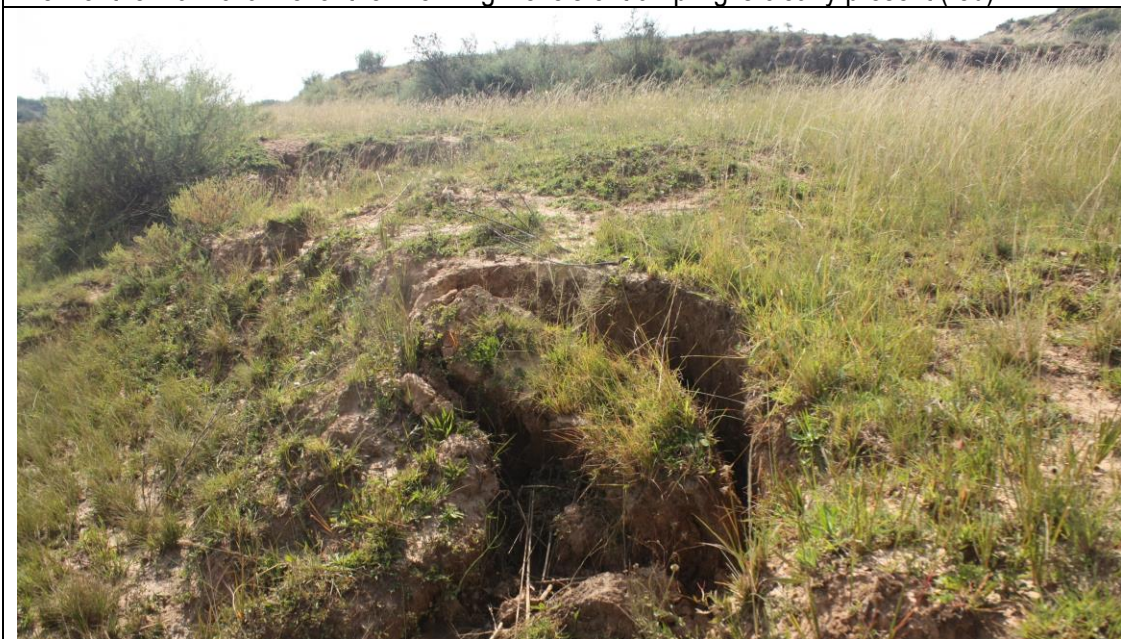
Erosion is clearly being exacerbated by overgrazing and trampling.

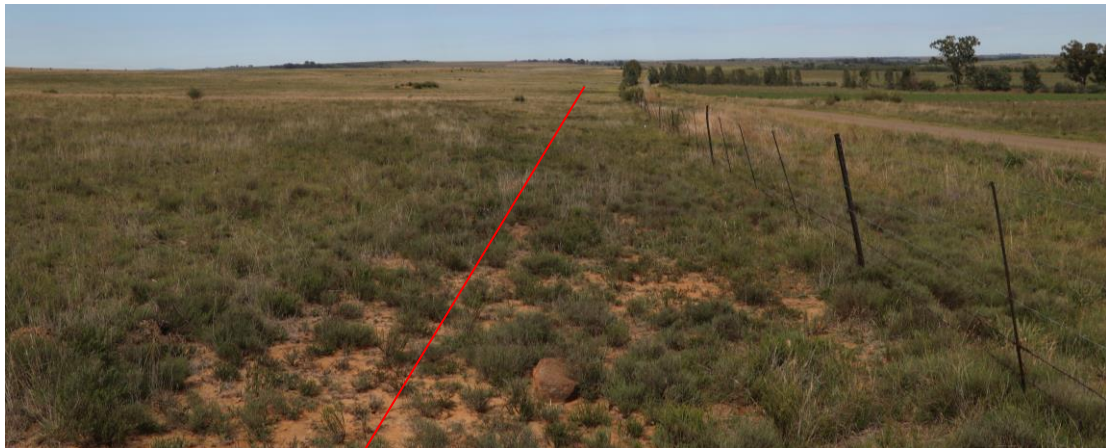
Figure 2: View of the portion of remaining natural vegetation south of the Ceyferfontein dam. The approximate location of the pipeline adjacent to the fenceline is indicated (red). Note the dominance by dwarf karroid shrubs indicating a degraded grass layer.

The section (approximately 2 km long) to the south of the dam is situated along the gravel road but outside the road reserve and although it is consequently still degraded, still consists of natural vegetation. This portion is also situated within Eastern Free State Clay Grassland, a Threatened Ecosystem, which is therefore of a high conservation value (Map 2). The portion immediately adjacent to the fenceline is notably degraded most likely due to a variety of impacts and which may include, firebreaks, grading of the vegetation for firebreaks, historical clearing of the vegetation associated with the road building activities and dirt tracks along the border fence. As a result the natural vegetation structure is modified to a significant degree and a dwarf karroid shrub component is dominant. Although dwarf karroid shrubs are natural to the vegetation type in the area they become dominant only where disturbance is high, otherwise a grass layer dominates. Dominant dwarf karroid shrubs include *Chrysocoma ciliata*, *Selago densiflora*, *Ruschia hamata* and *Stoebe vulgaris*. Grass species are still abundant but notably lower than dwarf karroid shrubs. These include *Eragrostis lehmanniana*, *E. curvula*, *E. obtusa*, *Aristida congesta*, *Sporobolus fimbriatus*, *Themeda triadra* and *Cymbopogon pospischillii*. This is a mixture of climax and pioneer species which indicates natural grassland, but which is evidently degraded to some extent. This is also affirmed by a few exotic weeds including *Verbena tenuisecta* and *Schkuhria pinata*. They are however not abundant. Other abundant herbs include *Hibiscus pusillus*, *Berkheya macrocephala*, *Crabbea acaulis* and *Solanum supinum*. A single geophyte was observed, *Hypoxis angustifolia*, but is a widespread and common species not of significant conservation value. However, due to limited surveying it is still likely that protected or Red Listed species may occur in this section. As can be deduced the vegetation immediately adjacent to the fenceline is significantly degraded. Being situated within a Threatened Ecosystem it is however still considered to have a high conservation value and the footprint of the construction of the pipeline in this section should be kept to a minimum.

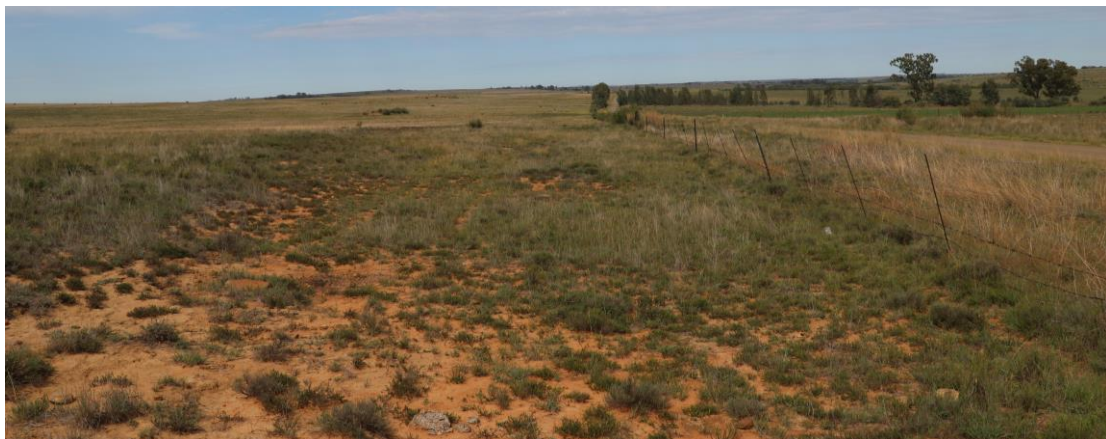
Figure 3: Another view of the portion of remaining natural vegetation where it is clear that a narrow strip adjacent to the fenceline is visibly degraded.

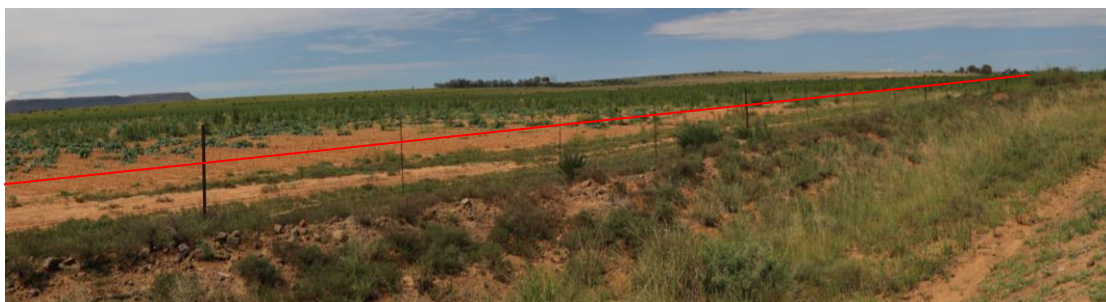
Figure 4: Large portion of the pipeline route (red) has been transformed by crop cultivation.

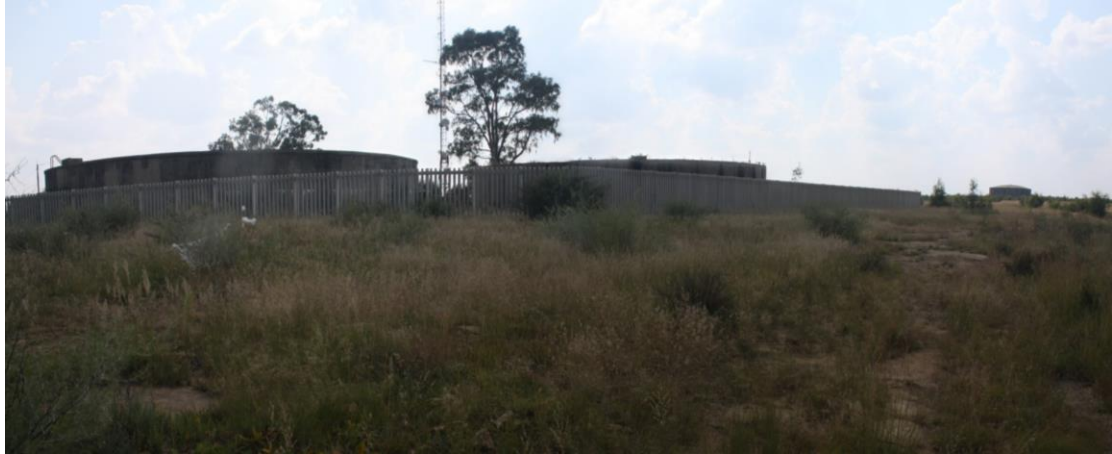
Figure 5: View of the water reservoirs on top of the sandstone hill where the pipeline will connect to.

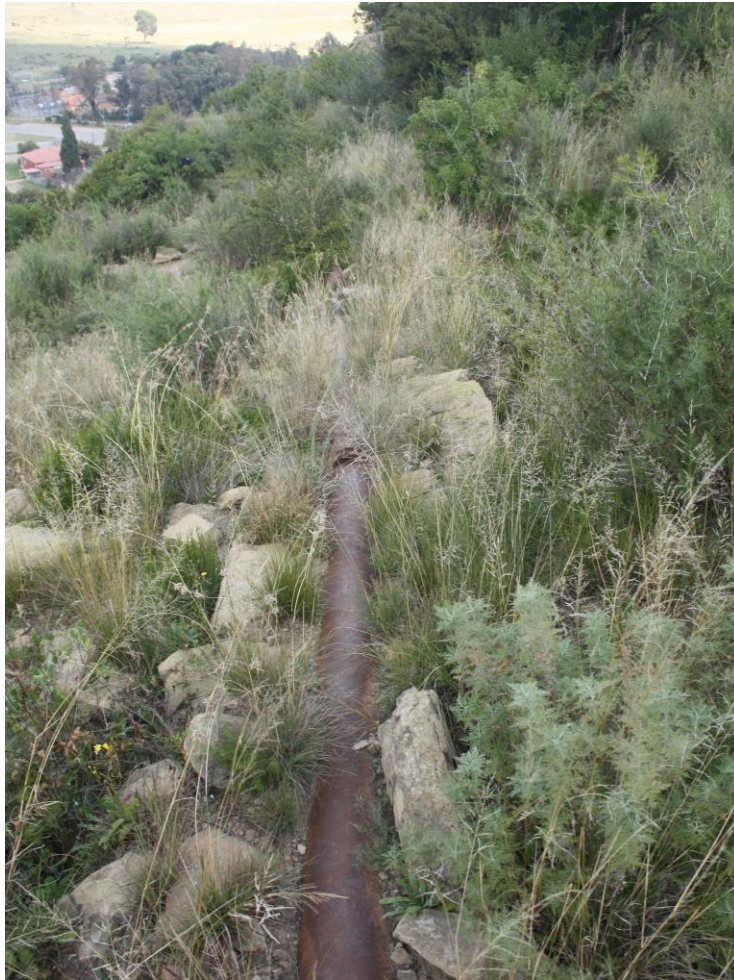
Figure 7: View of an existing pipeline along the slope of the hill. The current proposed pipeline should be installed along the same method where with regards to the sandstone hill, i.e. on top of the soil surface or semi-imbedded.

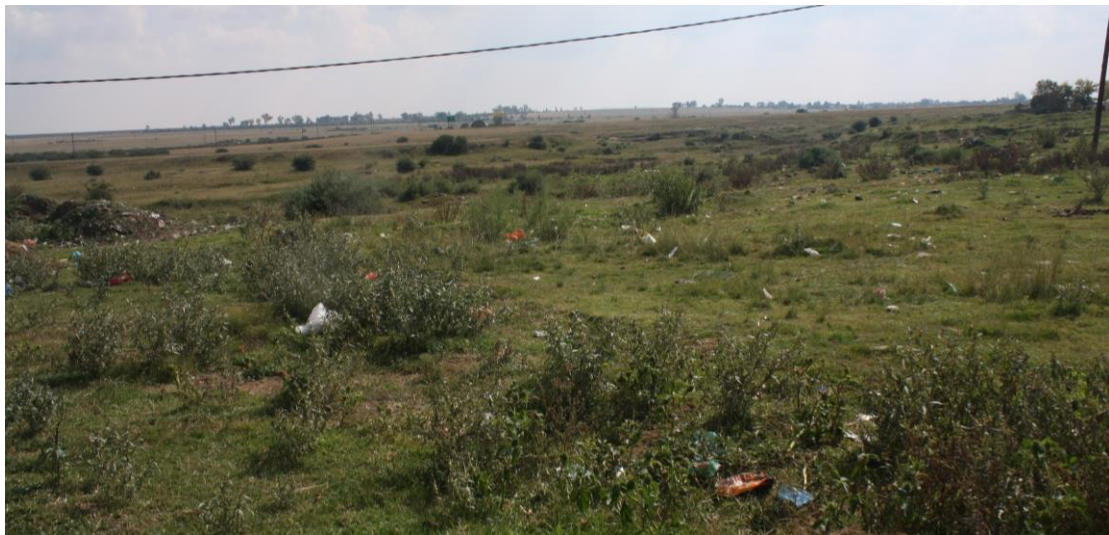
Figure 7: Grassland portions around the urban areas are mostly transformed from the natural condition and no longer considered as part of the threatened Eastern Free State Clay Grassland.

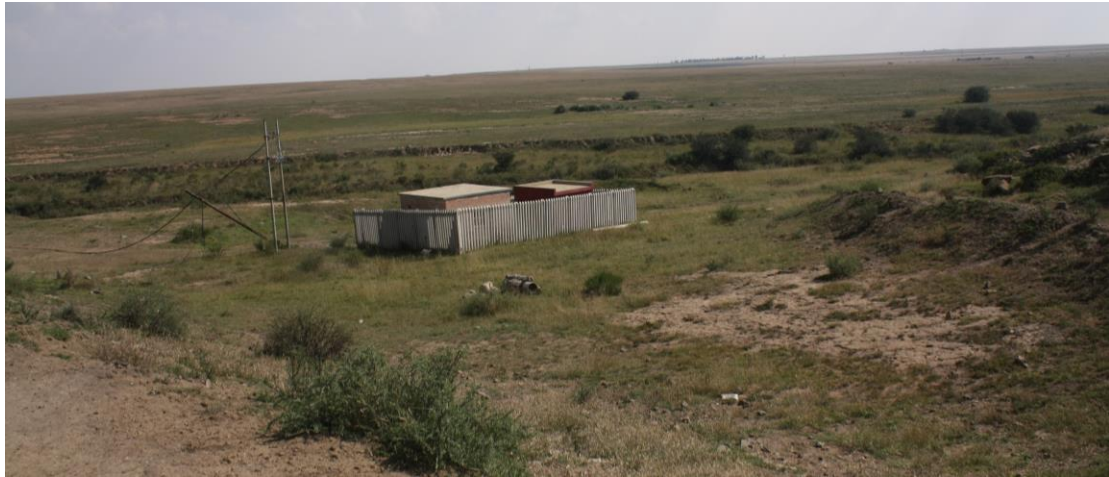
Figure 8: View of the pump station at the Senekal Dam where the pipeline will connect to the system.
