APPENDIX D₂

Ecological Report

Report on the ecological and wetland assessment of the proposed construction of a bulk water transfer pipeline in the Roodewal Small Holdings, Bloemfontein, Free State Province.

August 2019

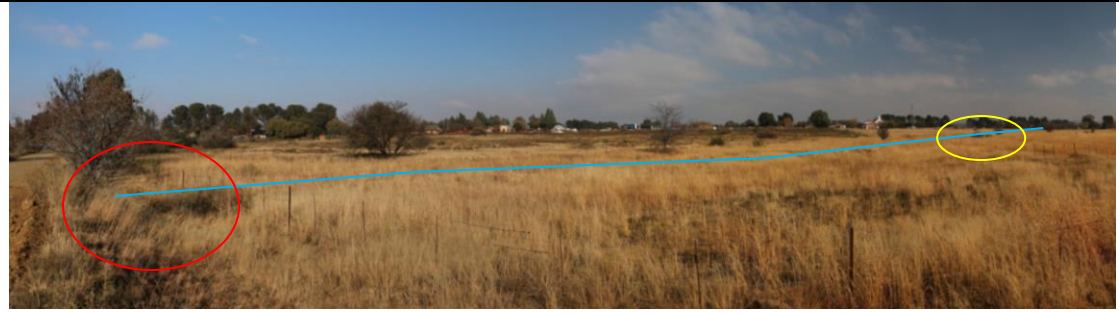
View of the small stream with the point of survey (red) and the actual point of crossing indicated (yellow). Note the grass dominated main channel and apparent natural surroundings.

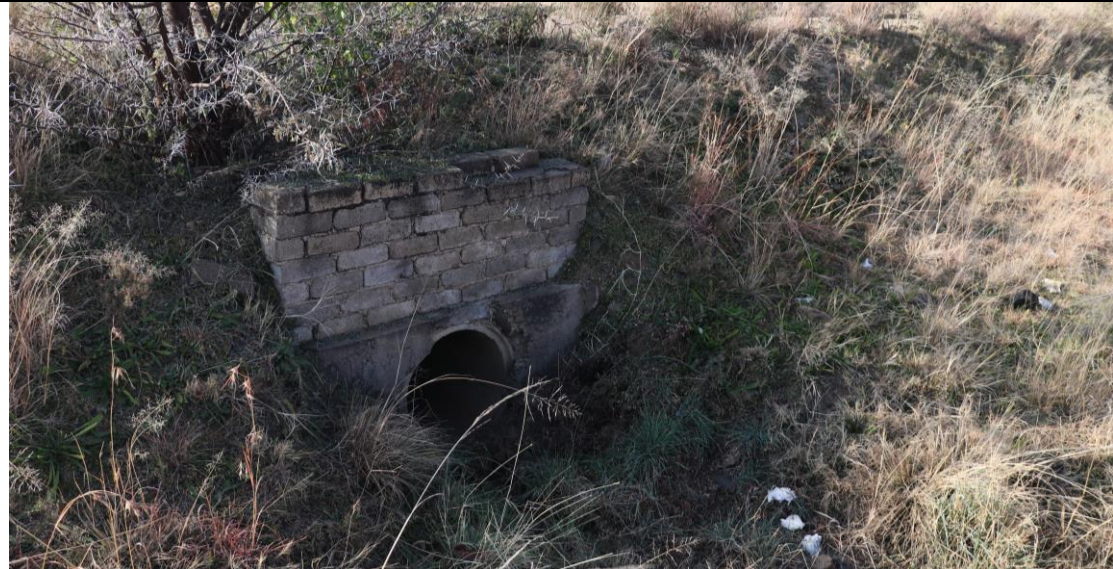
View of the culver crossing of the stream. This will clearly affect the natural flow and flooding regime of the stream.

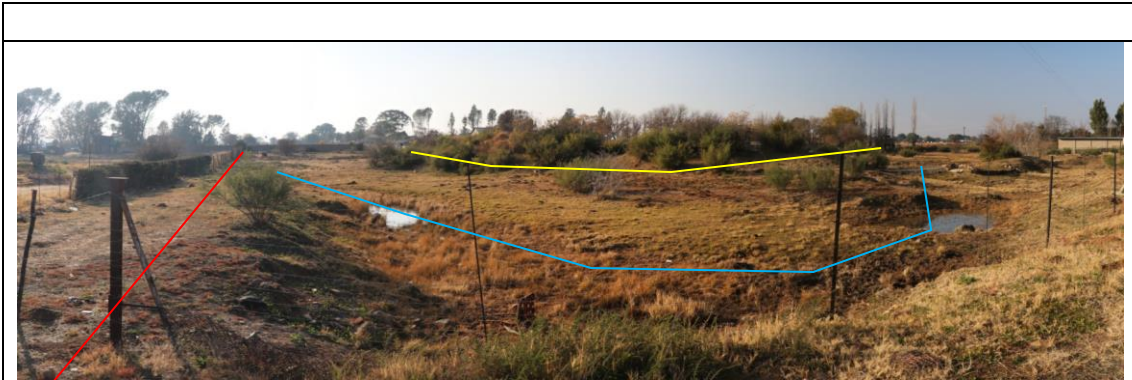
The stream system at this point becomes much more modified than the upstream section. In addition to impacts as discussed for the same stream under Crossing #1 the stream is also affected by crossing by the tarred road, an artificial impoundment and canalisation. The stream is being crossed by the tarred Maselspoort road, a busy road, causing significant disturbance of the stream. A small artificial impoundment has also been constructed in the stream which will have a significant impact on the flow and flooding regime and geomorphology of the stream. The survey also indicated that the riparian vegetation has been significantly altered as a result. Downstream of the dam the stream is also canalised passed an orchard which significantly alters the stream further. The stream at this crossing is significantly degraded and modified.

View of the stream system along the northern pipeline route (red). Note the artificial impoundment (yellow) and stream flowing from it. This area is clearly degraded and the stream heavily modified.

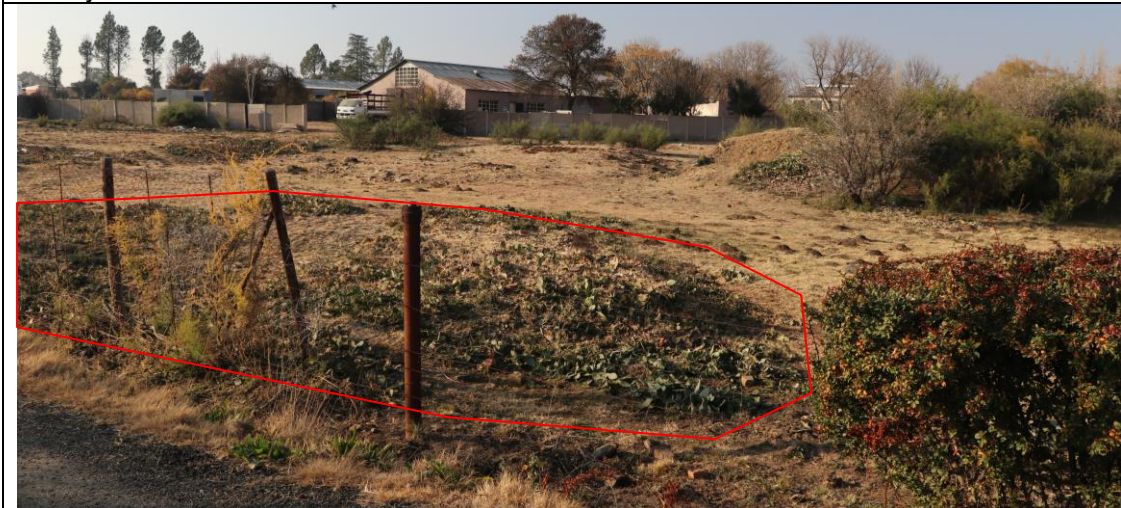
View of the floodplain of the stream. Note dense infestation by the exotic *Opuntia humifusa* (red).

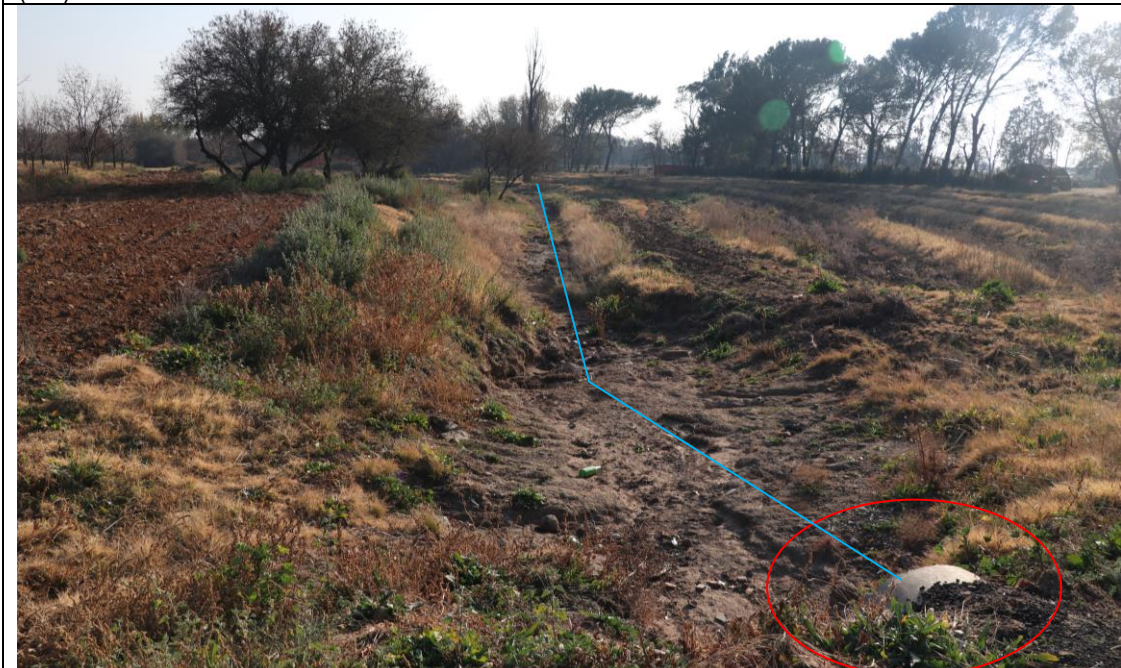
View of the culvert at the crossing (red) with the canalised section of the stream inbetween orchards and crop fields.

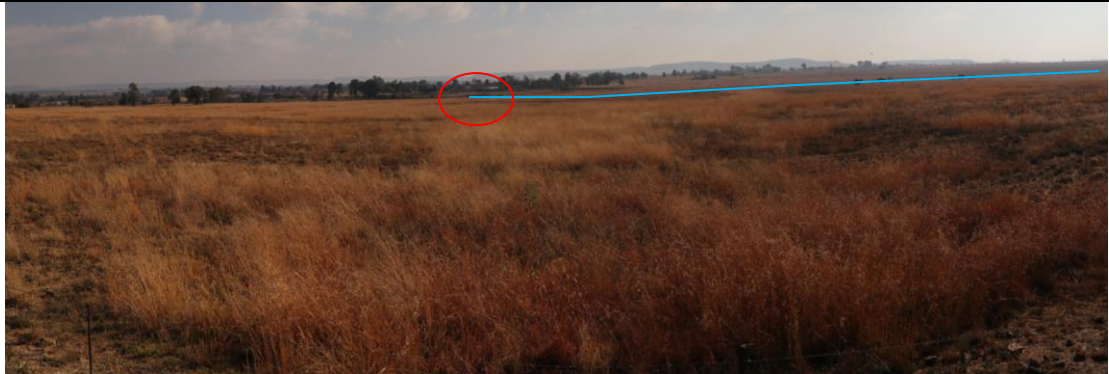
The stream at this point is considered still natural to a significant degree. The majority of the stream is situated within a natural area utilised for livestock farming. The impacts on it here will therefore be limited. Livestock overgrazing will however contribute to trampling which will decrease the vegetation cover and increase erosion and sedimentation of the stream. Manure will also contribute to increased nutrients. A small portion of dryland croplands also occurs in the catchment of the stream which will have some impact associated with fertiliser, herbicide and pesticide use. The impacts on the stream are however limited and should indicate that it is in a relatively good condition at this point of crossing.

View of the stream with the actual point of crossing indicated (red). Note the largely natural surroundings.

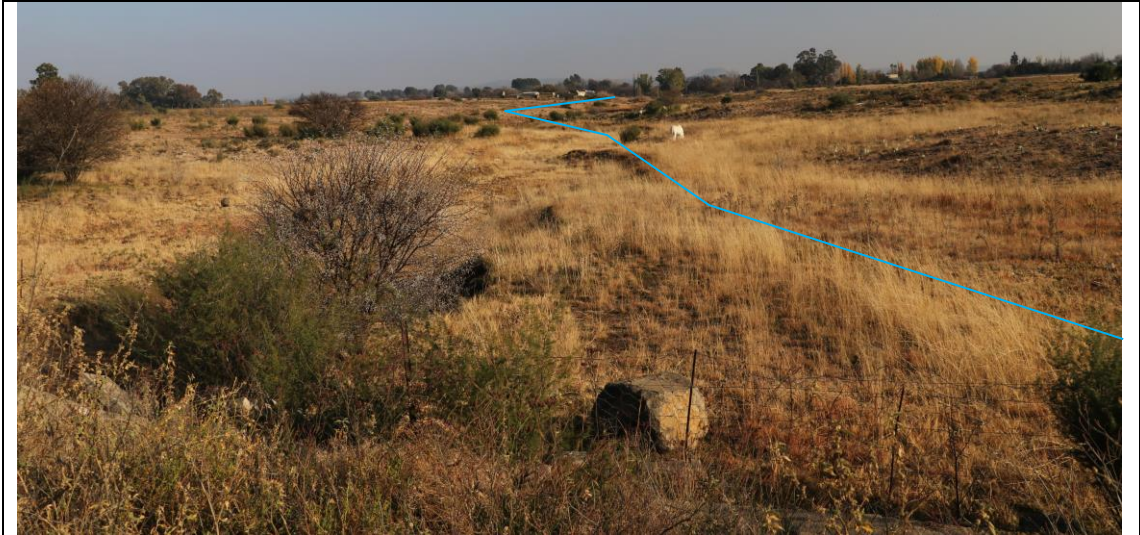
The stream system at this point becomes more modified though not significantly different than the upstream section. Additional impacts at this crossing point include crossing by the tarred road and a small artificial impoundment. The stream is being crossed by the tarred Maselspoort road, a busy road, causing significant disturbance of the stream. A small artificial impoundment has also been constructed in the stream which will have a significant impact on the flow and flooding regime and geomorphology of the stream. The stream at this crossing is therefore decreased in condition though only considered moderately modified.

View of the stream downstream of the point of crossing. Note the relatively natural environment, though significantly modified by surrounding small holdings.

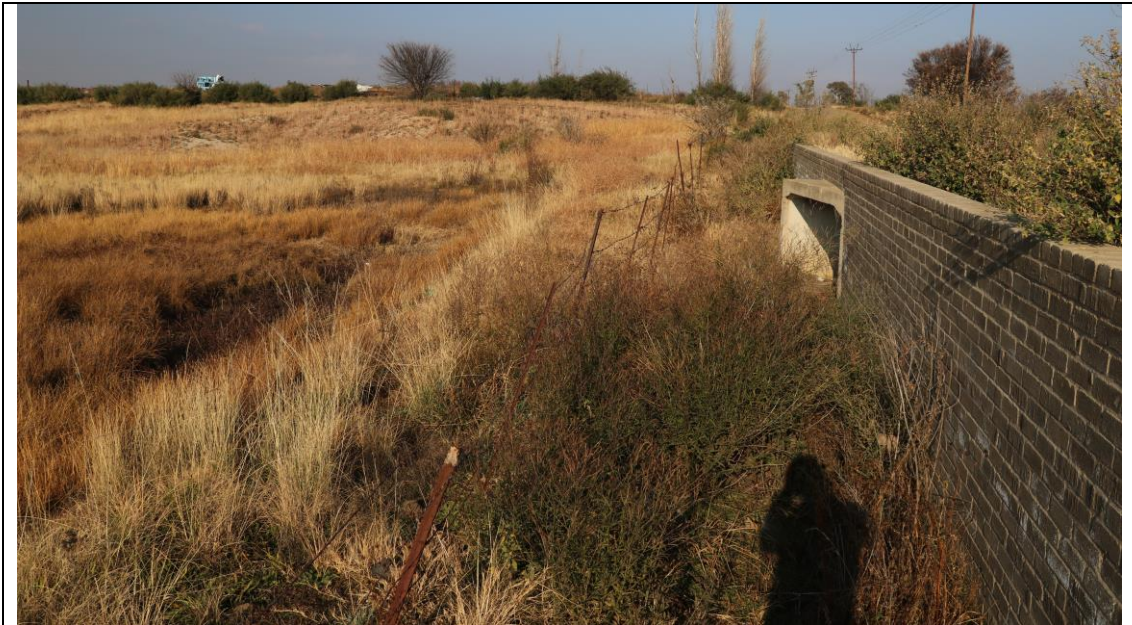
View of the culvert over the stream at the point of crossing. This also contributes to modification of the flow and flooding regime and ponding upstream of the culvert.

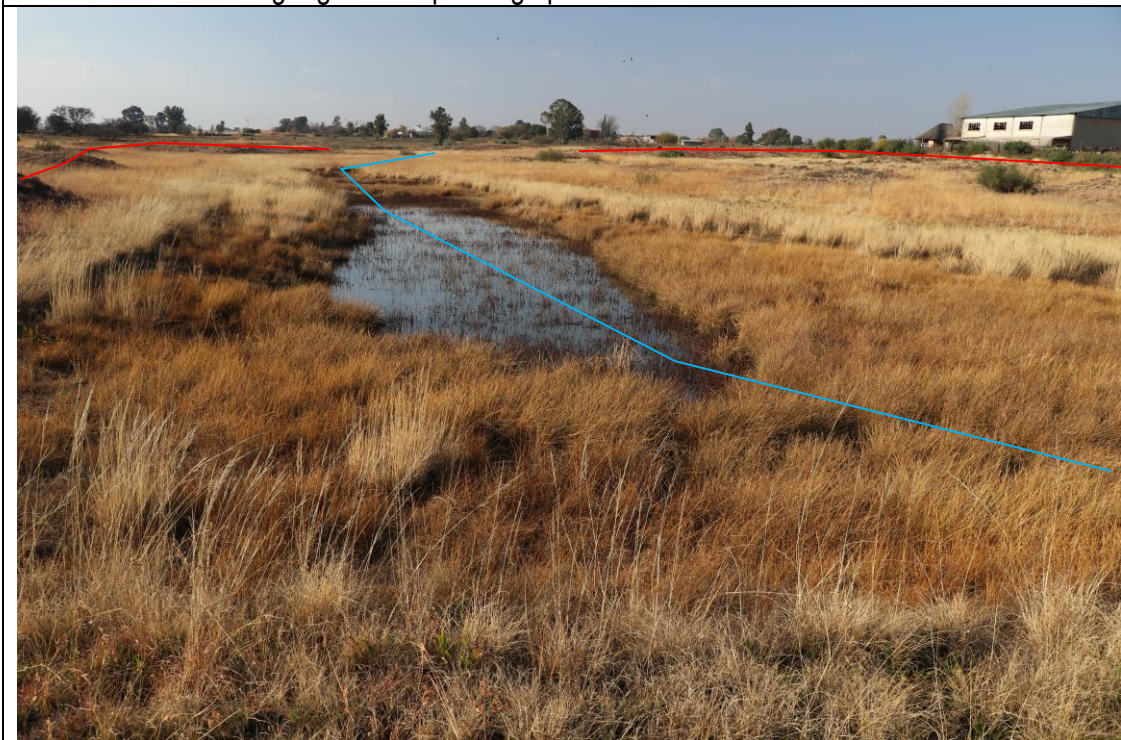
View of the stream upstream of the point of crossing. Note clear ponding caused by the road crossing. The flood bench is also quite visible here (red).

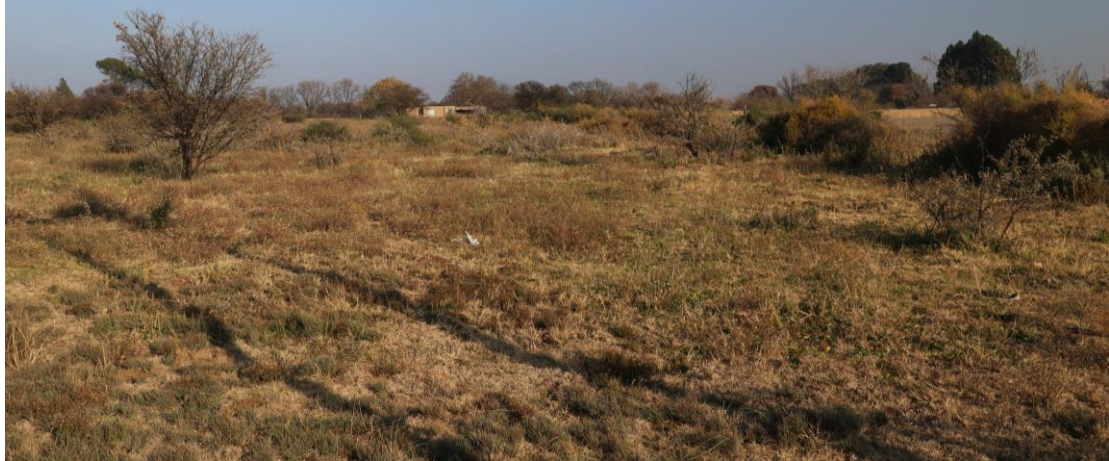
Figure 1: View of the environment along the Northern Pipeline alternative (Route 2). Note that the natural grassland is diminished and a vegetation structure dominated by dwarf karroid shrubs and trees have become established.

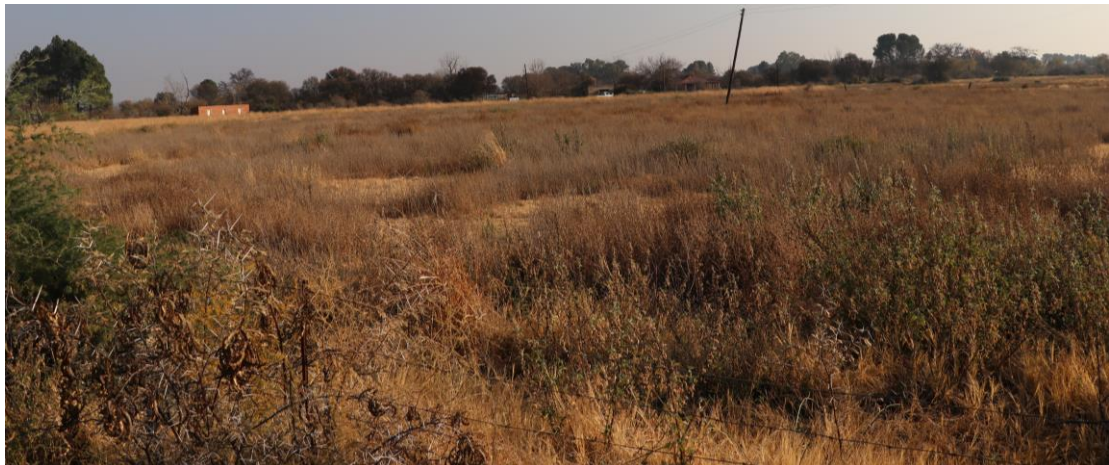
Figure 2: View of a portion of the Northern Pipeline alternative (Route 2). Large portions along this route consists of old agricultural fields dominated by weeds and pioneer herbs.

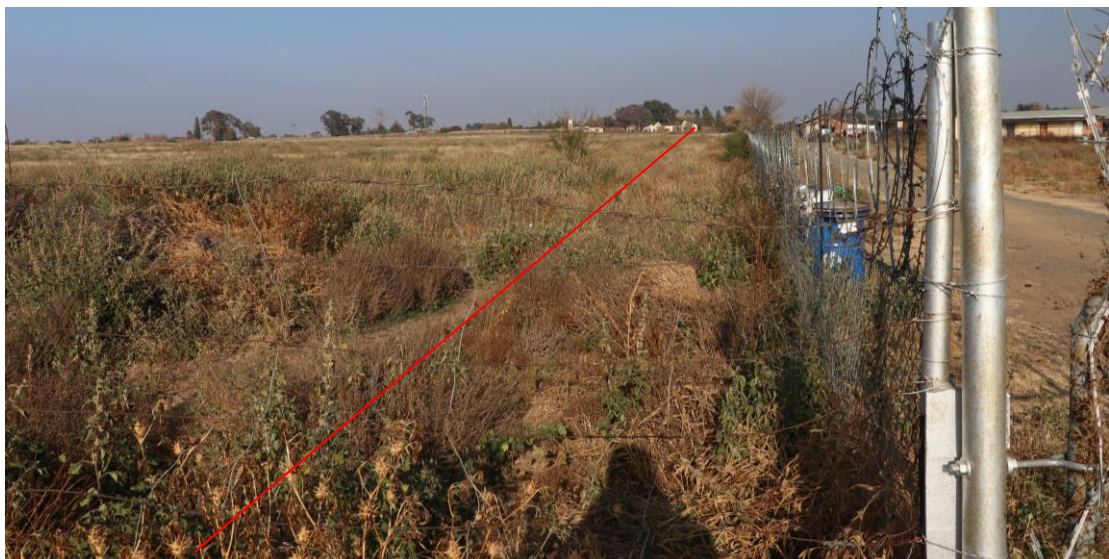
Figure 3: The vegetation along the Northern Pipeline alternative (Route 2) is evidently heavily degraded.

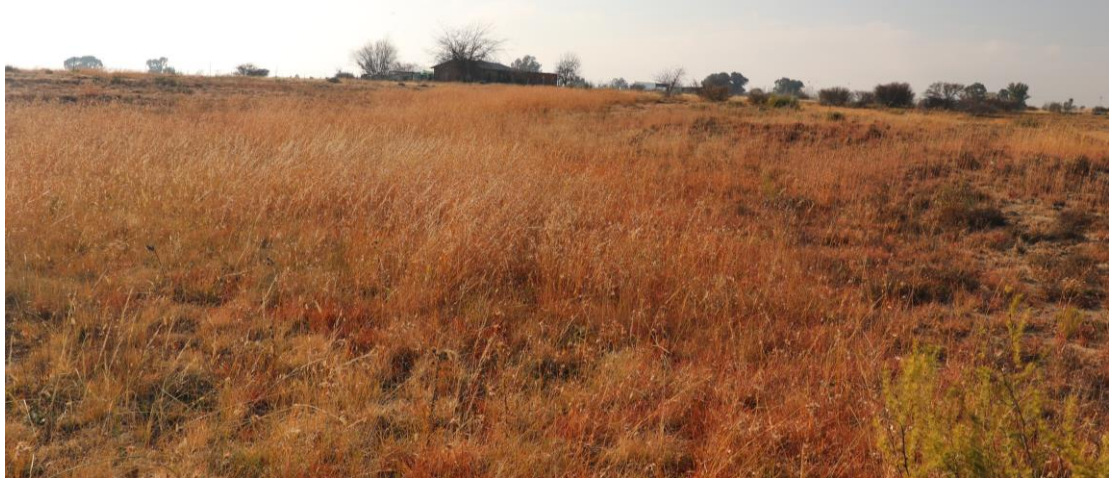
Figure 4: Remnant patches of the natural vegetation area however still present along the Northern Pipeline alternative (Route 2).

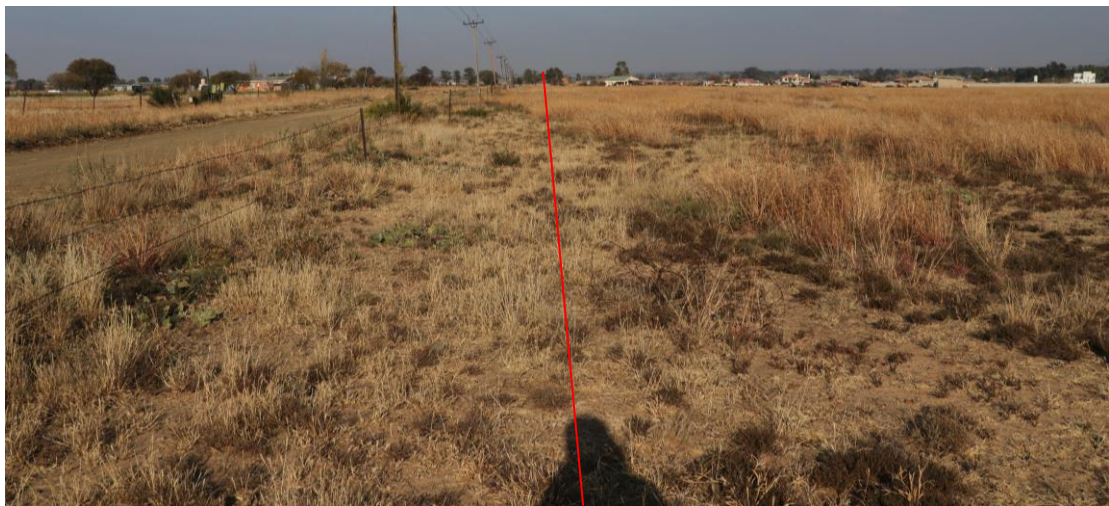
Figure 5: View of another remnant patch of natural vegetation along the Northern Pipeline alternative (Route 2) at the eastern border of the route.

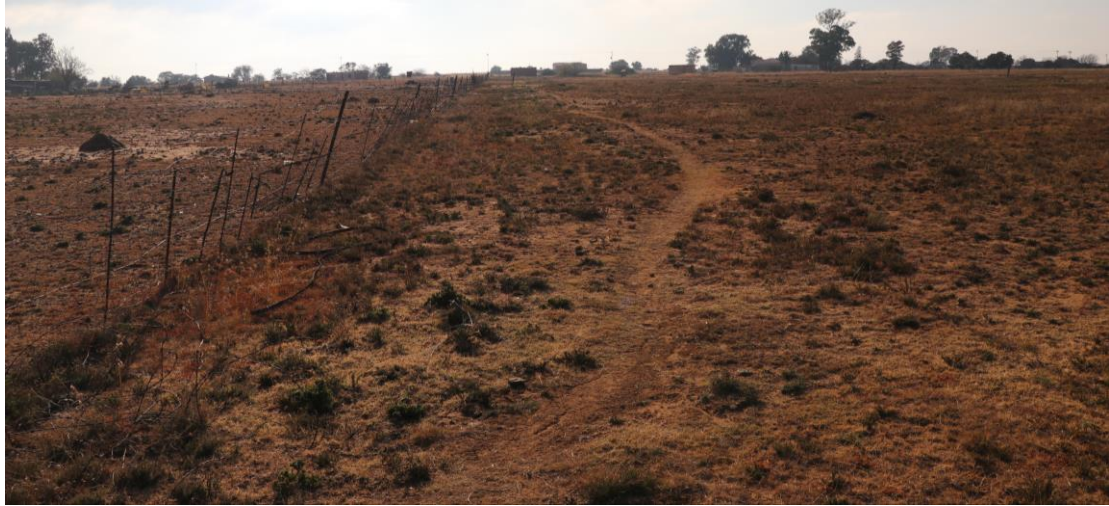
Figure 7: As mentioned in Fig. 6 the natural vegetation along the western portion of the Southern Pipeline alternative (Route 1) has been significantly degraded as clearly indicated here.

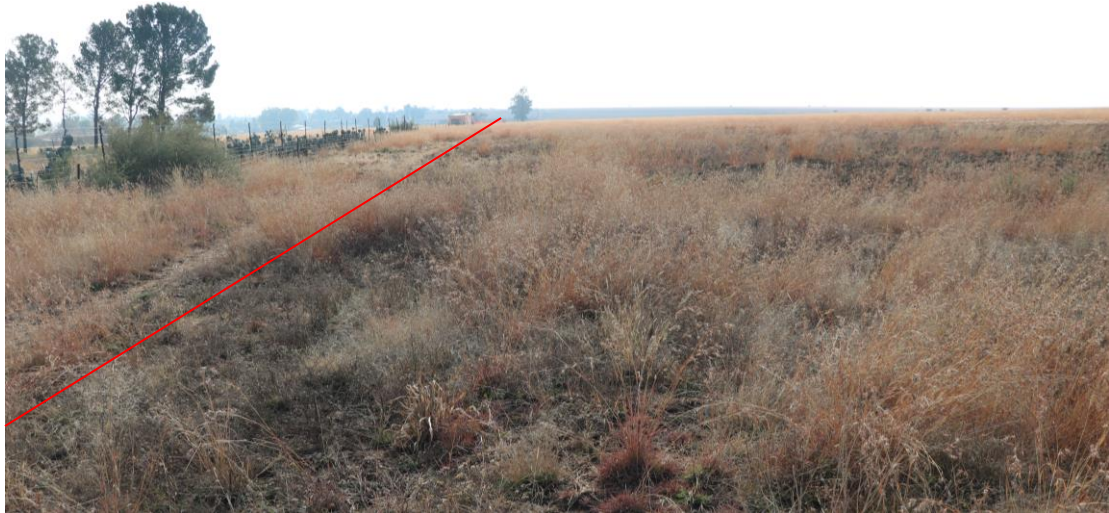
Figure 7: The eastern portion along the Southern Pipeline alternative (Route 1) clearly still consists of natural grassland though its condition could not be accurately assessed due to lack of access.

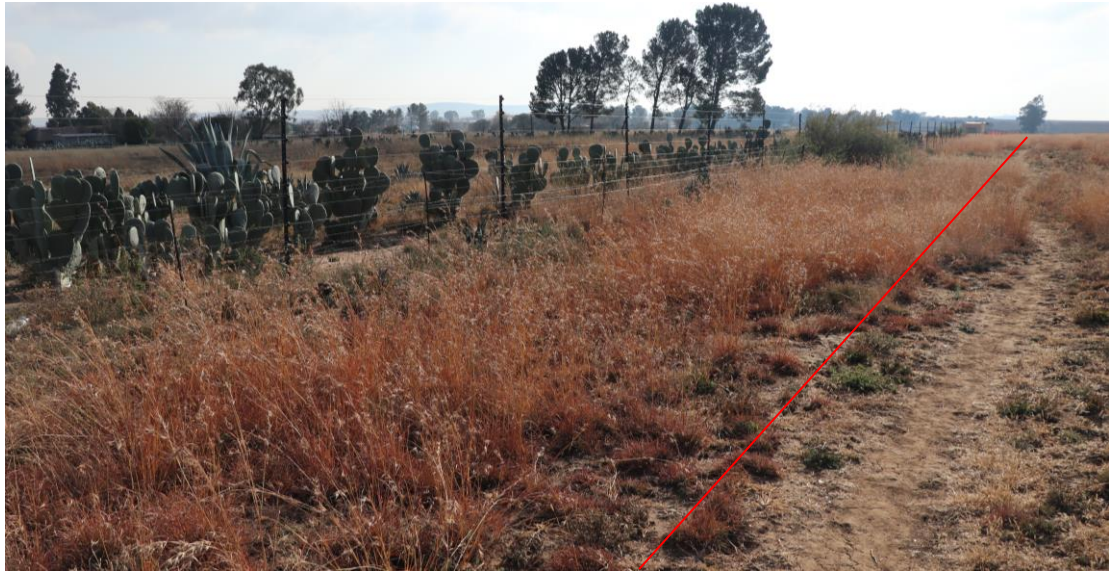
Figure 8: The remaining natural vegetation along the Southern Pipeline alternative (Route 1) does however seem to more disturbed along the bordefences.
