# APPENDIX D<sub>2</sub>

Ecological Report

## Report on the floristic and ecological assessment of the proposed Waste Water Treatment Works (WWTW) near the settlement of Ganspan, Jan Kempdorp, Northern Cape Province.

February 2017

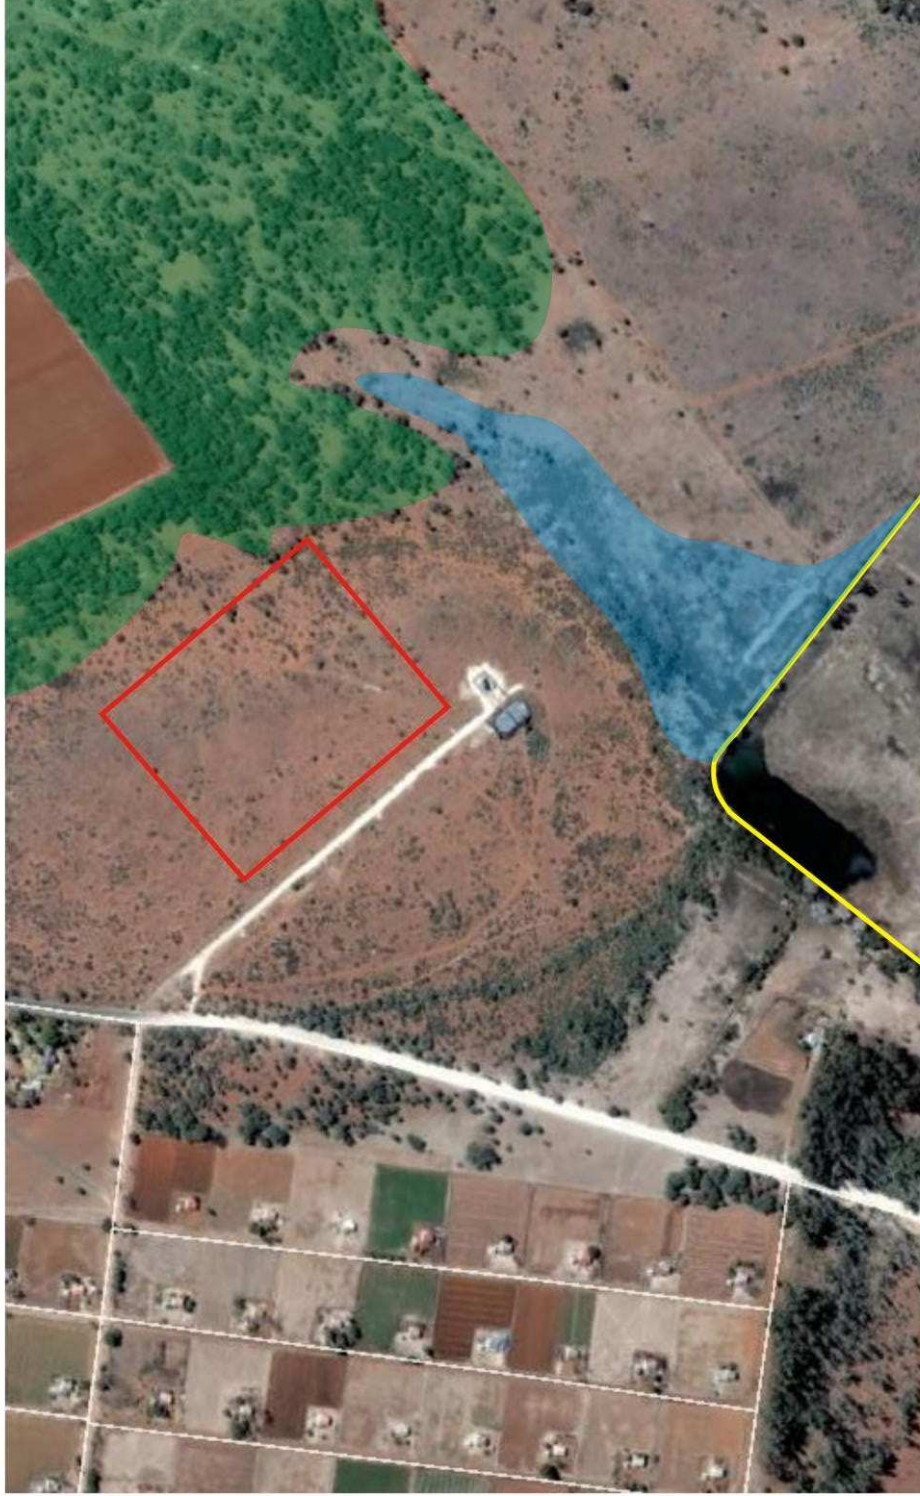
**Layout map for the proposed construction of a Waste Water Treatment Works (WWTW) near the settlement of Ganspan, Northern Cape Province.**

Map 1: Layout of the proposed WWTW near the settlement of Ganspan. The drainage area and adjacent woodland is indicated. Note that the footprint of the WWTW will exclude both these sensitive areas. The earthen berms forming the artificial impoundment is also indicated. The existing access road and water treatment plant is also visible. Also take note of surrounding agricultural activities.

- Monitoring of construction and compliance with recommended mitigation measures must take place.
- The drainage area to the south of the site and the woodland to the east of the site must be considered no-go areas and no activities should be permitted in these areas (Map 1).

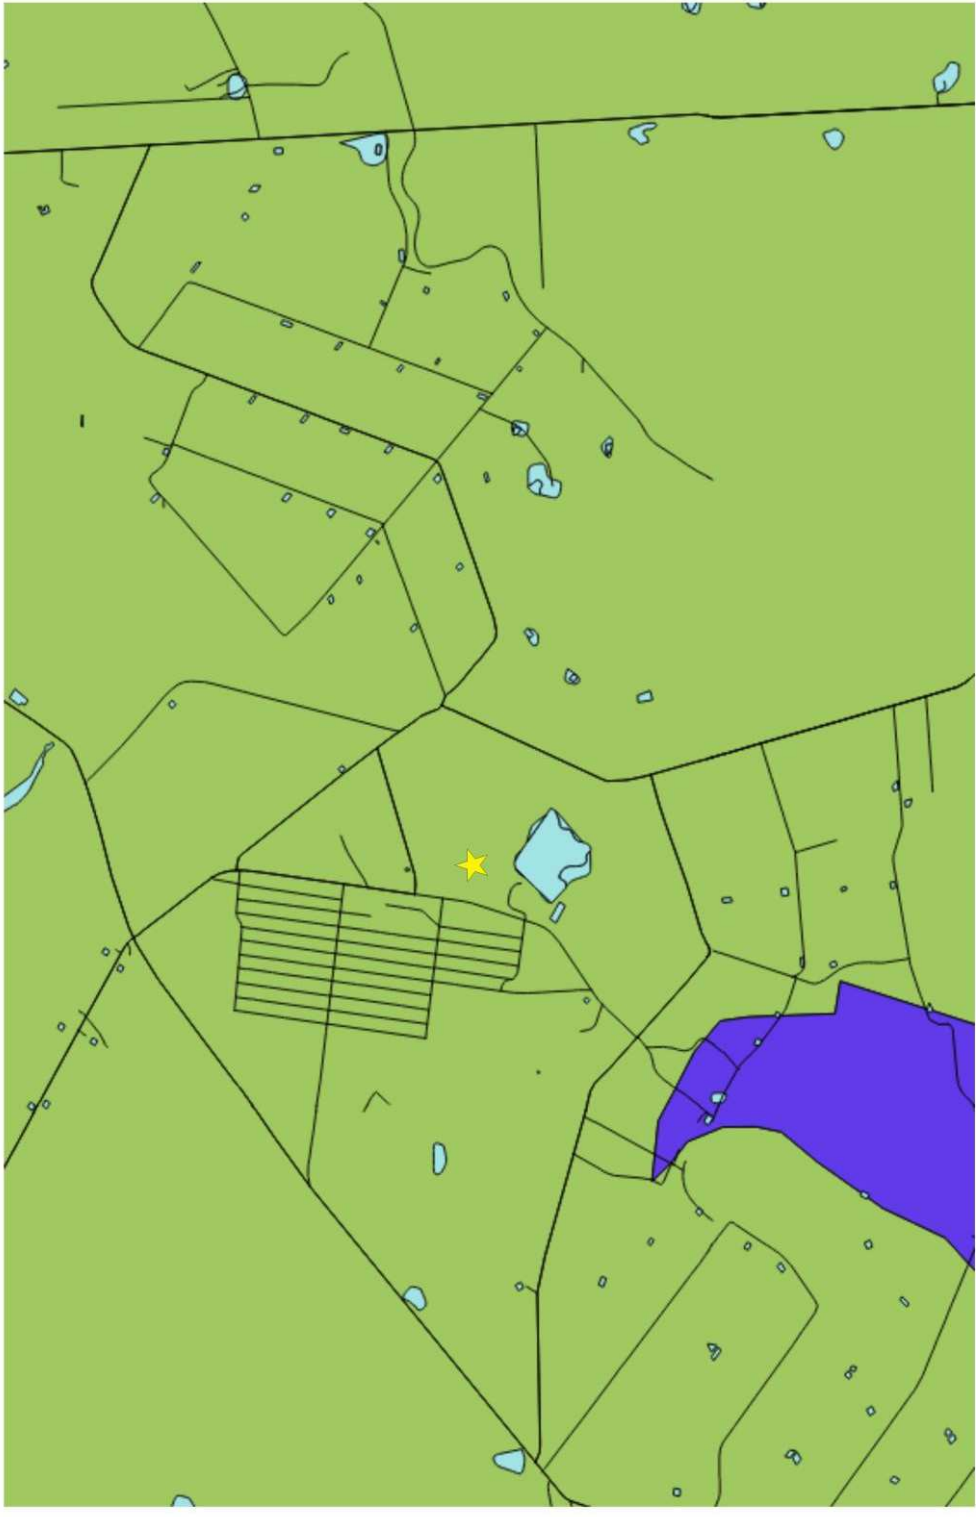
**General ecology map for the proposed construction of a Waste Water Treatment Works (WWTW) near the settlement of Ganspan, Northern Cape Province.**

Map 2: General ecology of the proposed WWTW near the settlement of Ganspan. The vegetation types as well as any Threatened Ecosystem is indicated as well as wetlands and impoundments in the area. Note that the adjacent artificial impoundment is also indicated.

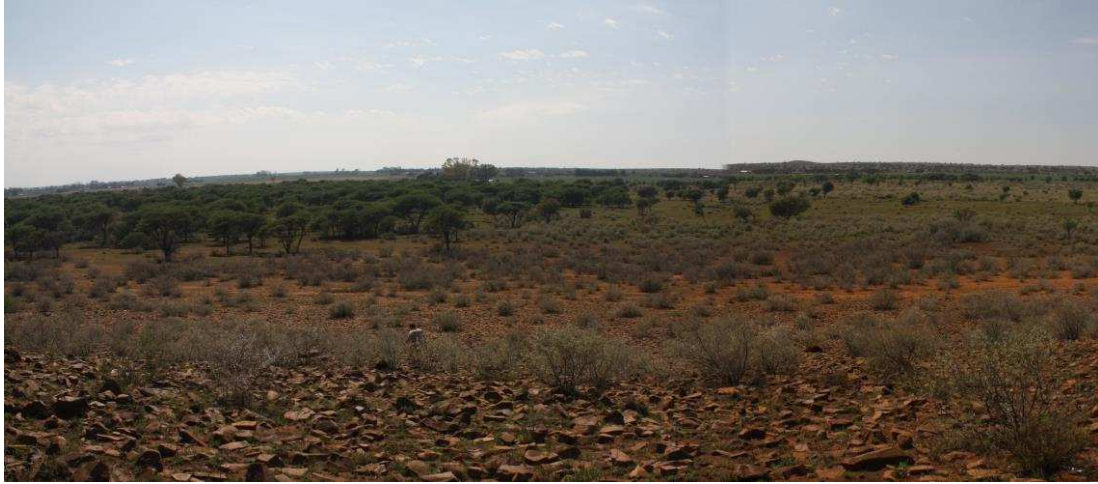
Figure 1: View of the site and towards the eastern adjacent areas. Note the low percentage vegetation cover, highly rocky terrain and the adjacent woodland area adjacent to the site. Large specimens of the protected Camel Thorn (*Vachellia erioloba*) is clearly visible in this area.

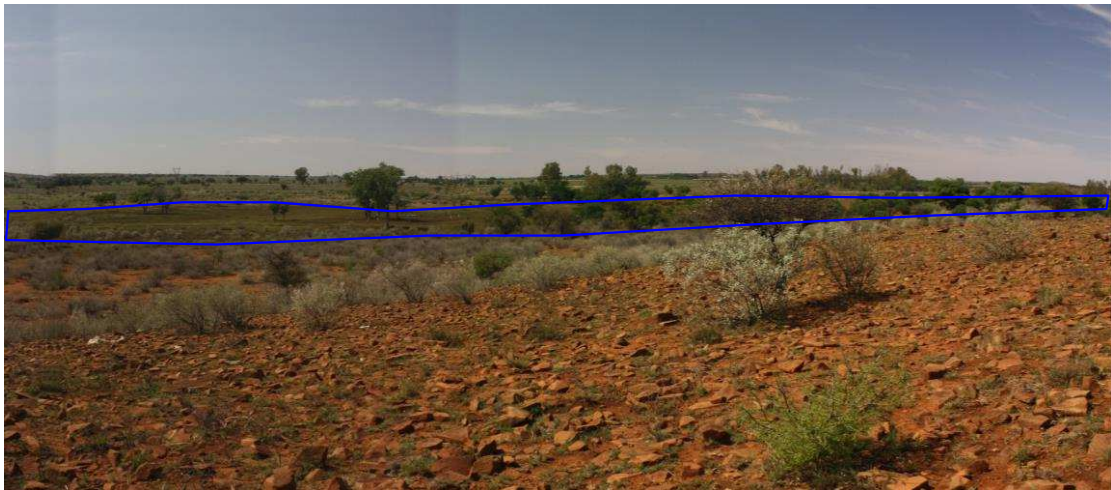
Figure 2: Panorama of the site and toward the south of the site. Note the rocky terrain and slope on the site. The drainage area to the south of the site is indicated.

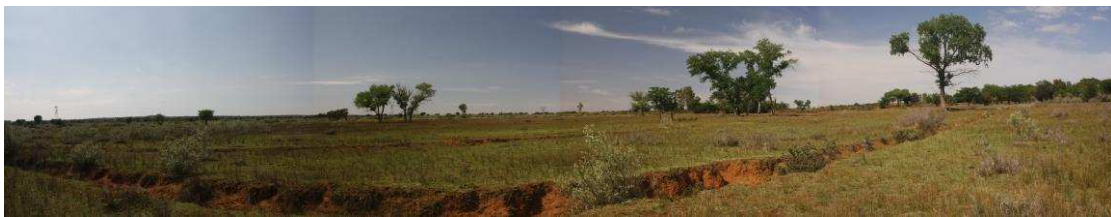
Figure 3: Panorama of the drainage area to the south of the site. Note drainage gullies forming in the area.

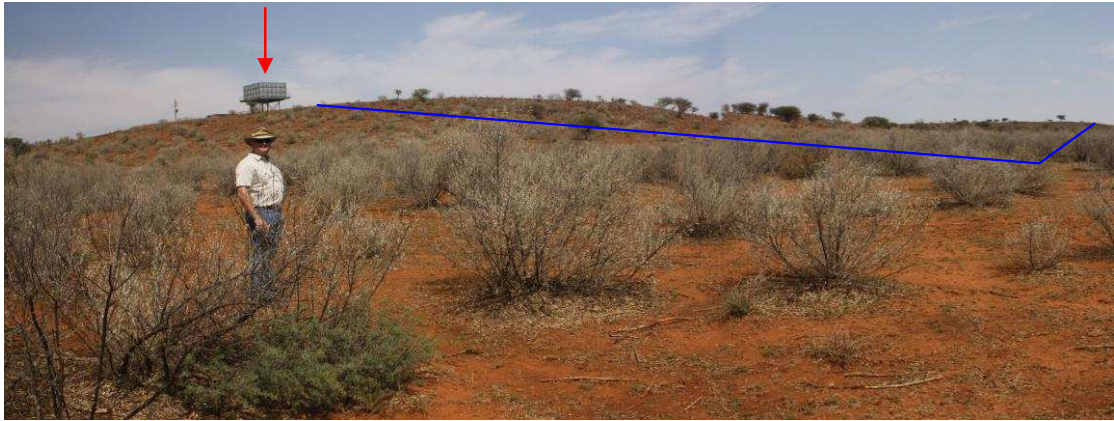
Figure 4: Panorama of the site (blue) as seen from the south. The topography and profile of the low hill is clearly visible. The small water treatment plant and reservoir is also visible (red arrow).

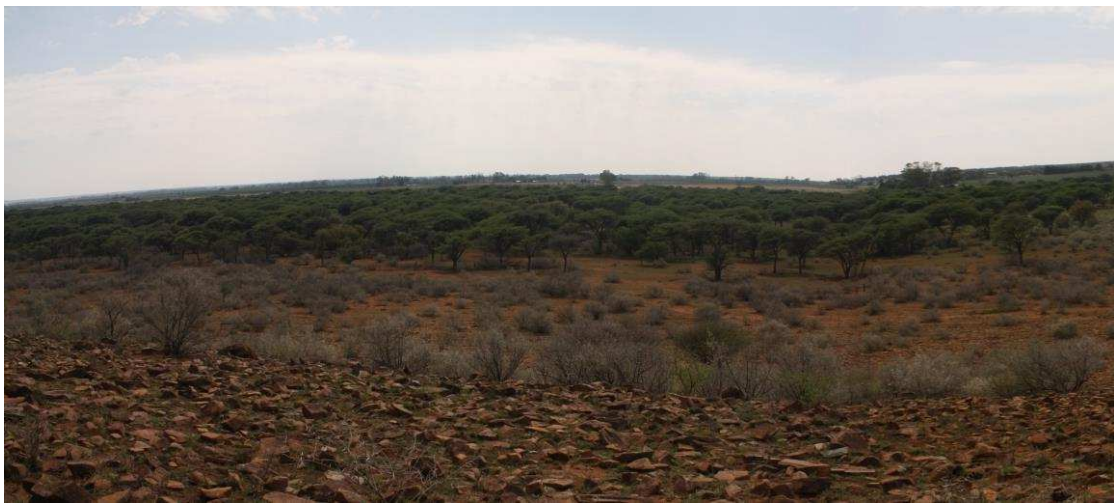
Figure 5: Panorama of the site. Note the dense woodland to the east of the site which will be excluded from the footprint.

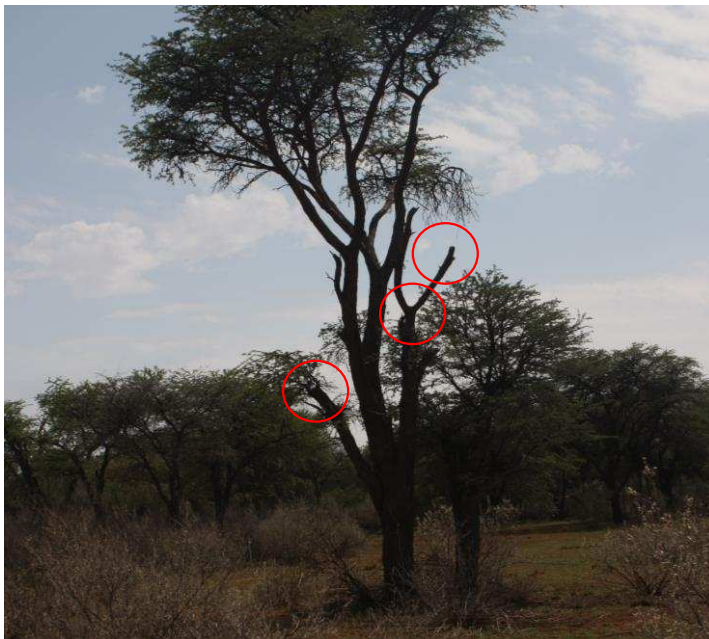
Figure 6: Cutting of trees on the site is common (red circles).

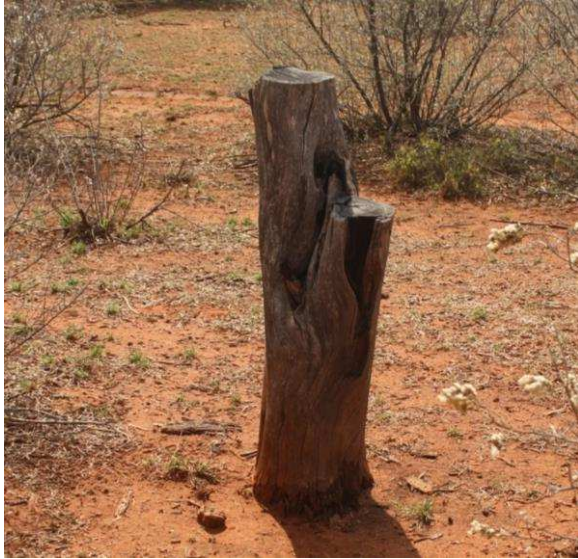
Figure 7: A sizable stump from a tree which was cut down for firewood.

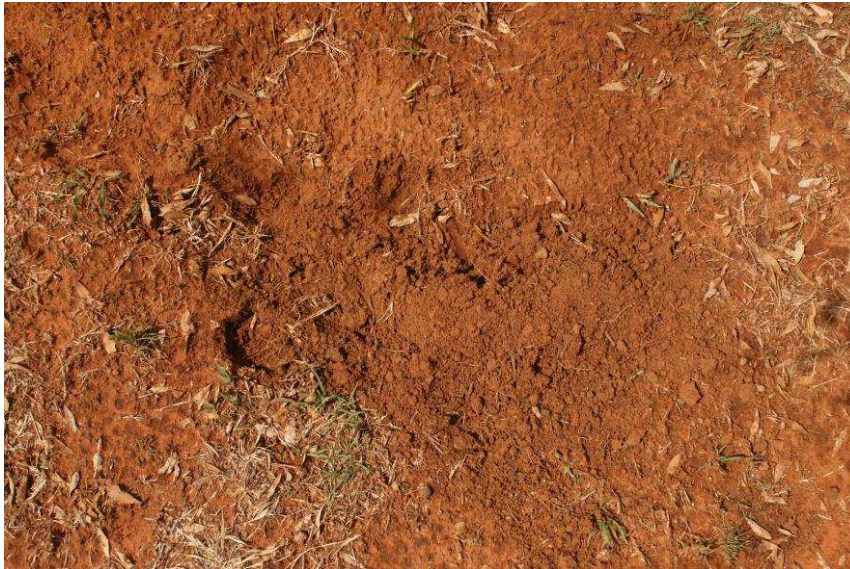
Figure 8: Shallow foraging excavations made by a small unidentified mammal.

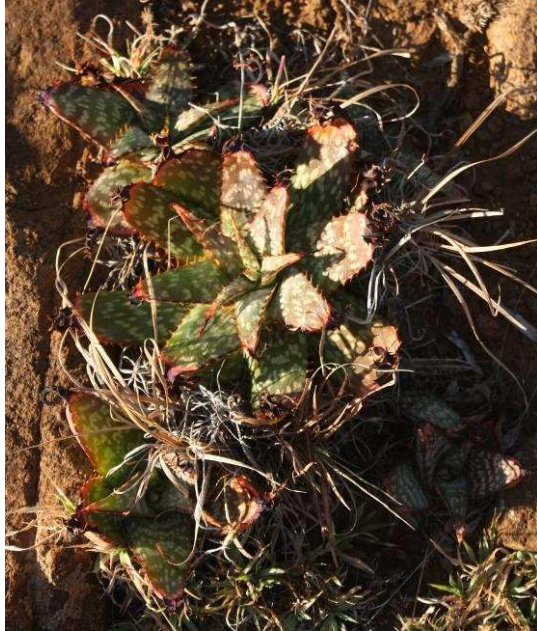
***Aloe grandidentata***  
**Bont Aalwyn**

Protected in the Northern Cape Province

National Red List Status: **Least Concern**

**Method: The species is abundant on the site especially rocky terrain. Specimens which occur in the footprint should be transplanted to adjacent areas where they will not be affected. They transplant easily.**

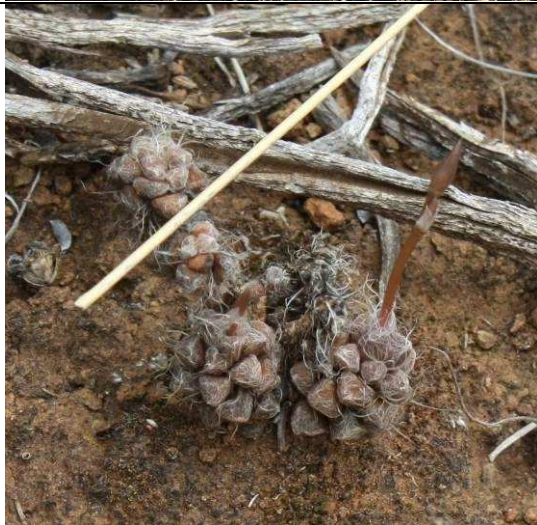
***Anacampseros filamentosa***  
**Haaskos**

Protected in the Northern Cape Province

National Red Listed Status: **Least Concern**

**Method: Common but scattered on the site. Should be transplanted to adjacent areas where they will not be affected by the development. They transplant easily.**

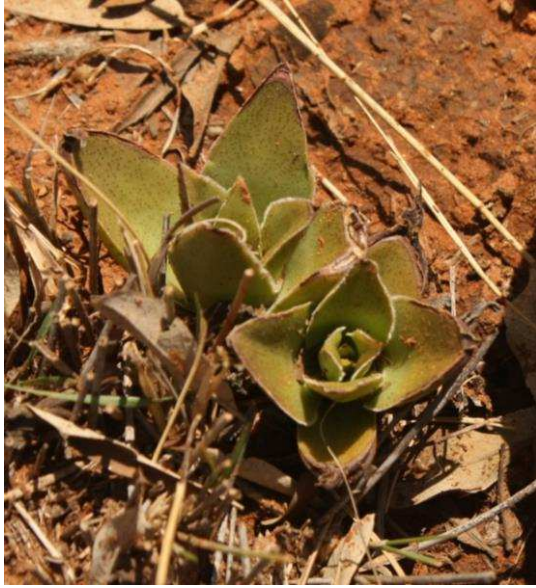
***Crassula capitella***

Protected in the Northern Cape Province.

National Red List Status: **Least Concern**

Method: **Common on the site. Should be transplanted to adjacent areas where they will not be affected by the development. They transplant easily.**

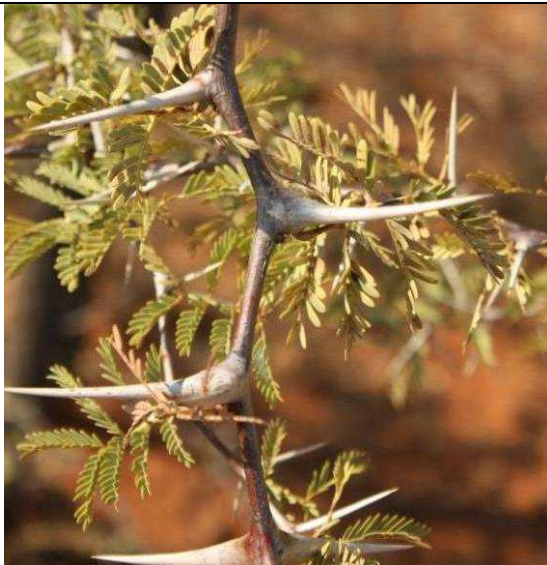
***Acacia erioloba***

**The species is subjected to a continuing decline and is therefore listed as a Declining species.**

**Due to this listed category the species must be left intact wherever possible. A permit must be obtained to remove those specimens that will require removal.**
