APPENDIX D3 HERITAGE

**ARCHAEOLOGICAL IMPACT ASSESSMENT
THE PROPOSED MOUNT ROPER ROMA ENERGY
SOLAR PLANT ON FARM 321 NEAR KURUMAN
NORTHERN CAPE PROVINCE**

Archaeological study proposed solar energy plant on Farm 321 near Kuruman

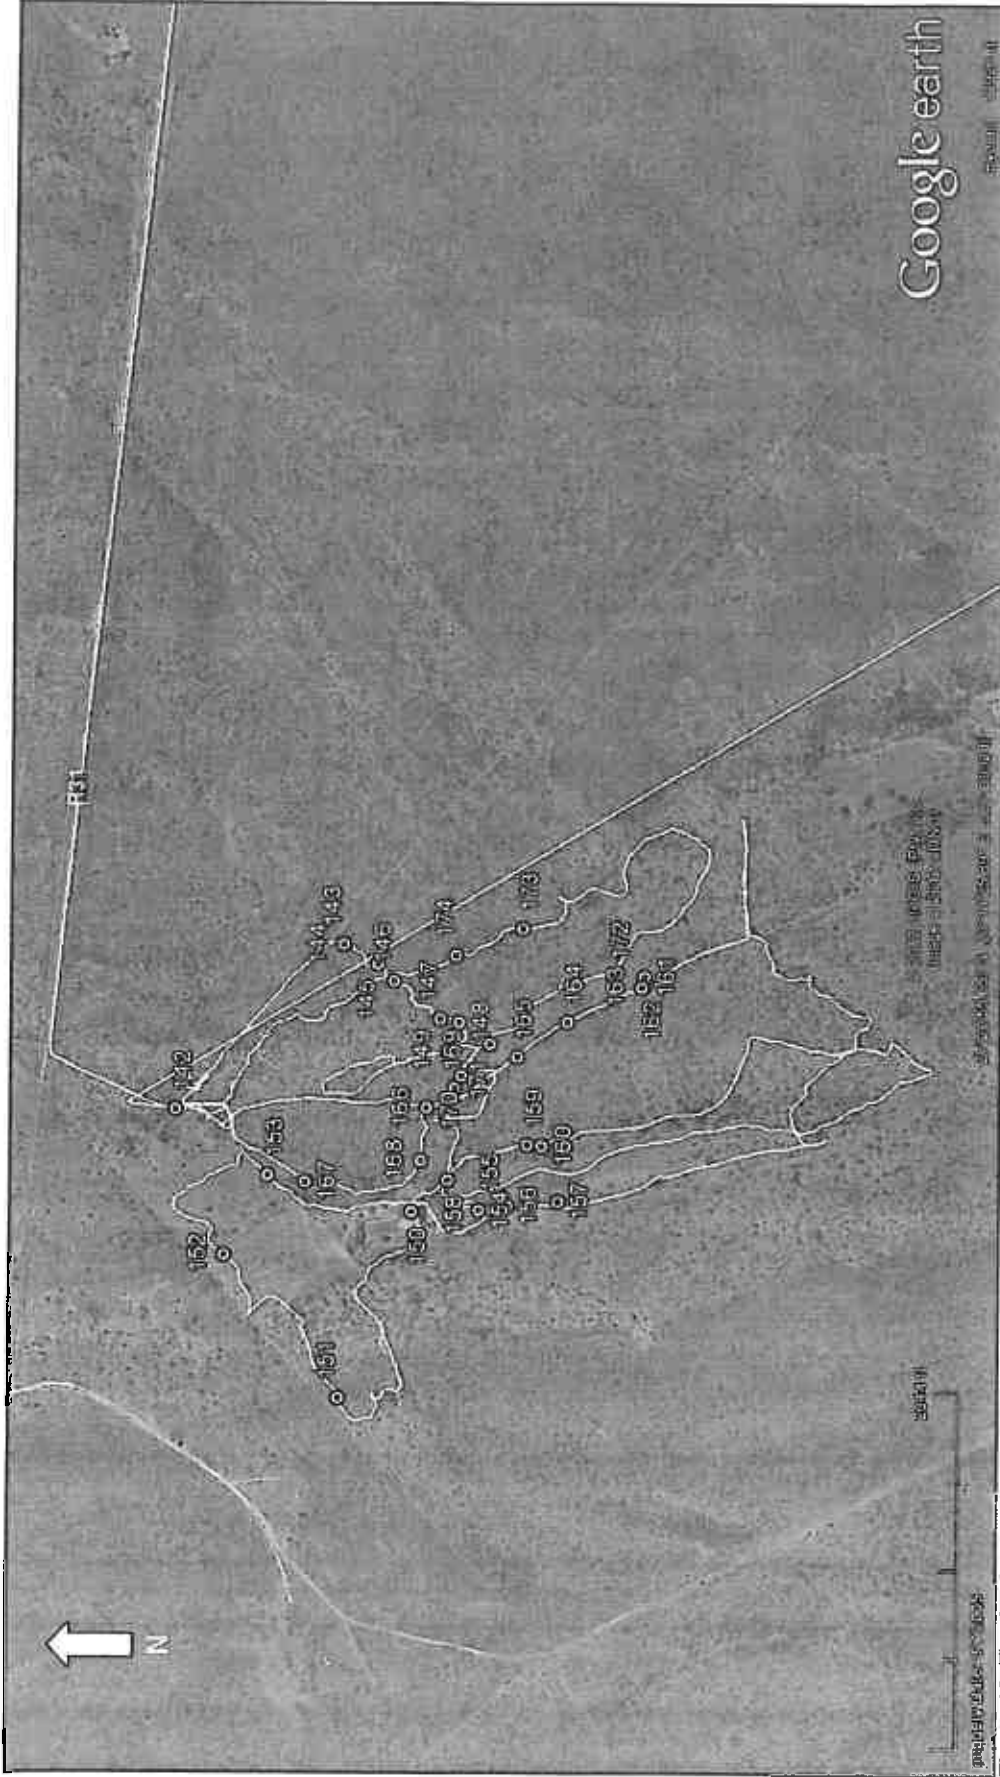
Figure 10. Track paths and waypoints of archaeological finds (refer to Table 2 In Appendix I)

A trackpath of the survey was created (refer to Figure 10).

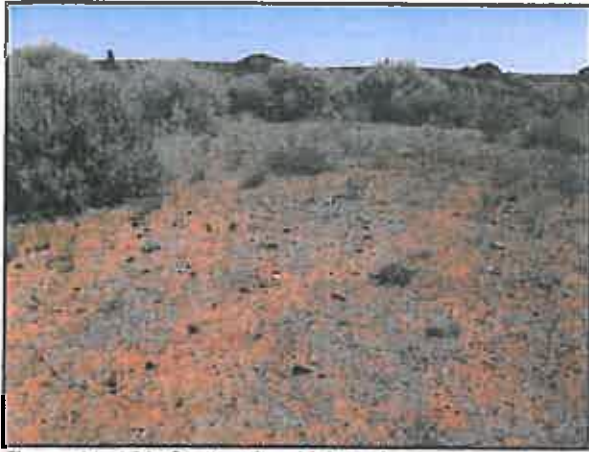
Figure 11. 154. Context in which tools were found

154		S27 20.907 E23 11.081	ESA handaxe/biface, 2 MSA flakes in ironstone and indurated shale on thin patch of ironstone and red sands
155		S27 20.920 E23 11.082	Retouched and utilized MSA flake
156		S27 20.934 E23 11.086	MSA flake blade in indurated shale
157		S27 20.983 E23 11.092	Flake and convex and utilized scraper
158		S27 20.877 E23 11.113	Blade flake retouched on both ends/scraper retouch
159		S27 20.952 E23 11.152	Snapped MRP flake, broken point, quartzite flake
160		S27 20.966 E23 11.152	Convex scraper
161		S27 21.062 E23 11.337	Chunk and flake next to Aardvark hole
162		S27 21.063 E23 11.329	Broken utilized flake in gravel roads
163		S27 21.059 E23 11.325	Thick chunky blade and flake in gravel road
164-165		S27 20.988 E23 11.287 S27 20.941 E23 11.248	Gravel road – broken utilized flake, chunk, MRP, thick weathered end retouched blade, large side retouched flake, flake, blade, large cobble side retouched flake, retouched flake

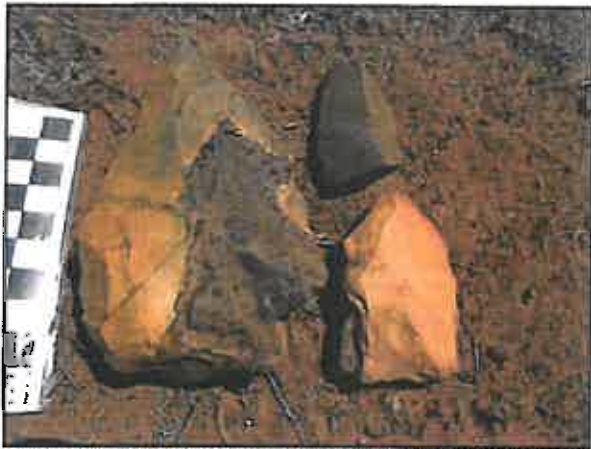
Figure 12. 155. ESA biface & MSA flakes. Scale is in cm

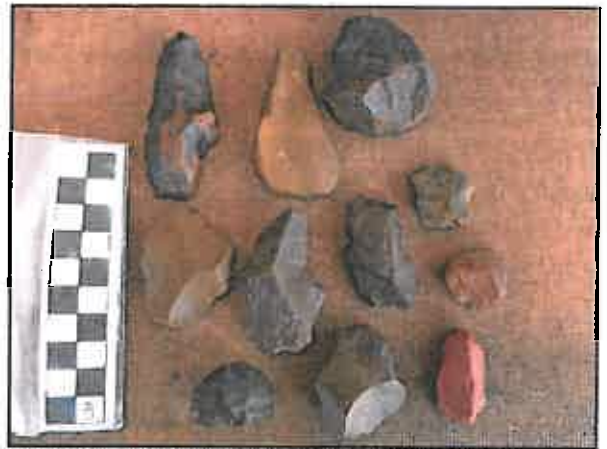
Figure 15. 144. Collection of tools. Scale is in cm

Most of the lithics comprise modified (i. e. retouched and utilized) flakes and pieces of stone, but several retouched blade tools, and two pointed flakes (159 & 168) were also found. Four scrapers were recovered, including one end scraper on a long blade (144) and three convex scrapers (157, 160 & 167). A few round cores were found.

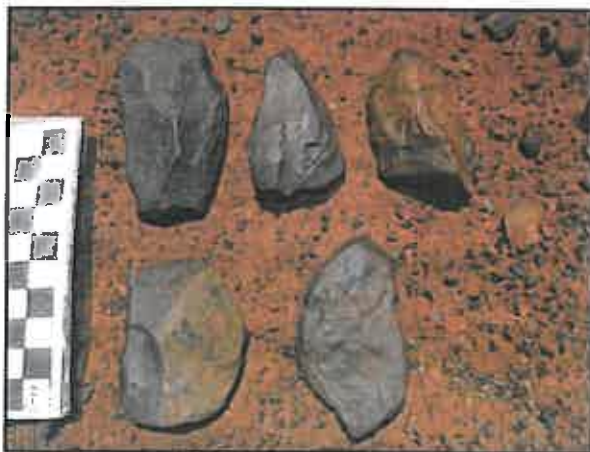
Figure 13. 172. MSA burnished flakes. Scale is in cm

Several very low density scatters of a few flake tools were documented on the gravels across the northern portion while a thin scatter of weathered and burnished indurated shale and ironstone flakes (172) were recovered from alongside small dry pan. As indicated the western portion of the site is severely degraded due to extensive grazing, trampling and infrastructure and a few dispersed flakes and chunks were also found near the dam (150) and alongside the road. However, no evidence of any factory or workshop site, or the result of any human settlement was identified in the footprint area.

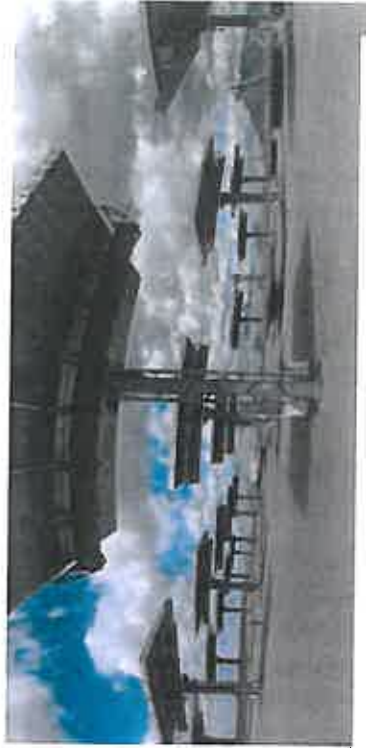
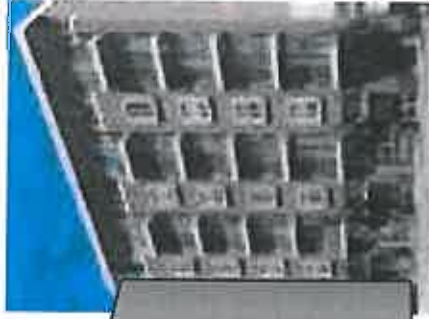
In the Night stow position it equals the facade of a 5 to 6 storey building

Figure 8: Night stow position

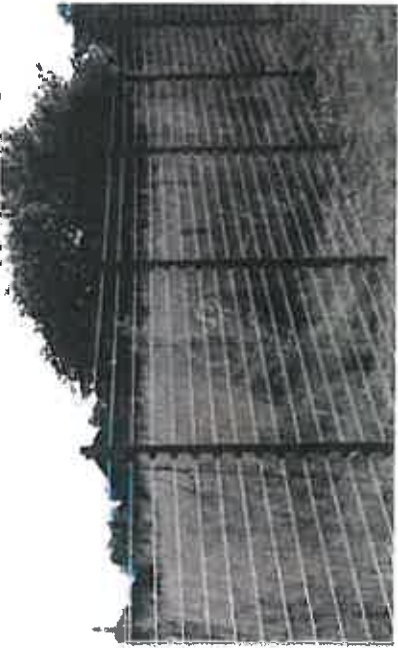
Double fencing with inner fence consisting of galvanized palisade fence and outer an electrified fence of 2.4m in height.

Figure 9: Typical electrical fence

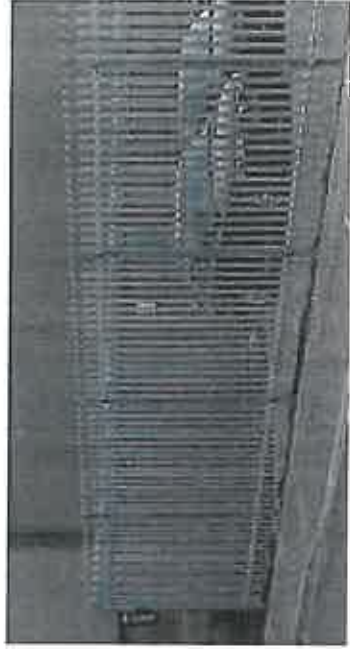
Figure 10: Typical galvanized palisade fence

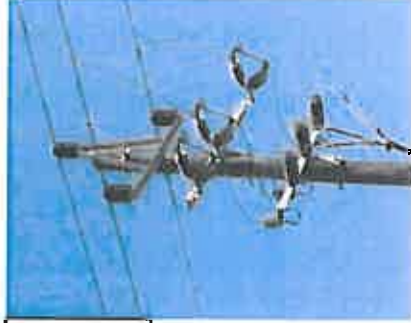
Single 22KV Power lines will feed from the transformers to the FSKOM

Figure 11: Typical 22KV single Power line

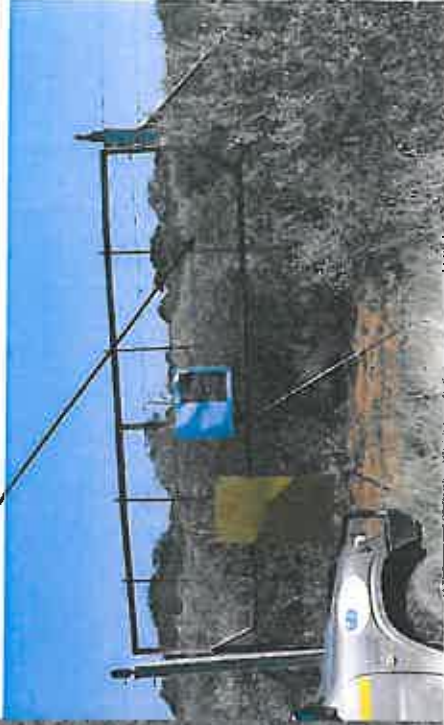
The view direction of the traveler is parallel to the site and not towards the site.
 The site slope away from the road, diminishing the exposure of the site.
 The site is more than 600m from the road reducing the intrusion level.
 The traveler is at a lower level than the site and dense vegetation reduce view in the direction of the site

Figure 15: R31 northbound as receptor

2. R31 northbound (Figure 16): The view direction of the traveler is parallel to the site and not towards the site. The site slope away from the road, diminishing the exposure of the site. The site is more than 600m from the road reducing the intrusion level. The traveler is at a lower level than the site and dense vegetation reduce view in the direction of the site. The visual significance on the northbound traveler is thus low.
