Geotechnical Engineering Survey of the Existing Manganese Rail Corridor between Hotazel and the Port of Ngqura on the Ngqura 16Mtpa Manganese Project

Report on Postmasburg Housing Development

Contract No H339473-S018

Reference : 12-186 – Rev 0A

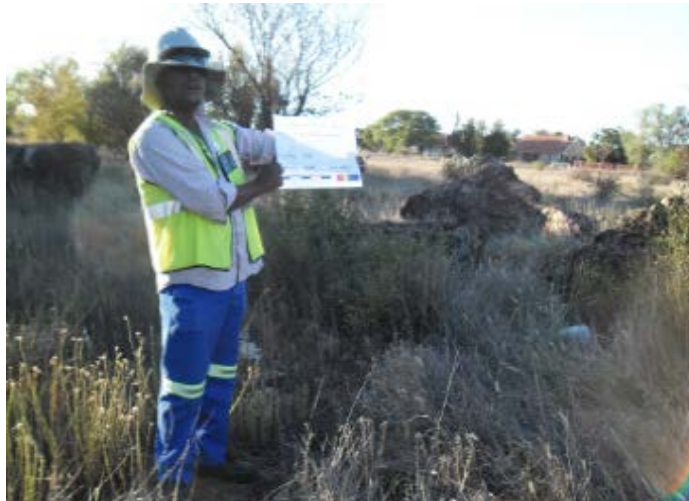
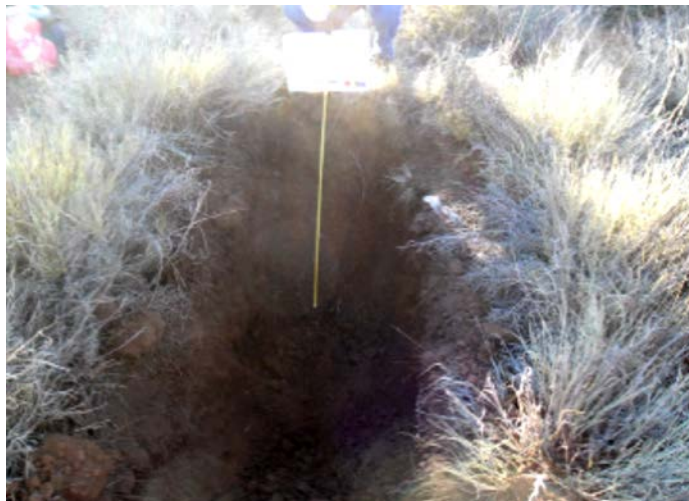
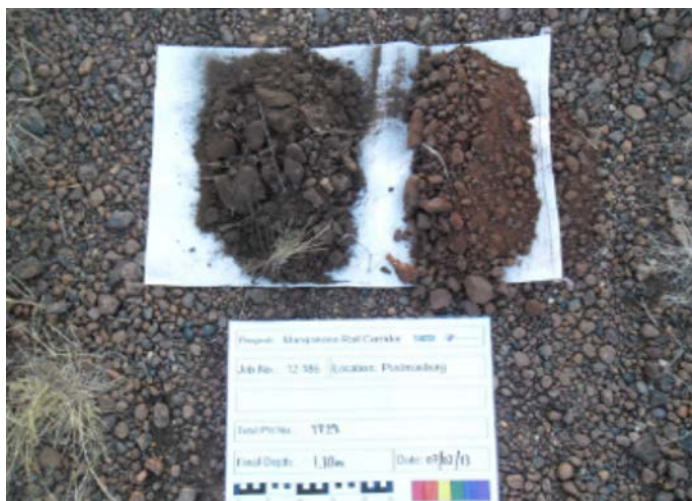
DEPTH (m) 1.10

- 1) Final depth at 1.10m Refusal on at least soft rock dolomite.
- 2) No groundwater seepage.
- 3) No sidewall collapse.
- 4) Samples taken :
S1 0.25--1.10m (1 x Small) and (3 x Bulk)
- 5) Test pit relocated due to access issues.

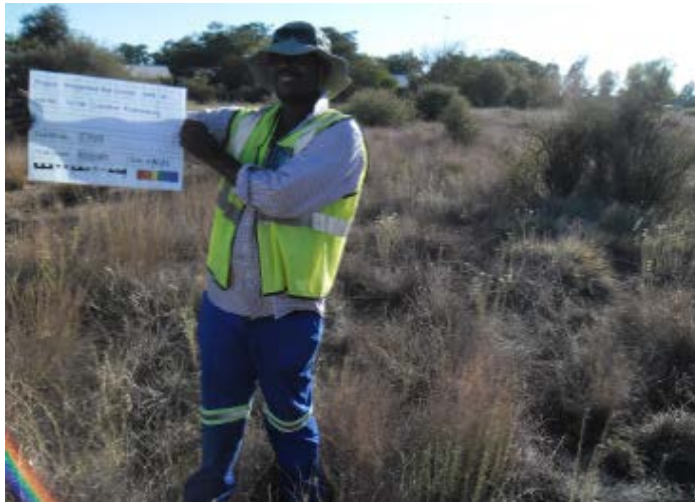
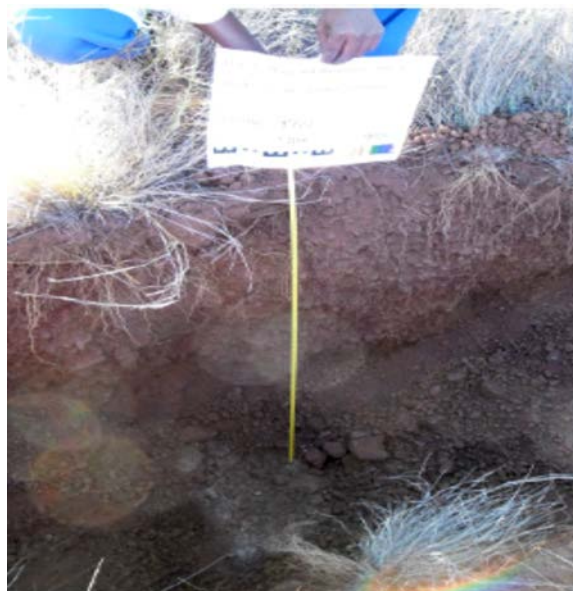
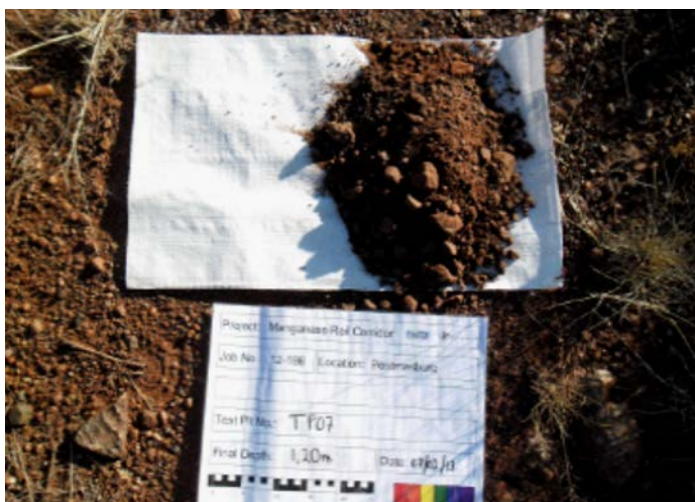
DEPTH (m) 1.20

Slightly moist dark orangey to reddish brown loose becoming very dense with depth intact silty sandy fine to coarse GRAVEL with grass roots. Residual Dolomite. Gravel consists of fine to coarse (2-60mm diameter) subrounded to rounded dolomite fragments.

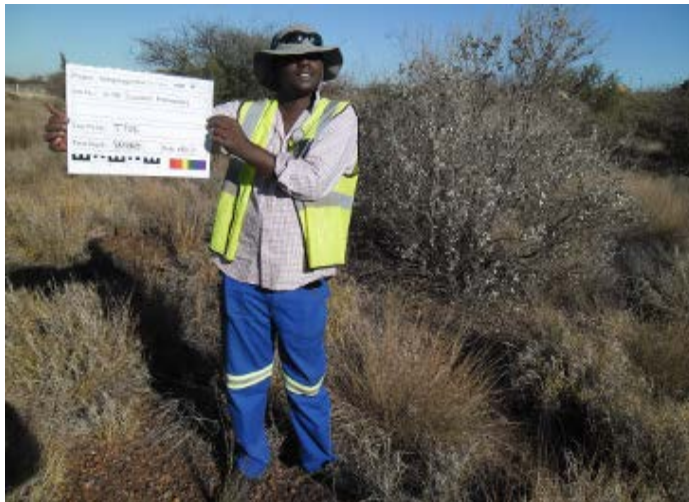
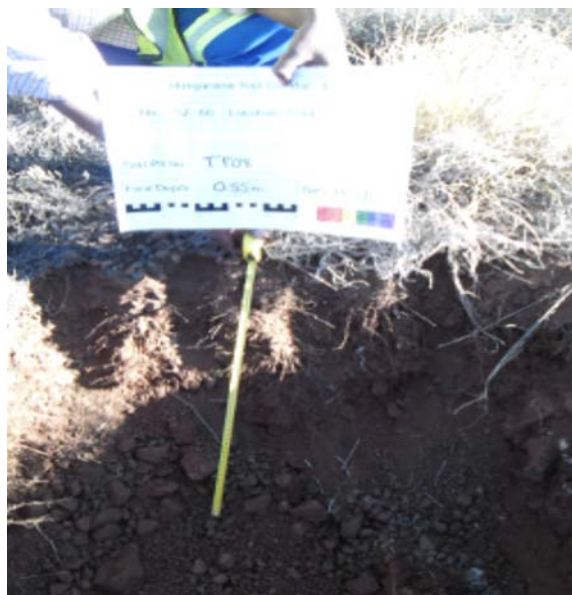
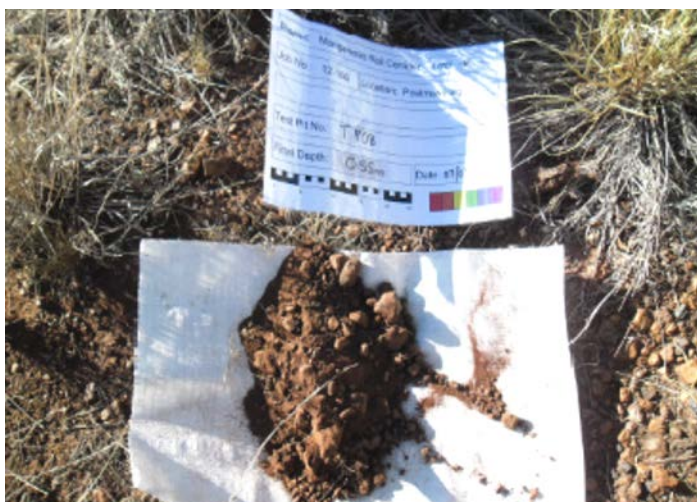
DEPTH (m) 0.55

Slightly moist dark orangey brown mottled grey loose becoming very dense with depth intact silty fine to medium grained sandy GRAVEL with abundant cobbles, boulders and some grass roots. Residual Dolomite. Gravel consists of fine to coarse subrounded (2-60mm diameter) dolomite fragments.

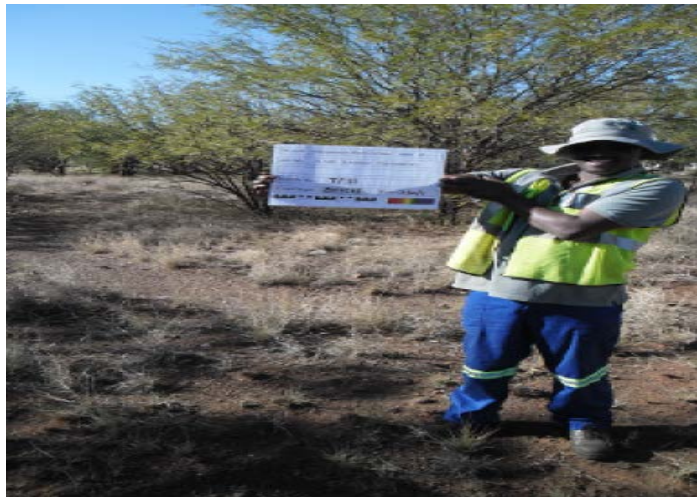
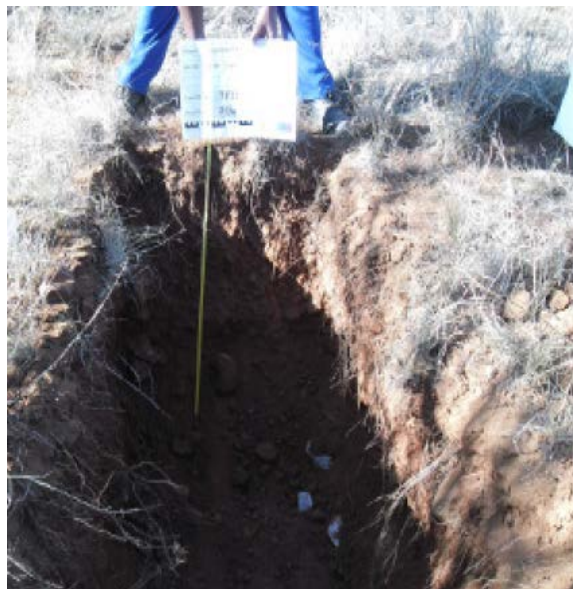
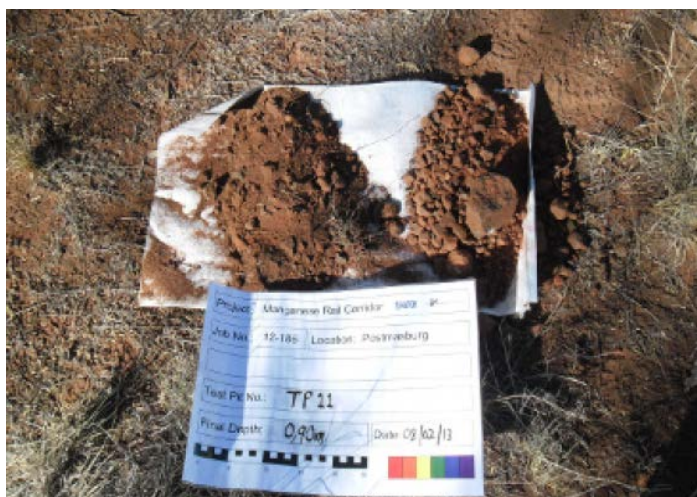
Dry greyish brown loose intact silty fine grained SAND with roots. Colluvium.

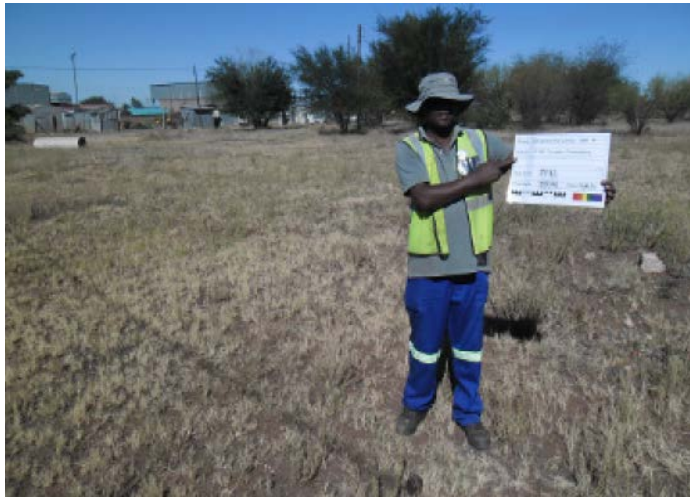
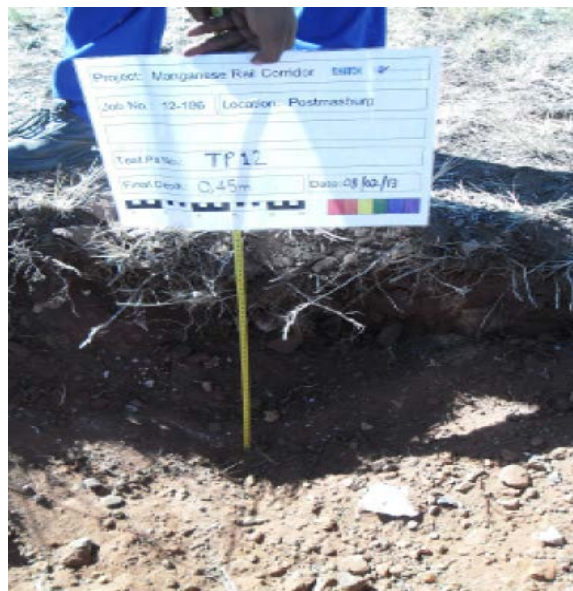
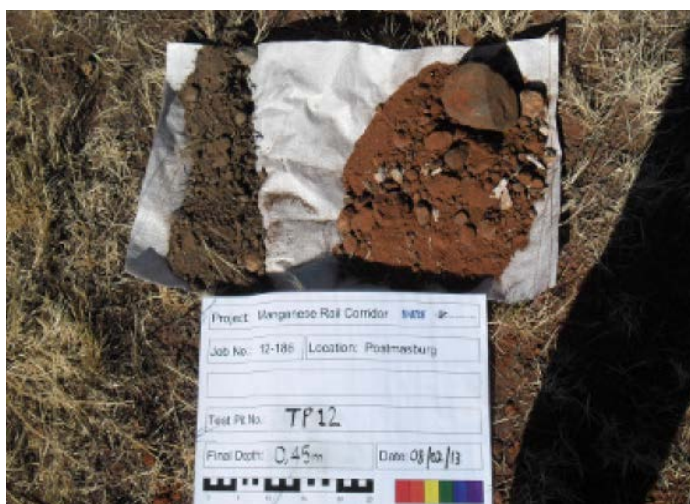
Dry light greyish brown loose intact silty fine to medium grained SAND with roots. Colluvium.

Dry orange to reddish brown mottled white loose becoming very dense with depth intact silty gravelly fine to medium grained SAND. Residual Calcrete. Gravel consists of abundant fine to coarse calcrete fragments.

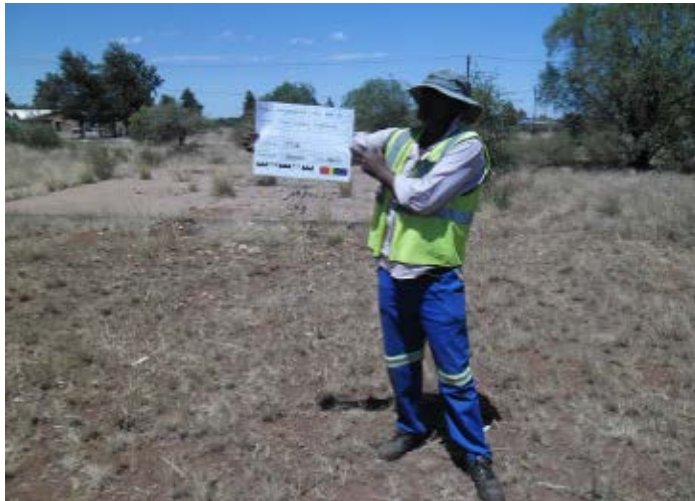
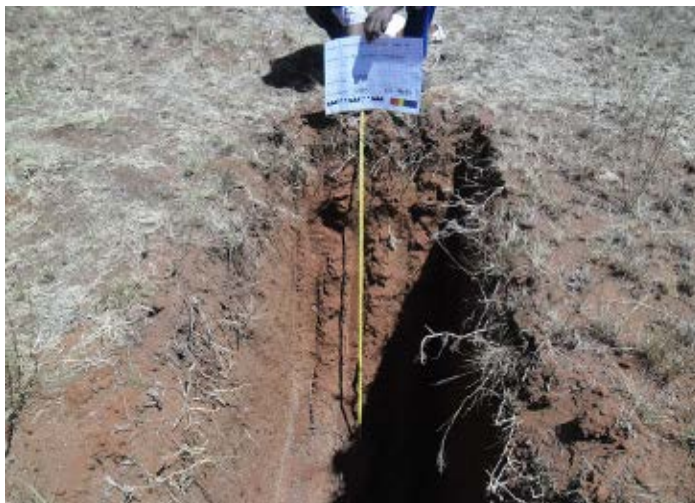
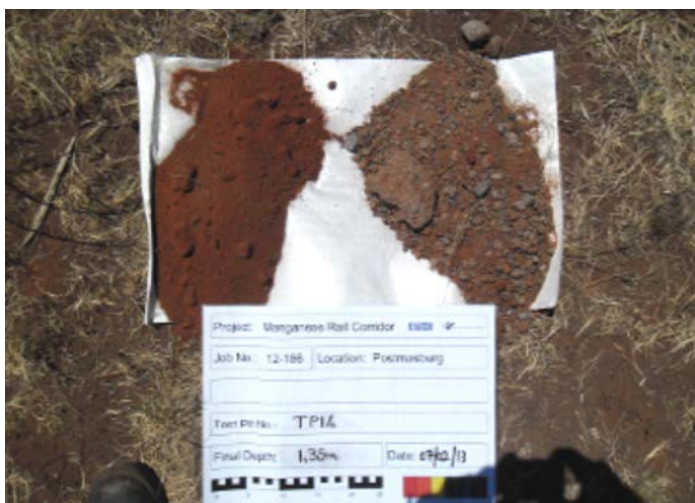
DEPTH (m) 1.35

- 1) Final depth at 1.35m. Refusal on at least soft rock dolomite.
- 2) No groundwater seepage.
- 3) No sidewall collapse.
- 4) Samples taken :
 S1 0.01--1.00m (1 x Small) and (3 x Bulk)
 S2 1.00--1.35m (1 x Small) and (3 x Bulk)

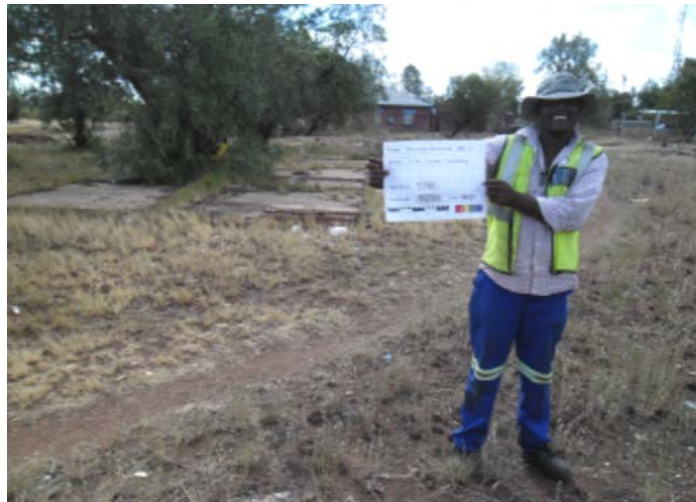
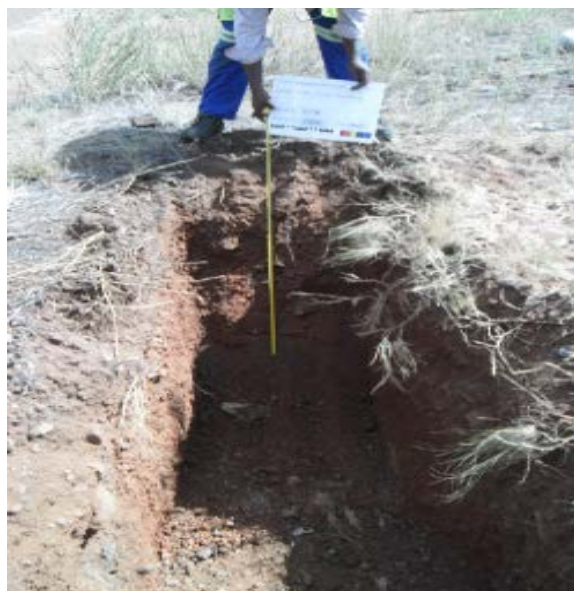
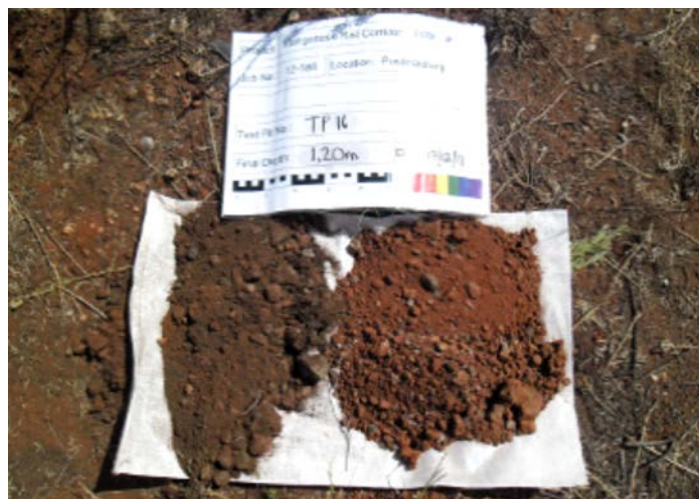
DEPTH (m) 1.20

- 1) Final depth at 1.20m. Refusal on at least soft rock dolomite.
- 2) No groundwater seepage.
- 3) No sidewall collapse.
- 4) Samples taken :
S1 0.35--1.20m (1 x Small) and (3 x Bulk)
- 5) Test pit relocated due to the reduced number of pits by Hatch.

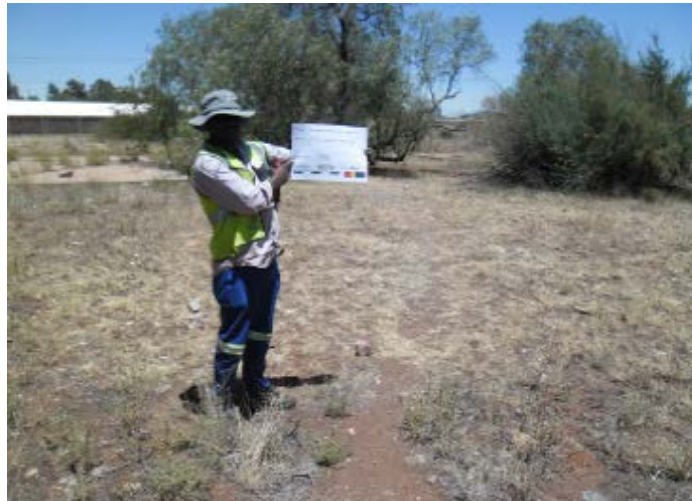
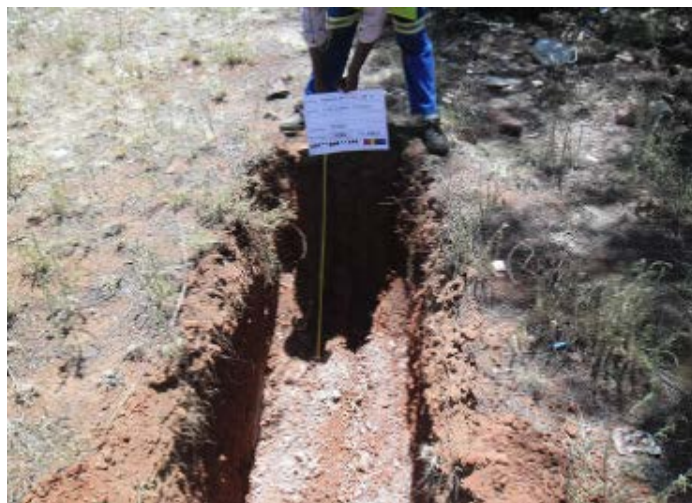
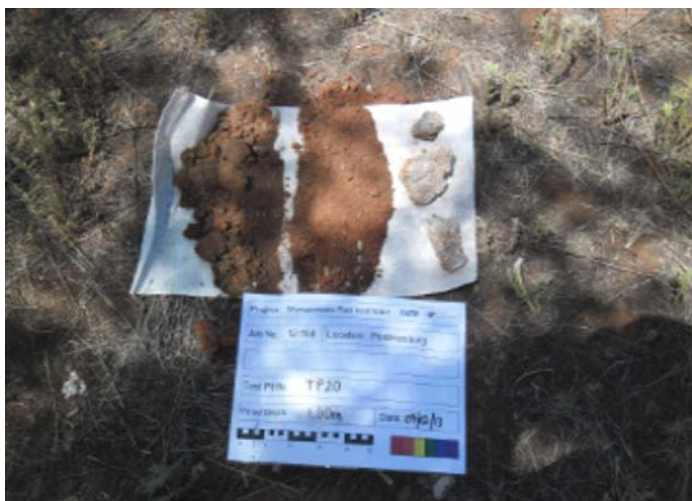
DEPTH (m) 1.00

- 1) Final depth at 1.00m. Refusal on at least hardpan calcrete.
- 2) No groundwater seepage.
- 3) No sidewall collapse.
- 4) Samples taken :
S1 0.20--0.80m (1 x Small) and (3 x Bulk)

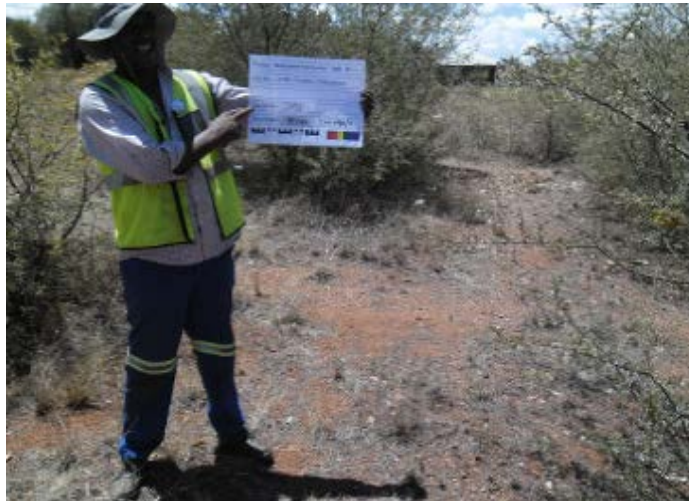
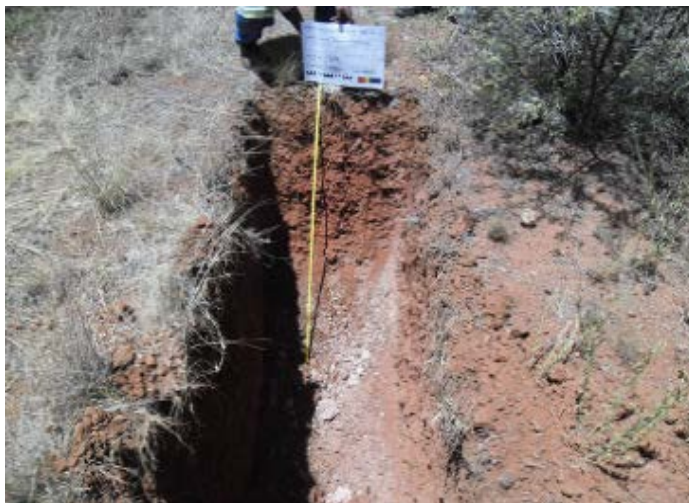
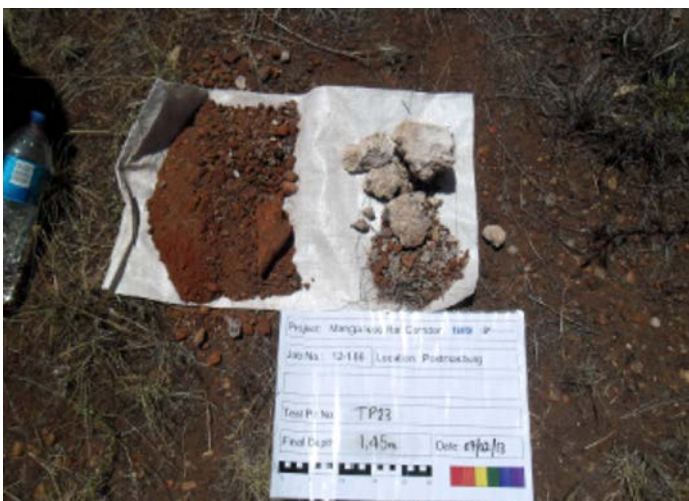
DEPTH (m) 1.45

- 1) Final depth at 1.45m. Refusal on at least hardpan calcrete.
- 2) No groundwater seepage.
- 3) No sidewall collapse.
- 4) Samples taken :
S1 0.01--1.30m (1 x Small) and (3 x Bulk)

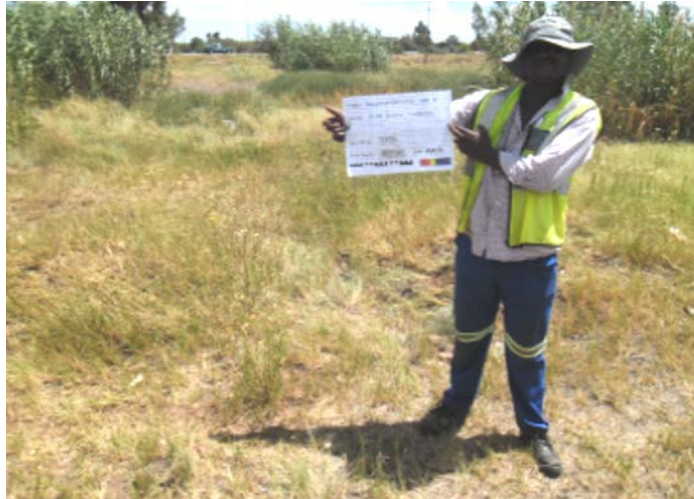
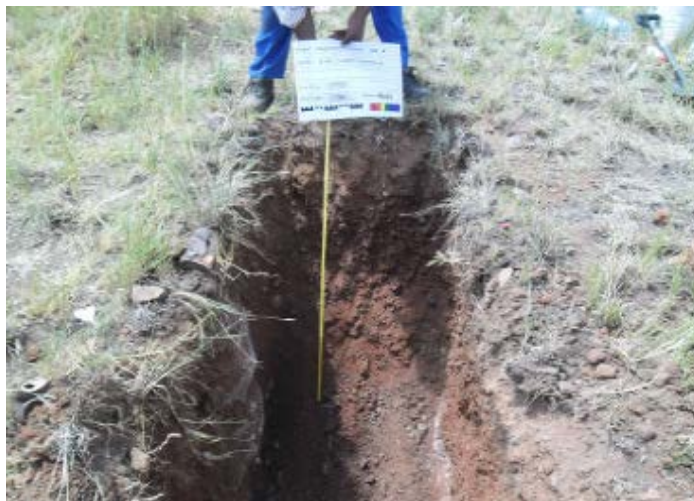
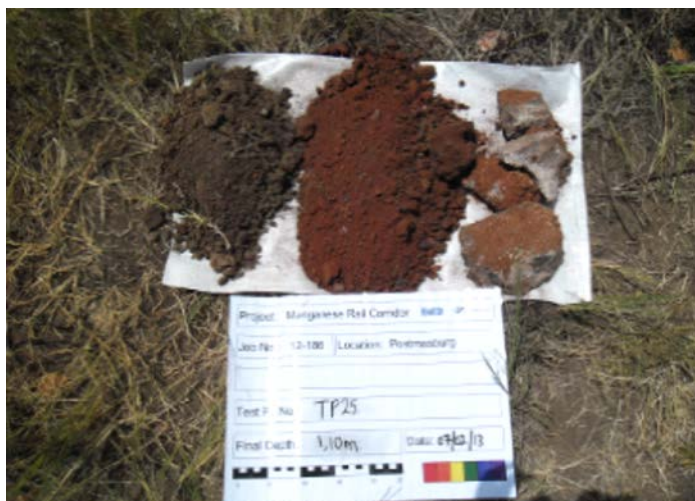
DEPTH (m) 1.10

- 1) Final depth at 1.10m. Refusal on at least hardpan calcrete.
- 2) No groundwater seepage.
- 3) No sidewall collapse.
- 4) Samples taken :
S1 0.15--0.90m (1 x Small) and (3 x Bulk)
- 5) Test pit position is close to a pipe.

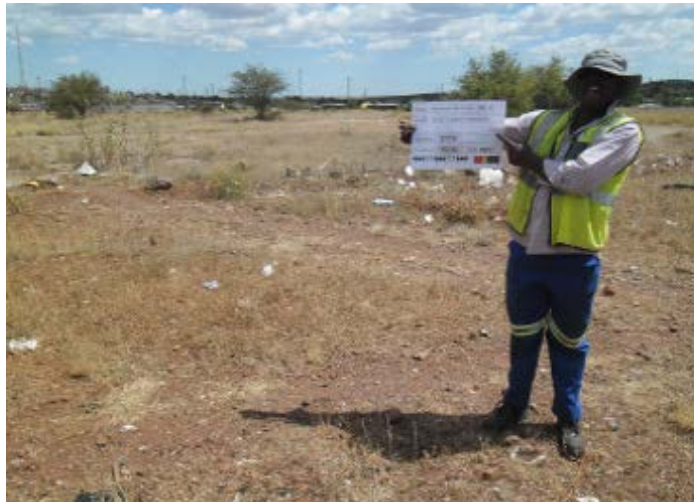
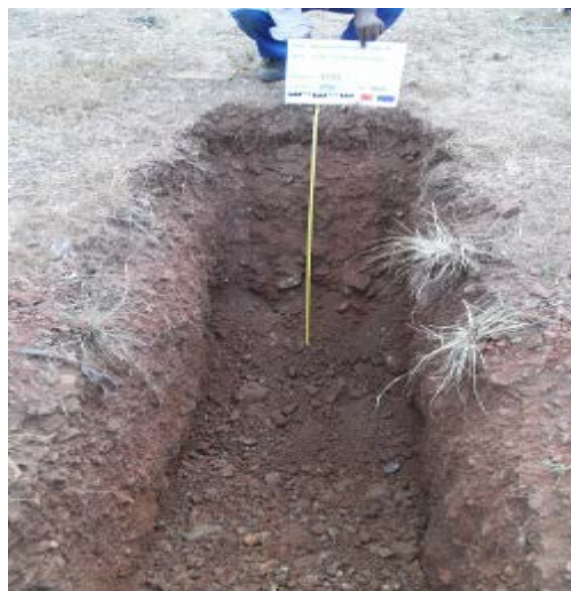
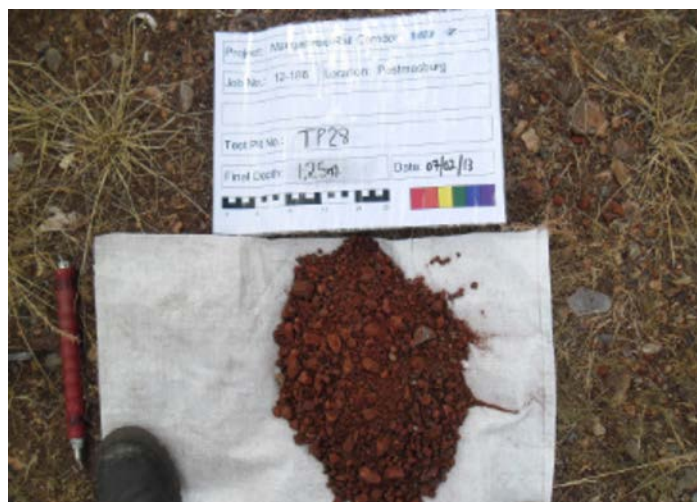
DEPTH (m) 1.25

- 1) Final depth at 1.25m. Refusal on at least soft rock dolomite bedrock.
- 2) No groundwater seepage.
- 3) No sidewall collapse.
- 4) Samples taken :
S1 0.01--1.25m (1 x Small) and (3 x Bulk)
- 5) Test pit relocated due to reduction in number of pits.

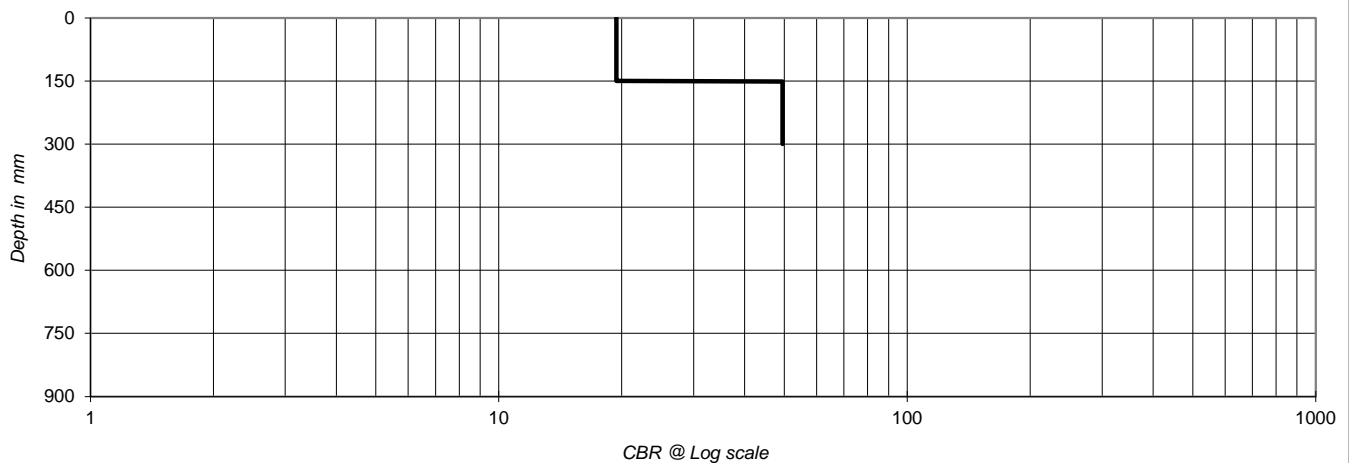
Layer - Strength diagram

no.	Depth (mm)		In situ	Blows/mm	
	From	To	DN	150mm	300mm
1	1	150	11	19	13
2	151	300	5.5	50	27
3	301	450			
4	451	600			
5	601	750			
6	751	900

REMARKS **Refusal at 362 mm**

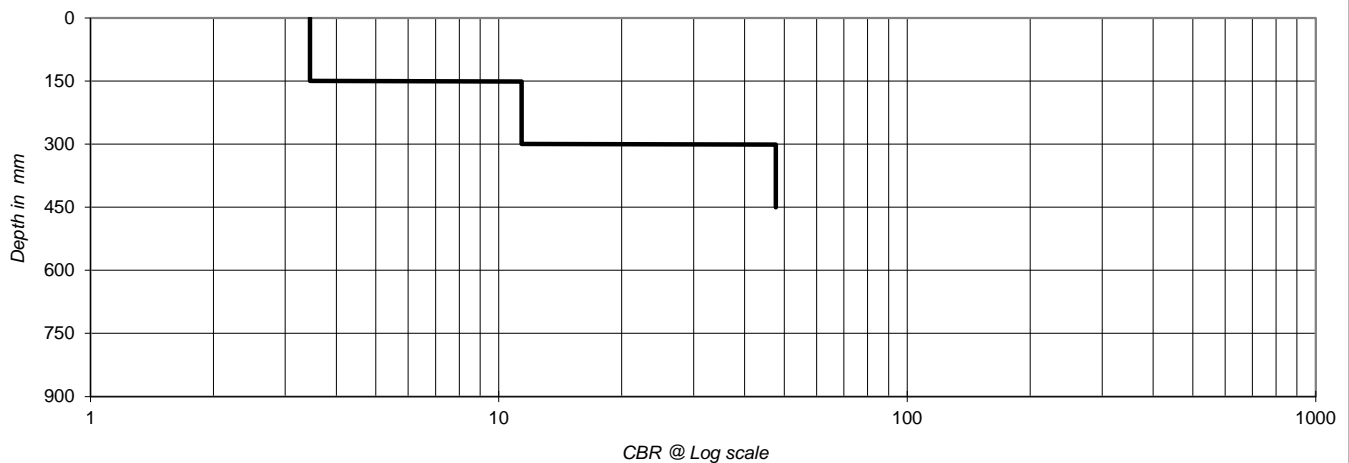
Layer - Strength diagram

no.	Depth (mm)		In situ CBR	Blows/mm	
	From	To		150mm	300mm
1	1	150	43	3	6.1
2	151	300	17	9	13.3
3	301	450	5.6	27	
4	451	600			
5	601	750			
6	751	900

REMARKS **Refusal at 540 mm**

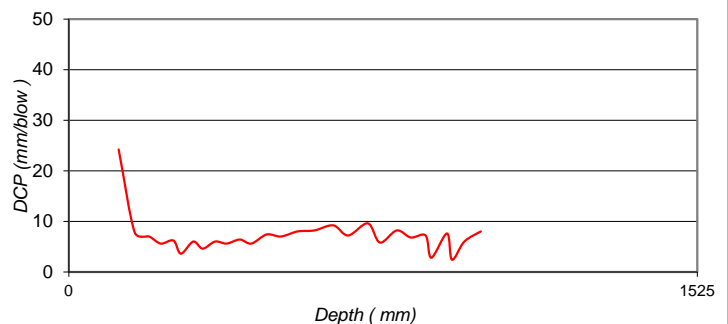
Layer - Strength diagram

no.	Depth (mm)		In situ CBR	Blows/mm	
	From	To		150mm	300mm
1	1	150	17	11	9
2	151	300	5.8	46	26
3	301	450	5.7	47	26
4	451	600	7.7	32	19
5	601	750	8	30	19
6	751	900	6.4	41	23

REMARKS Max. penetration depth : 1000 mm
