**Botanical Assessment for the proposed  
strengthening (partial reconstruction)  
of National Route 27 Sections 7 & 8 between  
the Western Cape Province/ Northern Cape Province  
Border and Calvinia**

**Prepared for CCA Environmental (Pty) Ltd)**

**Client: SANRAL**

PROPOSED STRENGTHENING (PARTIAL RECONSTRUCTION) OF NATIONAL ROUTE 27 SECTION 7 & 8 BETWEEN WESTERN/ NORTHERN CAPE BORDER (KM 40.0) AND CALVINIA (KM 70.0) - CONTRACT R.027-080-2011/1D

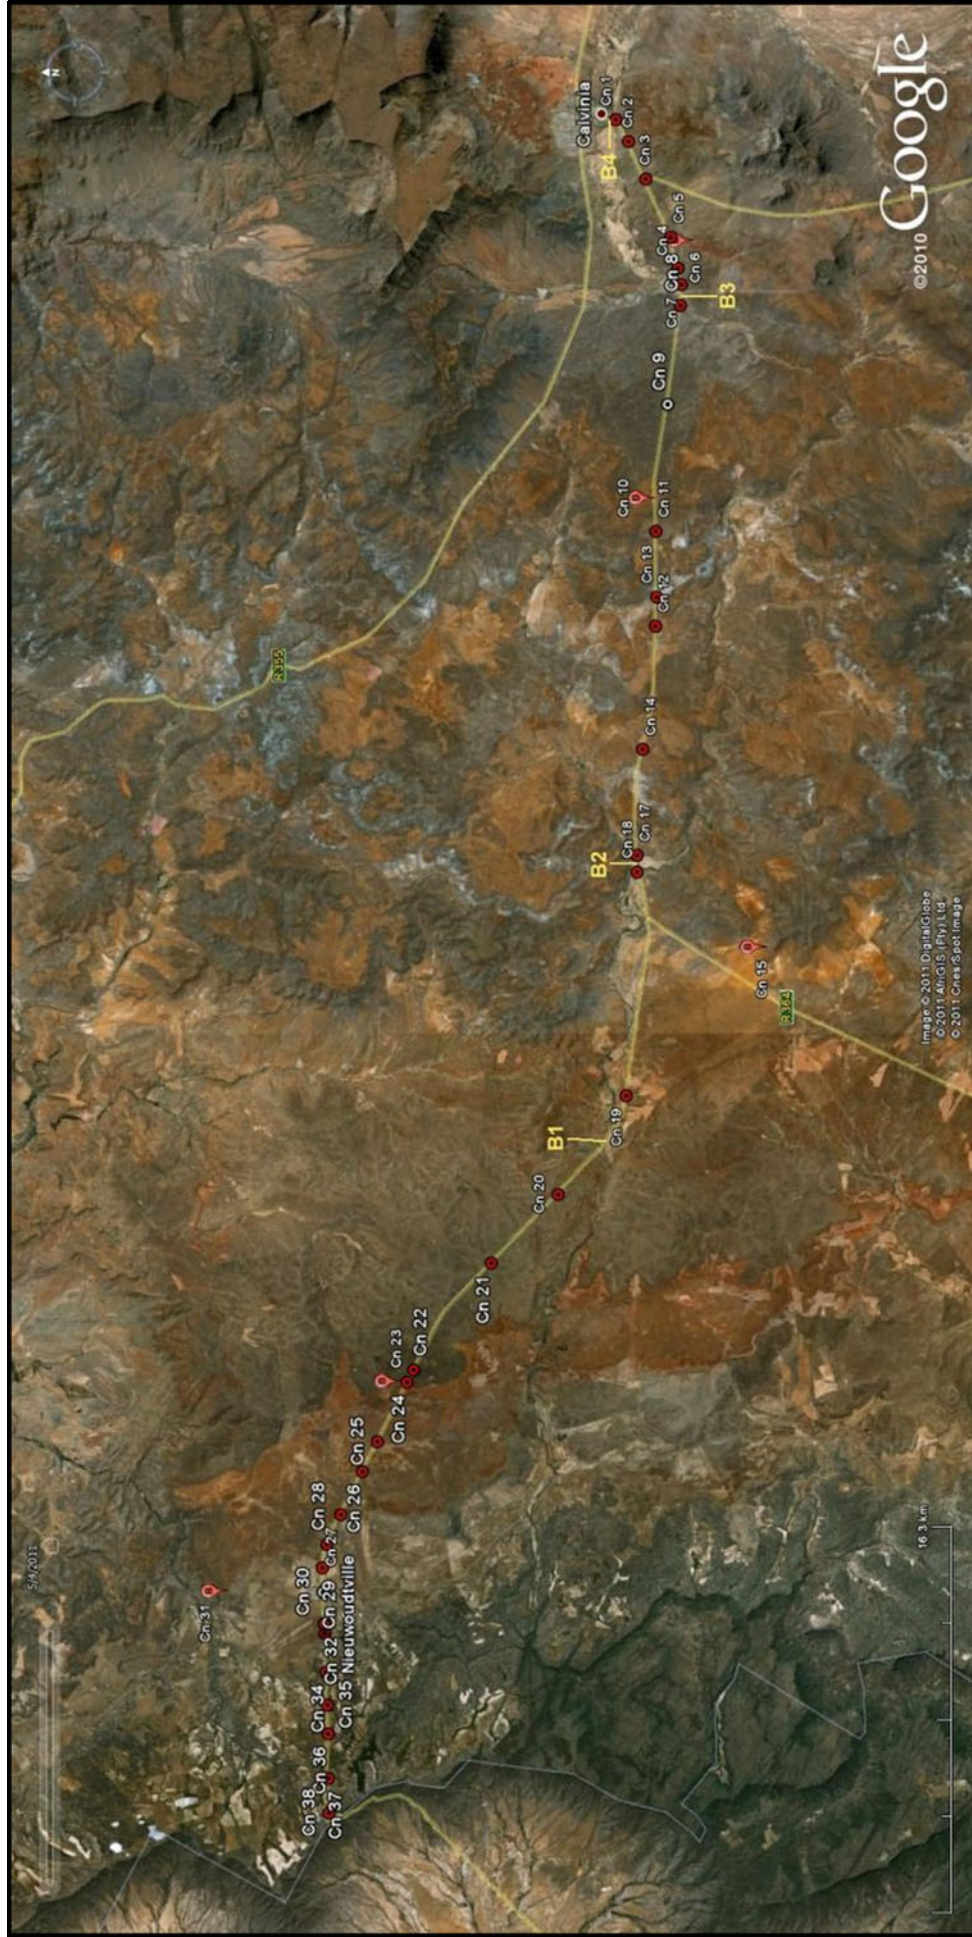
Figure 3. The R27 Sections 7 & 8 route between Vanrhyn's Pass in the west and Calvinia in the east showing the sample waypoints Cn# with red dots, the proposed borrow pits (pink tear-drop icons) and the four bridges B1 – B4 (yellow), superimposed on a Google Earth © aerial image of the study area.

Four bridges are found along the R27 Section 7 & 8 route (Figure 3). They cross the Oorlogskloof River as it meanders eastwards.

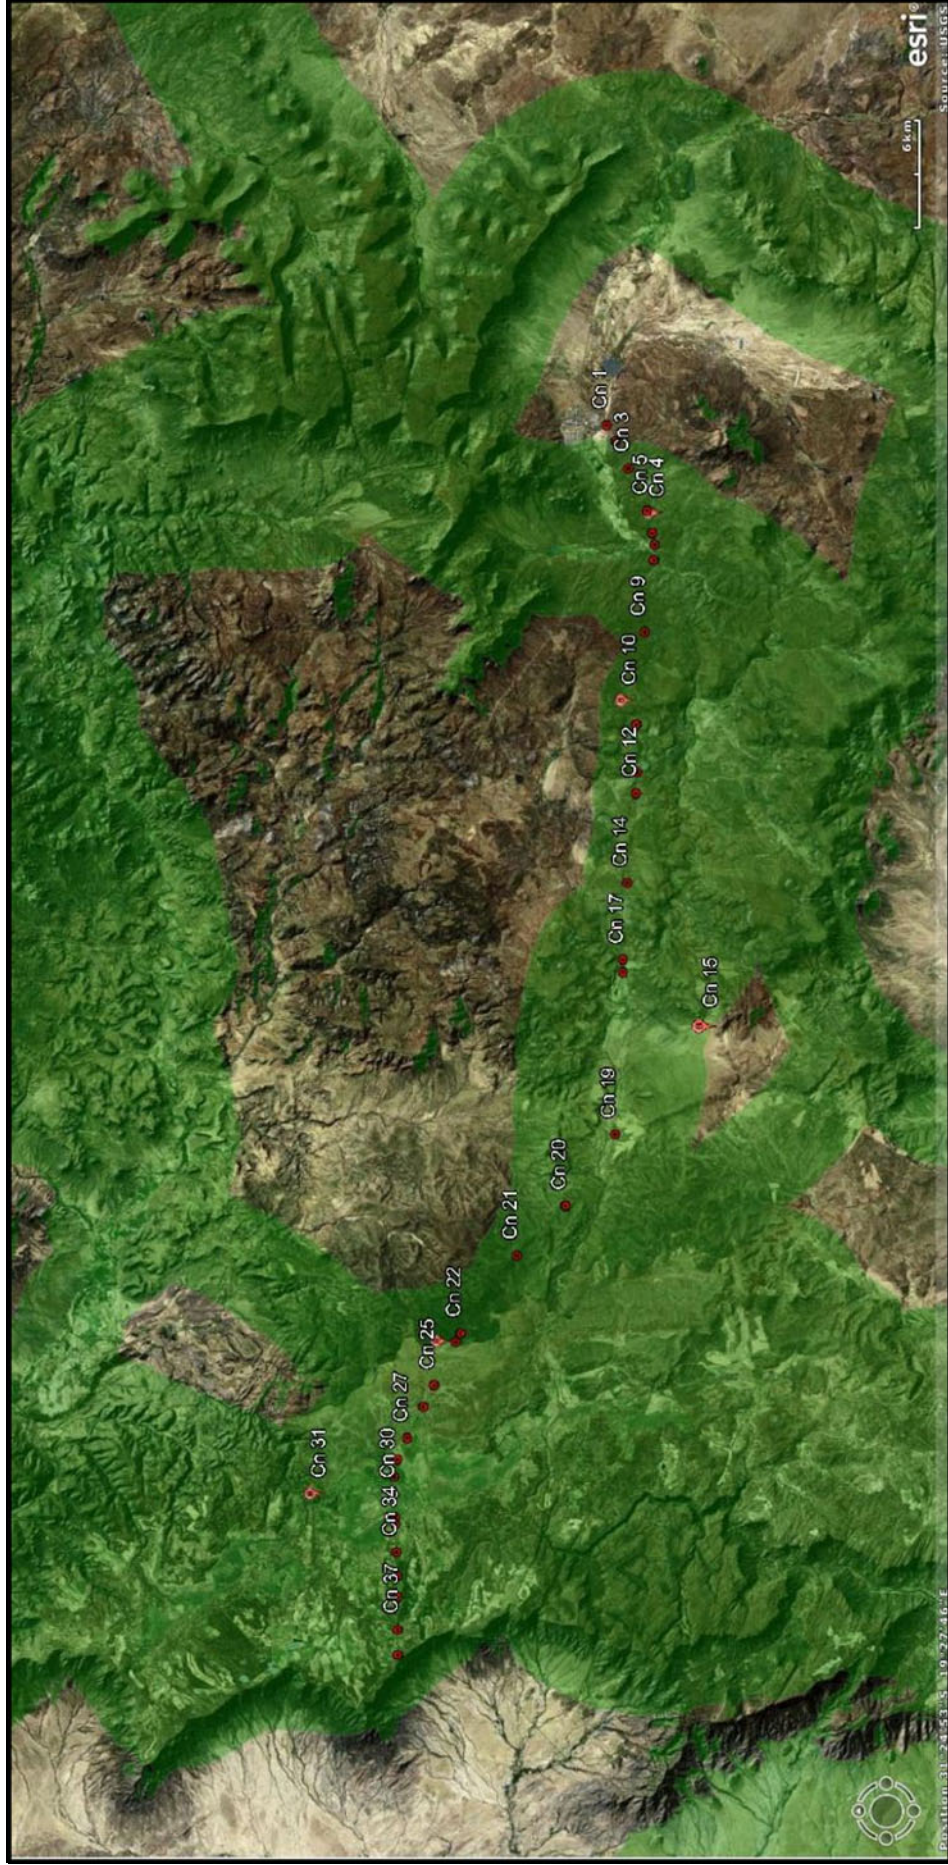
**Figure 4.** Portion of the mapped Critical Biodiversity Areas (CBA's) and Ecological Support Areas (ESA's) for Namaqualand District Municipality – shown together as green shading. The sample waypoints (Cn#) are superimposed and those from Cn1 – Cn20 fall within an ESA corridor. Those from Cn21 – Cn38 fall within a Critical Biodiversity Area (refer to Figure 5).

Borrow Pit 2 is situated in an undulating landscape approximately 10 km east of Nieuwoudtville. The soils are dolerite-derived and this area is included in the Critical Biodiversity Map (Figure 4) for the Nieuwoudtville District within the Namaqualand District Municipality (Desmet & Marsh, 2008). The existing borrow pit depression has been invaded by weedy *Dittrichia graveolens* and has otherwise restored with sparse shrubs. The intention is to extend the existing borrow pit in a north-easterly direction. Ideally this area should not be exploited if the principle of avoiding Critical Biodiversity Areas is to be applied. Future excavation would impact undisturbed natural succulent-dominated shrubland but it is felt that since the vegetation surrounding the borrow pit is relatively wide-spread and no dolerite koppies or outcrops would be affected and that the field investigation did not reveal any 'red flag' plant species, the proposed extension of the borrow pit is deemed acceptable. Impact on the vegetation will, however, be of HIGH NEGATIVE significance on a local scale. Mitigation by appropriate rehabilitation would lower the impact to MEDIUM NEGATIVE.

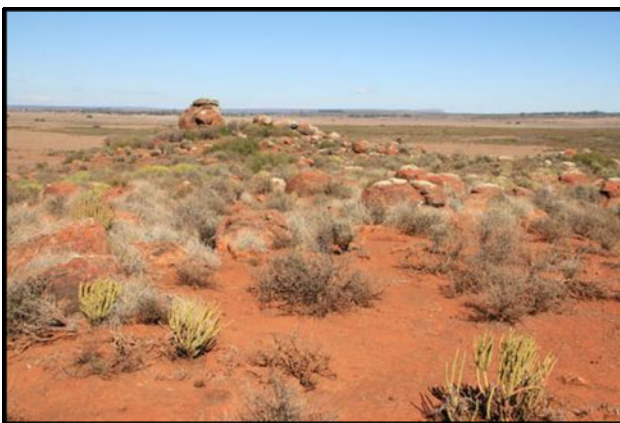
**Figure 6.** A typical dolerite 'koppie' outcrop near Nieuwoudtville with characteristic red soil.

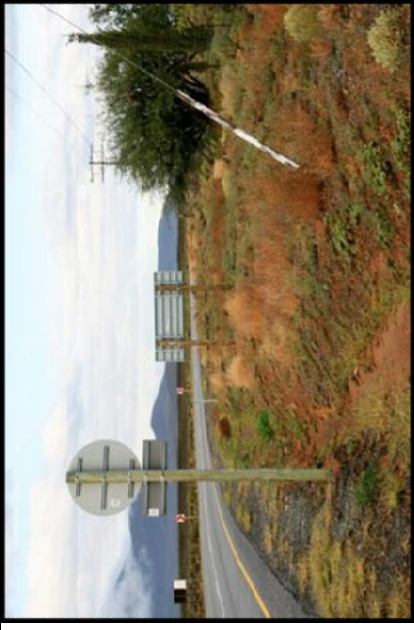
Waypoint	Vegetation Unit *	Brief descriptive notes	
<p><b>CN1</b> S 31° 28' 48.3" E 19° 46' 14.0"</p>	<p><b>Calvinia Mosaic</b> <b>Hantam Karoo</b></p>	<p>At the Keiskie turnoff outside Calvinia. The road reserve is highly disturbed on both sides of the road. The vegetation consists mainly of weeds such as <i>Salsola kali</i> (rolbos), <i>Atriplex semibaccata</i>, <i>Atriplex lindleyi</i> subsp. <i>inflata</i>, <i>Malephora crassa</i>, <i>Salsola</i> sp., <i>Ruschia</i> sp., <i>Chrysocoma ciliata</i>, <i>Galenia africana</i> and <i>Gazania krebsiana</i>.</p>

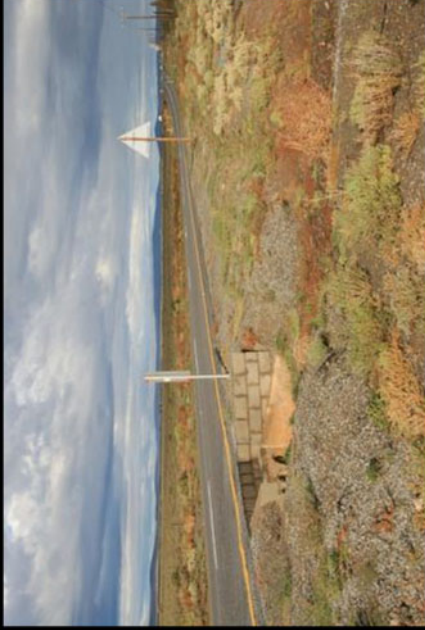
<p><b>CN2</b> S 31° 29' 05.8" E 19° 45' 38.9"</p>	<p><b>Calvinia Mosaic</b> <b>Hantam Karoo</b></p>	<p>Near road marker R27-8 66.0 E. A culvert is found here and both side of the road are disturbed and vegetated mainly with weedy species. <i>Galenia africana</i> is prominent. Other species include <i>Salsola kali</i>, <i>Eragrostis</i> sp., <i>Sonchus oleraceus</i>, <i>Fingerhuthia africana</i>, <i>Felicia muricata</i>, <i>Erodium cicutarium</i>, and <i>Cucumis myriocarpus</i> subsp. <i>leptodermis</i>.</p>

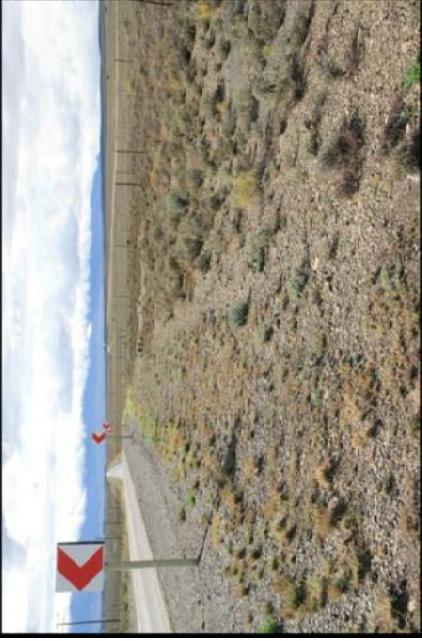
<p><b>CN5</b> S 31° 30' 03.7" E 19° 43' 06.3"</p>	<p><b>Calvinia Mosaic</b> <b>Hantam Karoo</b></p>	<p>This waypoint is at the entrance to the track to Borrow Pit 7 near road marker R27-8 61.2E. The vegetation on both sides of the road is in poor condition when compared with the vegetation on the adjacent private property.</p>

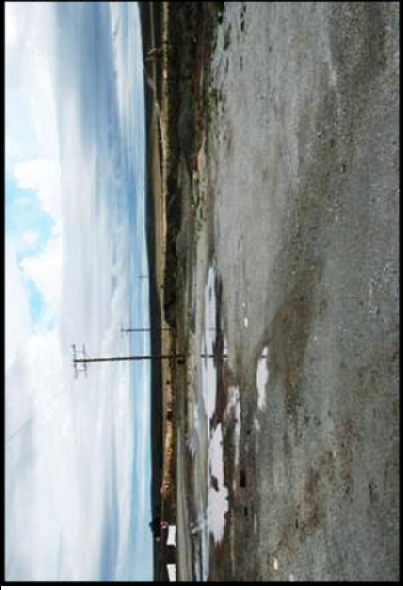
<p><b>CN7</b> S 31° 30' 18.2" E 19° 41' 50.4"</p>	<p><b>Calvinia Mosaic</b> <b>Hantam Karoo</b></p>	<p>Lay-by area on north side of road at R 27-8 59.4E which is highly disturbed. Piles of gravel are present and the area is used for road-works. The south side of the road has short shrubby vegetation with a mowed grassy verge.</p>

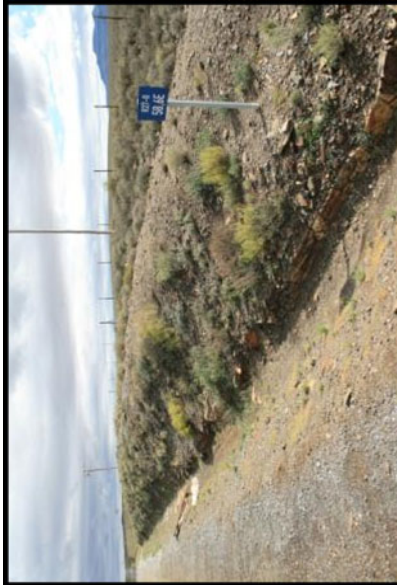
<p><b>Calvinia Mosaic</b> <b>Hantam Karoo</b></p>	<p>On the north side at waypoint CN8 the road cuts through shale sediments. The vegetation on the road verge is weedy but closer to the fence is less disturbed and is continuous with the natural community on the adjacent private property.</p>

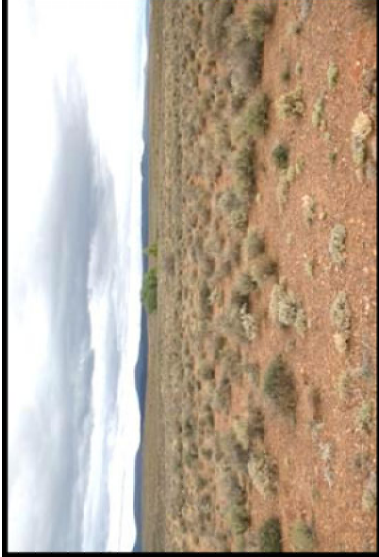
<p><b>CN13</b>                  S 31° 29' 45.4"                  E 19° 33' 31.2"</p>	<p><i>Ericephalus ericoides</i> –  <i>Pteronia glomerata</i>                  Roggeveld Karoo</p> <p><b>Hantam Karoo</b></p>	<p>Typical view of private property with low Karoo “bossieveld” – fairly heavily grazed -- to the south of entrance gate off the R27 to the proposed dolerite quarry.</p>

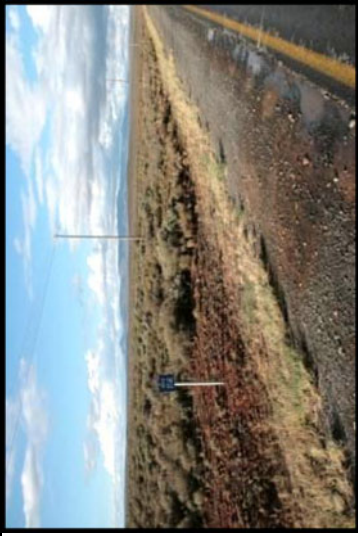
<p><b>CN16</b> S 31° 29' 17.0" E 19° 27' 59.3"</p>	<p><i>Erodium cicutarium</i> – <i>Eriocephalus purpureus</i> Hantam Karoo <b>Hantam Karoo</b></p>	<p>At road marker R27-8 37.4E. The road reserve on the north side (opposite) is narrower than that on the south side (below right). As is mostly the case, the vegetation on the road verge (both sides) is highly disturbed and grassy. Closer to the fence the vegetation is low "bossieveld" dominated by succulent shrubs (Aizoaceae) and composite shrubs (Asteraceae).</p>

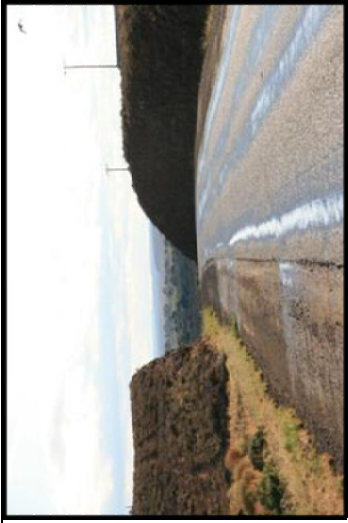
<p><i>Erodium cicutarium</i> –  <i>Ericephalus purpureus</i>                  Hantam Karoo                  Hantam Karoo</p>	<p>Near waypoint CN16 the road cuts through shale sediments of the Ecca Group.</p>

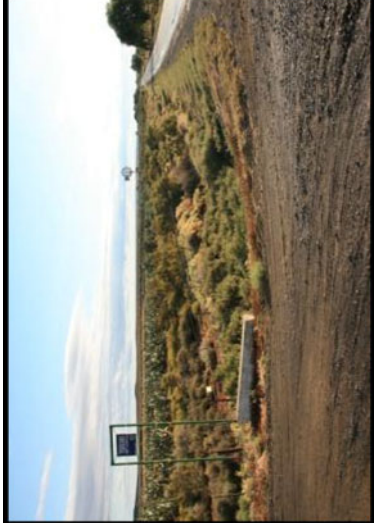
<p>CN17                  S 31° 29' 18.8"                  E 19° 26' 39.1"</p>	<p><i>Leipoldtia schulzei</i> –  <i>Ericephalus purpureus</i>                  Hantam Karoo                  Hantam Karoo</p>	<p>At the entrance to the farm Toekoms which is near the bridge built in 1959 over the Oorlogskloof River. The vegetation in the road reserve on the south side is highly disturbed with a suite of weedy species. On the north side of the road the vegetation is less disturbed, consisting of typical low 'bossieveld' where it has not been mowed.</p>

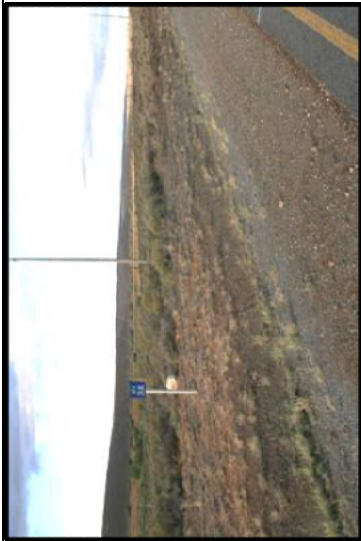
<p><b>CN19</b> S 31° 29' 03.9" E 19° 20' 16.1"</p>	<p><b>Leipoldtia schulzei</b> – <b>Ericephalus purpureus</b> Hantam Karoo <b>Hantam Karoo</b></p>	<p>At road marker R27-8 25 E. A change in the vegetation was noted at this waypoint. It is noticeably taller and dominated by <i>Pteronia pallens</i>. Other species include <i>Psilocaulon junceum</i>, <i>Zygophyllum</i> sp., <i>Ruschia intricata</i>, <i>Atriplex lindleyi</i> subsp. <i>inflata</i>, <i>Salsola tuberculata</i>.</p>

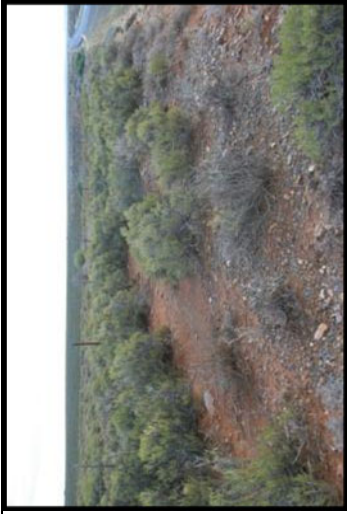
<p><i>Leipoldtia schulzei</i> –  <i>Eriocephalus purpureus</i>  Hantam Karoo  Hantam Karoo</p>	<p>Calcrete is found in the soil here on the south side of the road at waypoint CN19. This correlates well with the presence of <i>Pteronia pallens</i>.</p>

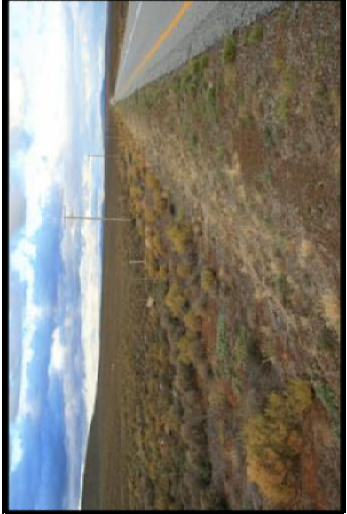
<p><b>CN20</b>  S 31° 27' 31.4"  E 19° 17' 38.6"</p>	<p>Grootfontein Mosaic  Hantam Karoo</p>	<p>At the R27-8 19.8E road marker the vegetation in the road reserve is highly disturbed with <i>Galenia africana</i>, <i>Augea capensis</i> and <i>Pentzia incana</i> prominent. Other species include <i>Ruschia</i> sp., <i>Eriocephalus ericoides</i>, <i>Asparagus</i> sp., <i>Salsola kali</i> and <i>Erodium cicutarium</i>.</p>

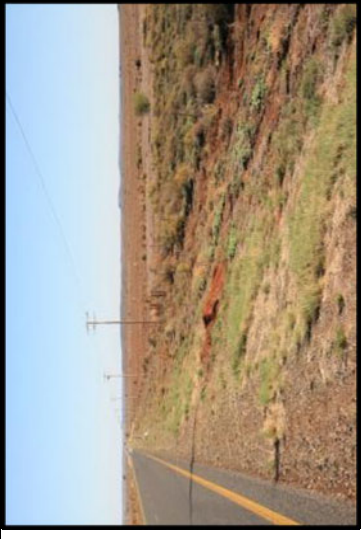
<p><b>CN24</b> S 31° 24' 05.5" E 19° 12' 39.6"</p>	<p><b>Nieuwoudtville Mosaic</b> <b>Hantam Karoo</b></p>	<p>At road marker R27-8 9.6E (near Borrow Pit 2). The road reserve on both sides is highly disturbed. On the north side the road verge is mowed for width of 5 m. The natural shrubby vegetation is dominated by <i>Pentzia incana</i>. Other species include <i>Augea capensis</i>, <i>Chrysocoma ciliata</i>, <i>Stipagrostis namaquense</i>, <i>Eragrostis curvula</i>, <i>Oxalis pes-caprae</i>, <i>Mesembryanthemum guerichianum</i>, <i>Galenia africana</i>, <i>Atriplex semibaccata</i>.</p>

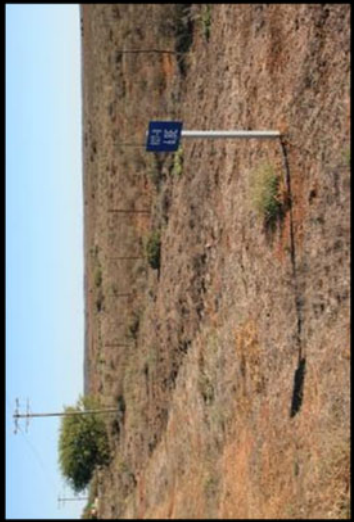
<p><b>CN25</b> S 31° 23' 25.1" E 19° 11' 04.8"</p>	<p><b>Nieuwoudtville Mosaic</b> <b>Hantam Karoo</b></p>	<p>This location is at the R27-8 6.8E road marker where the road reserve is highly disturbed. The vegetation is principally dry annual grasses with <i>Psilocaulon junceum</i>, <i>Lycium</i> sp., <i>Asparagus capensis</i>, <i>Atriplex nummularia</i>, <i>Atriplex semibaccata</i>, <i>Salsola kali</i>, <i>Mesembryanthemum guerichianum</i> and <i>Brunsvigia bosmaniae</i>.</p>

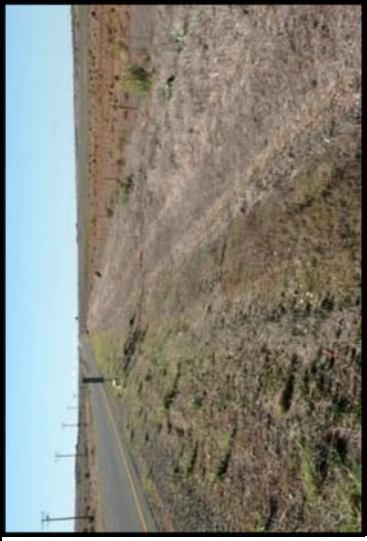
<p><b>CN27</b> S 31° 22' 35.1" E 19° 09' 08.8"</p>	<p><b>Nieuwoudtville Mosaic</b> <b>Nieuwoudtville Shale</b> <b>Renosterfeld</b></p>	<p>This location is at the R 27-8 3.4E marker. The road reserve is in poor condition. The vegetation consists mainly of dry grass and weedy species. No Nieuwoudtville Shale Renosterfeld is present and the adjacent private land has also been cleared of natural vegetation.</p>

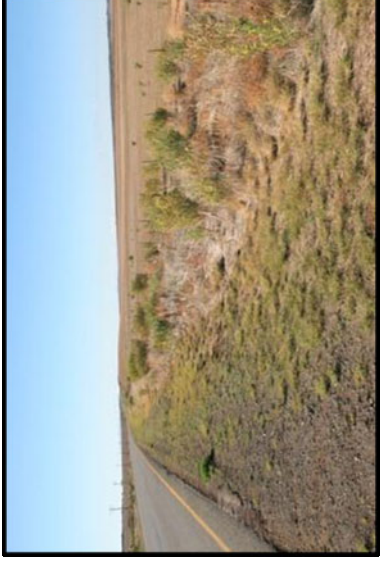
<p><b>CN29</b> S 31° 22' 09.8" E 19° 07' 43.7"</p>	<p><b>Nieuwoudtville Mosaic</b> <b>Nieuwoudtville Shale</b> <b>Renosterveld</b></p>	<p>This location is close to the R 27-8 1.0E marker at the entrance to the Nieuwoudtville Landfill. The road reserve is highly transformed and disturbed. The vegetation is dominated by grass and exotic statics or sea lavender (<i>Limonium sinuatum</i>) that has no doubt escaped from the nearby town. Other species recorded here include <i>Gomphocarpus fruticosus</i>, <i>Eragrostis curvula</i>, <i>Avena fatua</i> and <i>Salsola kali</i>.</p>

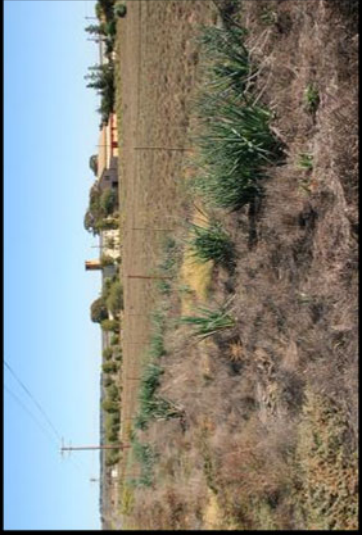
<p><b>CN30</b> S 31° 22' 10.6" E 19° 07' 05.1"</p>	<p><b>Nieuwoudtville Mosaic</b> <b>Nieuwoudtville Shale</b> <b>Renosterveld</b></p>	<p>This location is on the outskirts of Nieuwoudtville. Stands of <i>Albucca canadensis</i> are found on both sides of the road. According to Vlok &amp; Schutte-Vlok (2010) presence of this species in abundance indicates intense disturbance and this is clearly the case here. The road reserve is dominated by grass and other weedy species contribute to the vegetation matrix.</p>

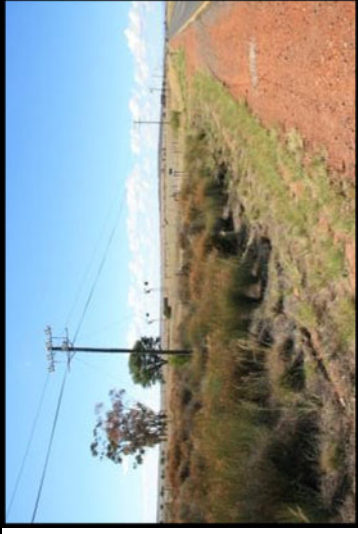
<p><b>Bokkeveld Sandstone</b> <b>Fynbos</b></p>	<p>The north side of the R27 near marker R 27-7 50.2E, dominated by <i>Willdenowia incurvata</i>. Other fynbos species of lower stature are also found here but some of the larger shrubs have been actively removed.</p>

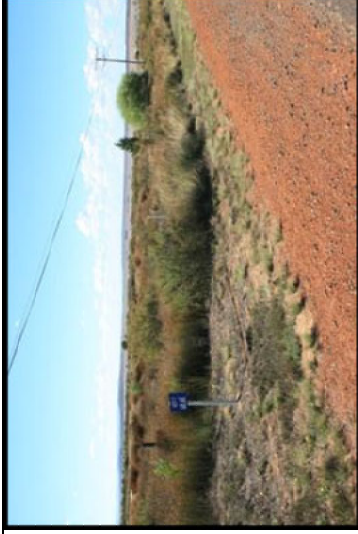
<p><b>CN34</b> S 31° 22' 14.6" E 19° 04' 57.5"</p>	<p><b>Bokkeveld Sandstone</b> <b>Fynbos</b></p>	<p>At road marker R27-7 48.6E there is fynbos on both sides of the road with the south side more heavily disturbed with mowed <i>Eragrostis curvula</i> on the road verge. Species found in the fynbos include <i>Anthospermum aethiopicum</i>, <i>Cliffortia ruscifolia</i>, <i>Searsia angustifolia</i>, <i>Oxalis</i> spp., <i>Diospyros glabra</i>, <i>Willdenowia incurvata</i>, <i>Lobelia</i> cf. <i>pinifolia</i>, <i>Pelargonium triste</i>.</p>

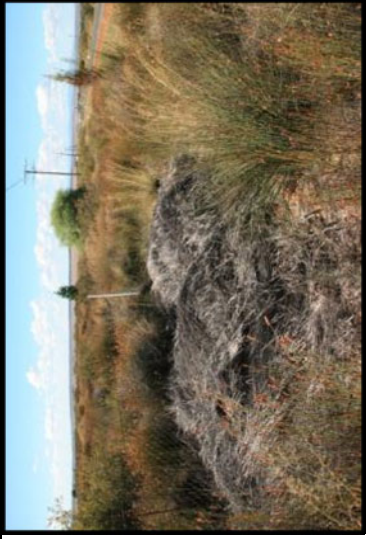
<p><b>Bokkeveld Sandstone</b> <b>Fynbos</b></p>	<p>The Restionaceae (<i>Willdenowia incurvata</i>) has been actively cut and piled into heaps near waypoint CN34. This was done as part of the 'job creation' programme. It is a highly undesirable practice that should be terminated since it negatively impacts the fynbos in the road reserve.</p>

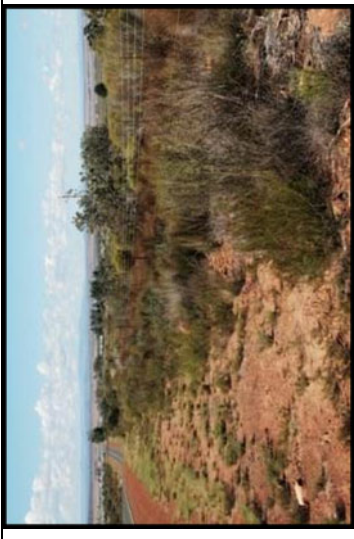
<p><b>CN35</b> S 31° 22' 16.2" S 19° 04' 04.9"</p>	<p><b>Bokkeveld Sandstone</b> <b>Fynbos</b></p>	<p><i>Willdenowia incurvata</i> has also be selectively cut and removed at this location near road marker R27-7 47.2E. Shrubs have also been actively cleared at this site. Despite this high degree of disturbance the fynbos vegetation has persisted and species recorded include, <i>Montinia caryophyllacea</i>, <i>Thesium sp.</i>, <i>Phylla sp.</i> (low, fluffy shrublet), <i>Ischyrolepis gaudichaudiana</i>, <i>Ruschia sp.</i>, <i>Lobostemon glaucophyllus</i>, <i>Anthospermum aethiopicum</i>, <i>Protea laurifolia</i>, <i>Senecio sp.</i></p>

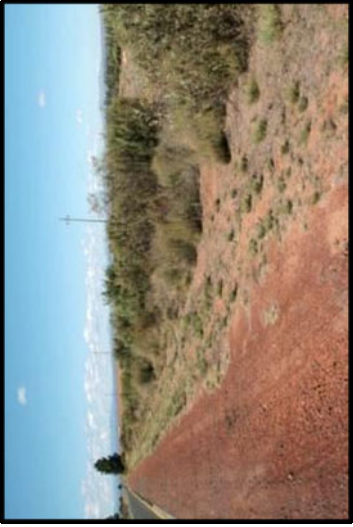
<p><b>CN36</b> S 31° 22' 17.0" E 19° 03' 18.8"</p>	<p><b>Bokkeveld Sandstone</b> <b>Fynbos</b></p>	<p>This waypoint is at the R27-7 46.0 road marker. The fynbos is intact in a narrow band on both sides of the road within the road reserve. (Over the fence the land has been cultivated). However, the fynbos is rather disturbed. Species recorded at this site include <i>Paranomus bracteolaris</i>, <i>Chironia baccifera</i>, <i>Anthospermum aethiopicum</i>, <i>Searsia angustifolia</i>, <i>Athanasia trifurcata</i>, <i>Eriocephalus africanus</i>, <i>Ruschia carolii</i>, <i>Cliffortia ruscifolia</i>, <i>Ischyrolepis gaudichaudiana</i>, <i>Lobostemon</i> sp., <i>Pelargonium scabrum</i>, <i>Chrysocoma ciliata</i>, <i>Leucadendron pubescens</i>, and <i>Passerina truncata</i> subsp. <i>truncata</i>. Further disturbance of this fynbos would be undesirable.</p>

- Section 7 (Vanrhyn's Pass to Nieuwoudtville) which passes through Bokkeveld Sandstone Vegetation is sensitive and no vehicles or construction equipment should be allowed to damage or disturb the fynbos. This vegetation should be cordoned off with danger tape along its entire length of occurrence. In addition an educational exercise should be implemented with the contractor and workforce to impress on them the importance of this vegetation.

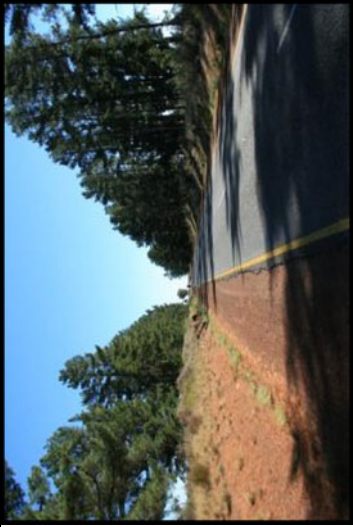
<p><b>CN37</b> S 31° 22' 17.1" E 19° 02' 07.9"</p>	<p><b>Bokkeveld Sandstone</b> <b>Fynbos</b></p>	<p>Between R27-7 44E and R 27-7 45E are two rows of pine trees (north and south side of the road) inside private property but close to the fence. There is fynbos in the road reserve but due to the proximity of the pine trees the fynbos has been suppressed and is not in good condition.</p>

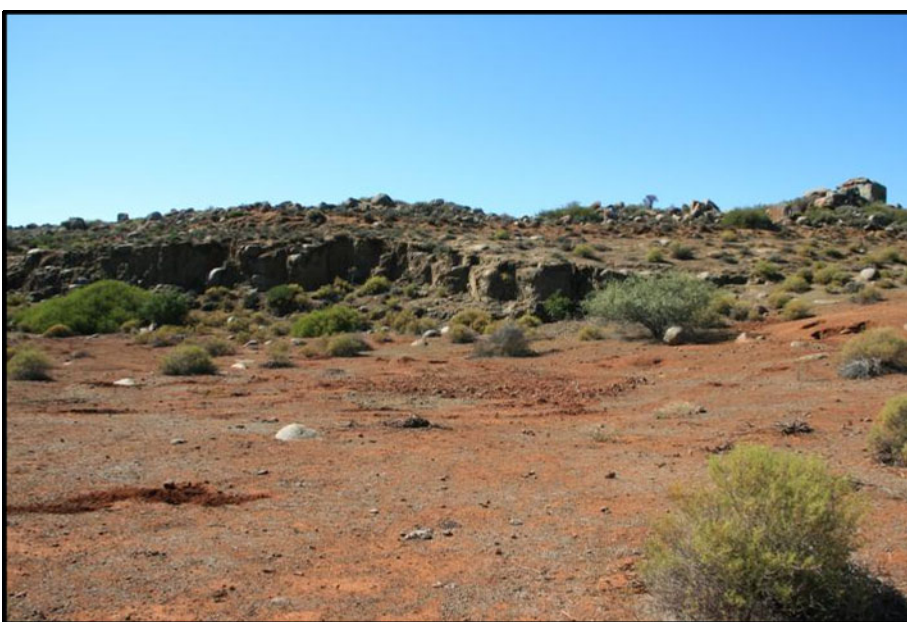
**Figure 11.** Dolerite outcrop with existing borrow pit (quarry) at the Borrow Pit 1 site, as seen from the west. This area falls within a Critical Biodiversity area and is botanically highly sensitive.

Of the seven borrow pits considered, six have been deemed acceptable in terms of impacts on the vegetation. The exception is Borrow Pit 1 which must be excluded completely from consideration since it is found in a sensitive habitat within a Critical Biodiversity Area.

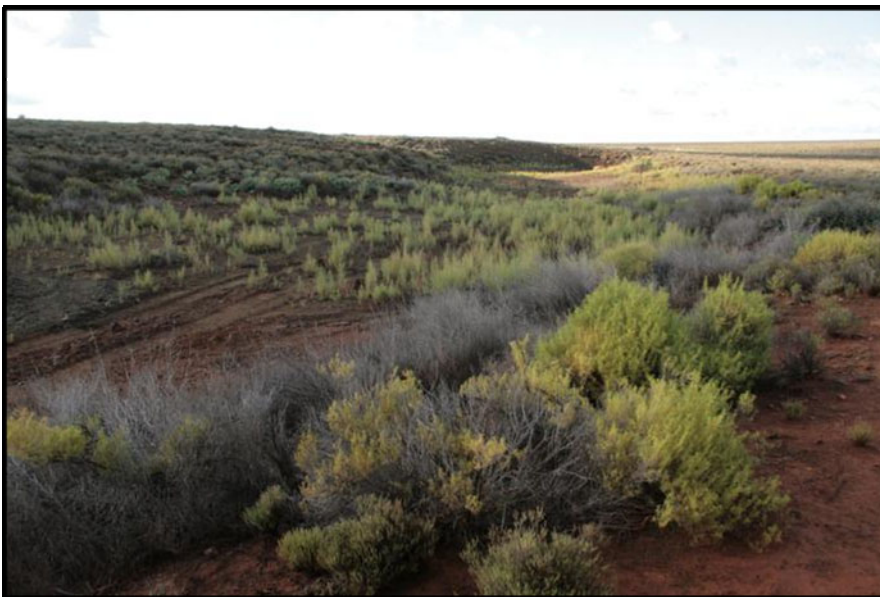
**Figure 12.** Borrow Pit 2 showing the existing excavation invaded by weedy pioneer species, notably *Dittrichia graveolens* and *Galenia africana*.

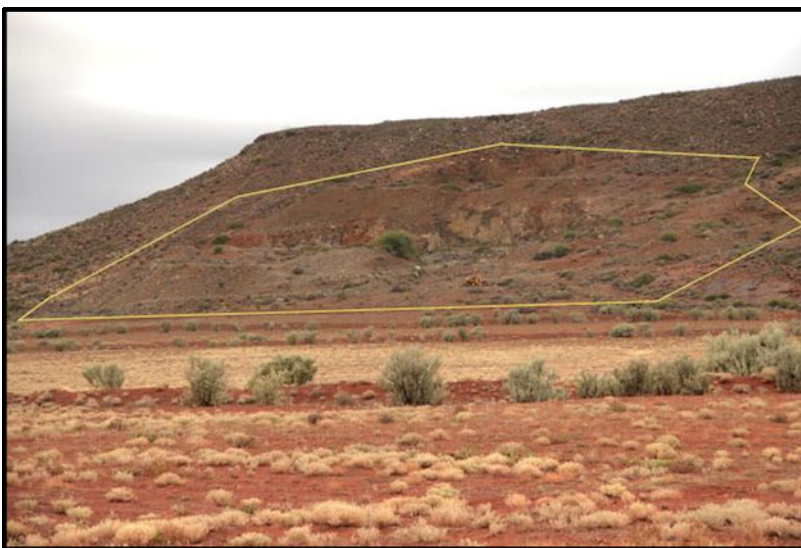
**Figure 13.** The abandoned Iceland Spar mine outlined in yellow. The tailings dump that can be used for road building is seen in the lower left-hand corner.

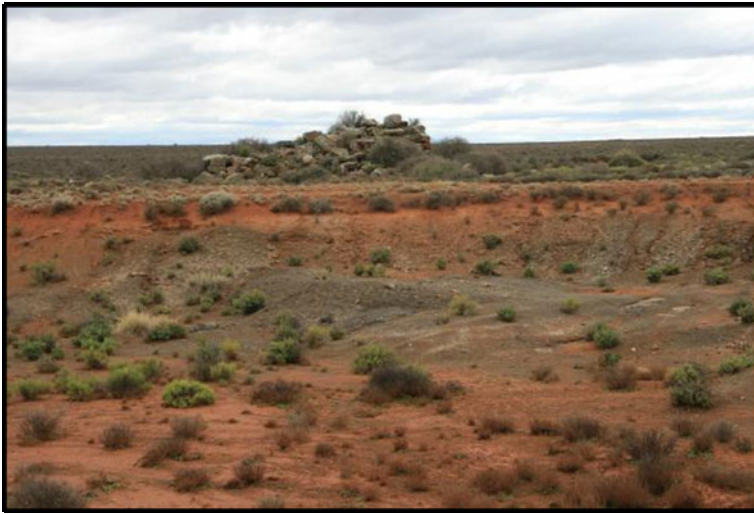
Borrow Pit 4 is on the farm Matjiesfontein and is close to the road on the north side. The existing pit is extensive and the proposal is to extend it northwards. The soil is dolerite-derived resulting from a dolerite intrusion into the Ecca shales. At this site there is no major discernable difference between the low shrubby succulent vegetation on the north-east side of the existing pit and the vegetation found on the shale-derived soils. The vegetation that would be impacted by extension of the borrow pit is extensive over the landscape to the north and east and the extension of the borrow pit is considered acceptable. A small dolerite koppie (Figure 14) will be lost due to the proposed excavation. This is unfortunate but the small size of the koppie and its relative isolation in the landscape indicate that this loss will be acceptable. As for Borrow Pit 2 impact on the vegetation will, however, be of HIGH NEGATIVE significance on a local scale. Mitigation by appropriate rehabilitation would lower the impact to MEDIUM NEGATIVE.

**Figure 14.** The existing Borrow Pit 4 on Matjiesfontein Farm which would be extended northwards into undisturbed Hantam Karoo veld. The small dolerite outcrop would be lost.

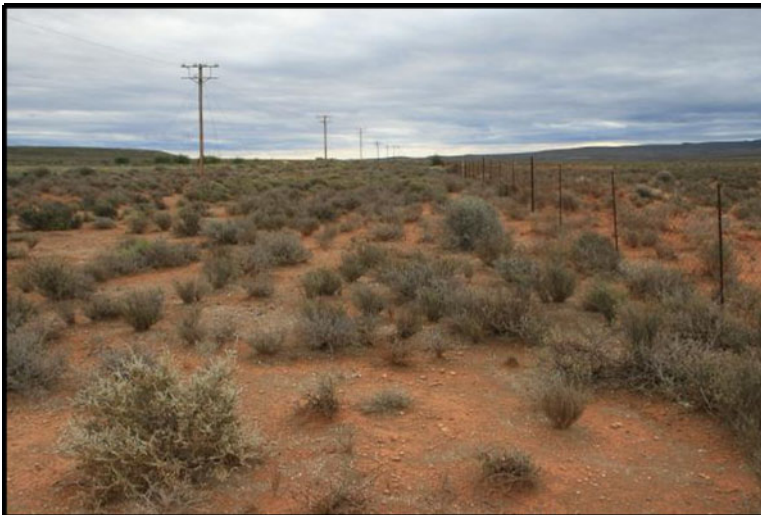
**Figure 15.** The Hantam Karoo vegetation on dolerite-derived soil at the boundary between Matjiesfontein Farm and the R27 road reserve.

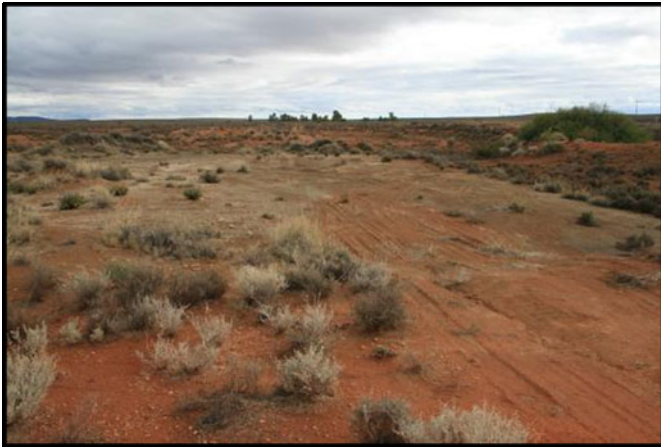
Borrow Pit 5 is extensively disturbed and has rehabilitated to a limited extent in certain parts. The disturbance has encouraged the invasion of exotic invasive species such as *Prosopis glandulosa*. The site is located in an area of Hantam Karoo 'bossieveld' (*Eriocephalus ericoides* – *Pteronia glomerata* Roggeveld Karoo according to Van der Merwe *et al.* 2008b) dominated by low succulent shrubs and composites such as *Pentzia incana*, *Eriocephalusericoides* and *Chrysocoma ciliata*. It has 'Least Threatened' conservation status (Rouget *et al.* 2004). There is little concern about the extension of this borrow pit and the potential impact is rated as MEDIUM NEGATIVE and with

**Figure 16.** Borrow pit 5 which presently covers an extensive area would be extended southwards and also made deeper in places.

mitigation i.e. smoothing of the disturbed surfaces to provide a graded landscape for re-colonisation of the shrubland, the impact can be mitigated to LOW NEGATIVE.

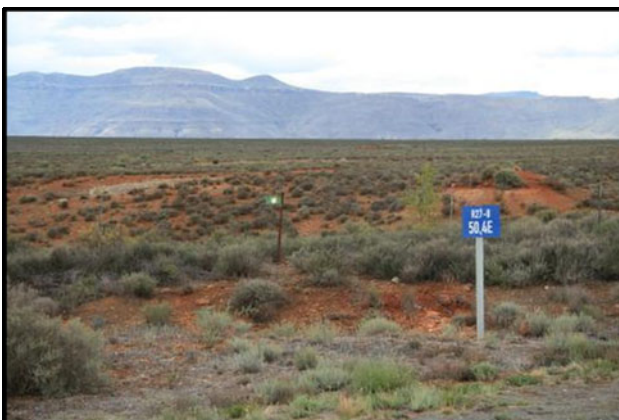
**Figure 17.** The existing borrow pit (BP6) would be extended northwards into undisturbed Hantam Karoo veld.

Borrow Pit 6 is located close to the R27 road on the north side approximately 20 km west of Calvinia in Hantam Karoo vegetation (*Eriocephalus ericoides* – *Pteronia glomerata* Roggeveld Karoo according to Van der Merwe *et al.* 2008b). The disturbed area of the existing borrow pit has restored to a limited extent. The proposal is to extend the excavation northwards and as for Borrow Pit 5 there is little concern about the extension of this borrow pit. The anticipated impact is rated as MEDIUM NEGATIVE and with mitigation i.e. smoothing of the disturbed surfaces to provide a graded landscape for re-colonisation of the shrubland, the impact can be mitigated to LOW NEGATIVE.

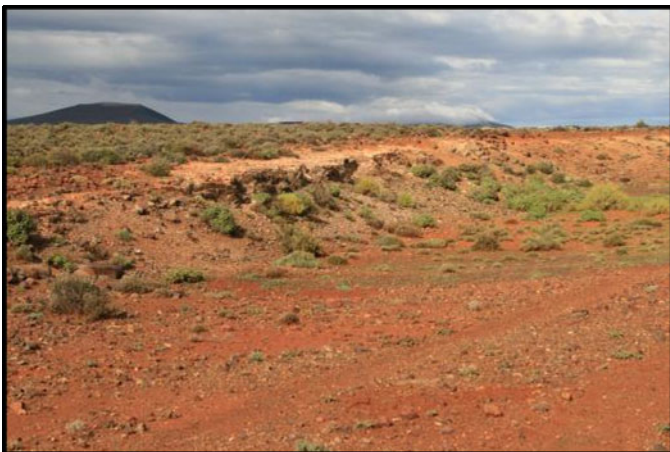
**Figure 18.** View of Borrow Pit 7 looking south-east. It would be extended further south-eastwards and southwards

Borrow Pit 7 is near and to the south-west of the Calvinia Airfield. It is on an undulating plain but more specifically the existing pit has been excavated into a small rise. The geology is weathered dolerite and calcrete. The proposed extension would be southwards and south-eastwards and would impact low succulent Hantam Karoo shrubland of the Calvinia Mosaic but more specifically the *Eriocephalus ericoides* – *Pteronia glomerata* Roggeveld Karoo since the substrate is doleritic (see Van der Merwe *et al.* 2008b). Species include *Asparagus capensis*, *Aptosimum indivisum*, *Atriplex lindleyi* subsp. *inflata*, *Crassula* sp., *Eriocephalus ericoides*, *Felicia cf. muricata*, *Gethyllis* sp., *Mesembryanthemum guerichianum*, *Pentzia incana*, *Psilocalon junceum*, *Ruschia* sp. (spine-tipped leaves) and *Ruschia* sp. 2.

The area around the existing borrow pit is already disturbed and since the vegetation is very extensive in this region and has a Least Threatened conservation status, extension of the borrow pit would result in an impact with MEDIUM NEGATIVE significance.

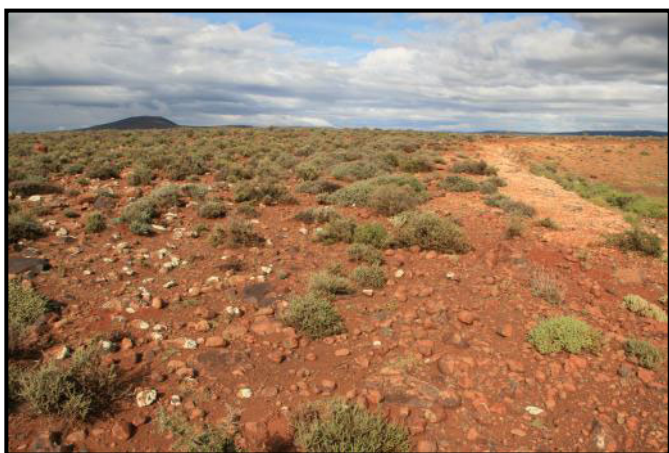
**Figure 19.** The edge of the existing Borrow Pit 7 on the east side. The vegetation has a high concentration of low succulents.

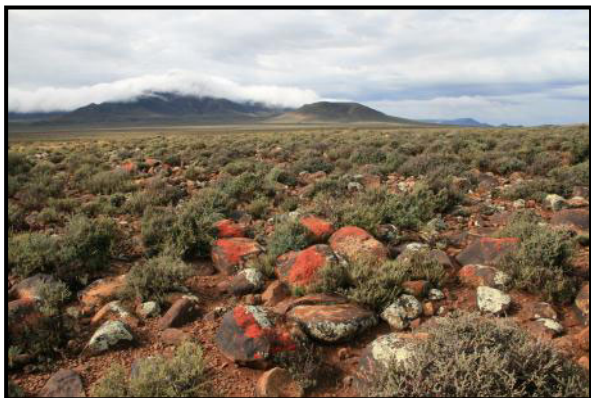
**Figure 20.** Dolerite boulders of various sizes, some covered with red and green lichen, litter the surface of the area where BP7 would be extended.

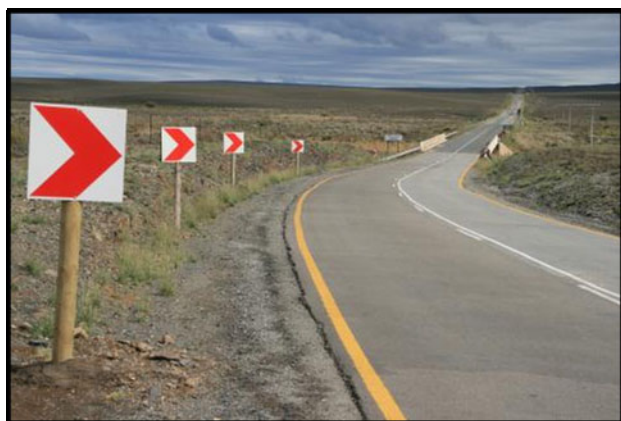
**Figure 21.** Approach to Bridge 3 on the east side. The vegetation near the bridge is as highly disturbed as the road reserve vegetation in the vicinity.

At Bridge 1 (S 31° 28' 34.68" E 19° 18' 57.23") and Bridge 3 (S 31° 30' 18.87" E 19° 41' 38.8"), the bridges have very little influence on the vegetation in the road reserve, with the vegetation being as disturbed as elsewhere in the road reserve in the vicinity of the bridges (Figure 21). At Bridge 2 (S 31° 29' 17.53" E 19° 26' 25.53") *Salsola aphylla* forms dense stands in the road reserve up to the bridge on the west side (Figure 22) whereas on the east side the roadside vegetation is a disturbed collection of weedy species on the south side and a cleared lay-by on the north side (Figure 23). Bridge 4 (S 31° 28' 46.06" E 19° 46' 13.85") is at the entrance to Calvinia and the vegetation around the bridge structure consists mainly of weedy species due to intense disturbance (Figure 24).

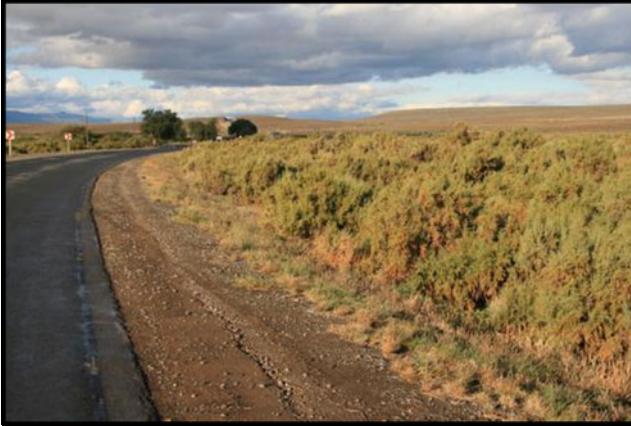
**Figure 22.** West side of bridge near Soetwater and Toekoms (Bridge 2) with dense *Salsola aphylla* in the road reserve.

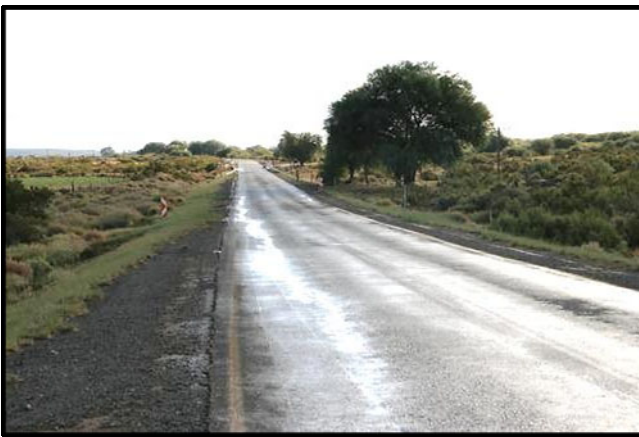
**Figure 23.** East side of Bridge 2 with disturbed road reserve colonised by weedy species. On the right hand side is a lay-by under the large thorn-tree.

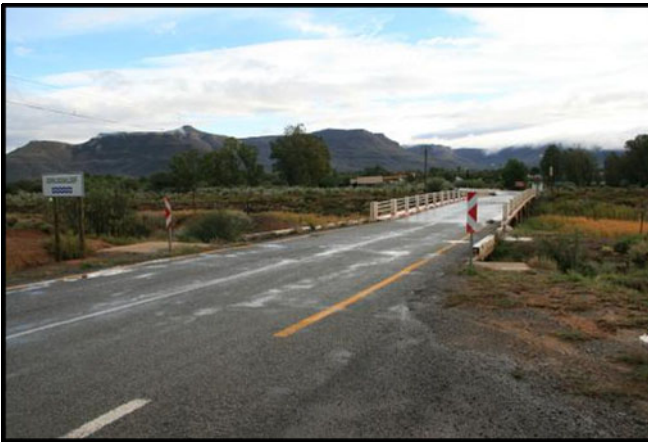
**Figure 24.** The entrance to Calvinia at the Oorlogskloof River crossing (Bridge 1). The area around the bridge at both ends is highly disturbed.
