# The **BLOODHOUND** Project

## **TECHNICAL REPORT**

WATER USE LICENCE APPLICATION

April 2017

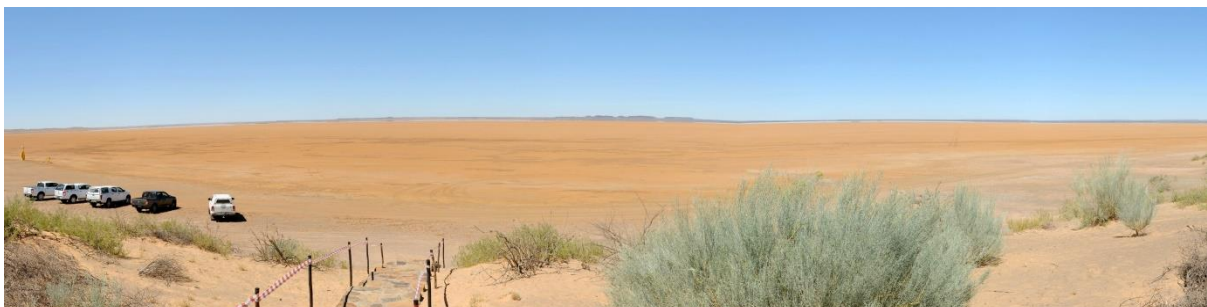
**Figure 1** Hakskeenpan

Following an extensive search for a suitable site for the speed record attempt all over the globe, Hakskeenpan (Figure 1) in the Northern Cape was selected. The Northern Cape Provincial Government embraced the Bloodhound SCC project. It now gained prominence as an item in the official provincial Integrated Development Plan (IDP).

Hakskeenpan is flat (Figure 1). Among other flat places on the planet, Hakskeenpan draws the attention as being even larger and flatter. The wide expanse of flatness makes it ideal for an attempt on the world land speed record.

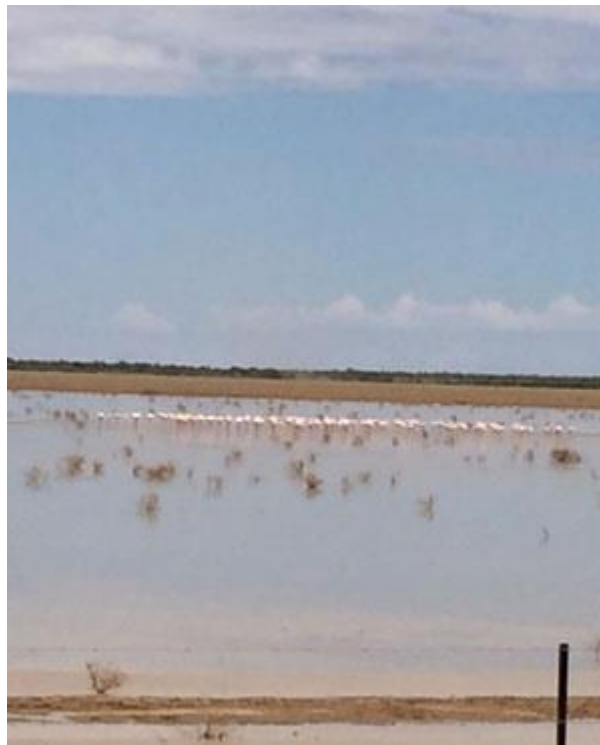
**Figure 2** Hakskeenpan Flooded

Hakskeenpan and its catchment (watershed) are subject to occasional heavy thunderstorms. The pan subsequently floods with standing water (Figure 2) that may last for several weeks before all of it finally evaporates because of the intense desert heat. When it floods a unique and vibrant aquatic life with an intricate food web comes into being, of which the survival forms retract into the pan's soils during the prolonged arid phase. Scientifically there is very little if anything at all known about these aquatic life forms in Hakskeenpan.

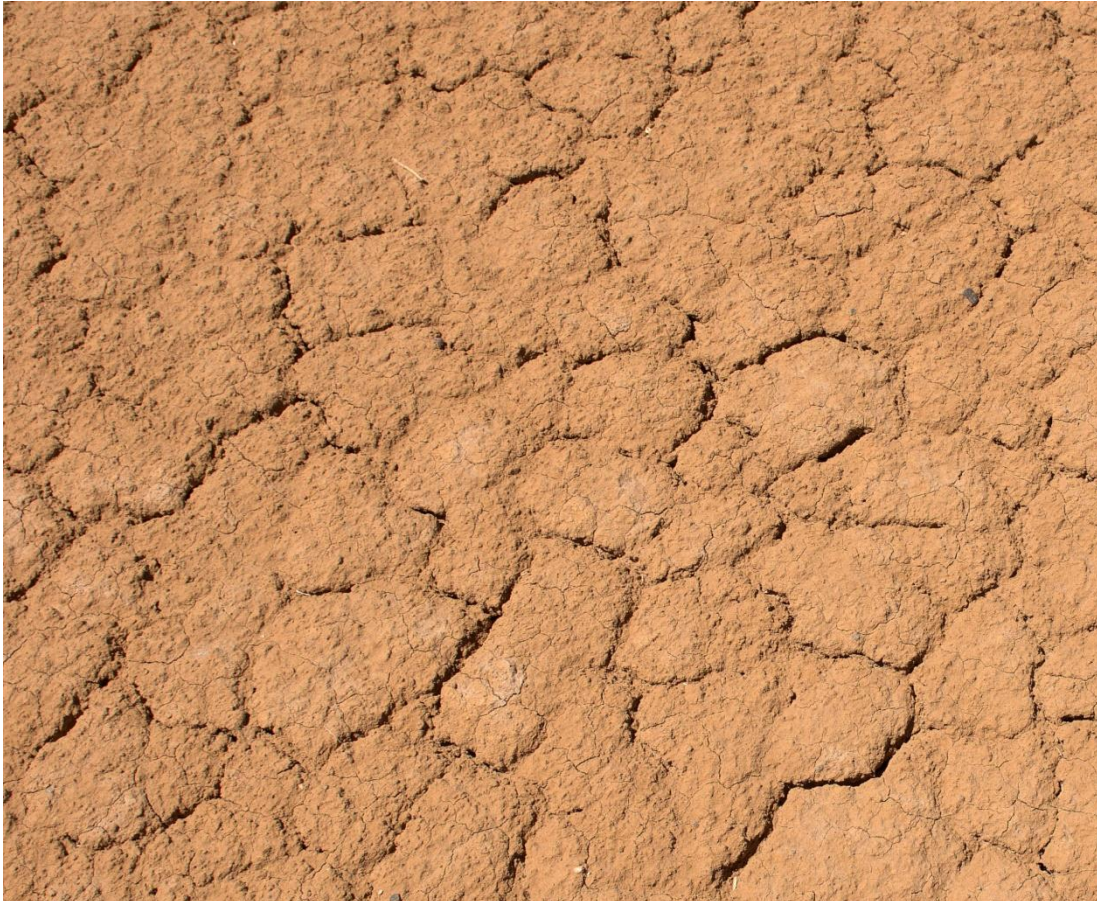
**Figure 4** Cracked Soil

The shallow soils of Hakskeenpan are derived from weathered tillite. When dry these soils typically crack (Figure 4). It feels spongy under foot. These are not the soils that have been described for temporary wetlands. It is a soil specific to the ephemeral pans of the Northern Cape, such as Hakskeenpan.

The soil at Hakskeenpan forms a efflorescent crust at the surface and when dry cracks appear (Figure 4). These cracks are some 2 cm deep. It is surmised that these cracks play an important part in the ecology of the pan. It is speculated that dormant spores and eggs of life forms end up in these cracks, where they are further mixed in with the soil and where they survive until the next wet cycle.

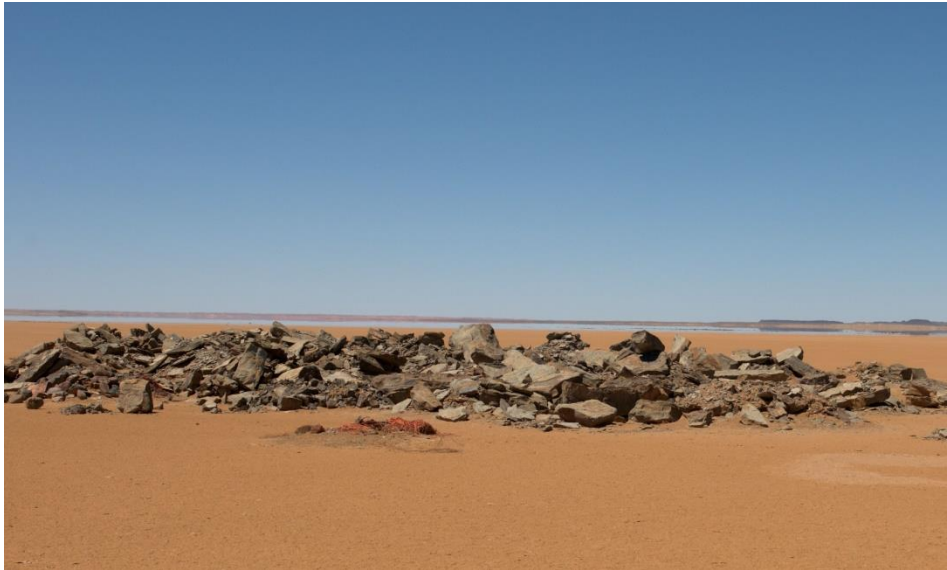
**Figure 6** Larger rocks to be removed from the track

According to press reports some 16 tons of stones have been manually collected from the track. Bigger rocks (Figure 6) were moved with earth moving machinery. This is probably an ongoing exercise, as new stones emerge from under the surface. The question arises if the removal of these stones can have any detrimental impact on the aquatic environment.

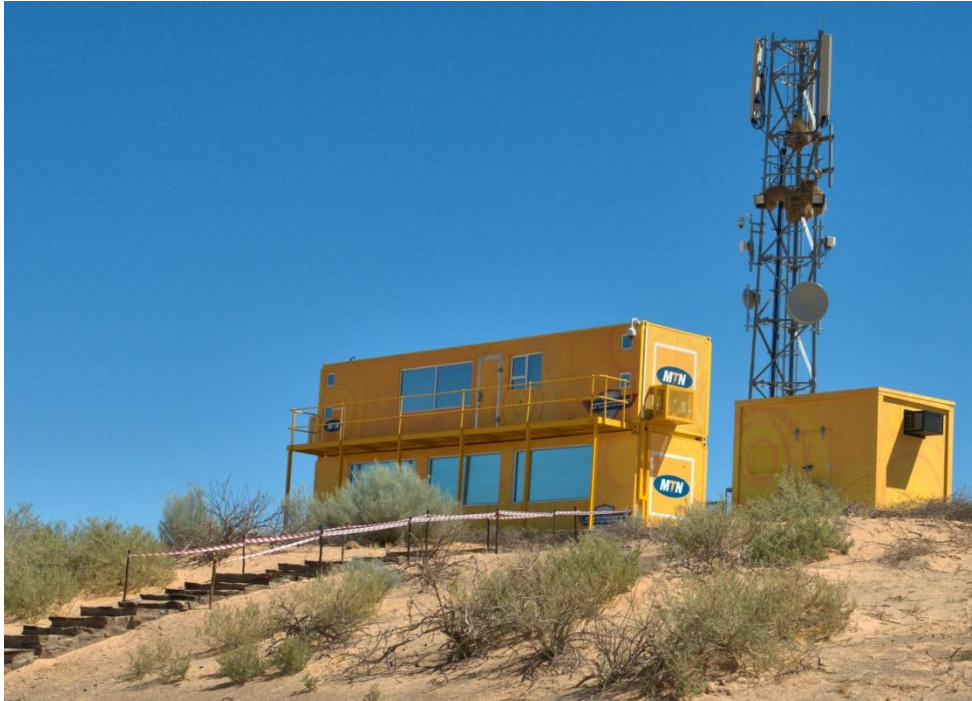
**Figure 8** Speedweek Complex

Borehole water is piped over a distance of 17 km from private land adjacent to the pan to holding tanks at the Speedweek complex (Figure 8).

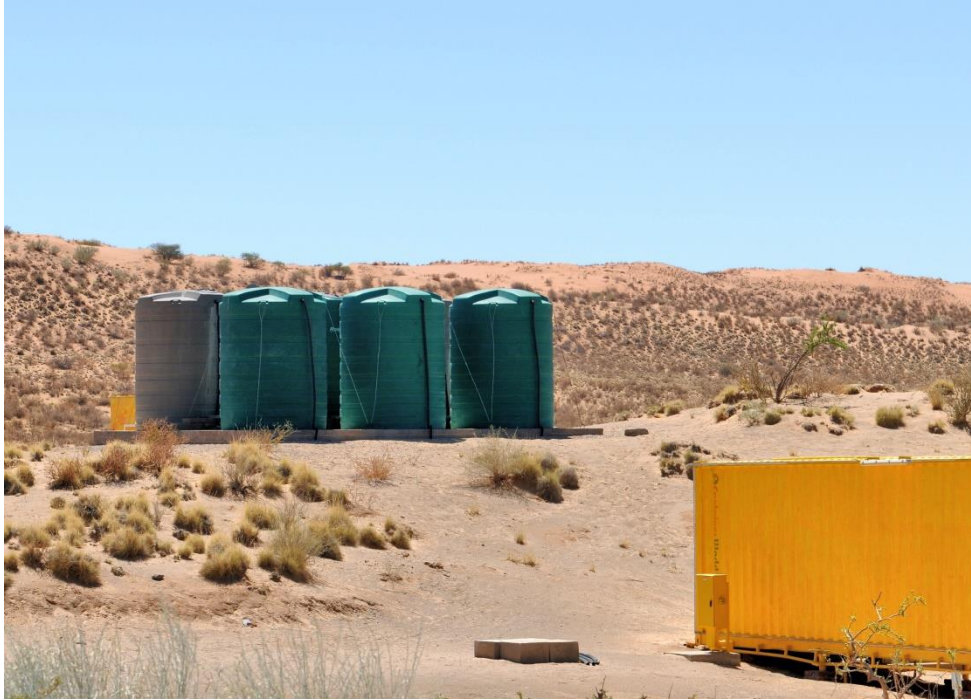
**Figure 9** Water tanks

There are already 6 water tanks at the Speedweek site. Bloodhound is to add another 12. These tanks have a holding capacity of 5000 litres each.

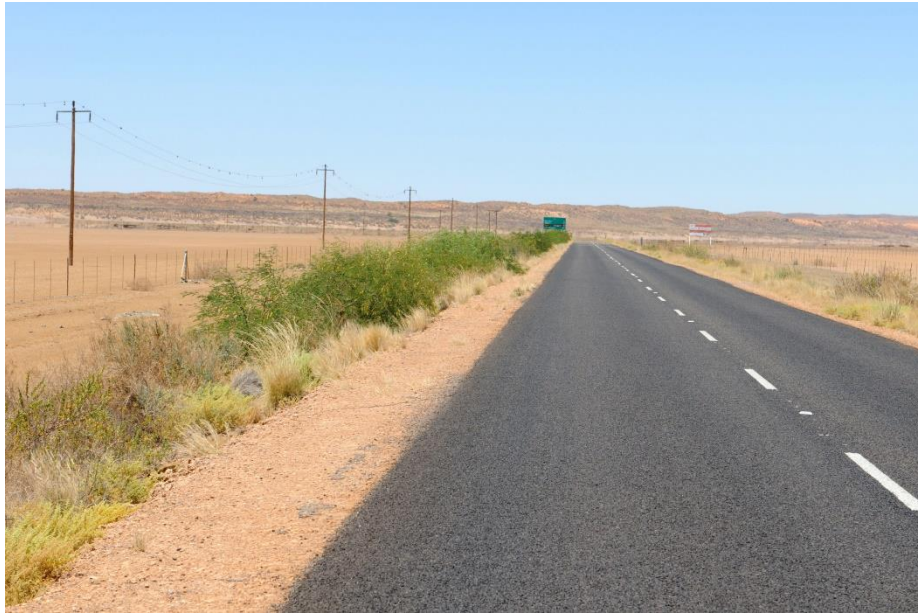
**Figure 10** R31 Trunk Road

The R31 trunk road (Figure 10) from Mier across the pan to Rietfontein on the Namibian border probably had and still has a larger environmental and especially limnological impact than the combined impact of the entire Bloodhound project. The road bisects the pan and cuts off the north eastern portion of the pan from the rest. The road changed the preferential flow paths. It is unknown exactly what the impacts on the pan's ecology are and these aspects need to be clarified by long-term scientific research.

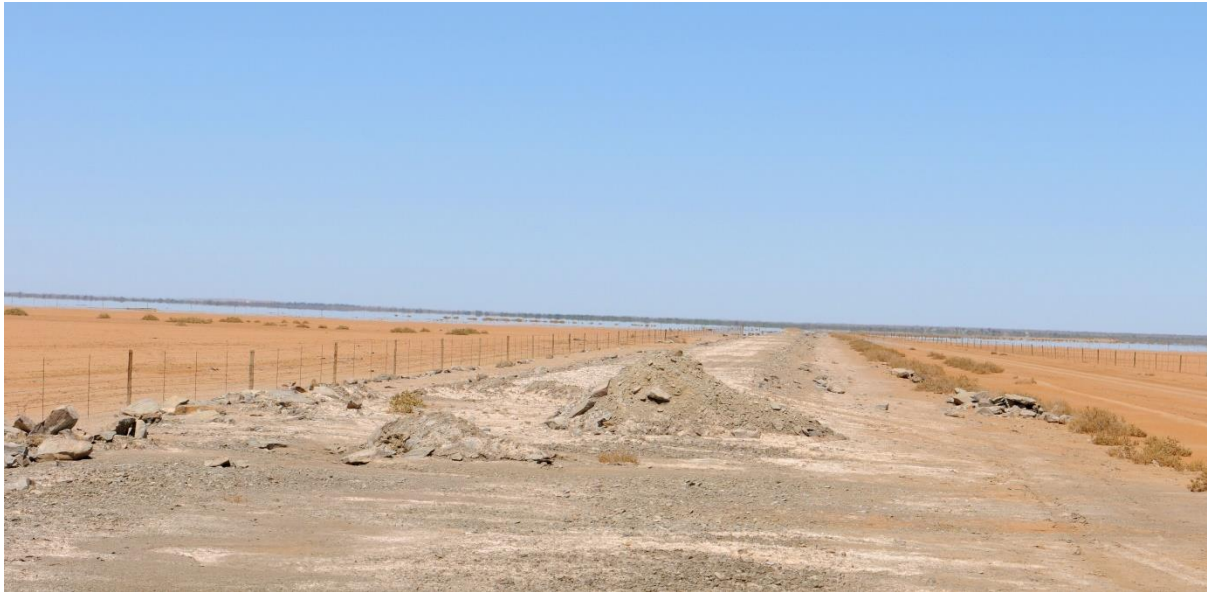
**Figure 11** Road Embankments

Likewise, the old and currently disused roads across the pan probably have a serious impact of which the proportions are not understood at present. The embankments are still evident all over the pan. These embankments have been broken through, probably manually, perhaps by flood water.

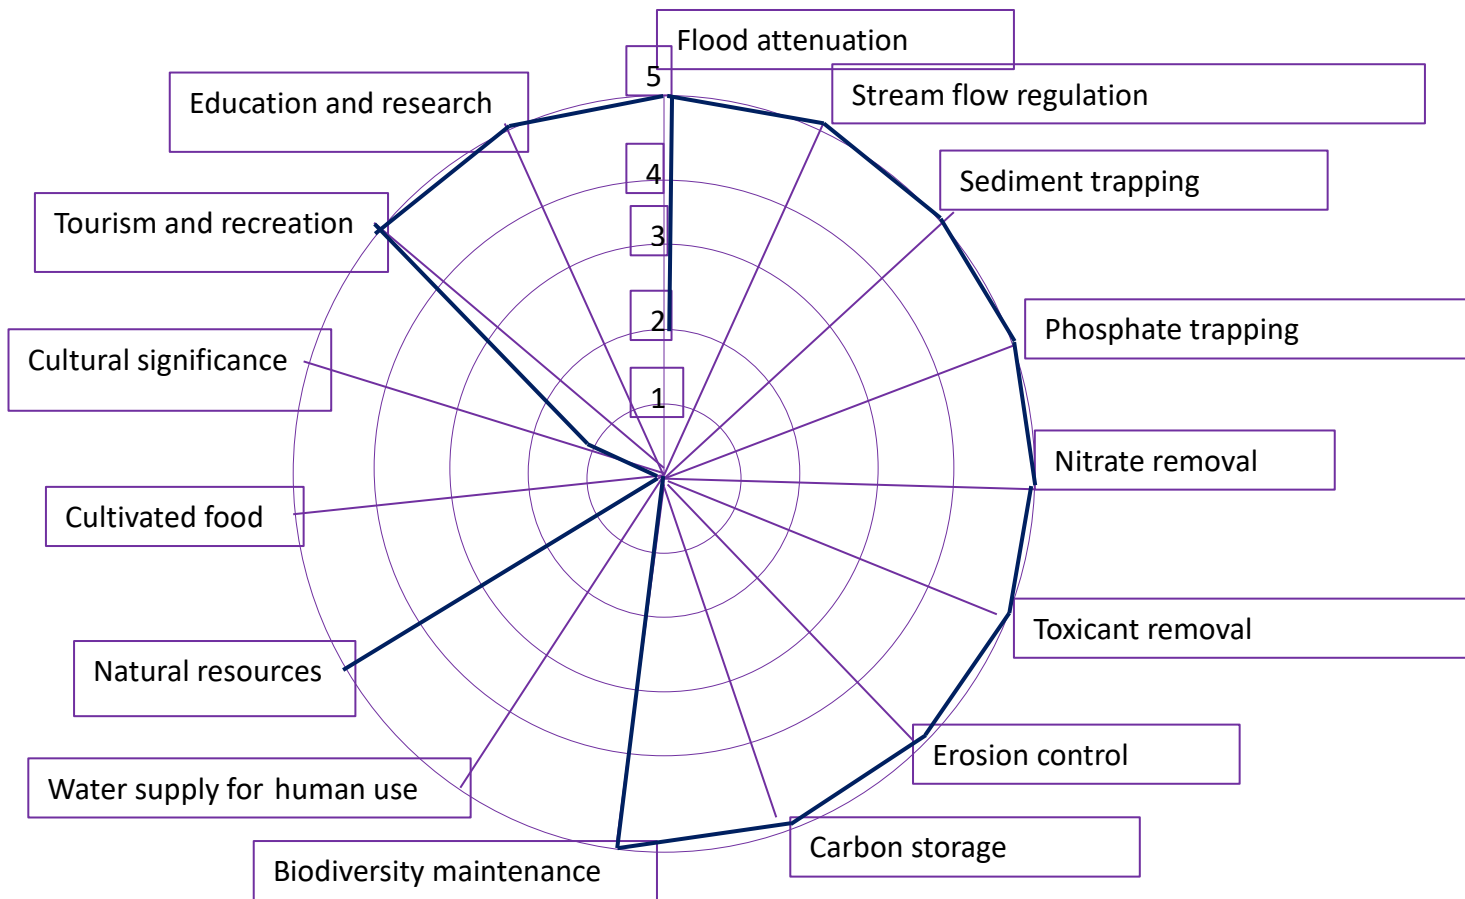
**Figure 12.** Resource Economics Footprint of Hakskeenpan

The diagram (Figure 12) is an accepted manner to visually illustrate the resource economic footprint the wetland.

The star shape is rather large, with a few “gaps” on the left hand side. The size will probably attract the attention of decision-makers, as it illustrates that Hakskeenpan is a significant resource with a notable conservation status.

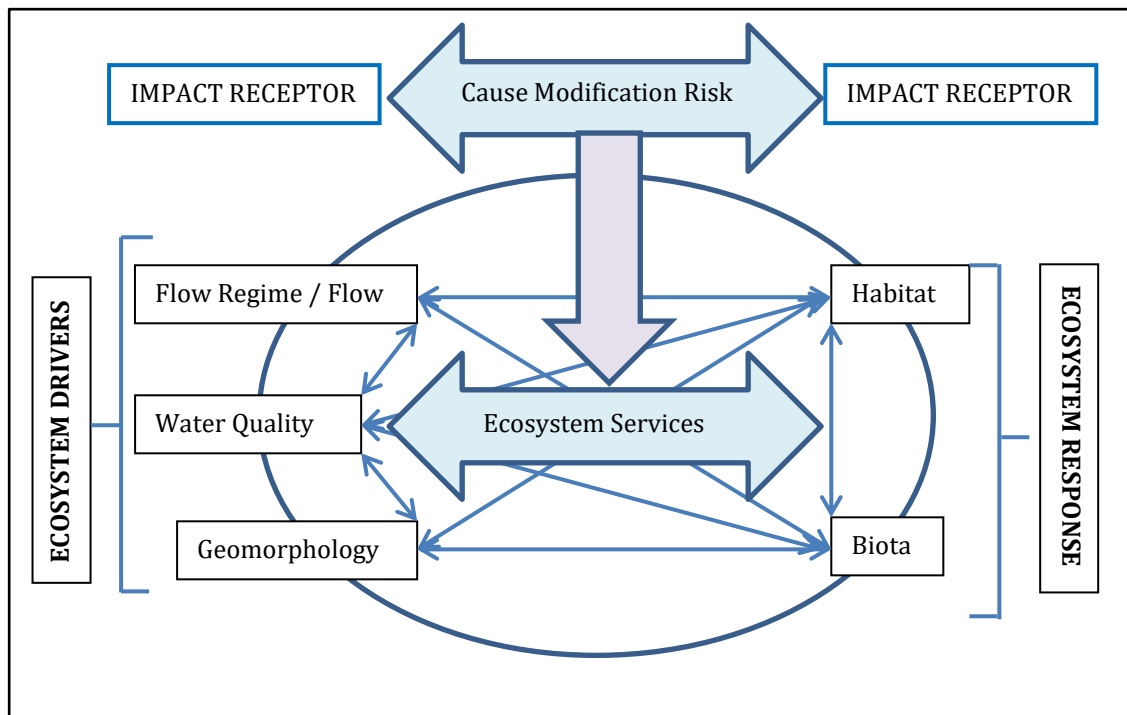
**Figure 13** Minimum Requirements for a S21(c) and (i) Application.

Figure 13 has been adapted from one of the most recent DWS policy documents.

An anthropogenic activity can impact on any of the ecosystem drivers or responses and this can have a knock-on effect on all of the other drivers and responses. This, in turn, will predictably impact on the ecosystem services. The WULA and the EAI must provide mitigation measured for these impacts.
