# The **BLOODHOUND** Project

## **FRESH WATER REPORT**

A requirement in terms of Section 21 (c) and (i)  
of the  
National Water Act (36 of 1998)

November 2016

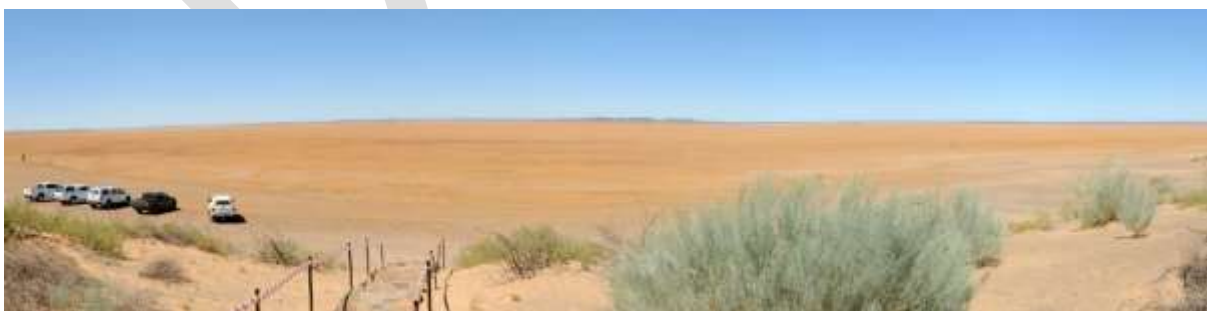
**Figure 1** Hakskeenpan

Following an extensive search for a suitable site for the speed record attempt all over the globe, Hakskeenpan (Figure 1) in the Northern Cape was selected. The Northern Cape Provincial Government embraced the Bloodhound SCC project. It now gained prominence as an item in the official provincial Integrated Development Plan (IDP).

Hakskeenpan is flat (Figure 1). Among other flat places on the planet, Hakskeenpan draws the attention as being even larger and flatter. The wide expanse of flatness makes it ideal for an attempt on the world land speed record.

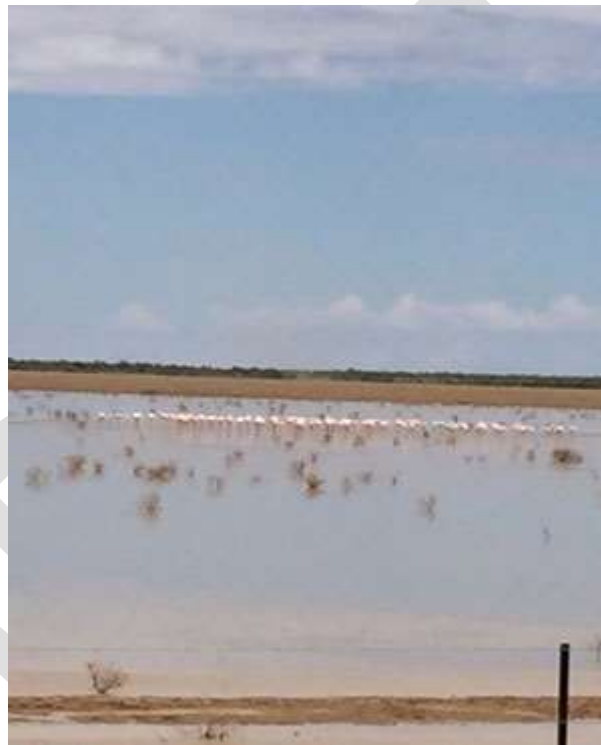
**Figure 2** Hakskeenpan Flooded

Hakskeenpan and its catchment (watershed) are subject to occasional heavy thunderstorms. The pan subsequently floods with standing water (Figure 2) that may last for several weeks before all of it finally evaporates because of the intense desert heat. When it floods a unique and vibrant aquatic life with an intricate food web comes into being, of which the survival forms retract into the pan's soils during the prolonged arid phase. Scientifically there is very little if anything at all known about these aquatic life forms in Hakskeenpan.

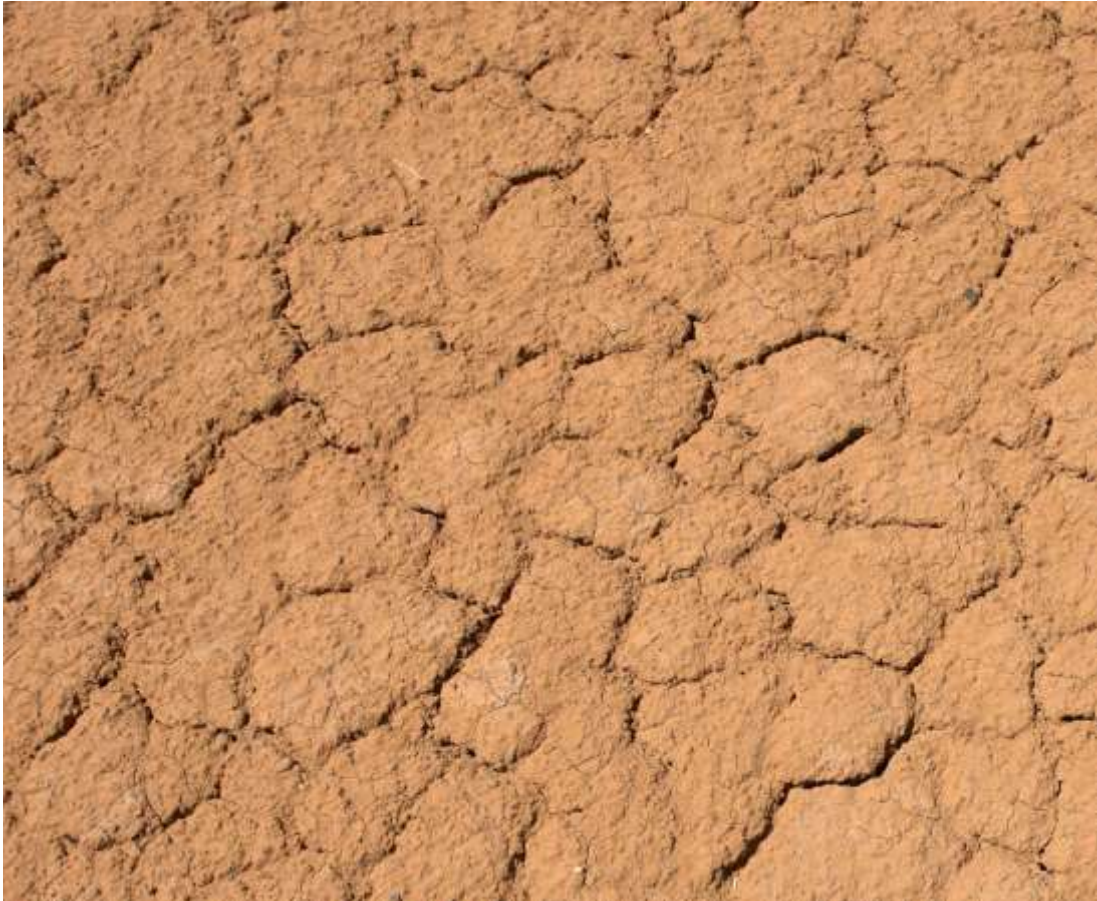
**Figure 4** Cracked Soil

The shallow soils of Hakskeenpan are derived from weathered tillite. When dry these soils typically crack (Figure 4). It feels spongy under foot. These are not the soils that have been described for temporary wetlands. It is a soil specific to the ephemeral pans of the Northern Cape, such as Hakskeenpan.

The soil at Hakskeenpan forms a crust at the surface and when dry cracks appear (Figure 4). These cracks are some 2 cm deep. It is surmised that these cracks play an important part in the ecology of the pan. It is speculated that dormant spores and eggs of life forms end up in these cracks, where they are further mixed in with the soil and where they survive until the next wet cycle.

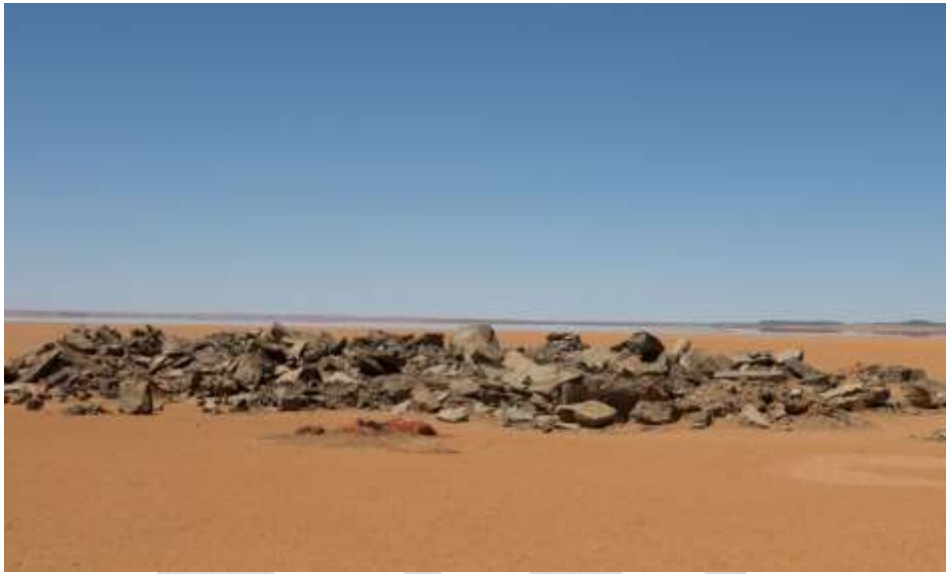
**Figure 6** Larger rocks to be removed from the track

According to press reports some 16 tons of stones have been manually collected from the track. Bigger rocks (Figure 6) were moved with earth moving machinery. This is probably an ongoing exercise, as new stones emerge from under the surface. The question arises if the removal of these stones can have any detrimental impact on the aquatic environment.

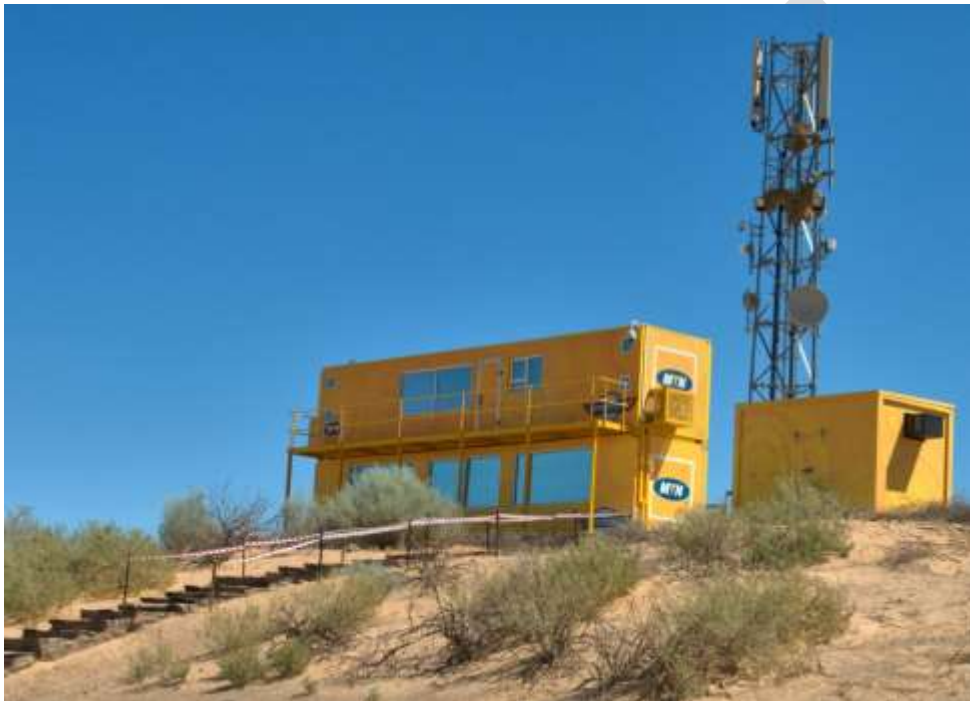
**Figure 8** Speedweek Complex

Borehole water is piped over a distance of 17 km from private land adjacent to the pan to holding tanks at the Speedweek complex (Figure 8).

This pipe does not cross the actual pan.

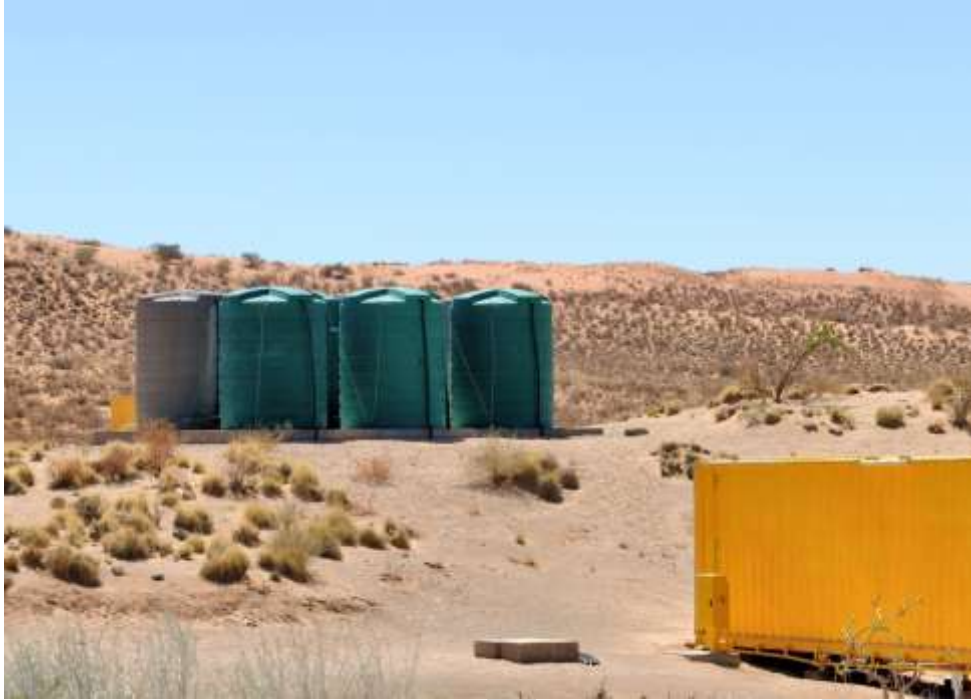
**Figure 9** Water tanks

There are already 6 water tanks at the Speedweek site. Bloodhound is to add another 12. These tanks have a holding capacity of 5000 litres each.

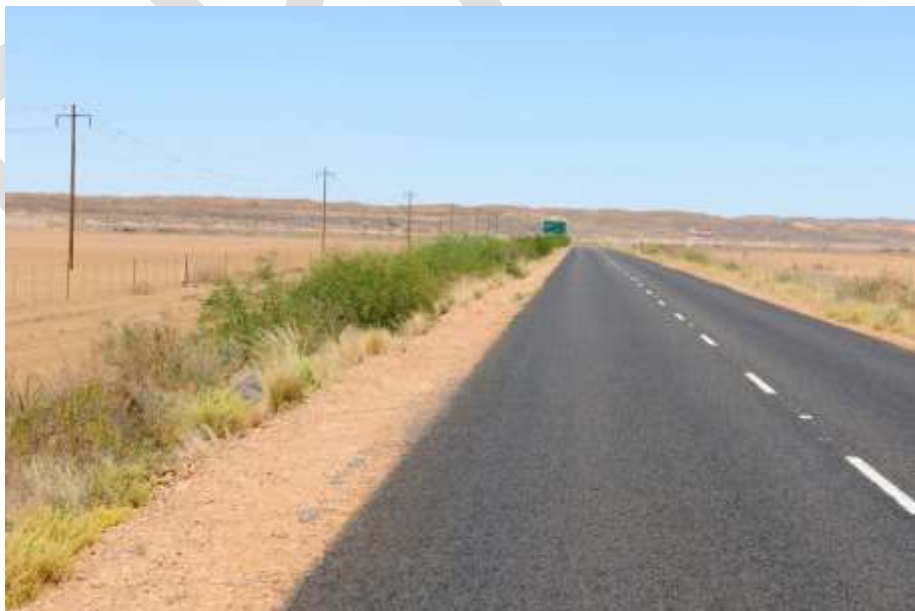
**Figure 10** R31 Trunk Road

The R31 trunk road (Figure 10) from Mier across the pan to Rietfontein on the Namibian border probably had and still has a larger environmental and especially limnological impact than the combined impact of the entire Bloodhound project. The road bisects the pan and cuts off the north eastern portion of the pan from the rest. The road changed the preferential flow paths. It is unknown exactly what the impacts on the pan's ecology are and these aspects need to be clarified by long-term scientific research.

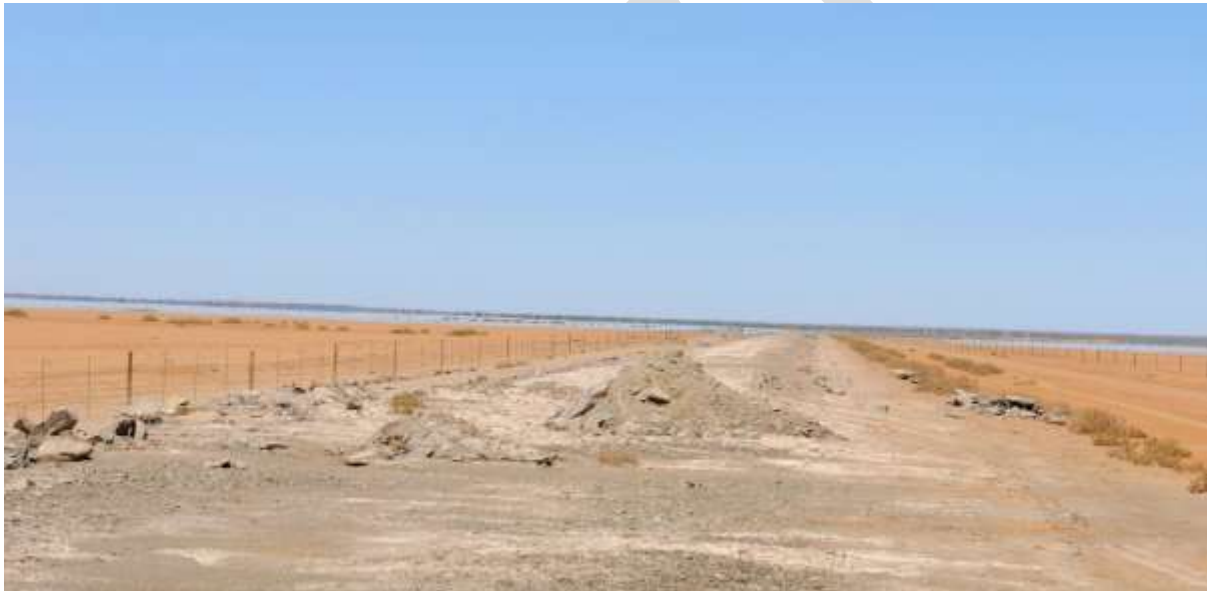
**Figure 11** Road Embankments

Likewise, the old and currently disused roads across the pan probably have a serious impact of which the proportions are not understood at present. The embankments are still evident all over the pan. These embankments have been broken through, probably manually, perhaps by flood water.
