MT ROPER, PORTION FARM 321: SOLAR ENERGY FACILITY

VISUAL ASSESSMENT

Final Report

11 May 2012

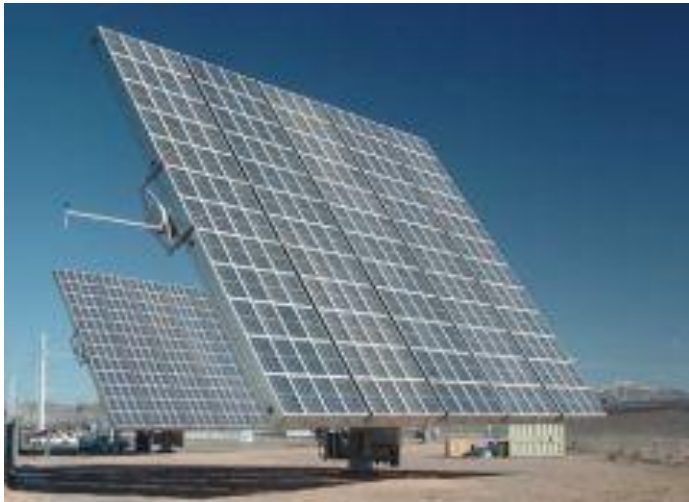
Figure 4: Typical CPV Unit

Construction of Solar energy production facility ("Solar Farm") with a maximum capacity of 10Megawatt, consisting of approximately 140 tracking CPV units, on approximately 20ha. The exact technology to be used has not been determined and this assessment is based on the following typical parameters. Units are typically positioned in rows with access roads between every second row. Unit spacing typically varies between 43x37 and 33x30m.

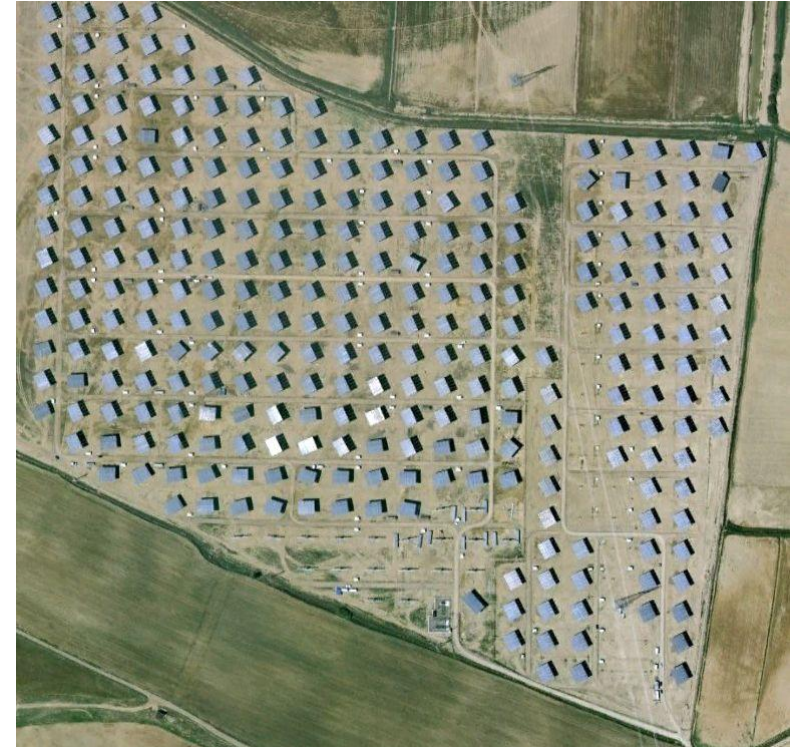
Figure 3: Typical Solar Farm layout

The Solar Farm includes supportive infrastructure which consists of 2 -4 concrete transformer pads approximately 20x15m respectively, a fenced construction staging area, maintenance shed and a switch panel for connection to the grid and transmission lines from the transformers to the closest ESKOM substation.

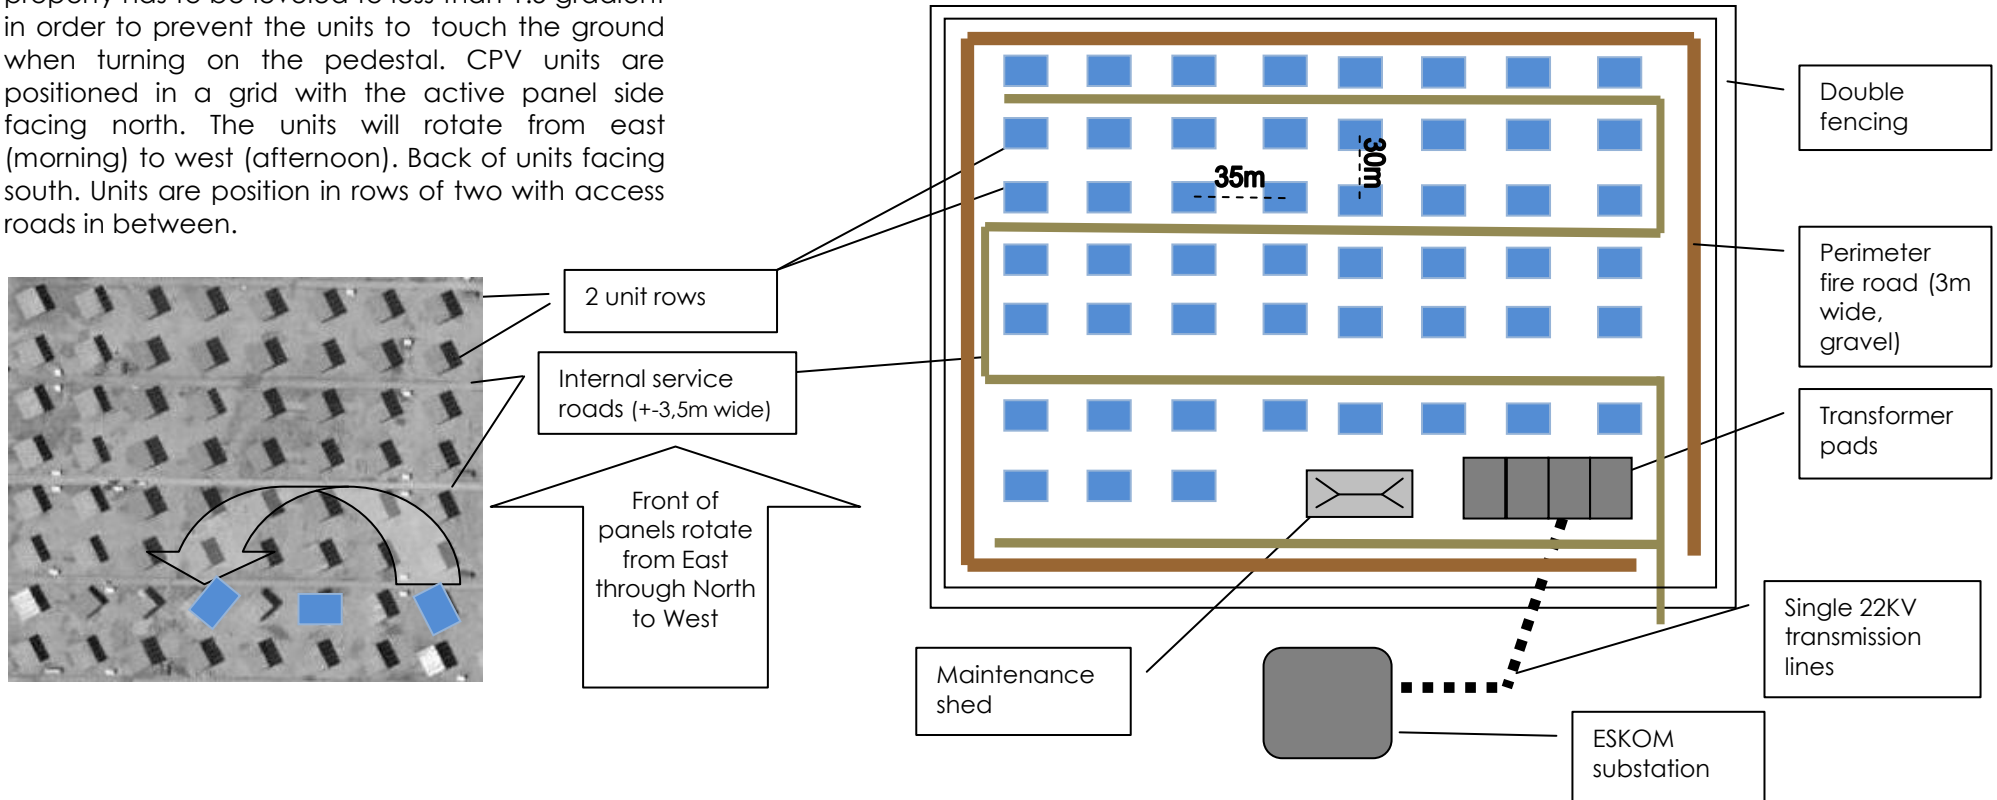
Figure 5: Typical Layout configuration

The Solar farm will occupy approximately 20ha. The nature of the tracking CPV units are such that the property has to be leveled to less than 1:5 gradient in order to prevent the units to touch the ground when turning on the pedestal. CPV units are positioned in a grid with the active panel side facing north. The units will rotate from east (morning) to west (afternoon). Back of units facing south. Units are position in rows of two with access roads in between.

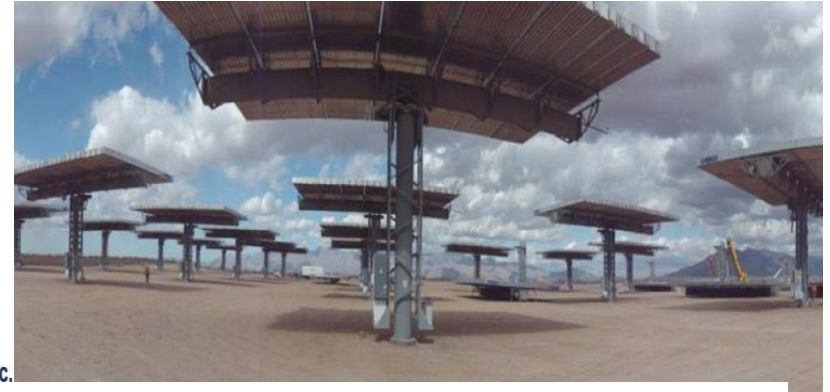
Figure 8: Night stow position

In the Night stow position it equals the facade of a 5 to 6 storey building

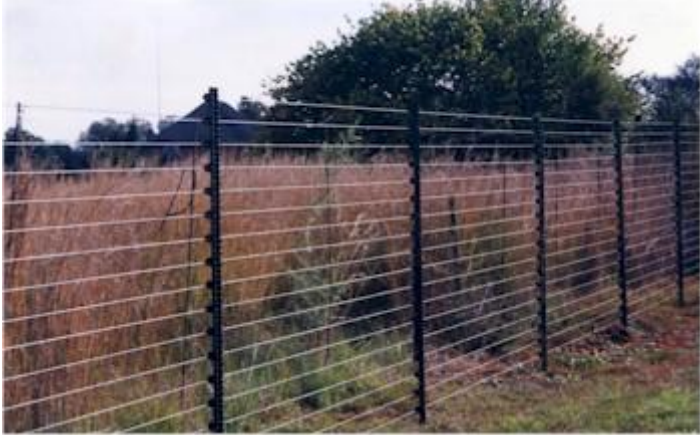
Figure 9: Typical electrical fence

Double fencing with inner fence consisting of galvanized palisade fence and outer an electrified fence of 2,4m in height.

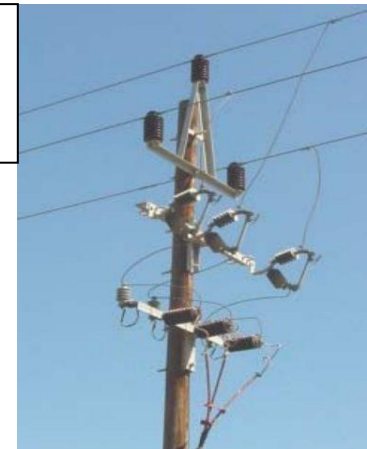
Figure 11: Typical 22KV single Power line

Single 22KV Power lines will feed from the transformers to the FSKOM

As the CPV units are across the road from the substation and therefore additional 22KV power lines will have to cross the R31. As long as these lines are combined with the alignment of the existing lines crossing the road it will have no significant additional visual impact.
