**ANGLO GOLD ASHANTI  
- MINE WASTE SOLUTIONS –  
KAREERAND TSF EXTENSION PROJECT**

**AQUATIC FAUNA IMPACT ASSESSMENT**

Report reference: **MWS/A/2017V3**  
Report status: **Final**

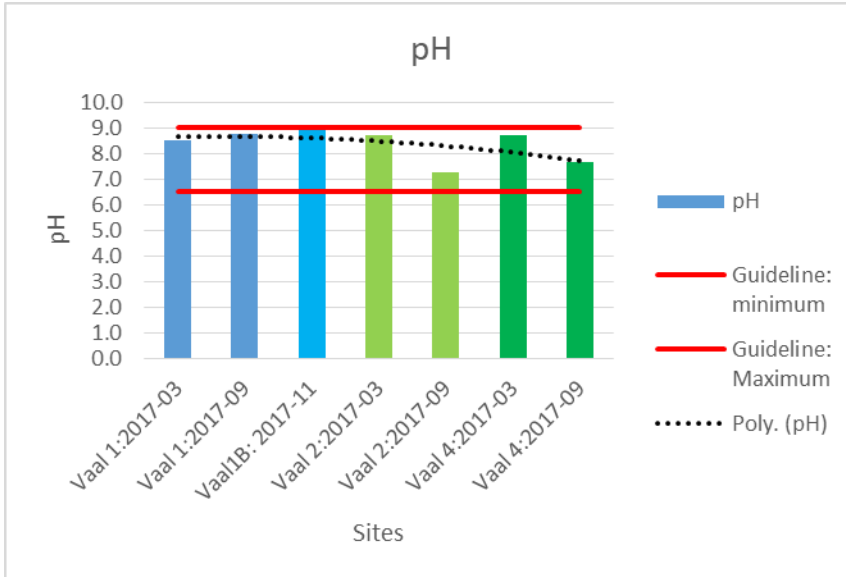
**Figure 4: pH measurements at selected sites in the Vaal River reach (2017 surveys)**

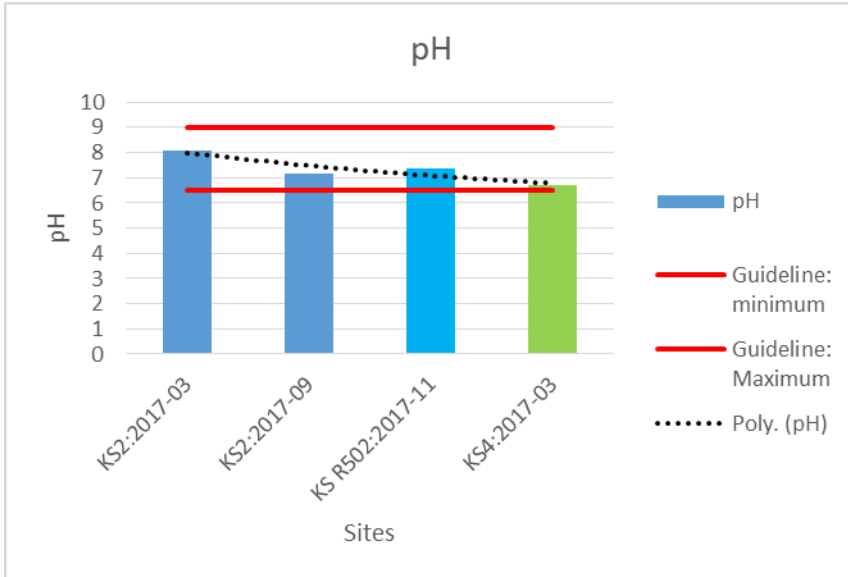
**Figure 7: pH measurements at selected sites in the Koekemoer Spruit reach (2017 surveys)**

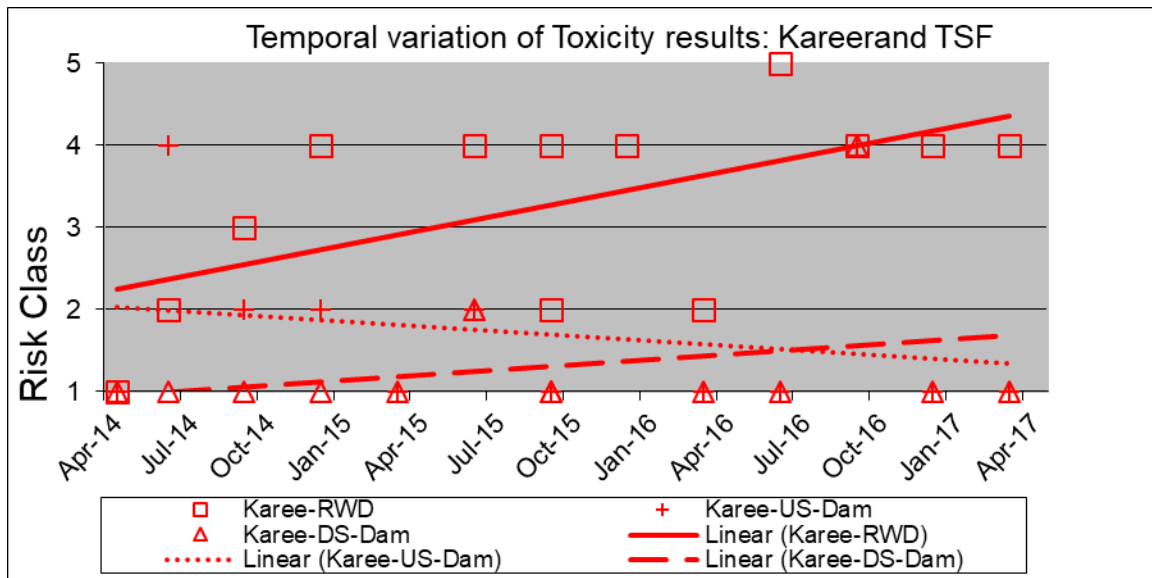
**Figure 9: Temporal results of environmental toxicity tests (risk class) at existing Kareerand TSF.**

The latest (September 2017) environmental toxicity testing survey indicated that the Kareerand operations return water dam (Karee-RWD) was of a very high acute/chronic environmental toxicity hazard (Class V), with a very high safe dilution ratio of 0.1% required to negate potential impacts. It appears that this hazard was largely mitigated at the time of sampling as the downstream dams measured no acute/chronic environmental toxicity hazard (Class I) at Karee-US-Dam and slight acute/chronic environmental hazard (Class II) at Karee-DS-Dam. Since the inception of toxicity testing at Kareerand TFS, hazards are consistently identified at Karee-RWD and Karee-US-Dam (Figure 9). It is however already clear that the hazards have mostly been negated at the most downstream pollution control dam (Karee-DS-Dam), which has only showed a few incidences of hazards since the onset of monitoring. High EC levels are also often measured at these sources (460 mS/m at site Karee-RWD during September 2017), indicating that they may be potential contributors to the high EC levels observed in the lower Kareerand tributary at site Karee-Vaal.
