Prepared by:
UMHLABA GEOTECHNICAL ENGINEERS

**GEOTECHNICAL INVESTIGATION REPORT FOR THE PROPOSED NEW SERVICE STATION AND
ASSOCIATED INFRASTRUCTURE AT KWAMBONAMBI, KWAZULU-NATAL**

DATE: 14 JULY 2022

REASON FOR ISSUE: FINAL GEOTECHNICAL INVESTIGATION REPORT

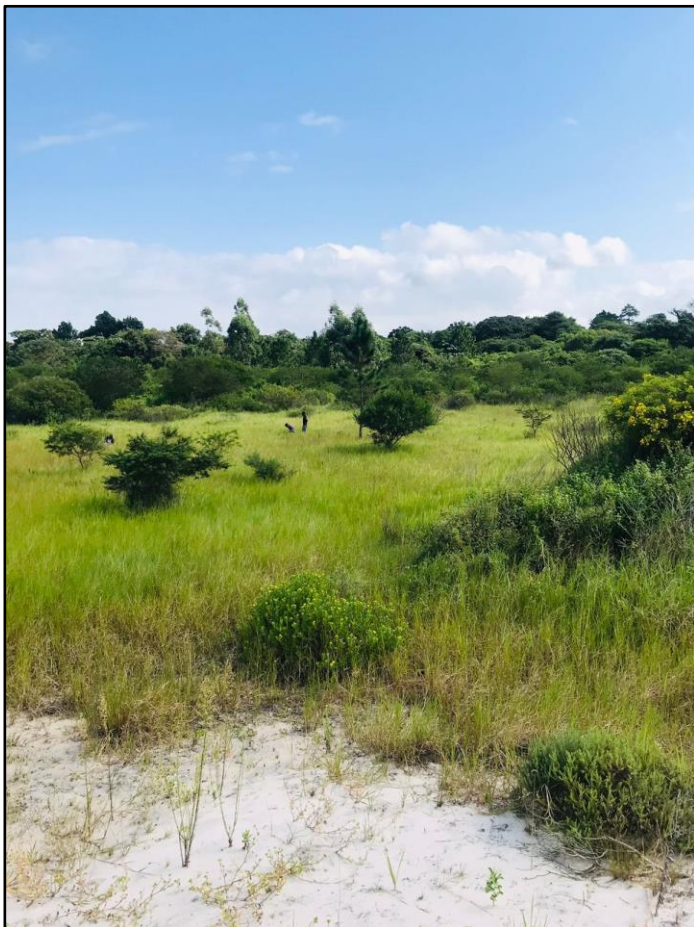
KwaMbonambi is approximately 30km north of Richards Bay. The proposed development area is to the west of N2 Road. At the time of the site investigation, there was no development on site, with the exception of informal crop farming that was noted on isolated areas of the site. The study area was predominately covered by dense vegetation and trees. The terrain on site was relatively flat, no steep slopes were observed (Figure 1).

Figure 1: General overview of the site.

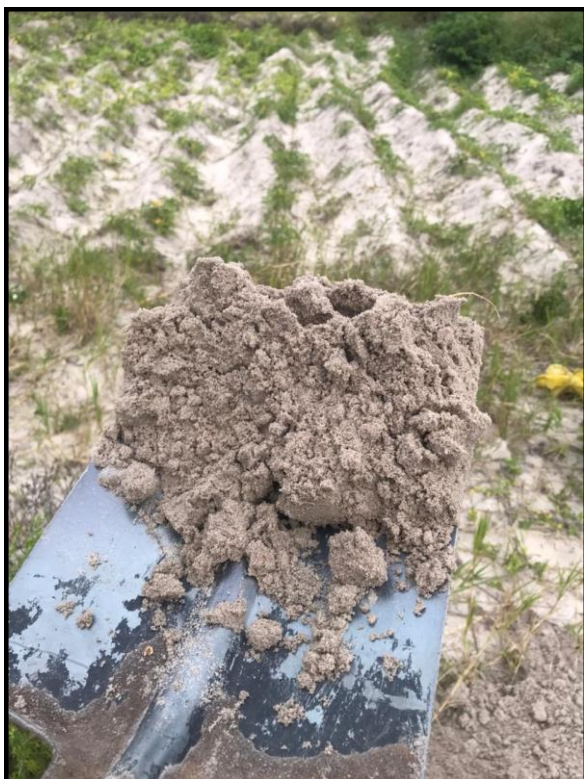
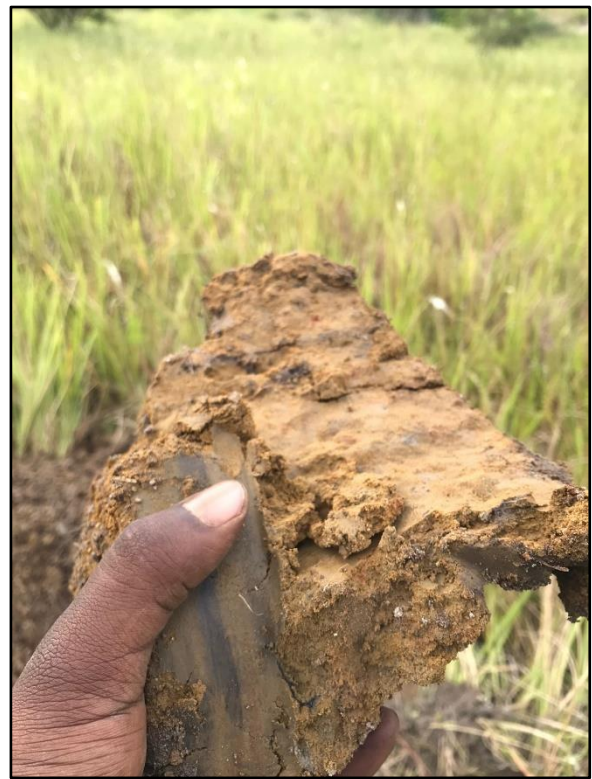
Aeolian horizon was noted through the upper profile of the excavated test pits. The material was intercepted from natural ground level down to a maximum depth of 2.50m BEGL. The horizon was profiled as moist/very moist, greyish pale brown/pale brown/dark grey, loose to medium dense with depth, silty fine grained sand/slightly silty fine grained sand with minor rootlets.

Alluvial horizon was generally noted to be overlain by aeolian horizon throughout the site. the material was intercepted from a minimum depth of 0.30m down to a maximum excavation depth 2.50m BEGL. The horizon was profiled as moist, reddish orange speckled orange/yellowish orange mottled red, soft/ firm to stiff with depth, intact, slightly silty clay.

Figure 3: (a) Sandy aeolian material (b) clayey alluvial material.

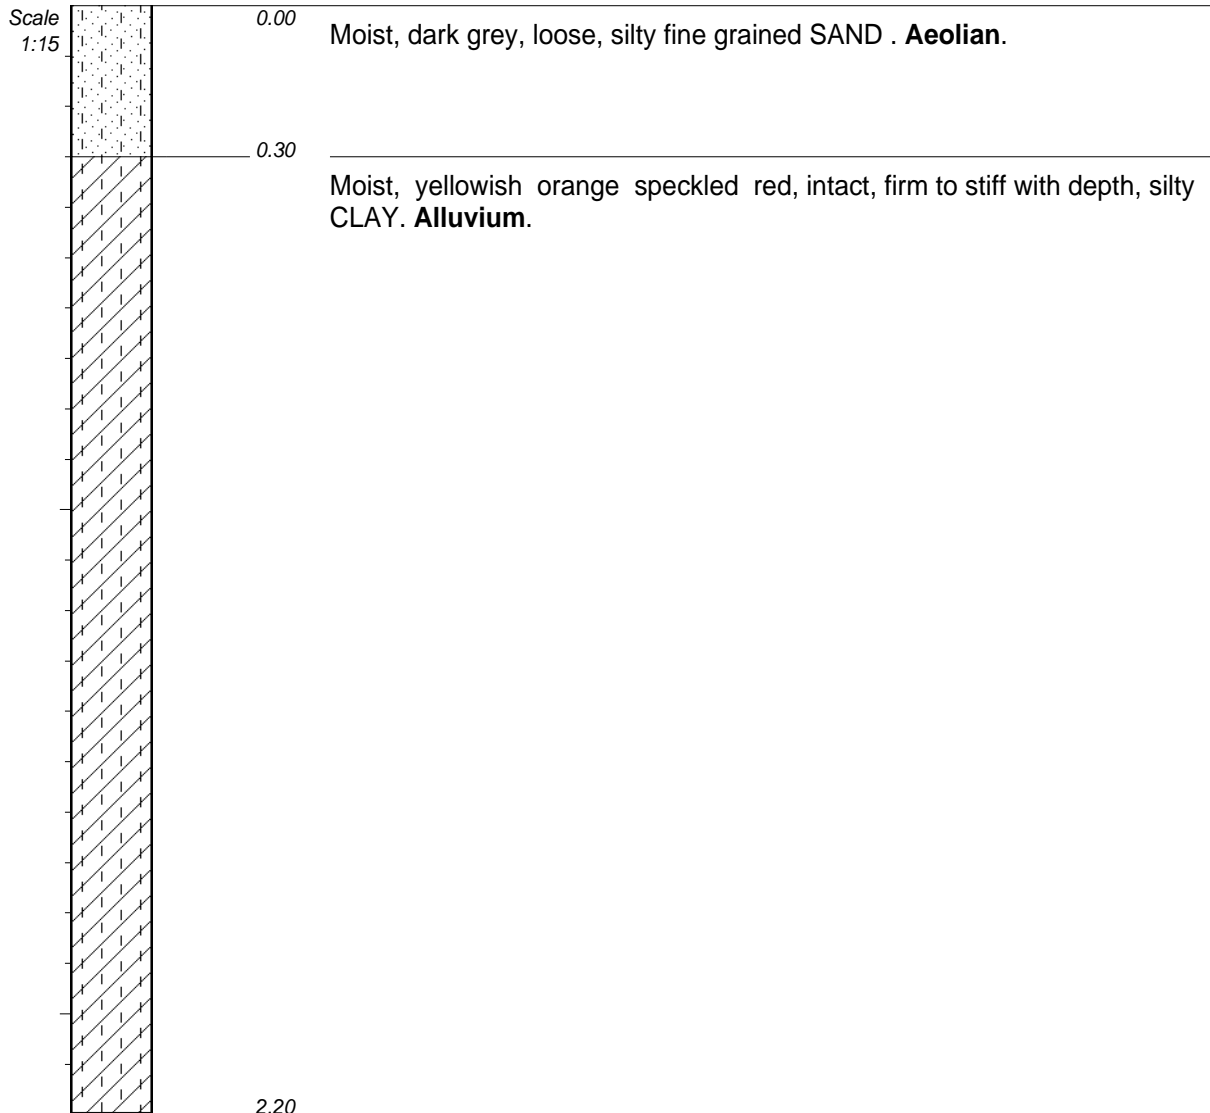
- 1) No sample taken.
- 2) No groundwater seepage noted.
- 3) Hand auger refused at 2.20m.

Moist, yellowish orange speckled red, intact, firm to stiff with depth, silty CLAY. **Alluvium.**
