**REPORT DVH-20-28 REV.2**

**GEOTECHNICAL INVESTIGATION FOR TOWNSHIP REZONING,  
ACORN CITY URBAN MIXED-USE DEVELOPMENT**

**GEOTECHNICAL REPORT**

**February 2022**

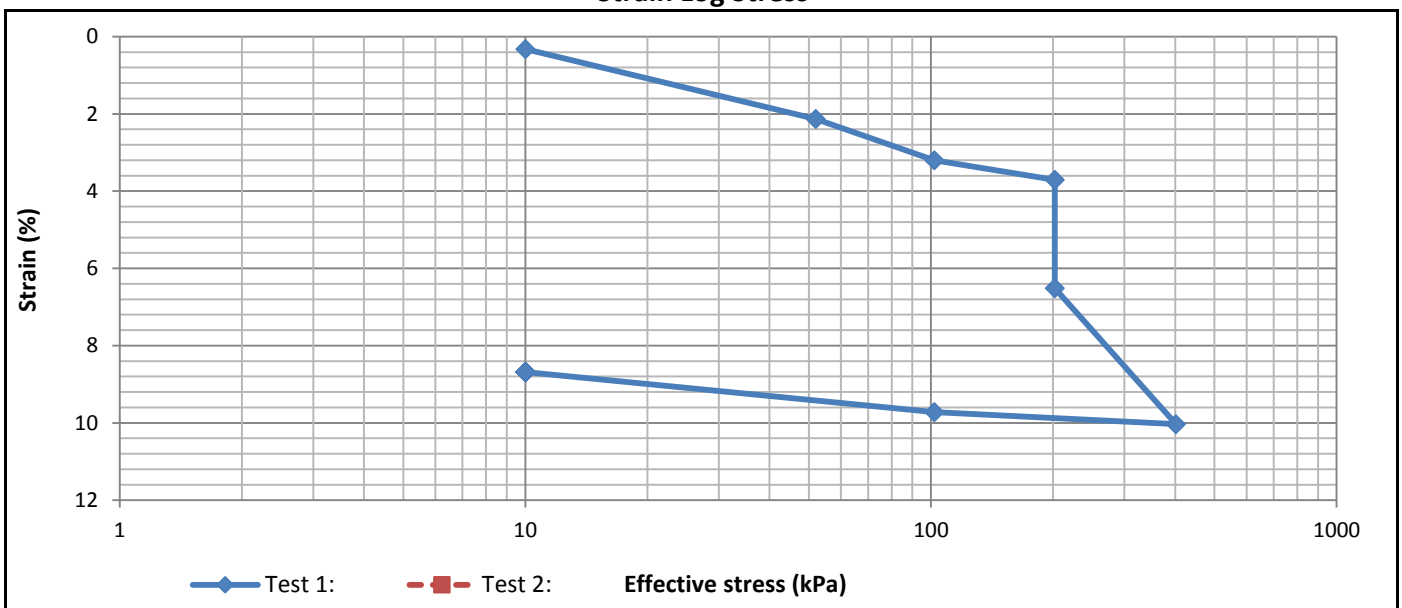
**CONSOLIDATION TEST RESULTS - BS 1377: Part 5**

**Strain Log Stress**

**Void Ratio Log Stress**
