# Pienaarsrivier Filling Station Geotechnical Investigation Report

## Geotechnical Investigation Report Report No: 8536/17071

REFERENCE NUMBER: 8536/17071

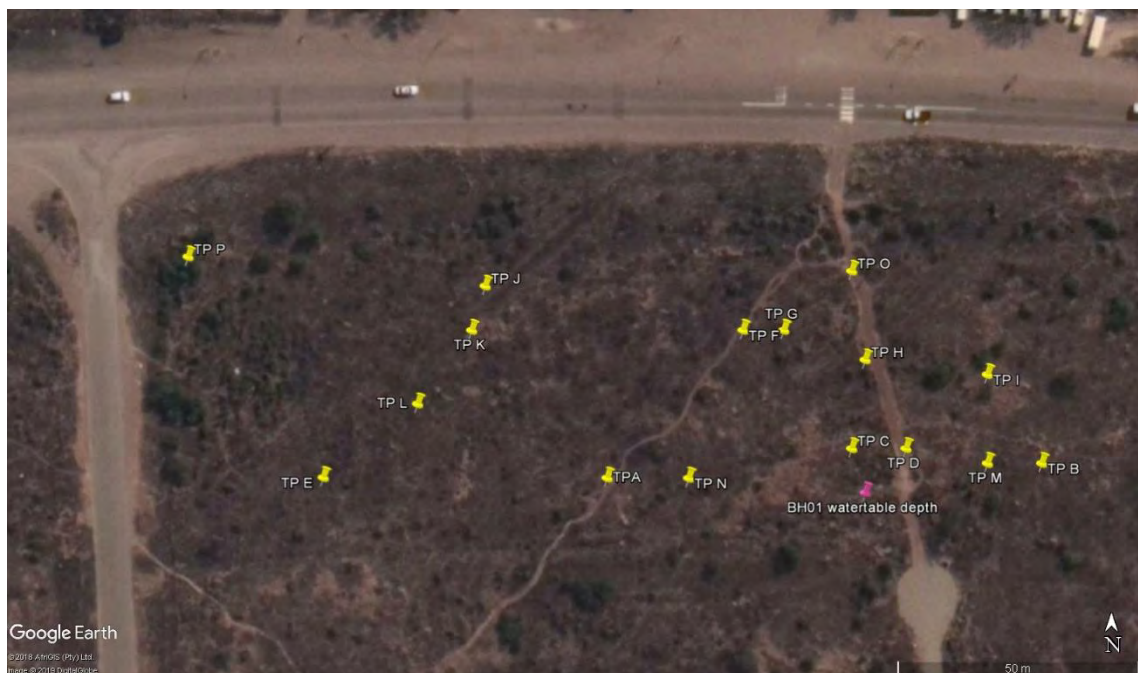
Figure 6-1 overleaf shows positions of test pits in yellow markers and borehole in pink marker, as seen in Google Earth™.

**Figure 6-1: Site layout showing positions of TP A to TP P and BH01.**

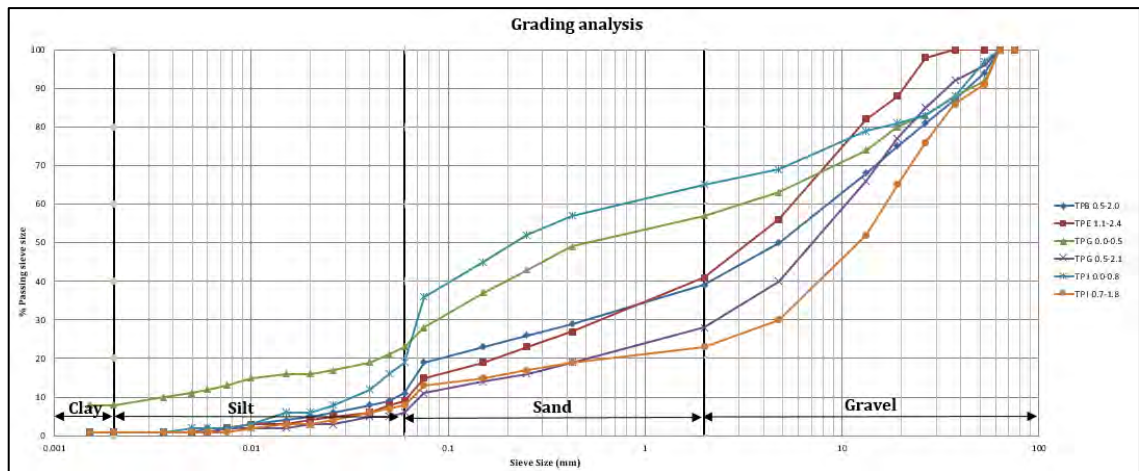
The grading curve of the material tested can be viewed in Figure 7-1. Specific values can be viewed in the individual laboratory results in **Appendix C**.

Figure 7-1: Grading curve.

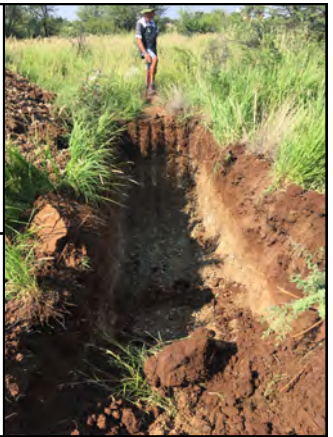
**Test Pit: TP A**

<b>SOFT TO STIFF, SANDY SILTY CLAY</b> Slightly moist, dark brown, soft to stiff, sandy silty clay Topsoil	
0.2					
0.3					
0.4					
0.5					
0.6				(0.6 m)

0.7			X	<b>SOFT ROCK TO HARD ROCK, ALTERED SANDSTONE AND DOLERITE</b> Light brown, slightly weathered to moderately weathered with joint staining, fine grained, highly jointed, soft rock to hard rock, altered sandstone and dolerite

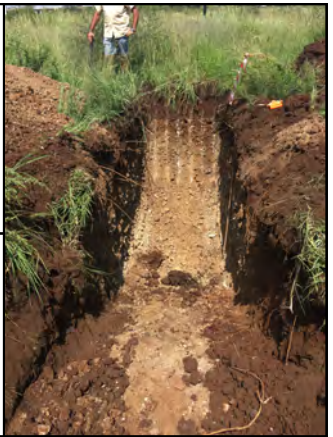
**Test Pit: TP B**

<b>SOFT, SANDY SILTY CLAY</b> Slightly moist, dark brown, soft, sandy silty clay Topsoil	
0.2					
0.3					
0.4					
0.5					
0.6	<div>D</div>

<b>SOFT ROCK TO HARD ROCK, ALTERED SANDSTONE AND DOLERITE</b> Light brown, slightly weathered to moderately weathered with joint staining, fine grained, highly jointed, soft rock to hard rock, altered sandstone and dolerite

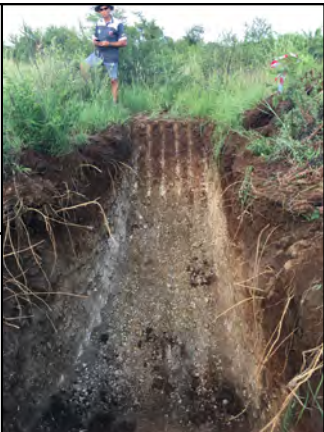
**Test Pit: TP C**

<b>SOFT, SANDY SILTY CLAY</b> Slightly moist, dark brown, soft, sandy silty clay Topsoil	
0.2					
0.3					
0.4					
0.5					
0.6				(0.6 m)	
0.7

<b>SOFT ROCK TO HARD ROCK, ALTERED SANDSTONE AND DOLERITE</b> Light brown, slightly weathered to moderately weathered with joint staining, fine grained, highly jointed, soft rock to hard rock, altered sandstone and dolerite

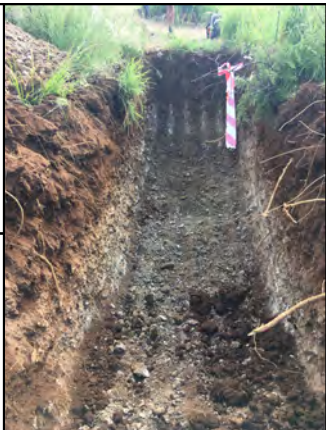
**Test Pit: TP D**

<b>SOFT, SANDY SILTY CLAY</b> Slightly moist, dark brown, soft, sandy silty clay Topsoil	
0.2					
0.3					
0.4					
0.5					
0.6				(0.6 m)	
0.7

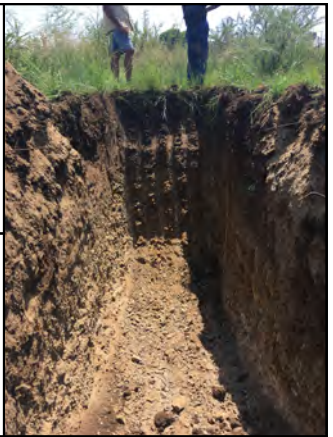
**Test Pit: TP E**

<b>SOFT TO STIFF, SANDY SILTY CLAY</b> Slightly moist, dark brown, soft to stiff, sandy silty clay Topsoil	
0.2					
0.3					
0.4					
0.5					
0.6

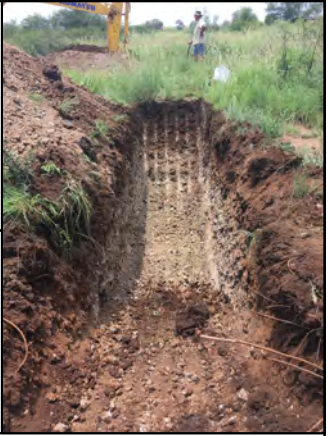
**Test Pit: TP F**

0.1				<b>SOFT, SANDY SILTY CLAY</b> Slightly moist, dark brown, soft, sandy silty clay Topsoil	
0.2					
0.3					
0.4					
0.5					
0.6					
0.7				<b>SOFT ROCK TO HARD ROCK, ALTERED SANDSTONE AND DOLERITE</b> Light brown, slightly weathered to moderately weathered with joint staining, fine grained, highly jointed, soft rock to hard rock, altered sandstone and dolerite	(0.7 m)

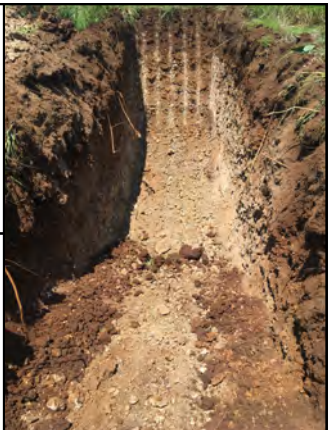
**Test Pit: TP O**

0.1				<b>STIFF, SANDY SILTY CLAY</b> Slightly moist, dark brown, stiff, sandy silty clay Topsoil	
0.2					
0.3					
0.4					
0.5					
0.6					
0.7					
0.8					(0.8 m)

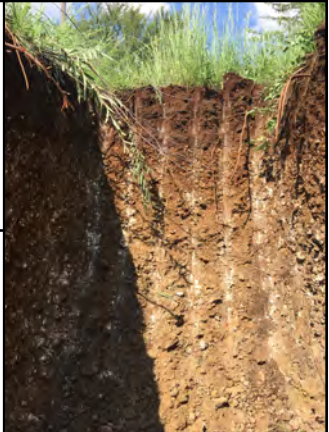
**Test Pit: TP P**

0.1				<b>VERY SOFT TO SOFT, SANDY SILTY CLAY</b> Slightly moist, dark brown, very soft to soft, sandy silty clay Topsoil	
0.2					
0.3					
0.4					
0.5			X	<b>SOFT ROCK TO HARD ROCK, ALTERED SANDSTONE AND DOLERITE</b> Light brown, slightly weathered to moderately weathered, fine grained, highly jointed, soft rock to hard rock, altered sandstone and dolerite	(0.45 m)

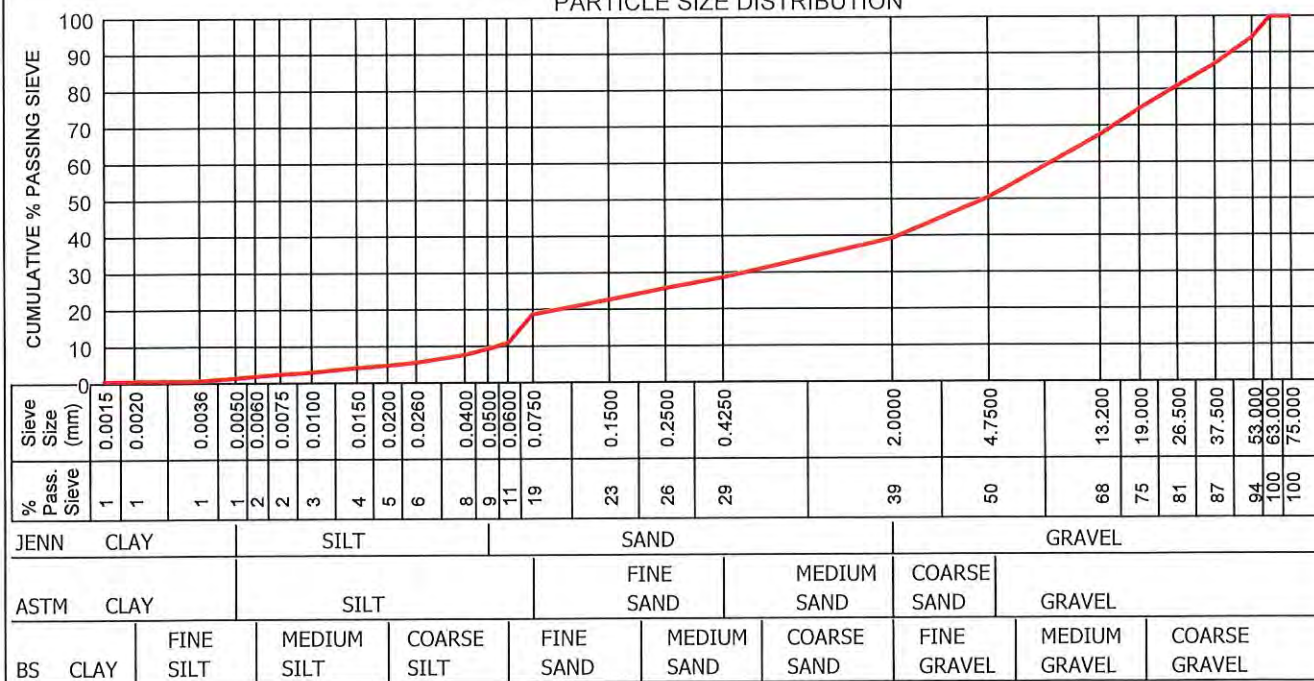
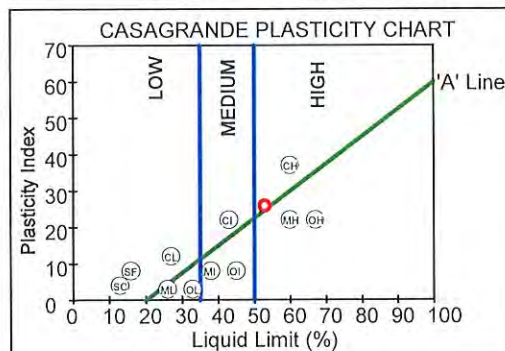
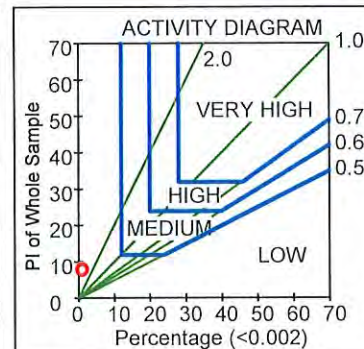
Material Description : Light brown SILTY SAND

Clay (%)	Silt (%)	Sand (%)	Gravel (%)	Classification
Jennings	1.4	7.9	30.1	60.6	SILTY SAND
Astm	1.4	17.4	31.6	49.6	SILTY SAND
British Standard	0.6	10.4	28.4	60.6	SILTY SAND

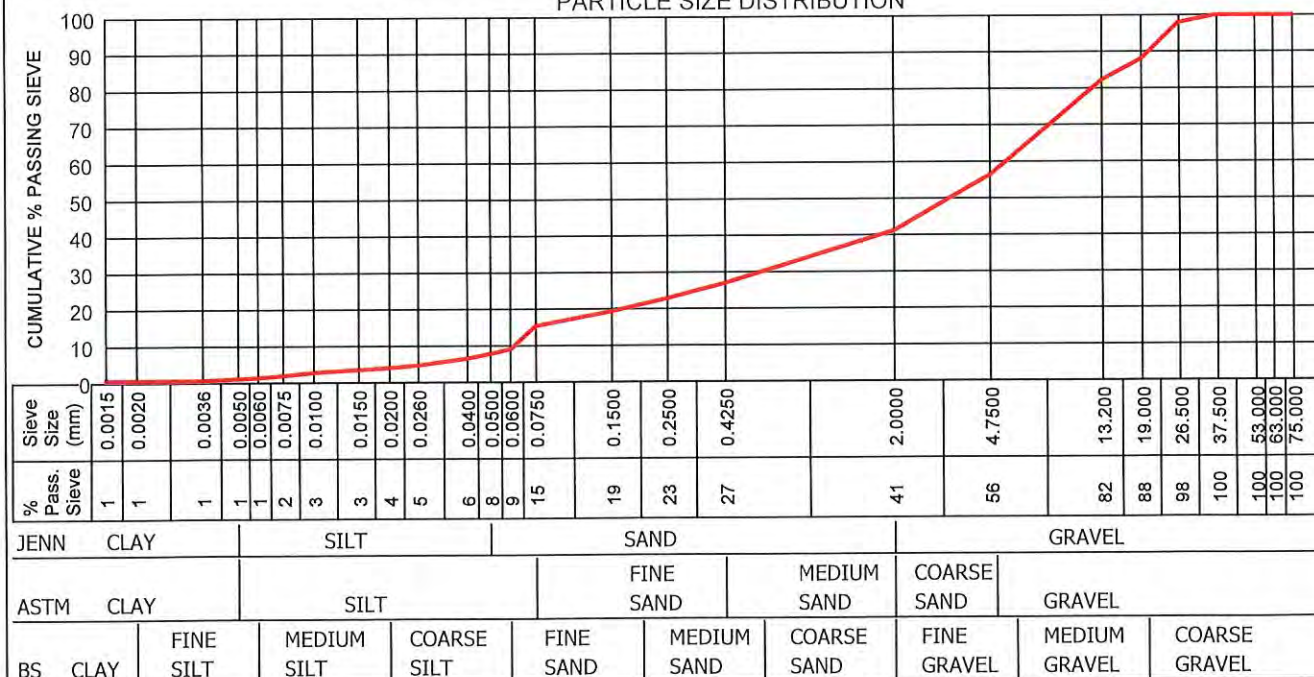
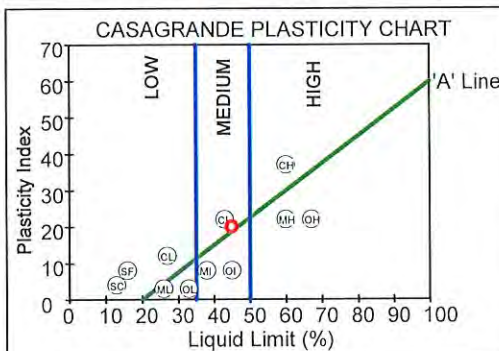
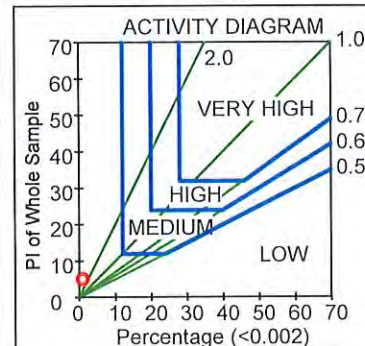
Material Description : Light yellow brown SILTY SAND

Clay (%)	Silt (%)	Sand (%)	Gravel (%)	Classification
Jennings	1.0	6.7	33.5	58.8	SAND
Astm	1.0	14.3	41.0	43.7	SILTY SAND
British Standard	0.5	8.5	32.1	58.8	SILTY SAND

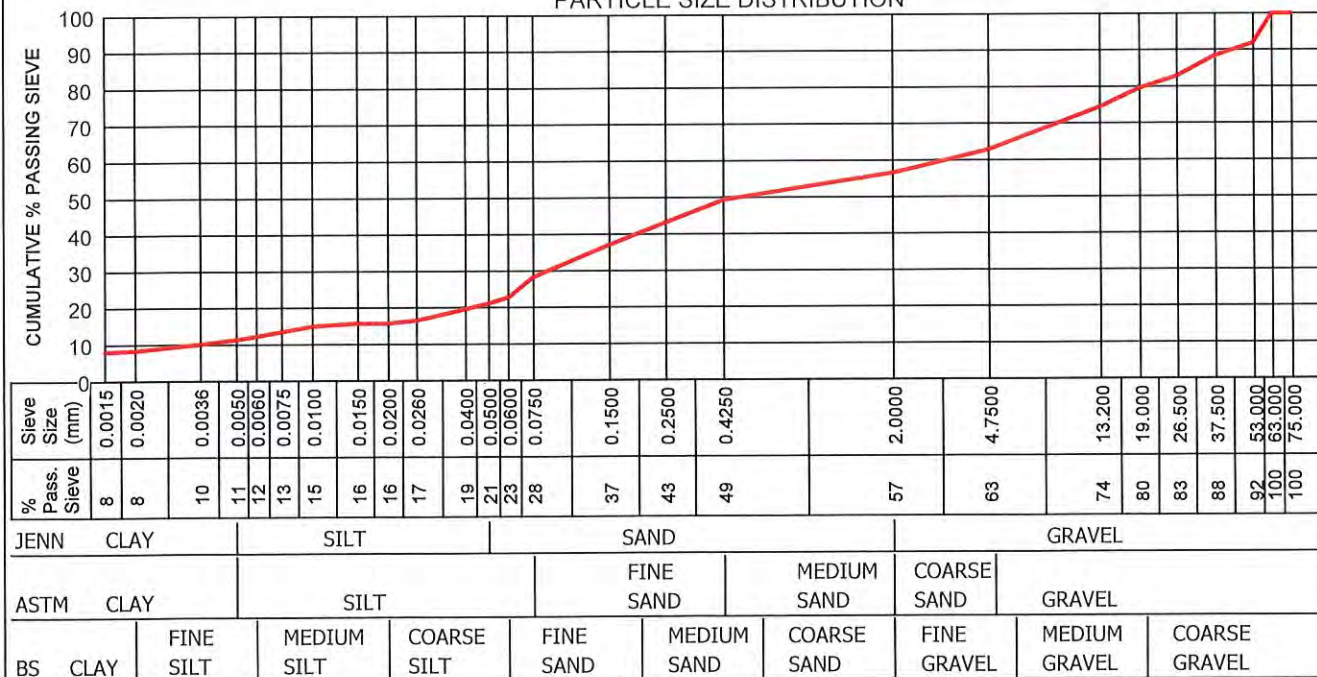
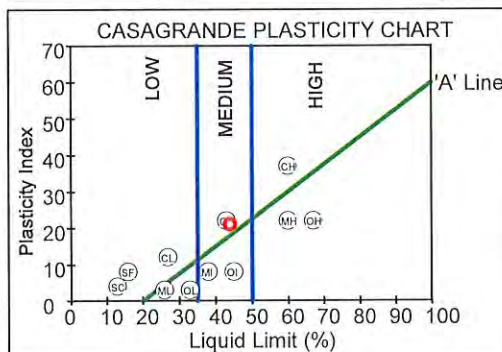
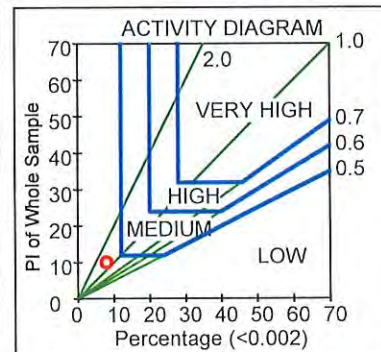
Material Description : Dark olive SILTY SAND

Clay (%)	Silt (%)	Sand (%)	Gravel (%)	Classification
Jennings	11.3	9.8	35.4	43.5	CLAYEY SAND
Astm	11.3	16.9	34.6	37.2	SILTY SAND
British Standard	8.4	14.4	33.8	43.5	SILTY SAND

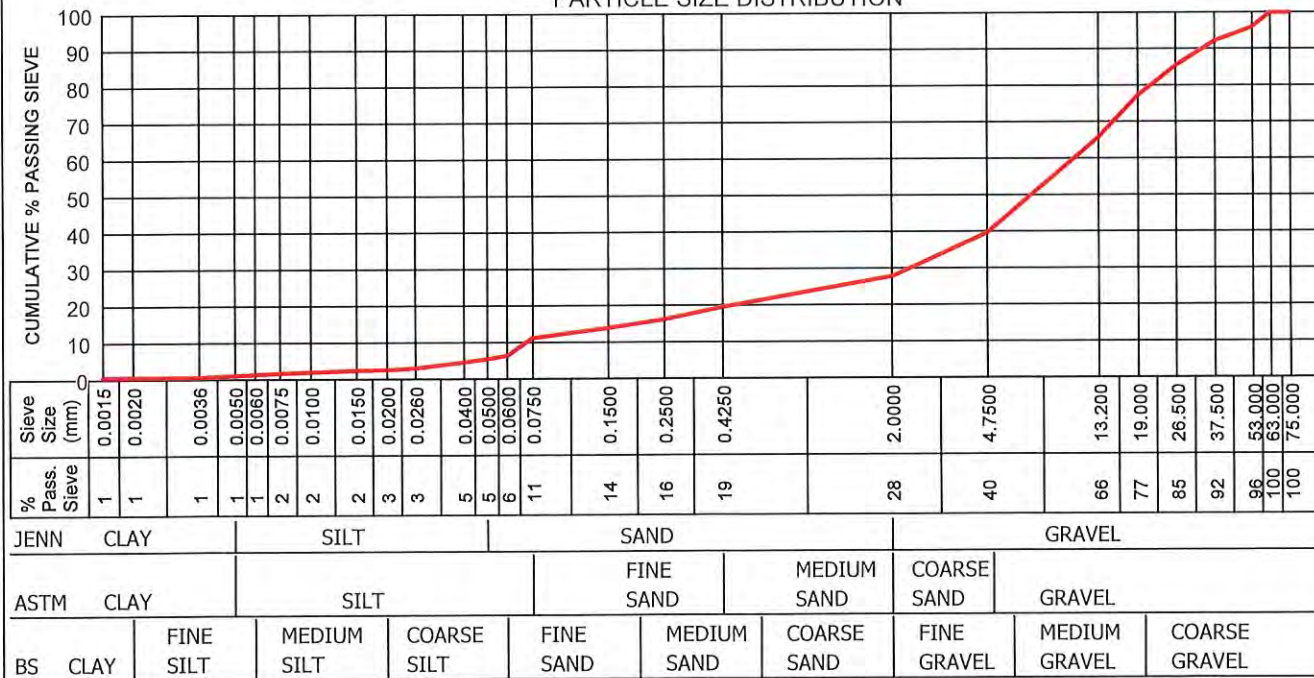
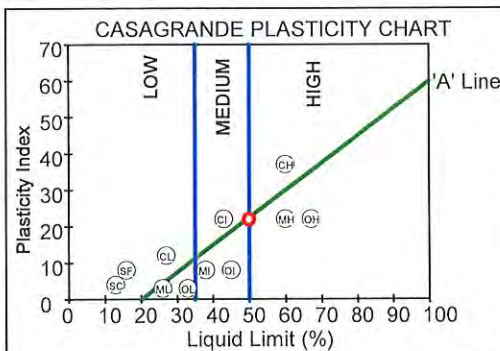
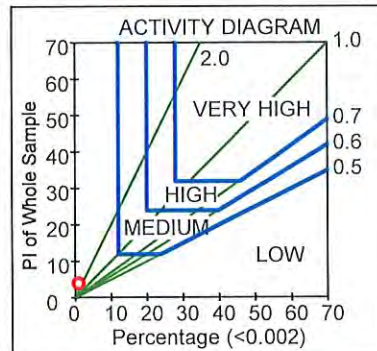
Material Description : Light yellow brown SILTY SAND

Clay (%)	Silt (%)	Sand (%)	Gravel (%)	Classification
Jennings	1.0	4.4	22.4	72.2	SAND
Astm	1.0	10.2	28.4	60.5	SILTY SAND
British Standard	0.6	5.8	21.4	72.2	SILTY SAND

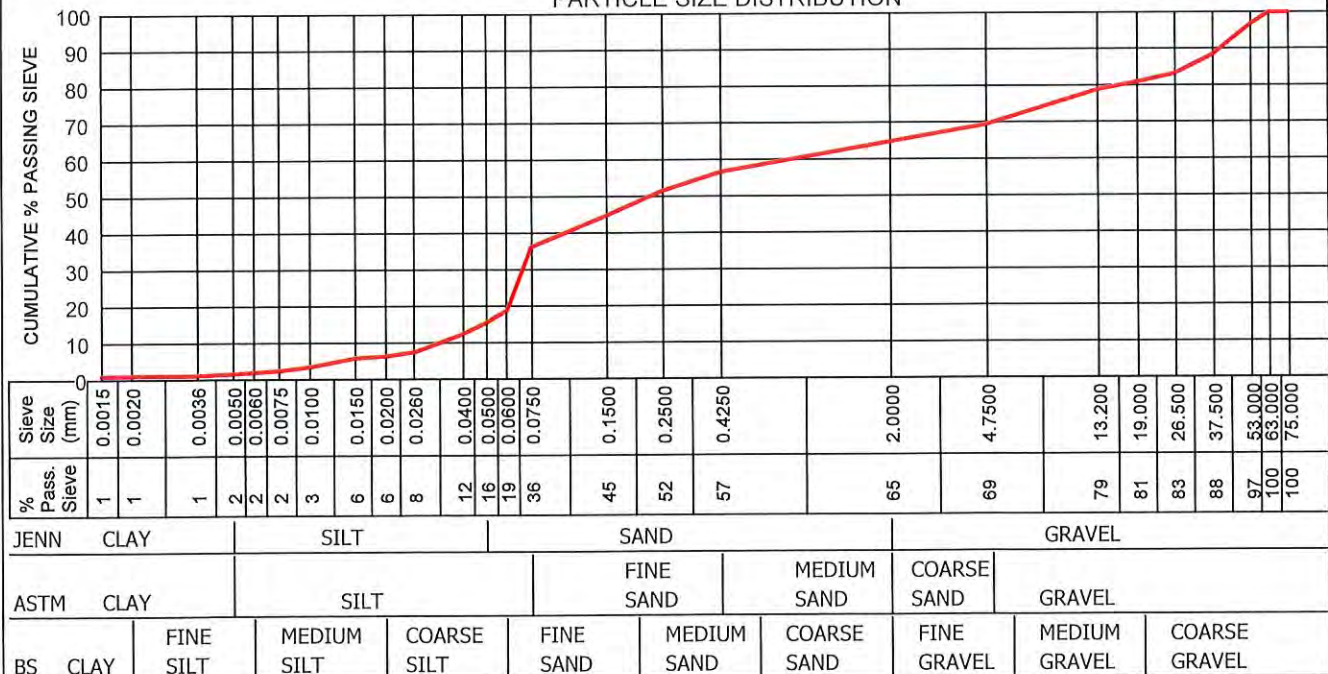
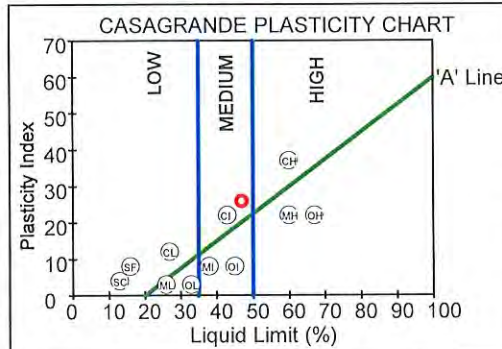
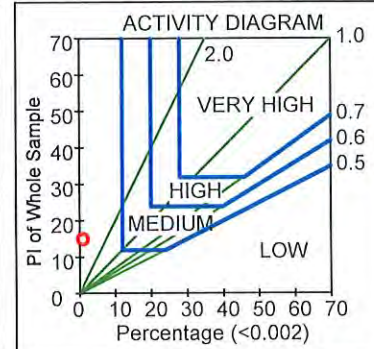
Material Description : Dark brown SILTY SAND

Clay (%)	Silt (%)	Sand (%)	Gravel (%)	Classification
Jennings	1.6	14.0	49.2	35.2	SILTY SAND
Astm	1.6	34.6	33.2	30.6	SILTY SAND
British Standard	1.1	17.8	45.9	35.2	SILTY SAND

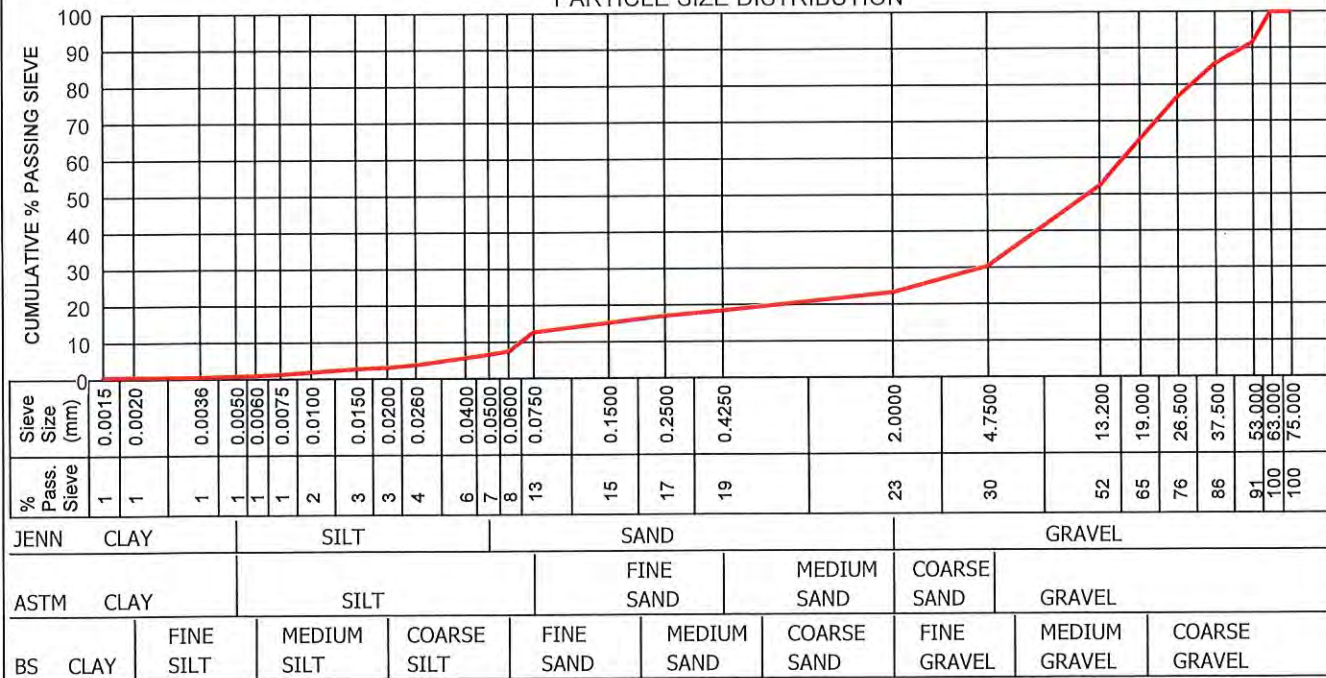
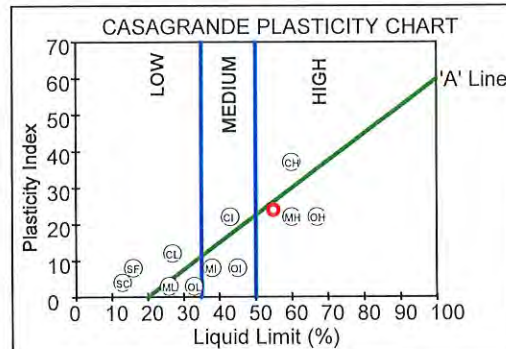
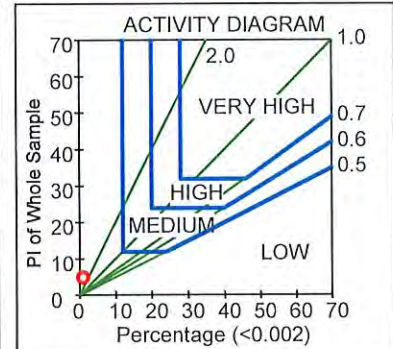
Material Description : Yellowish brown SILTY SAND

Clay (%)	Silt (%)	Sand (%)	Gravel (%)	Classification
Jennings	0.8	5.8	16.7	76.6	SILTY SAND
Astm	0.8	11.9	17.7	69.6	SILTY SAND
British Standard	0.6	7.0	15.8	76.6	SILTY SAND

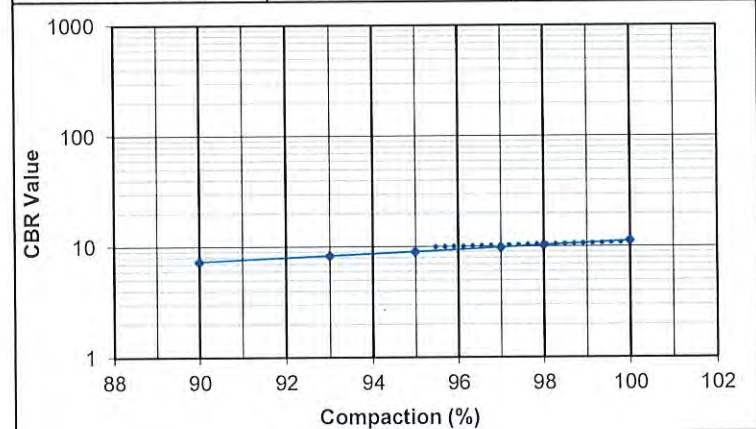
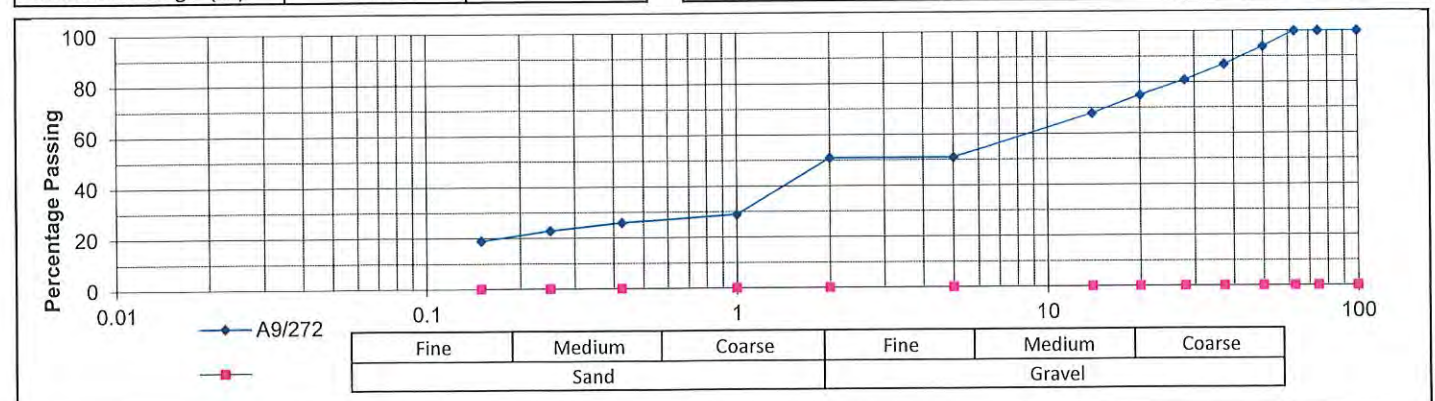
### California Bearing Ratio SANS 3001: GR40

Compaction Data			
Moisture	%	14.6	
Dry Density	kg/m <sup>3</sup>	1972 1879 1780	
Compaction	%	100.0 95.3 90.3	
Penetration Data			
CBR at	2.50 mm	11 10 7	
	5.00 mm	12 10 9	
	7.50 mm	12 10 9	
Swell	%	0.7 0.9 1	
Final Moisture (%)

Interpolated CBR Data		
@ 100%	11	
@ 98%	10	
@ 97%	10	
@ 95%	9	
@ 93%	8	
@ 90%	7	
@ SANS3001 Midpoint	10

Classifications	
HRB (AASHTO)	A-2-7(1)
COLTO	
TRH14	G9

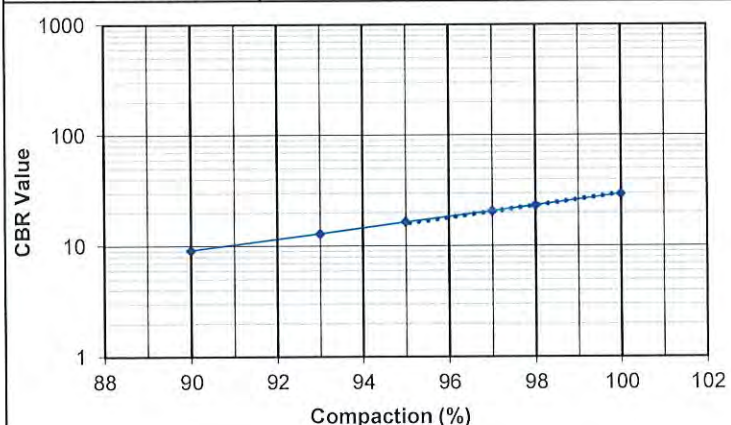
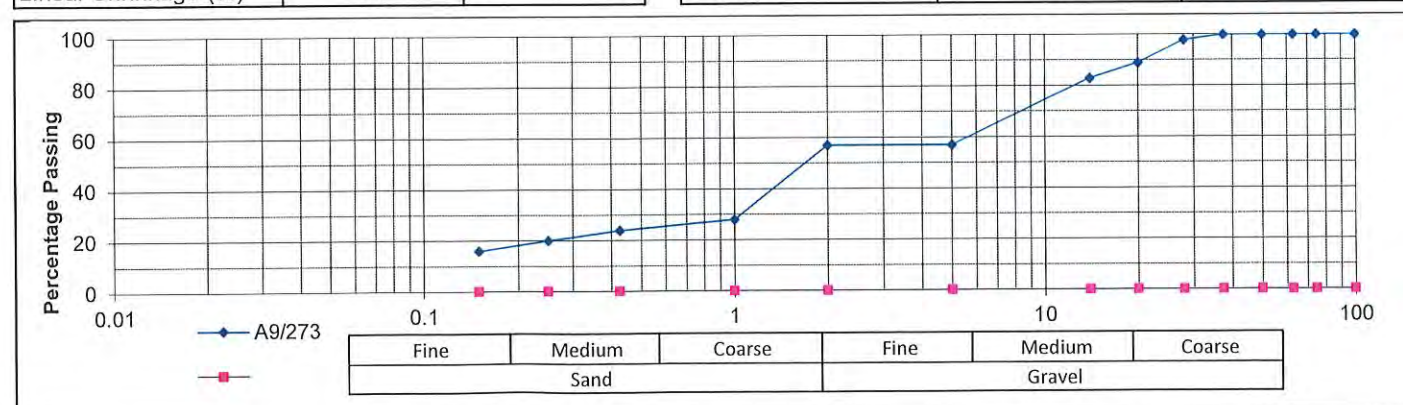
Liquid Limit (%)	45
Plasticity Index (%)	20
Linear Shrinkage (%)	9.0

@ 100%	30
@ 98%	23
@ 97%	21
@ 95%	17
@ 93%	13
@ 90%	9
@ SANS3001 Midpoint	22

HRB (AASHTO)	A-2-7(0)
COLTO	
TRH14	G9

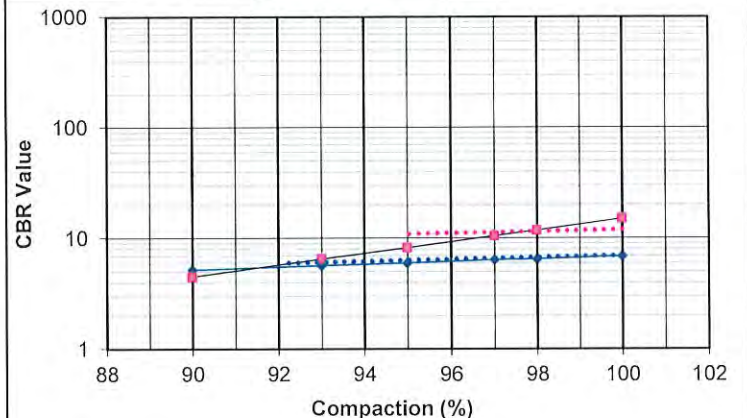
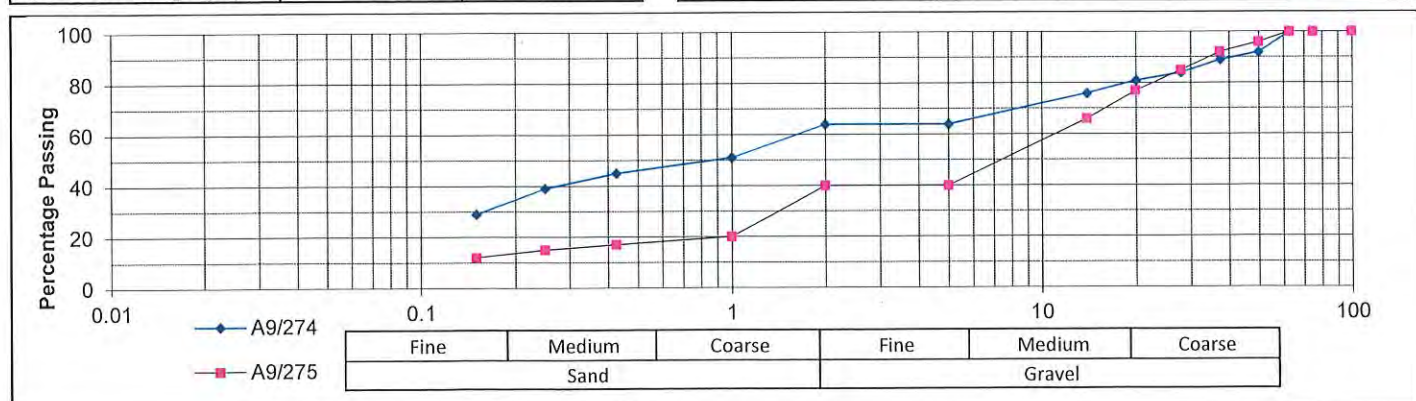
Liquid Limit (%)	45	50
Plasticity Index (%)	22	22
Linear Shrinkage (%)	10.5	11.0

@ 100%	7	15
@ 98%	7	12
@ 97%	6	11
@ 95%	6	8
@ 93%	6	7
@ 90%	5	5
@ SANS3001 Midpoint	6	11

HRB (AASHTO)	A-2-7(2)	A-2-7(0)
COLTO		
TRH14	G10	G10

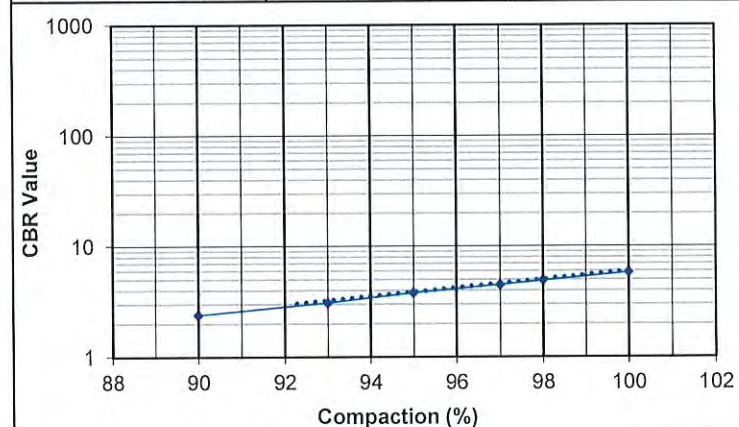
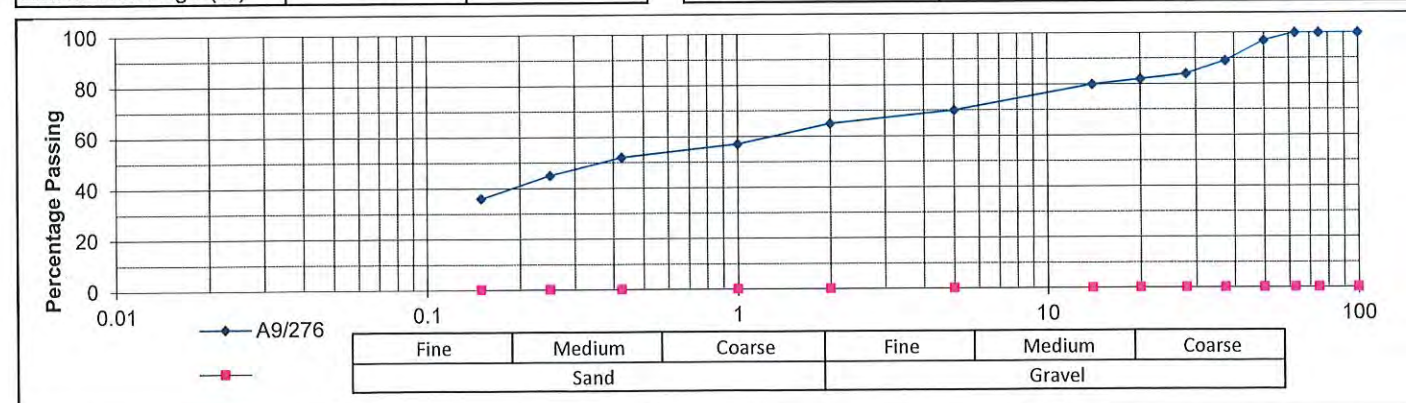
Liquid Limit (%)	47
Plasticity Index (%)	26
Linear Shrinkage (%)	13.5

CBR	@ 100%	6
	@ 98%	5
	@ 97%	5
	@ 95%	4
	@ 93%	3
	@ 90%	2
	@ SANS3001 Midpoint	4

HRB (AASHTO)	A-7-6(4)
COLTO	
TRH14

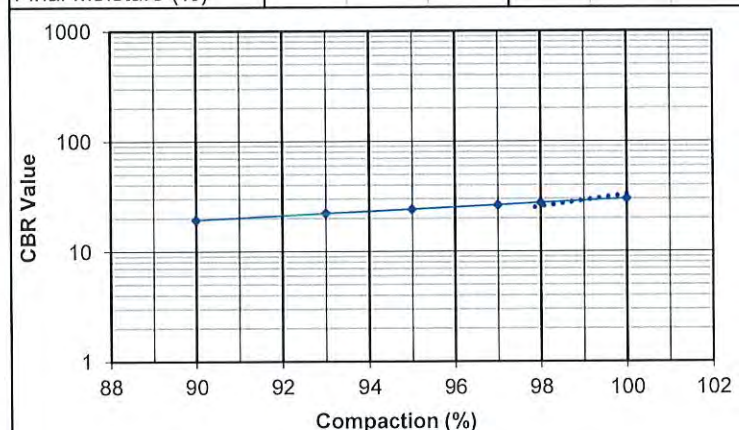
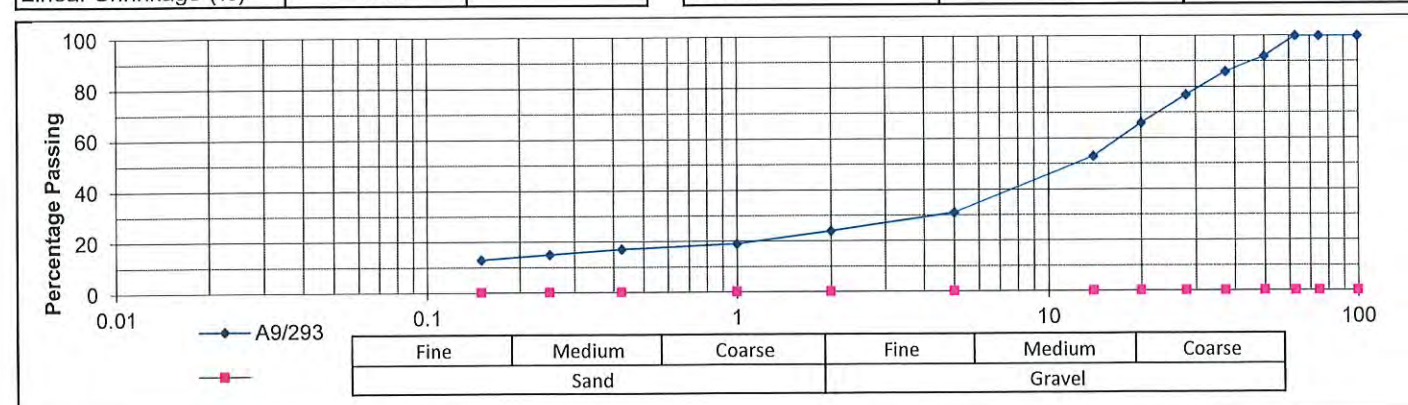
Compaction Data				
Moisture	%	9.6		
Dry Density	kg/m <sup>3</sup>	2105	2058	1911
Compaction	%	100.0	97.8	90.8

Penetration Data				
CBR at	2.50 mm	33	25	20
	5.00 mm	42	33	22
	7.50 mm	44	36	22
Swell	%	0.3	0.4	0.6
Final Moisture (%)

Interpolated CBR Data		
CBR	@ 100%	30
	@ 98%	28
	@ 97%	27
	@ 95%	24
	@ 93%	22
	@ 90%	19
	@ SANS3001 Midpoint	29

Classifications	
HRB (AASHTO)	A-2-7(0)
COLTO	
TRH14	G8
