**SANS634:2012 Preliminary Engineering Geological
Investigation Conducted on Erf 184 Olifantsnek situated on
Portion 62 of the farm Commissiesdrift 327-JQ, North-West
Province, South Africa**

SANS634:2012 Preliminary Shallow Soil Engineering Geological Assessment

Project number: RS19022

20 August 2019

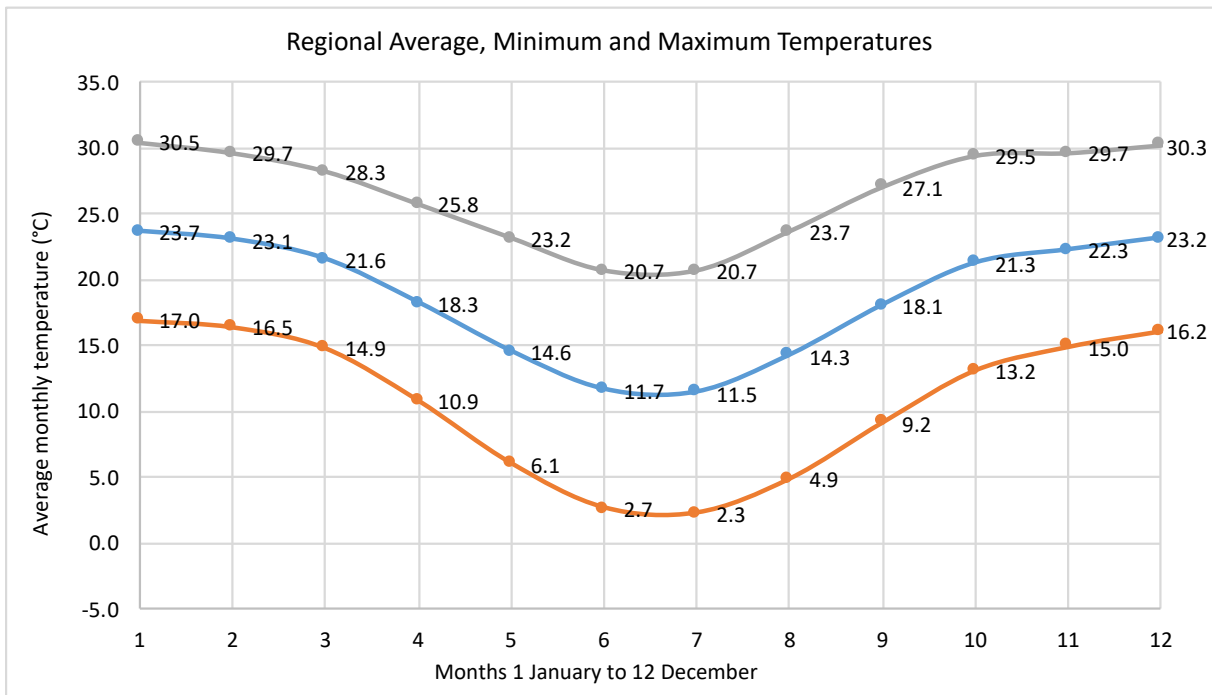
Chart 1: Regional Average, Minimum and Maximum Temperatures

As per climate-data.org, the climate in the Randburg area is considered “Cwa” according to the Koppen-Geiger climate classification. The average annual temperature is ~18.6 °C with an average annual rainfall of ~663 mm. The temperatures are highest on average in January, at around 23.7 °C. The lowest average temperatures in the year occur in July at around 11.5 °C. The regional average, minimum and maximum temperatures are depicted in **Chart 1**. The regional average monthly rainfall is depicted in **Chart 2**.

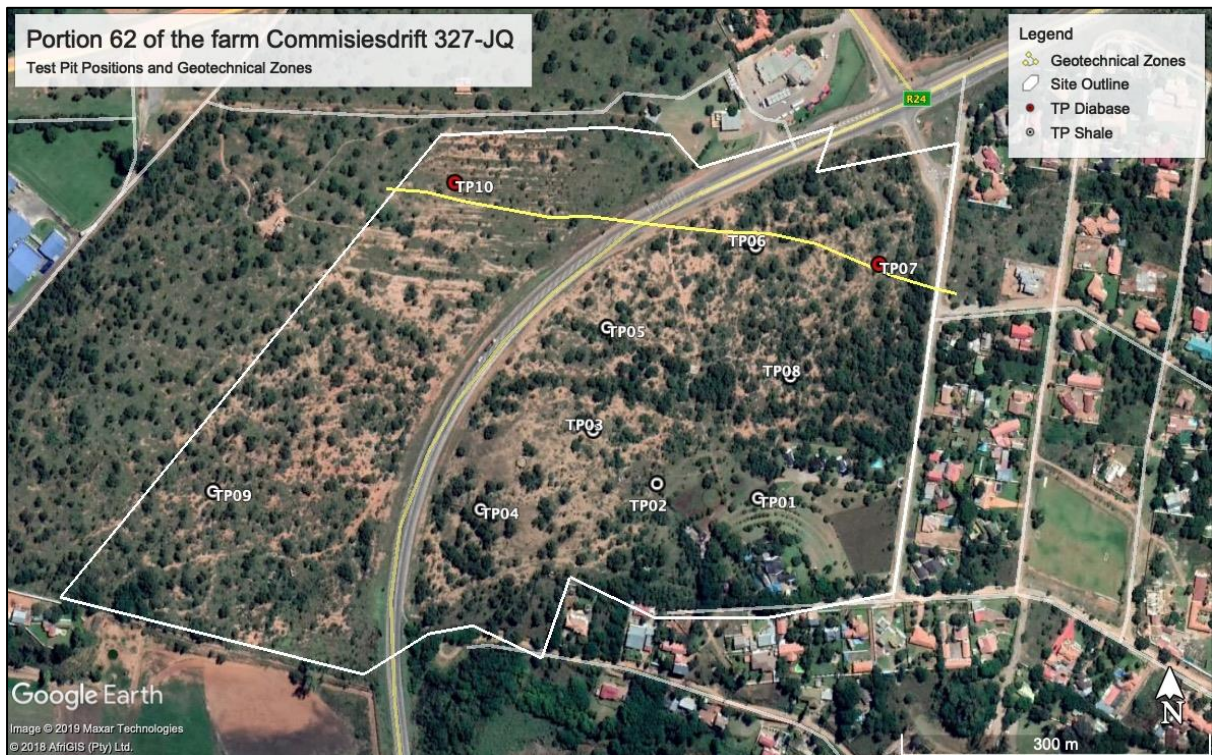
Figure 4: Test Pit Positions

Engineering and material characterisation is based on ten soil profiles described on the site (positions indicated on Figure 4; photographs and logs supplied in Appendix B and Appendix C respectively). Seven representative soil samples were submitted for foundation indicator tests and determination of pH and electrical conductivity (Table R3 and Appendix D).

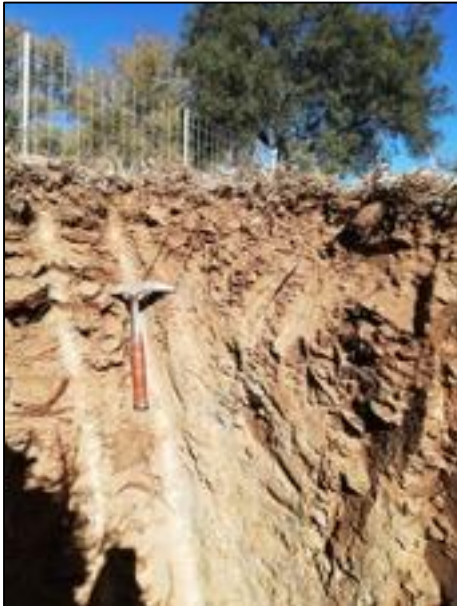
Test Pit no: TP01

Notes: Upper soil profile.

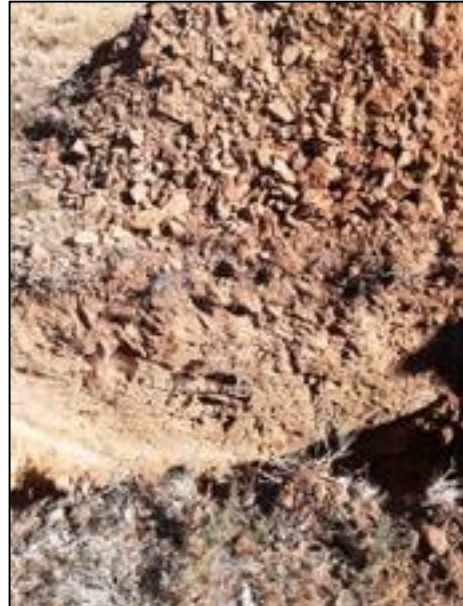
Test Pit no: TP01

Notes: Excavated excavation and material.

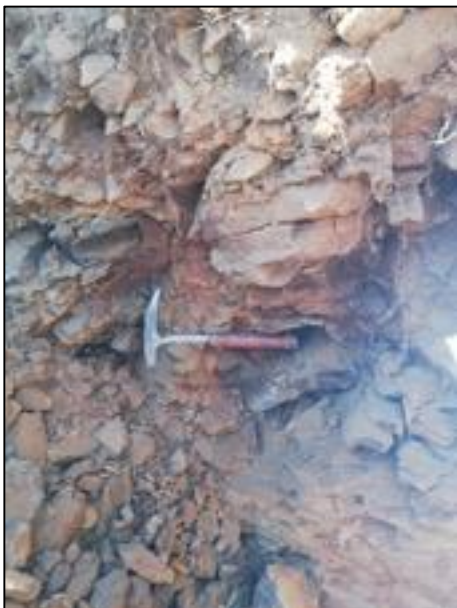
Test Pit no: TP02

Notes: Soil profile down to 1.20 m below surface.

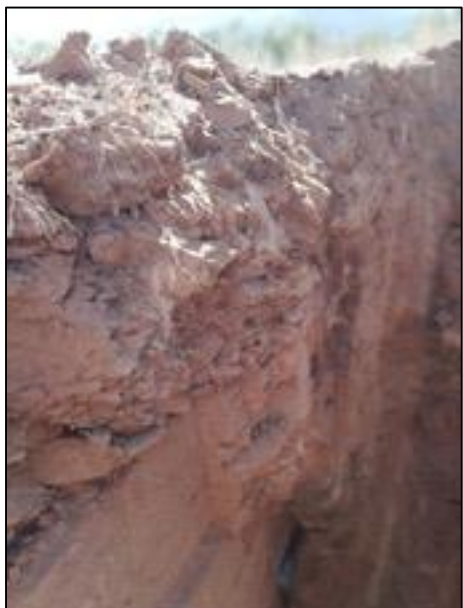
Test Pit no: TP03

Notes: Upper soil profile.

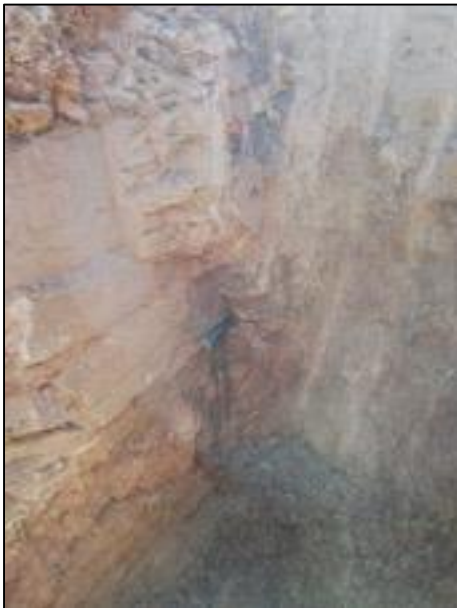
Test Pit no: TP03

Notes: Soil profile down to 1.60 m below surface.

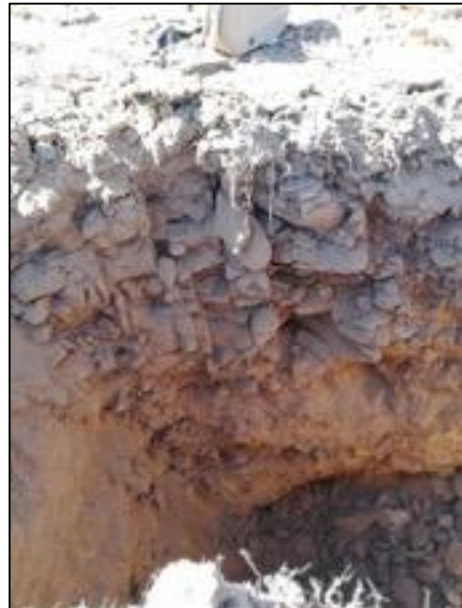
Test Pit no: TP04

Notes: Soil profile down to 1.90 m below surface.

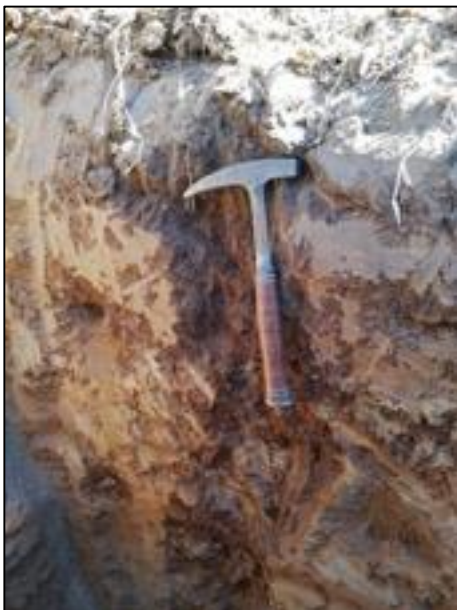
Test Pit no: TP05

Notes: Upper soil profile.

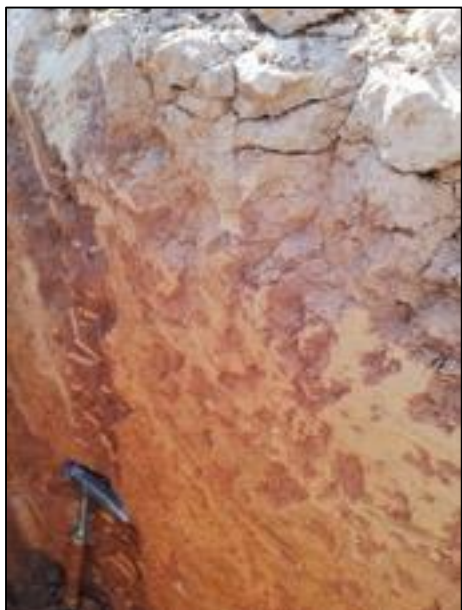
Test Pit no: TP06

Notes: Soil profile down to 1.40 m below surface.

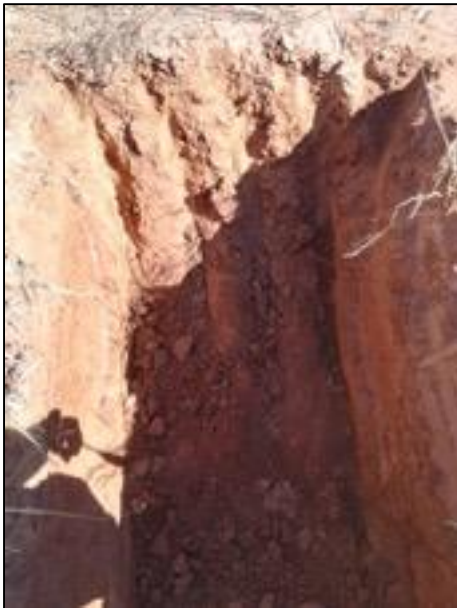
Test Pit no: TP07

Notes: Excavation down to 1.20 m below surface.

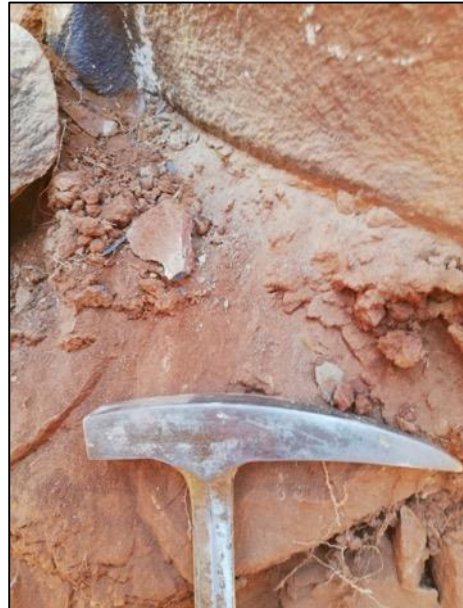
Test Pit no: TP07

Notes: Lower diabase.

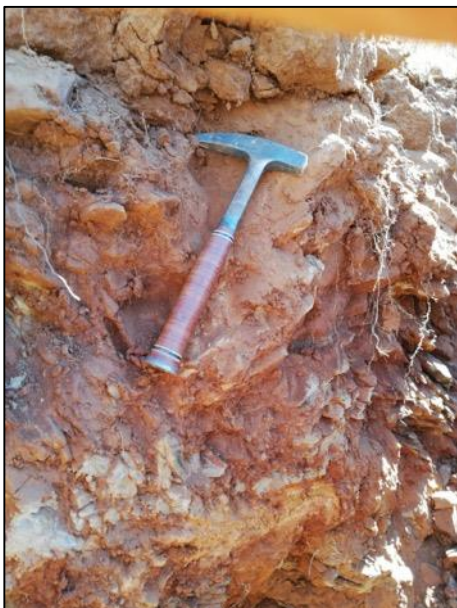
Test Pit no: TP08

Notes: Upper soil profile.

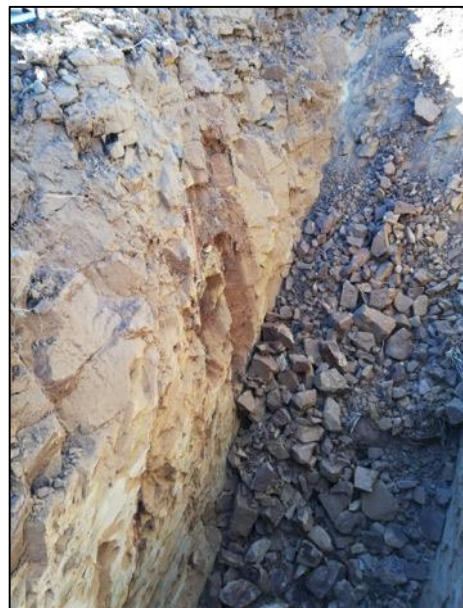
Test Pit no: TP09

Notes: Soil profile down to 1.60 m below surface.

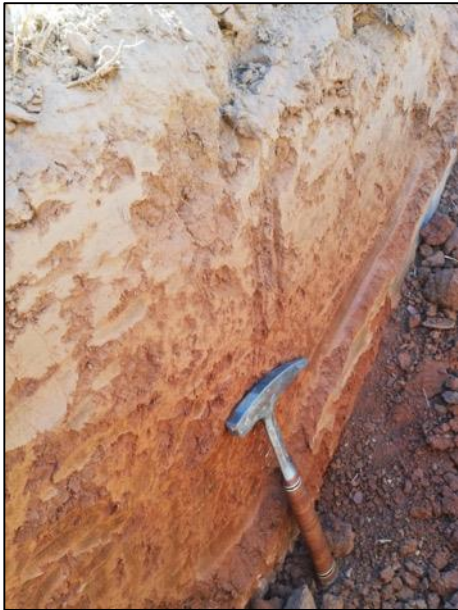
Test Pit no: TP10

Notes: Soil profile down to 0.80 m below surface.
