**PHASE 1 ARCHAEOLOGICAL IMPACT ASSESSMENT  
OF THE PROPOSED DRIEFONTEIN RESORT  
(DRIEFONTEIN FARM NO. 127)  
SUTHERLAND  
NORTHERN CAPE PROVINCE**

**MARCH  
2009**

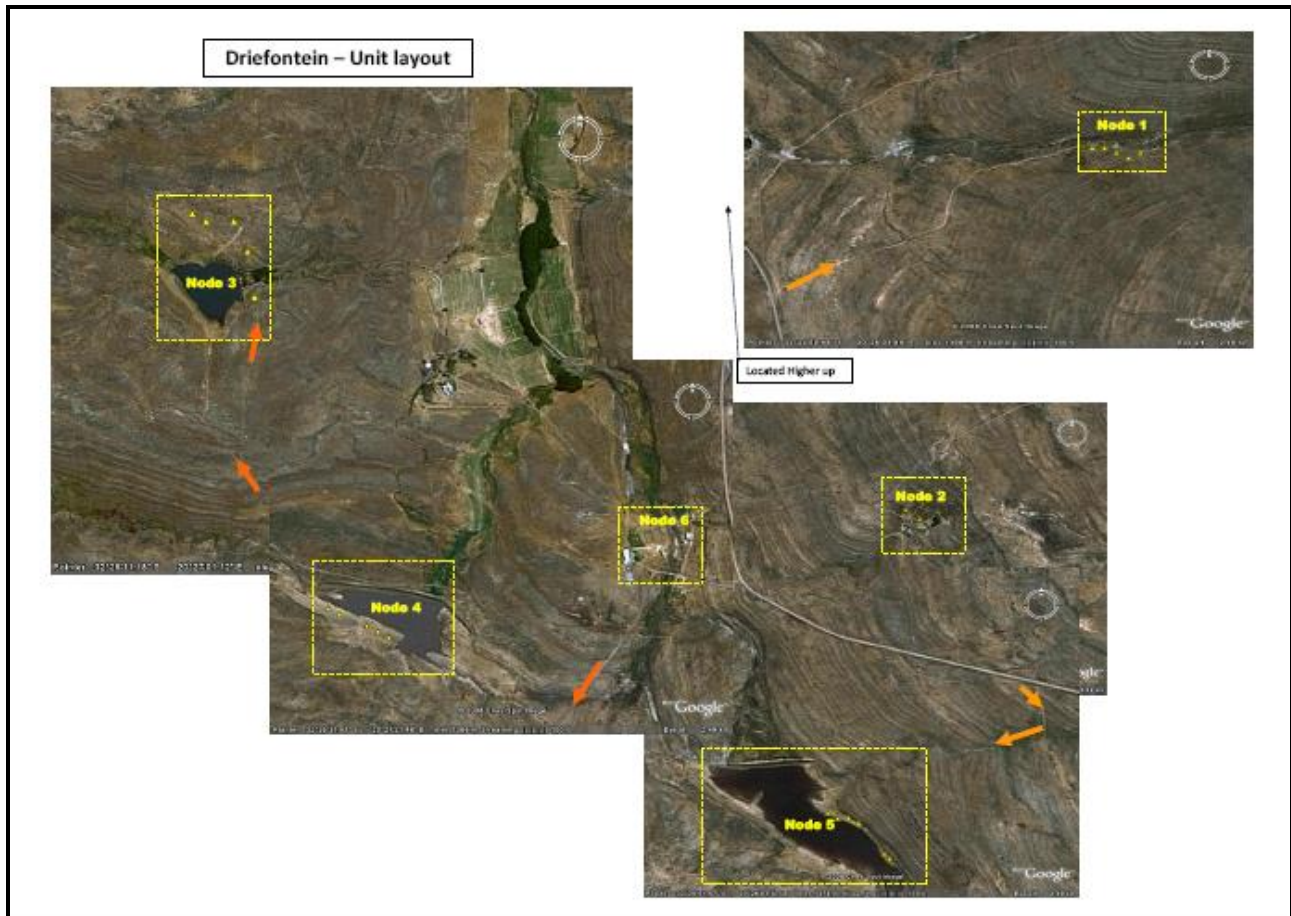
**Figure 3. Aerial photograph of the site illustrating the proposed development Nodes**

An aerial photograph of the study site indicating the proposed development Nodes is illustrated in Figure 3.

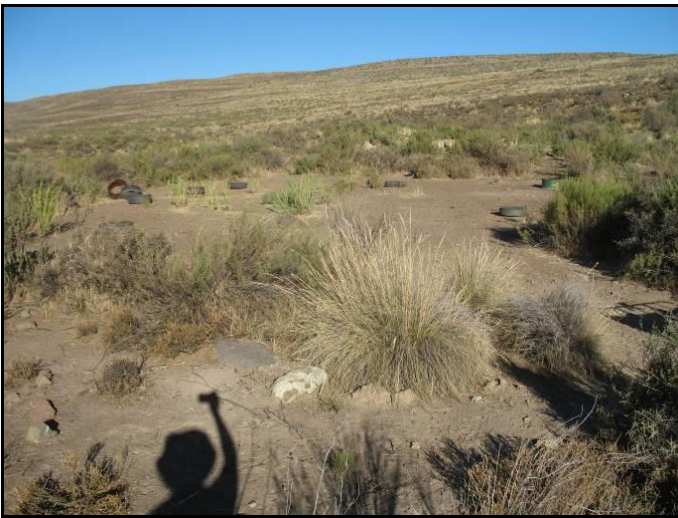
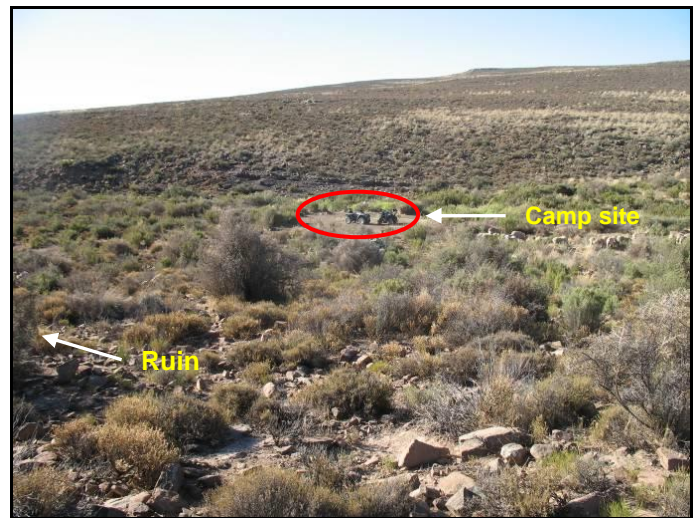
Approximately five camping sites are envisaged in Node 1, which is situated about midway up a fairly steep, narrow kloof, alongside a small stream (Figures 3, 4 & 5). An existing 2-track farm road will be used to access the proposed site. The site, which is heavily overgrazed by sheep, is located about 35 m west of a small stone ruin (Figure 6), most likely a shepherd's hut (or veewagterhuis). Such ruins are quite common in the Karoo landscape and reflect the early Trek Boer movements in the region during the late 18<sup>th</sup> and early 19<sup>th</sup> centuries. (Kaplan 2007, 2006, 2005).

**Finds:** No archaeological remains were documented in Node 1.

Figure 4. Node 1 view facing north

Figure 5. Node 1 view facing west

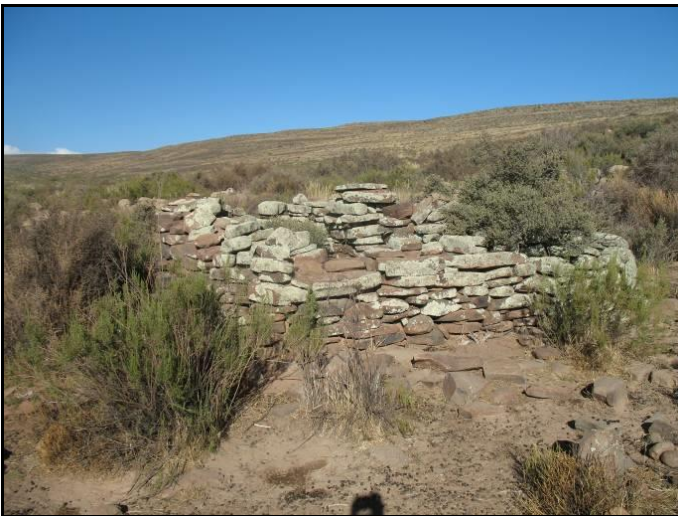
Figure 6. Stone ruin near Node 1

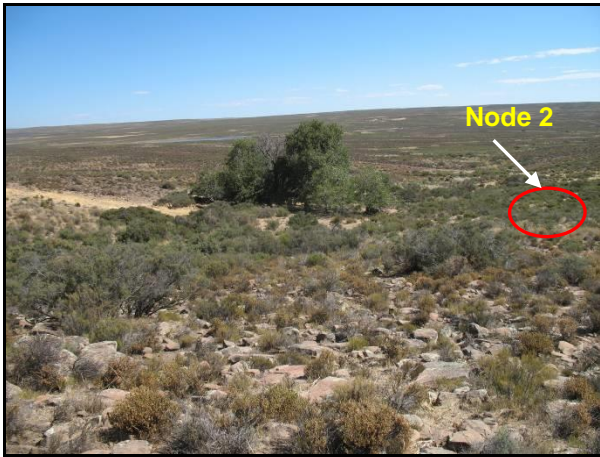
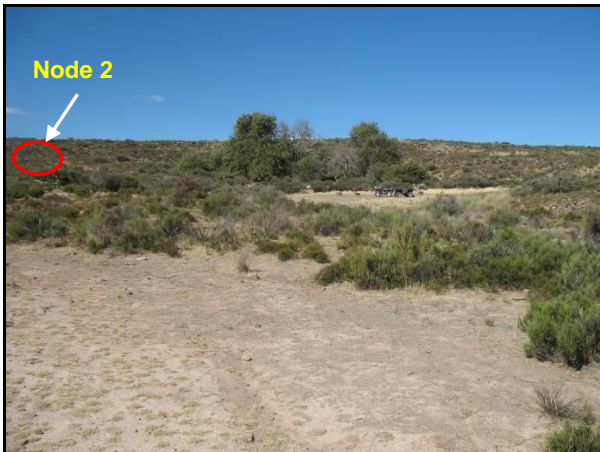
Two luxury units are planned for Node 2, which is situated about 30 m to the west of a group of large Wild Pear trees, on a rocky well vegetated slope (Figures 3, 7 & 8). An existing gravel road will be used to access the proposed site. The Pear trees and an open area in front are surrounded by a low, stone wall enclosure. A walled terrace is situated within the enclosure, behind which is located a stone lined well (Figure 9). According to the owner of the property (Mr J. van der Merwe), the ruins are the site of a vegetable garden, which was fed by the stone well. The walled enclosure was built in order to prevent animals from entering the garden and eating the vegetables. The remains of a collapsed, two roomed stone structure occur at the end of a small gravel track about 50 m south west of the stone enclosure (Figure 10). This dwelling was possibly built to house farm workers tending the garden. Several pieces of glass and white porcelain were found lying about. A seasonal stream exposing large sections of shale bedrock occurs about 60 m south east of the group of Wild Pear trees.

**Finds:** No archaeological remains were documented in Node 2.

**Figure 7. Node 2 view facing south**

**Figure 8. Node 2 view facing north**

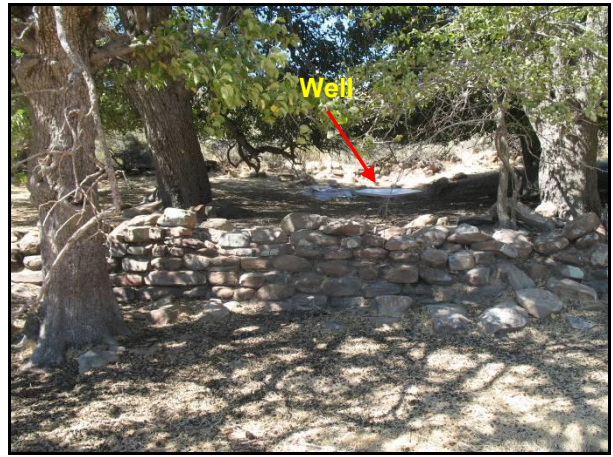
The historic vegetable garden and associated ruins will not be directly impacted by the proposed development.

**Figure 9. Stone walled terrace**

- Protected stone walling and ruins in Node 2 must not be damaged, or disturbed, and no stone may be removed for building purposes. It is not recommended that the ruins be demolished or altered. This 'site' could be researched in more detail and possibly be developed as a public interest (heritage) site for visitors to the proposed resort. A Conservation Heritage Management Plan will need to be developed to safeguard the integrity of the site.

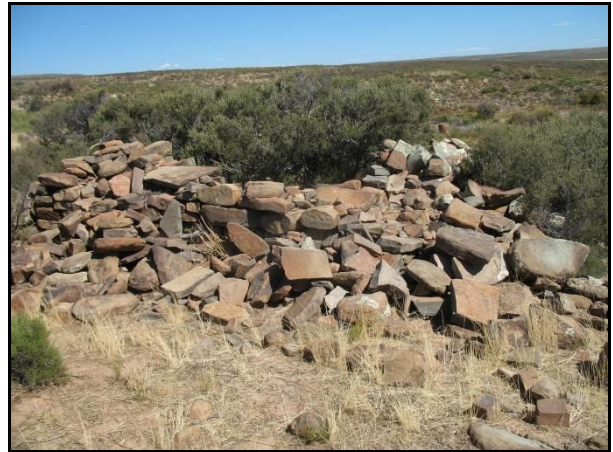
**Figure 10. Collapsed ruins**

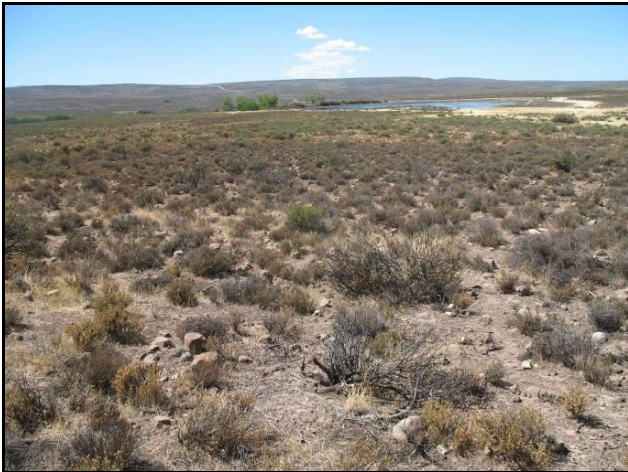
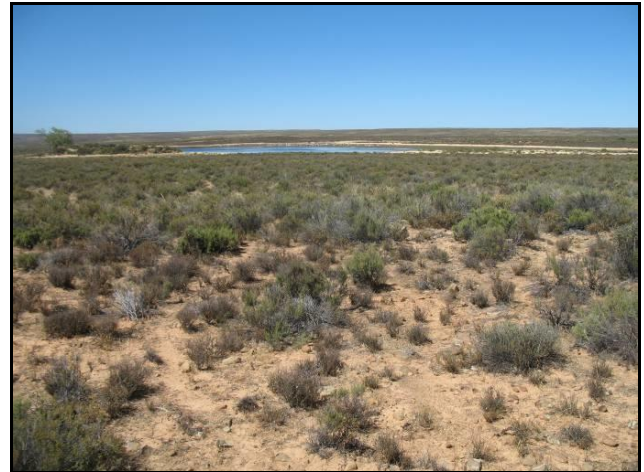
Approximately five units are envisaged at this site, which is situated on the western side of a small farm dam (Figures 3, 11 and 12). A new road (from the north) will have to be built to access the proposed site. A proposed access road from the south is not suitable as this will impact negatively on an extensive series of stone walling. The receiving environment has been quite heavily grazed, while the surrounding (higher) slopes and shale ridge is vegetated and quite rocky. No dolerite outcrops occur anywhere close to the proposed site. There is very little surface stone on the proposed development site, which is fairly level, but there are areas where some stone (mainly dolerite chunks and nodules) do occur. A seasonal stream that feeds the existing dam, exposing large sections of shale bedrock, occurs about 200 m south of the proposed development footprint.

**Finds:** No archaeological remains were documented in Node 3.

No archaeological remains were documented in the proposed access road (from the north) to the site.

Figure 11. Node 3 view facing north east

Figure 12. Node 3 view facing south east

- The proposed northern access road to Node 3 is the preferred route. The proposed alternative access road from the south is not acceptable as this will impact on extensive historical stone walling.

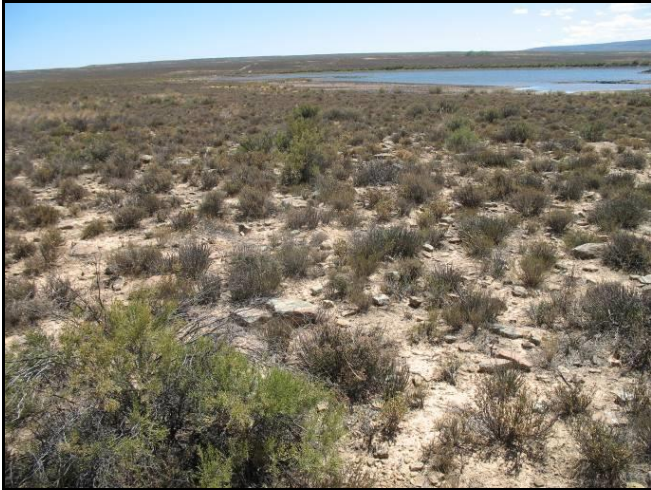
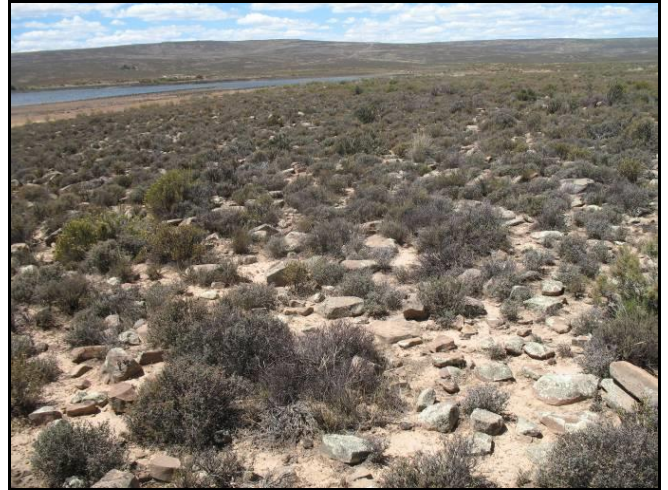
Approximately three units are planned for Node 4, which is located on the eastern bank of a moderately large farm dam (Figures 3, 13 & 14). The site is fairly level, and very rocky and covered in bush, low scrub and some grasses. A new road will be built to access the proposed site. The upper slopes of the affected lands are moderately steeper and a low shale ridge is situated further to the east, close to a gravel farm road. Two small outcroppings of dolerite occur outside the proposed development footprint.

**Finds:** An indurated shale end scraper was found on the affected site, but this was located outside the proposed development footprint.

Figure 13. Node 4 view facing west

Figure 14, Node 4 view facing north west

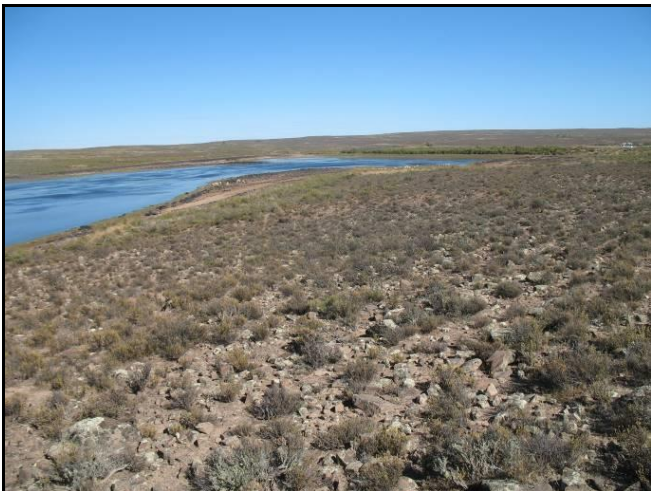
Approximately five units are envisaged for Node 5 which is situated on the northern bank of a large farm dam, about 400 m south of the Bo-Visriver Road, and about 500 m from the entrance to Driefontein Farm (Figures 2 & 15). A new road will have to be built to access the proposed site (Figure 16). The site is covered in low bush and scrub and is very rocky and stony, with some open patches occurring in places. The proposed site is fairly level, but slopes gently toward the farm dam. There are no significant landscape features that occur on the proposed site, but a dolerite ridge about 350 m to the east of the proposed site was inspected for archaeological remains.

**Finds:** No archaeological remains were documented in Node 5.

Figure 15. Node 5 view facing south west

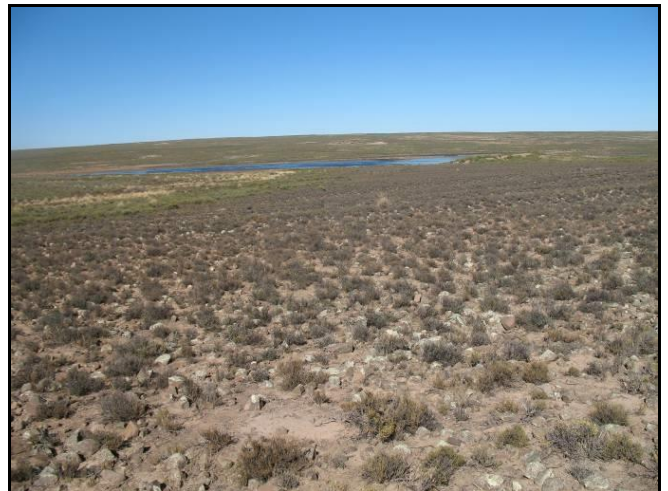
No archaeological remains were found in the proposed access road.

Figure 16. Node 5 view of dam and proposed access road facing south

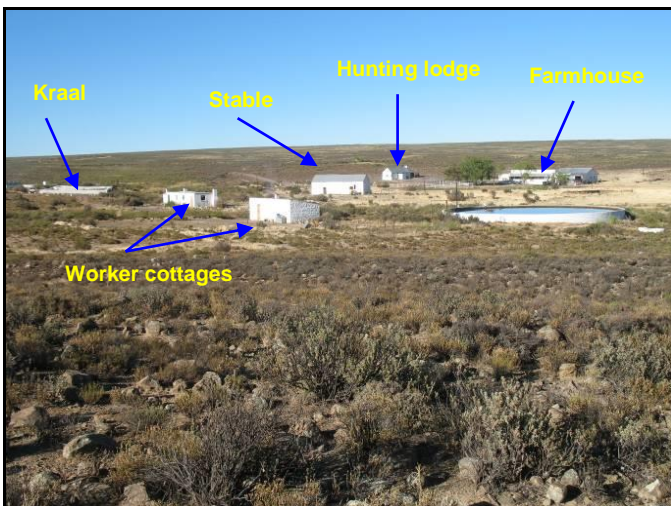
Node 6 comprises the existing Driefontein Farm werf with cottage/hunting lodge, stables, sheep kraal, worker cottages and dam (Figure 17). It is envisaged that the worker cottages will be upgraded as possible weekend rental options. The cottage/hunting lodge and stables may also be restored (and upgraded) to accommodate visitors and their horses. As indicated above (on page 3), the worker cottages are of recent age and are of no historical value, while the hunting lodge retains some integrity even though a bathroom has been inappropriately added at the back and the original windows and roof have been replaced (Figures 18 & 19). The original (thatch) roof of the stable has also been replaced (Figure 20). The original farmhouse burnt down in the 1960s and has been inappropriately 'restored' and converted into flats.

**Finds:** No archaeological remains were documented in Node 6.

**Figure 17. Node 6 farm werf**

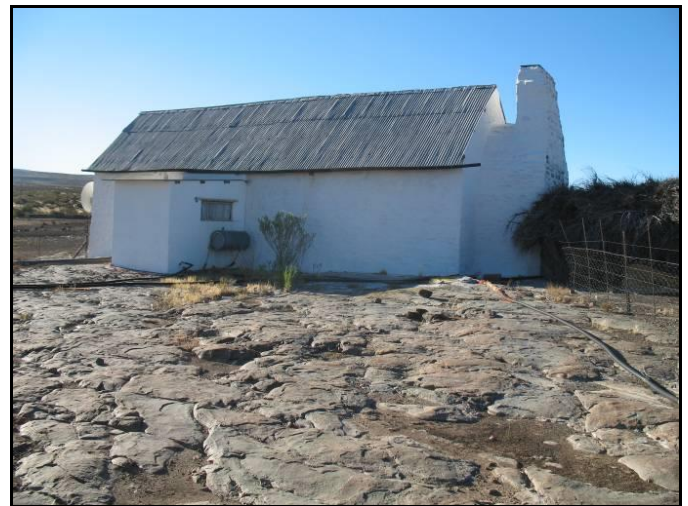
**Figure 18. Node 6 Hunting lodge (back). Note bathroom addition**

- A conservation architect must be consulted to assist in the (proposed) restoration of the stables and cottage/hunting lodge within the Driefontein farm werf.

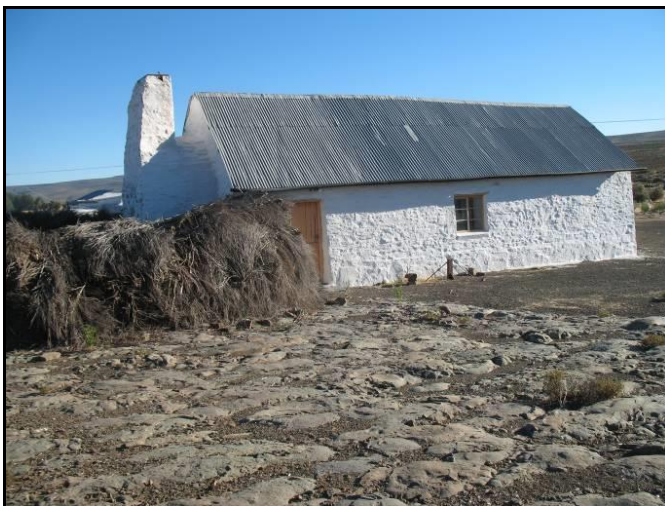
**Figure 19. Node 6 Hunting Lodge (front)**

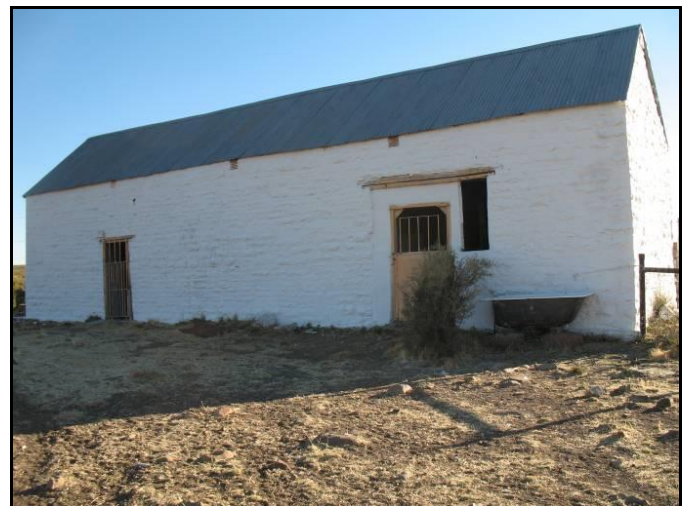
**Figure 20. Node 6 Stables**
