**PROPOSED STRENGTHENING (PARTIAL RECONSTRUCTION) OF
NATIONAL ROUTE 27 SECTION 7 & 8 BETWEEN WESTERN/
NORTHERN CAPE BORDER (KM 40.0) AND CALVINIA (KM 70.0)
CONTRACT R.027-080-2011/1D**

Heritage Impact Assessment conducted under Section 38 (8) of the National
Heritage Resources Act No 25 of 1999 as part of a Basic Assessment.

David Halkett and Tim Hart
Archaeology Contracts Office
8 Jacobs Ladder
St James
7945

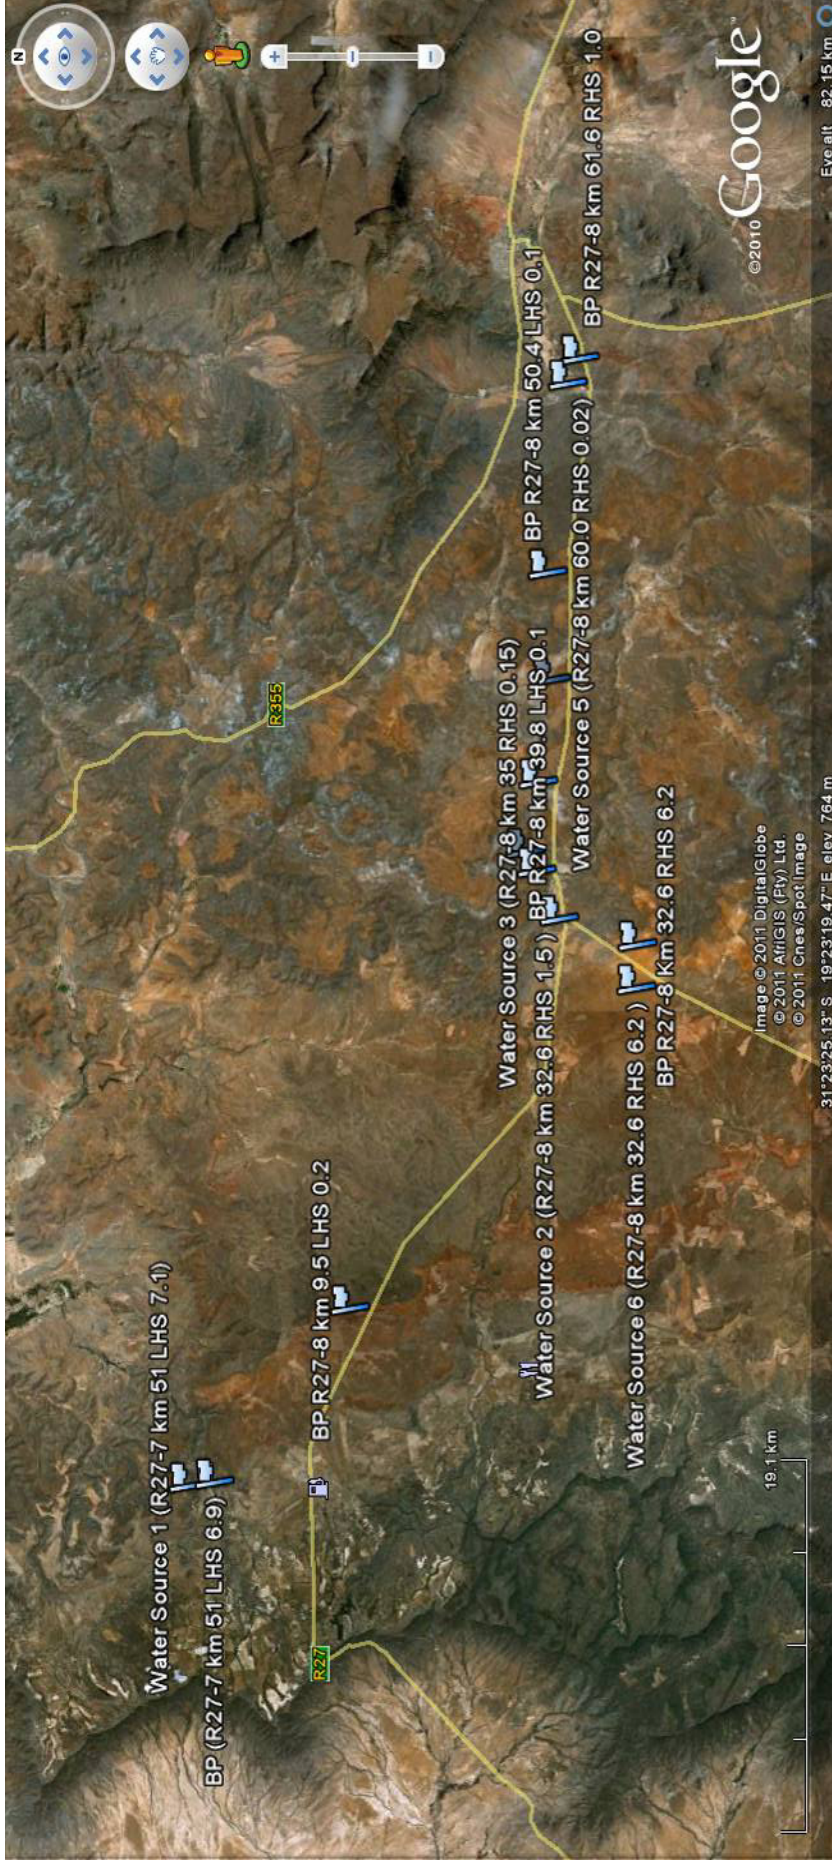
Figure 2. Locations of borrow pits and water sources.

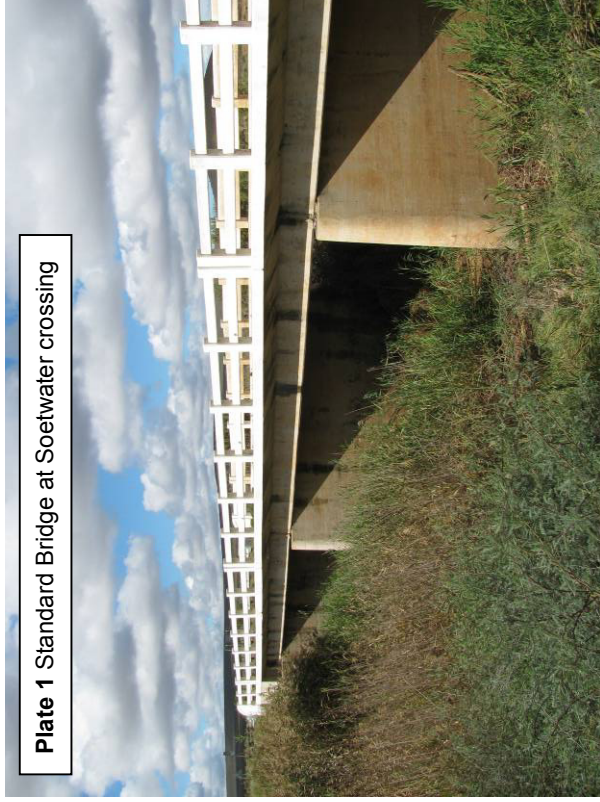
Plate 1 Standard Bridge at Soetwater crossing

Bridges. Of the 4 bridges on the route, one of these is of heritage significance. The other three bridges are standard South African road bridges (Plate 1) built circa 1955-1965. These are not unique and are not generally protected.

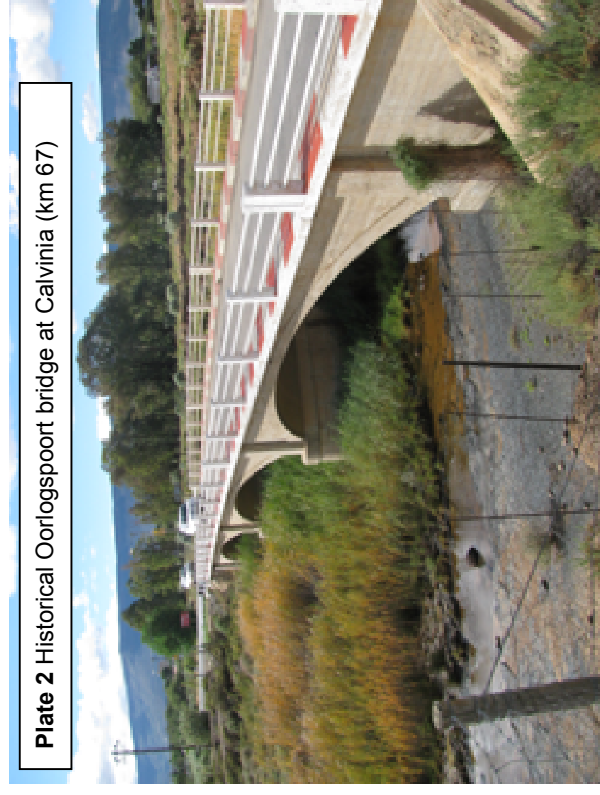
Plate 2 Historical Oorlogspoort bridge at Calvinia (km 67)

The Calvinia bridge (km 67) however, is a 4 pier concrete arch bridge typical of bridges built by the engineering firm Murray and Stewart Ltd shortly after the establishment of the company circa 1930 (Plate 2). Archival research conducted by ourselves and CCA Environmental Pty Ltd has revealed that the bridge was constructed in 1937-38 (Figures 3) to replace an earlier concrete bridge which was washing away (see Appendix A). The Calvinia bridge is significant on account of its age, its aesthetic qualities and gateway position at the western “entrance” to Calvinia. Similar examples exist at Keimoes, Upington as well as over the Fish River in the Eastern Cape (Middleton) and at a rail crossing over the Gamka River at Laingsburg. No doubt there are others which have not been documented.

Built environment. Impacts to the built environment involve the potential changing of a bridge structure that shows very little evidence of change in that last 70-80 years.

The bridge deck and balustrades do not comply with modern load requirements and its alteration has become necessary for safety considerations. The design approach of limiting the bridge widening to one side only has been adopted in order to preserve as much of possible of the original structure. In addition, the design would retain the essential arch form to match the existing design style and characteristics. Without mitigation the impact of alterations to Bridge NB38 has been assessed as of local extent, permanent duration and high intensity, with an associated significance rating of **Medium**. With mitigation the impact will be **low**.

It is proposed to widen the bridge by 6.15 m to the downstream side only so as to retain as much as possible of the existing historical substructure. The additional structure would be designed in the form of arch-type piers in order to match the existing design style. The physical footprint of the bridge substructure would increase by approximately 41.1 m² as a result of the additions. The existing balustrades pose a safety hazard as they are substandard and would not be capable of absorbing current vehicle impact loads in the event of an accident. It is therefore proposed to replace the balustrades in order to comply with the minimum required safety standards for the bridge. Detailed design proposals for this bridge are not yet available at this stage. It will be undertaken by specialist bridge design engineers to ensure compliance with both SANRAL safety standards and heritage requirements to conserve the historical structure (CCA Environmental Pty Ltd 2011).

Mitigation is proposed for the Calvinia road bridge over the Oorlogsrivier. Modification of the bridge will need to be permitted by the Northern Cape Heritage Authority (Ngwao Boswa Kapa Bokone).

- Ensure that the addition and modifications to Bridge NB38 adheres to the design style and characteristics of the existing arch bridge.
- Change the fabric of the structure only where unavoidable.
- Ensure that the appropriate design solution for the proposed modifications is acceptable to the responsible heritage authority, Heritage Northern Cape, as well as the project proponent, SANRAL.
- Commission a systematic recording of fabric of Bridge NB38 prior to alteration by means of measured drawings and a photographic survey.
- Undertake a comprehensive photographic survey of the site before work commences and during construction to generate an archive of information.
- Lodge a compact disc containing the above information with the Provincial Heritage Authority and SAHRA.

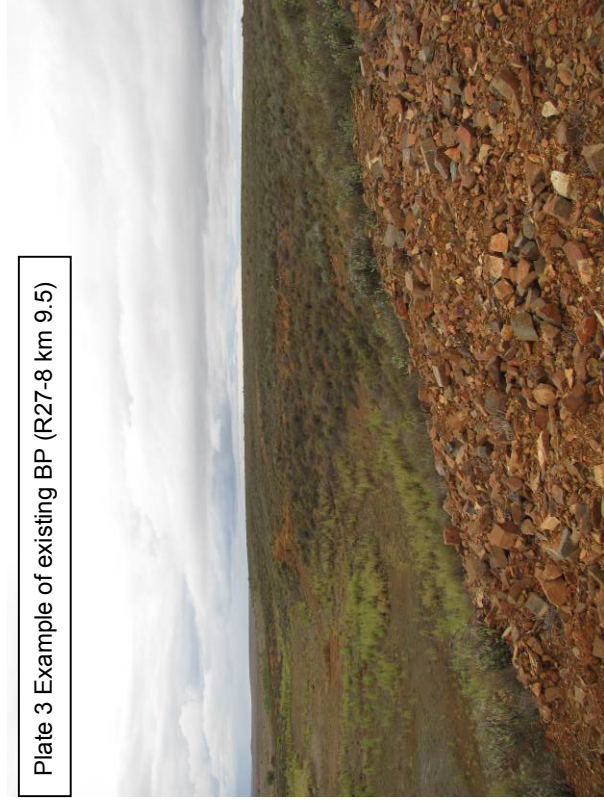
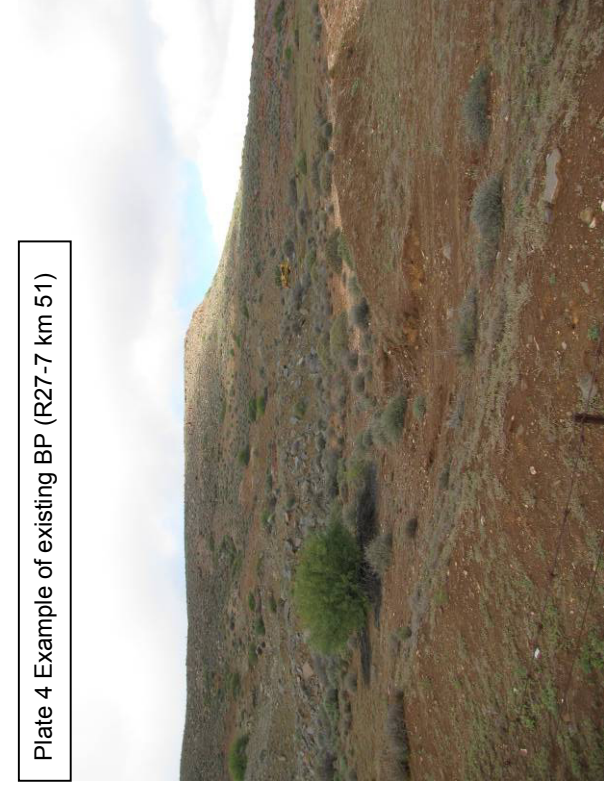
Borrow pits. The field inspection of the borrow pits (examples Plates 3-4) indicated that heritage impacts were minimal. All the sites are situated in a rural context, and

all will be rehabilitated after use in compliance with current environmental standards. In only two instances did archaeology occur at frequencies of 1 artefact per 10 sq.m. The impacts associated with these two occurrences are of very low significance, and no mitigation is proposed. Observations are summarised in Appendix A. Walk paths of the team are indicated in Appendix B.

Plate 3 Example of existing BP (R27-8 km 9.5)

Plate 4 Example of existing BP (R27-7 km 51)

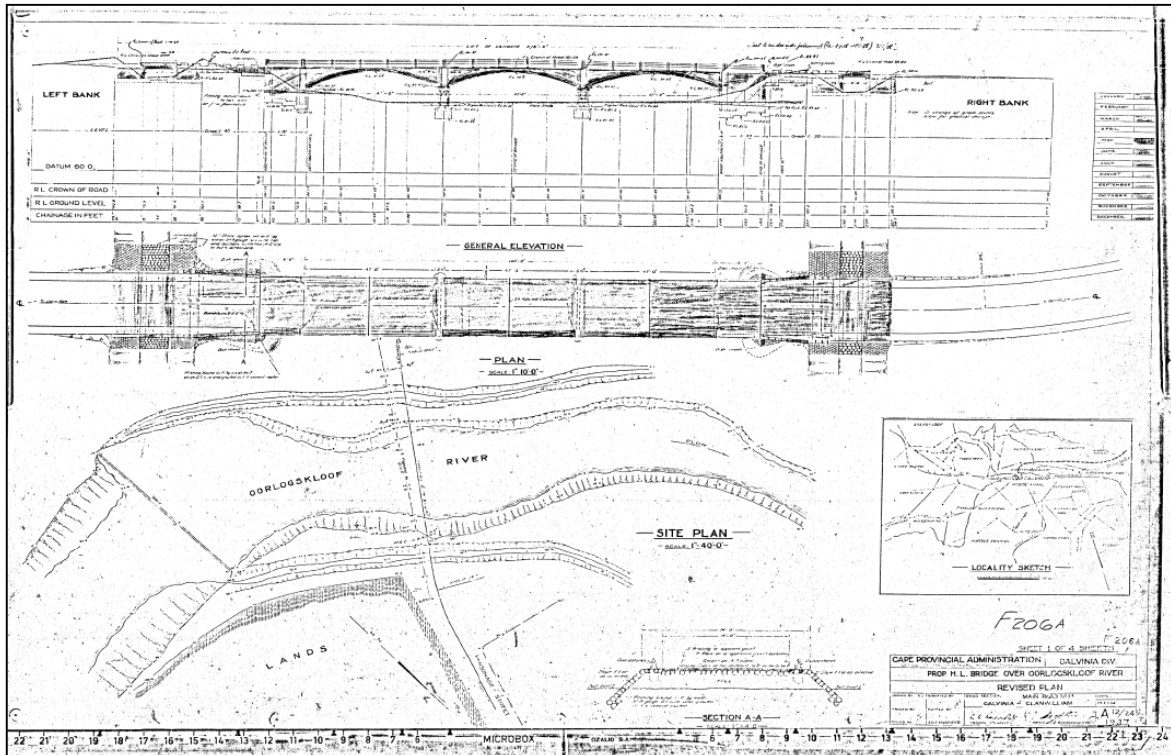
Trunk Road 16 Section 3		BRIDGE	2497
Bridge Reference Numbers			
Bridge Number	:	2497	
Bridge Name	:	Oorlogskloof River No 4	
File Number	:	Unknown	
Index Number (General Arrangement)	:	A12/24	
Progress Plan Number	:	F206A	
Bridge Location			
D.R.E. Area	:	Ceres	
R.S.C. Area	:	Noordweste	
Bridge Warrant History			
Warrant 1	:	New Location	
Bridge Type Information			
Crossing Type	:	Road over River	
Bridge Type	:	Fixed Arch Bridge with Spandrel Walls	
Deck Type	:	Arch under Fill	
Deck Material Type	:	Ordinary Reinforced Concrete	
Deck Construction Type	:	In-Situ Construction	
Balustrade Type	:	R.C. Stanchion with Precast Railing	
Bearing Type	:	Steel Roller	
Expansion Joint Type	:	Filled Gap	
Abutment Type	:	R.C. Cellular Box	
Pier Type	:	Solid R.C. Wall	
Foundation Type	:	Spread Footing	
Founding Material Type	:	Unknown	
Bridge Dimensions			
Skew (degrees)	:	90	
Radius (m)	:	On Straight	
Number of Spans (side view)	:	3

Number of Main Spans	:	3	
Maximum Span Length (m)	:	14.30	
Overall Length (m)	:	53.50	
Number of Carriageways	:	1	
Number of Traffic Lanes	:	2	
Carriageway Width (m)	:	5.50	
Number of Footwalks	:	2	
Overall Width (m)	:	7.20	
Vertical Clearance (m)	:	3.00	
Bridge Design Information			
Design Authority	:	CPA (Roads Department)	
Design Date (year/month)	:	37/06	
Design Flood Return Period	:	Unknown	
Design Discharge (cub m/s)	:		
Design Flood Level (m)	:		
Maximum Depth of Flow (m)	:		
Design Freeboard (m)	:		
Highest Known Flood Level (m)	:		
Design Code	:	CPA (Before 1977)	
Traffic NA/HA Loading	:	Unknown	
Traffic NB/BB Loading	:	Unknown	
Traffic NC/HC Loading	:	Unknown	
Traffic (NC+2/3NA) Loading	:	No	
Bridge Construction Information			
Construction Authority	:	Divisional Council	
Completion Date (year/month)	:	38/06	
Construction Cost (Rands)	:	6780	
Report date : 2 Feb 1984

Figure 3 Details of Oorlogskloof Bridge (Provincial Engineers archive NC B2497, NC F206A)
