**GCS-RP/34/2021:
GEOHYDROLOGICAL
STUDY REPORT FOR THE
PIENAARSRIVIER FILLING
STATION,
PIENAARSRIVIER,
LIMPOPO PROVINCE.**

Report Prepared
for ACCURATE
TRADING 47 (PTY)
LTD

Report No
GCS-RP/034/2021

November 2021

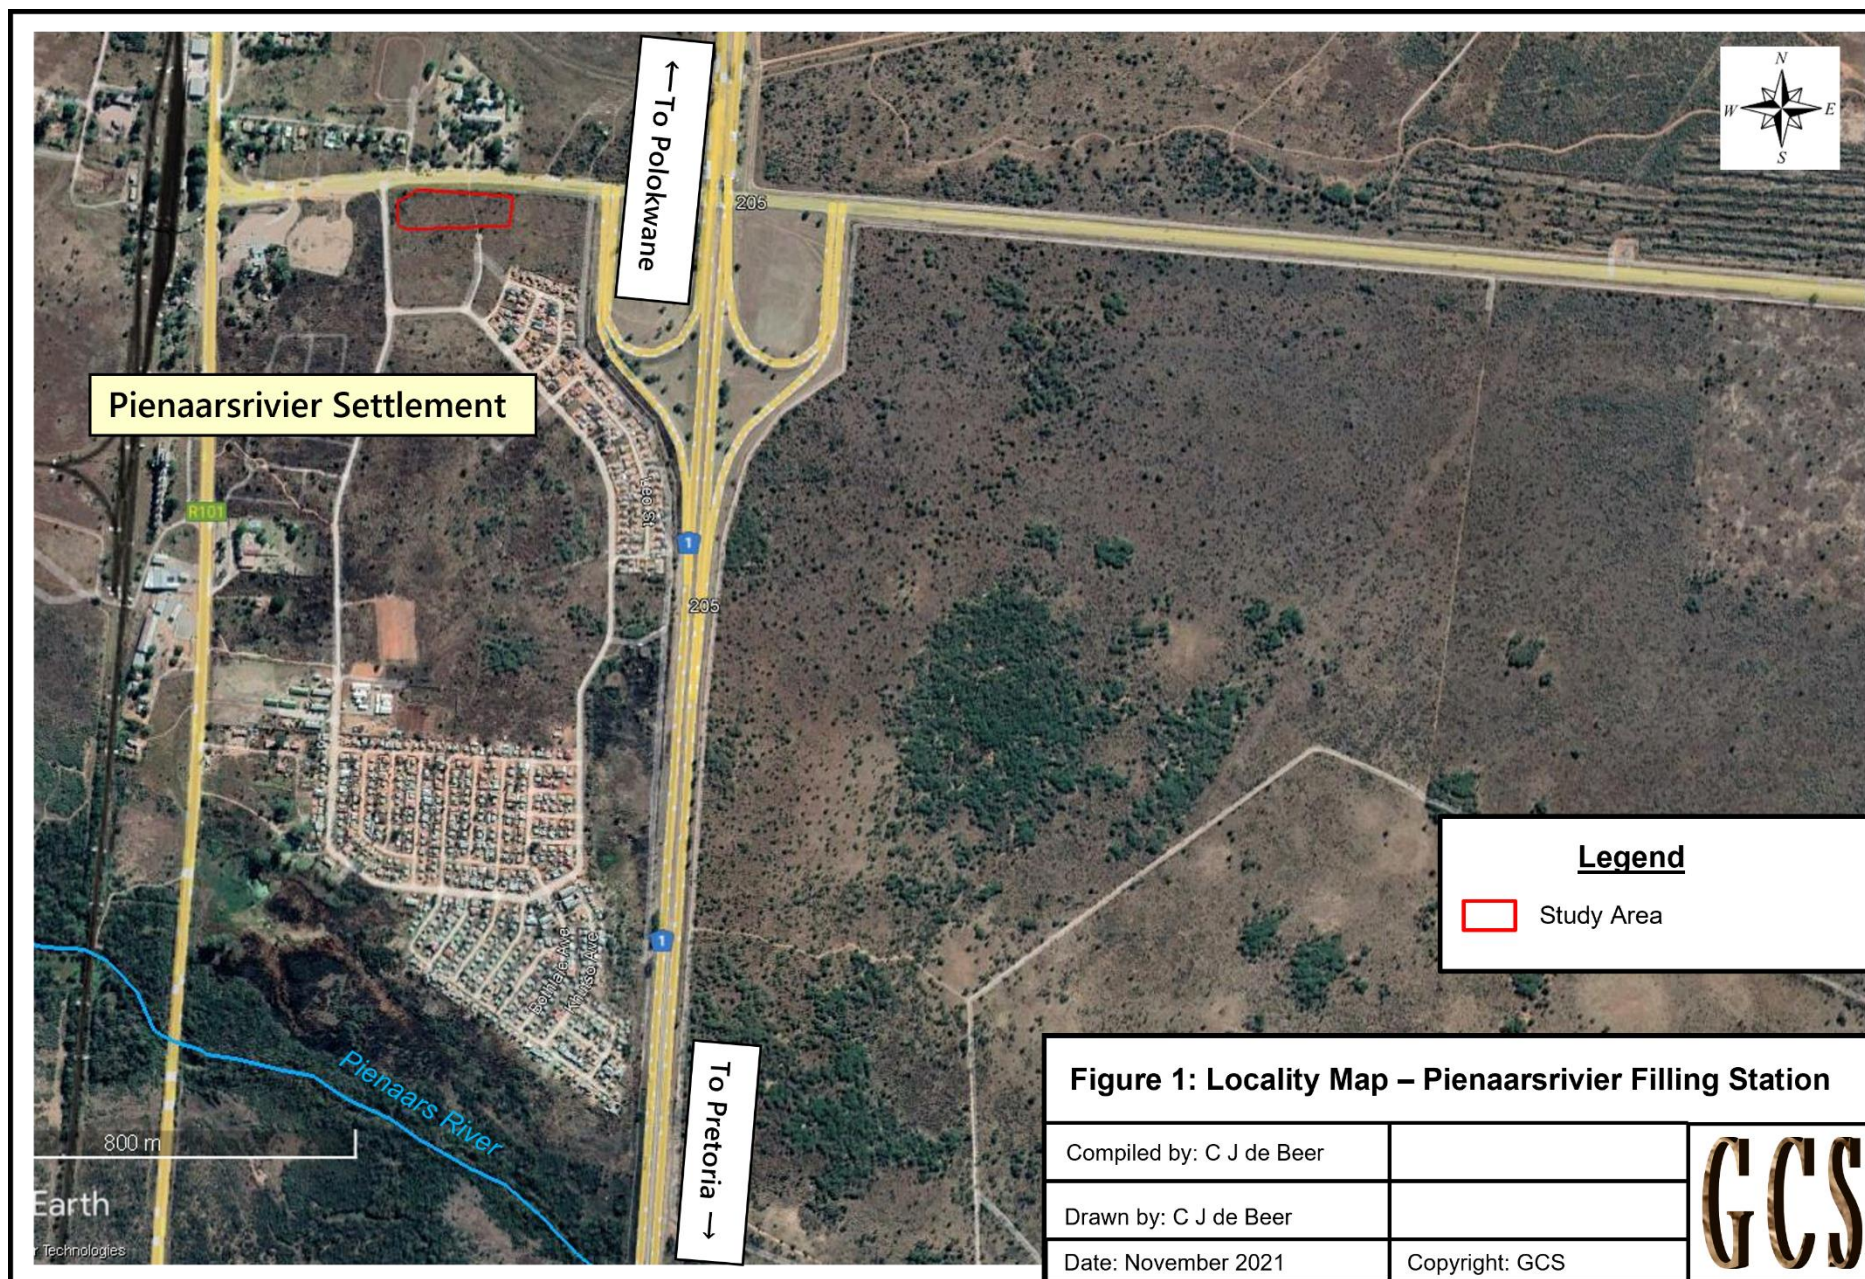
The site is located to the west of the N1 and east of the R101, on the southern side of the D626 road opposite the Pienaarsrivier Primary School at the town of Pienaarsrivier in the Limpopo Province at the approximate co-ordinates; 25°12'21.28"S 28°18'0.23"E. Refer to Figure 1

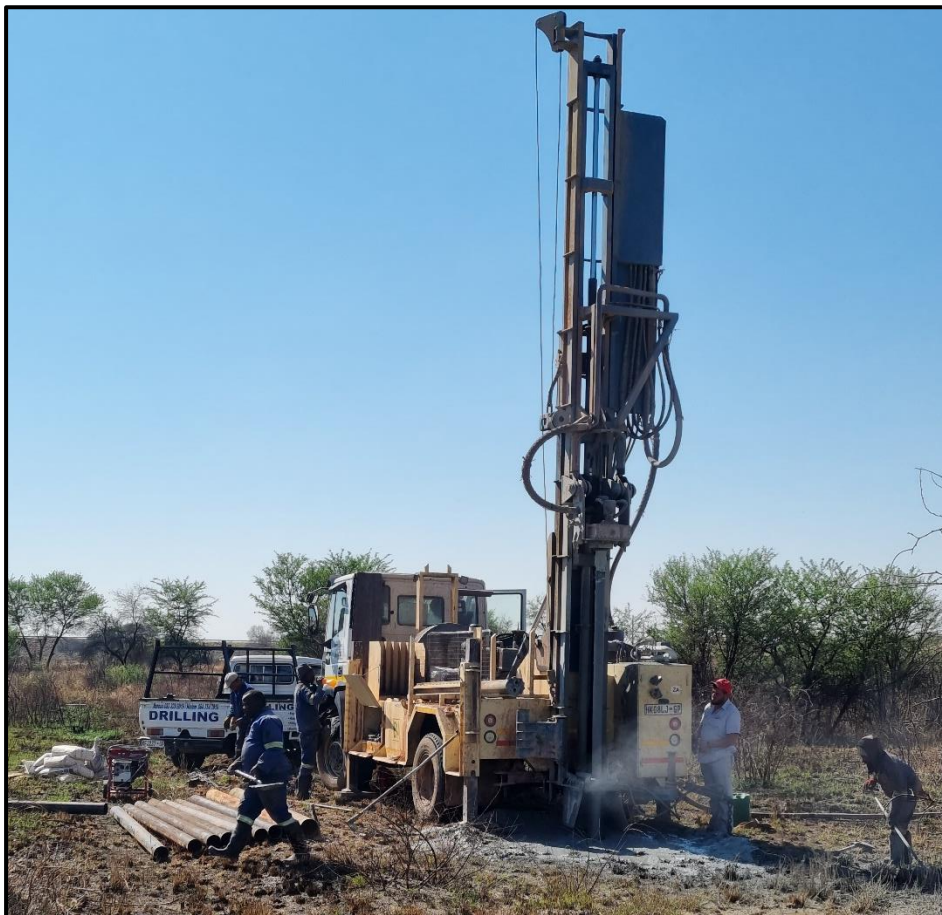
PHOTO 1: DRILLING OF MONITORING BOREHOLE

Torque Africa Drilling was contracted to drill a water monitoring borehole at the selected position and to equip it as a long-term monitoring borehole. The drilling was conducted on 17 September 2021. The borehole was drilled 132mm and a casing installed to 24m after an initial water strike at 17m the upper 16m of the casing were solid and the bottom two 4m

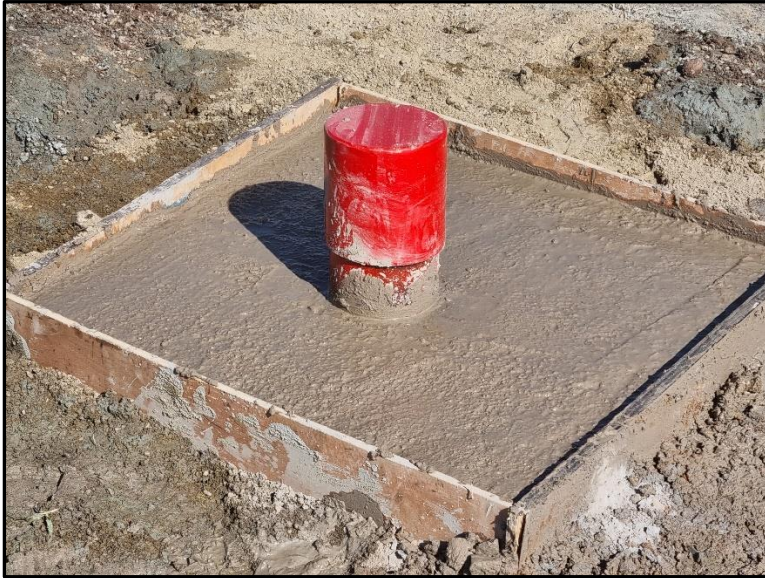
PHOTO 2: CONCRET PLINTH AND LOCKABLE CAP INSTALLED ON BOREHOLE

lengths were perforated. Attempting to continue drilling the borehole deeper to the planned depth of 30m, no sample return was achieved due to the difference between the diameter of the percussion hammer and the inside diameter of the casing was less than 10mm. this resulted in the drill chips wedging the hammer. Due to the risk of losing the drilling equipment in the hole. It was decided to terminate the hole at 24m below surface. A gravel pack was also installed around the casing and a concrete plinth was installed, see photo 2.

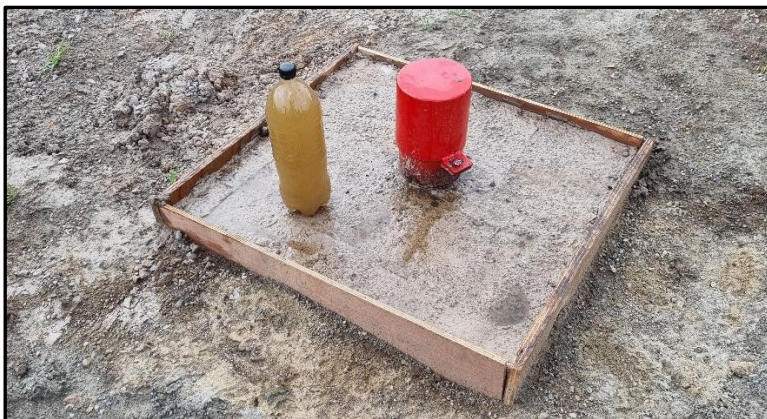
PHOTO 3: WATER SAMPLE COLLECTED

The driller flushed the borehole for 1 hour and then it was left to settle for seven days before the water sample was collected using a bailer on 25 September 2021 (Photo 3)

Before the water sample were collected the static water level in the borehole were measured at 4.57m below the collar
