Appendix D6
Kareerand Tailings Storage Facility Expansion Project.
Wetland/Riparian Delineation and Functional Assessment
-Limosella Consulting, 2020

Kareerand Tailings Storage Facility Expansion Project.

Wetland/Riparian Delineation and Functional Assessment
June 2020

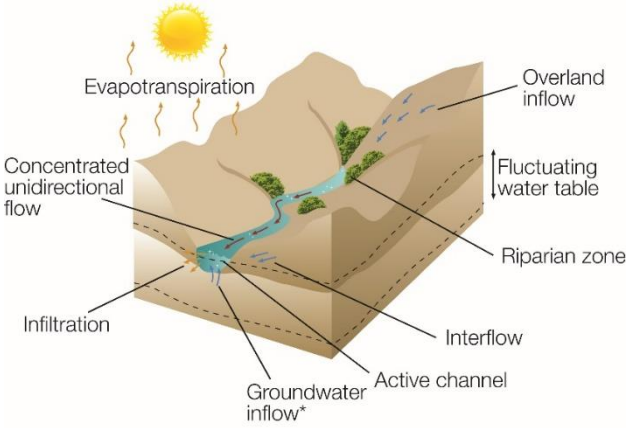
<p>RIVER * Not always present</p>	<p>Linear fluvial, eroded landforms which carry channelized flow on a permanent, seasonal or ephemeral/episodic basis. The river channel flows within a confined valley (gorge) or within an incised macro-channel. The “river” includes both the active channel (the portion which carries the water) as well as the riparian zone.</p>
<p>Valley bottom with a channel</p>

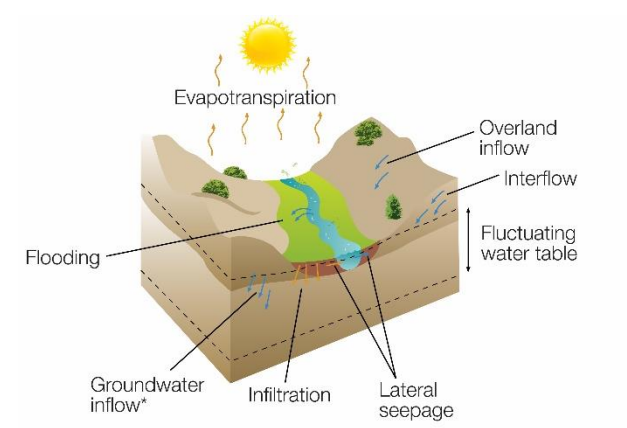
<p>CHANNELLED VALLEY-BOTTOM WETLAND * Not always present</p>	<p>Linear fluvial, net depositional valley bottom surfaces which have a straight channel with flow on a permanent or seasonal basis. Episodic flow is thought to be unlikely in this wetland setting. The straight channel tends to flow parallel with the direction of the valley (i.e. there is no meandering), and no ox-bows or cut-off meanders are present in these wetland systems. The valley floor is, however, a depositional environment such that the channel flows through fluviially-deposited sediment. These systems tend to be found in the upper catchment areas.</p>

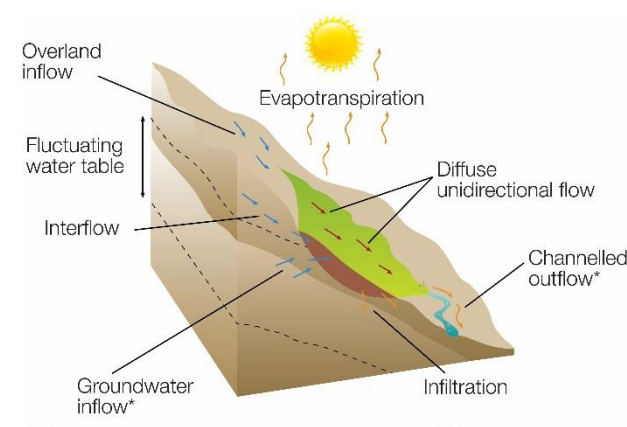
<p>SEEP * Not always present</p>	<p>Seepage wetlands are the most common type of wetland (in number), but probably also the most overlooked. These wetlands can be located on the mid- and footslopes of hillsides; either as isolated systems or connected to downslope valley bottom wetlands. They may also occur fringing depressional pans. Seepages occur where springs are decanting into the soil profile near the surface, causing hydric conditions to develop; or where through flow in the soil profile is forced close to the surface due to impervious layers (such as plinthite layers; or where large outcrops of impervious rock force subsurface water to the surface).</p>

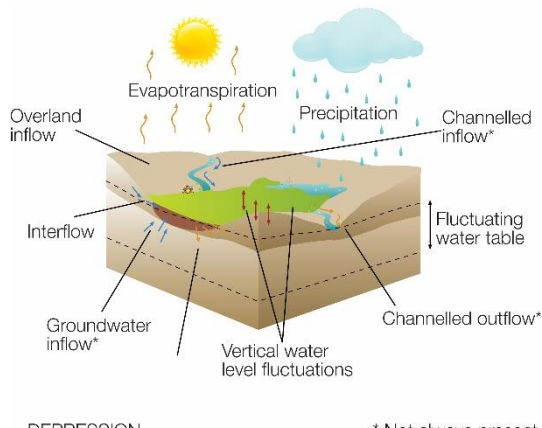
<p>DEPRESSION</p> <p>* Not always present</p>	<p>Small (deflationary) depressions which are circular or oval in shape; usually found on the crest positions in the landscape. The topographic catchment area can usually be well-defined (i.e. a small catchment area following the surrounding watershed). Although often apparently endorheic (inward draining), many pans are “leaky” in the sense that they are hydrologically connected to adjacent valley bottoms through subsurface diffuse flow paths.</p>

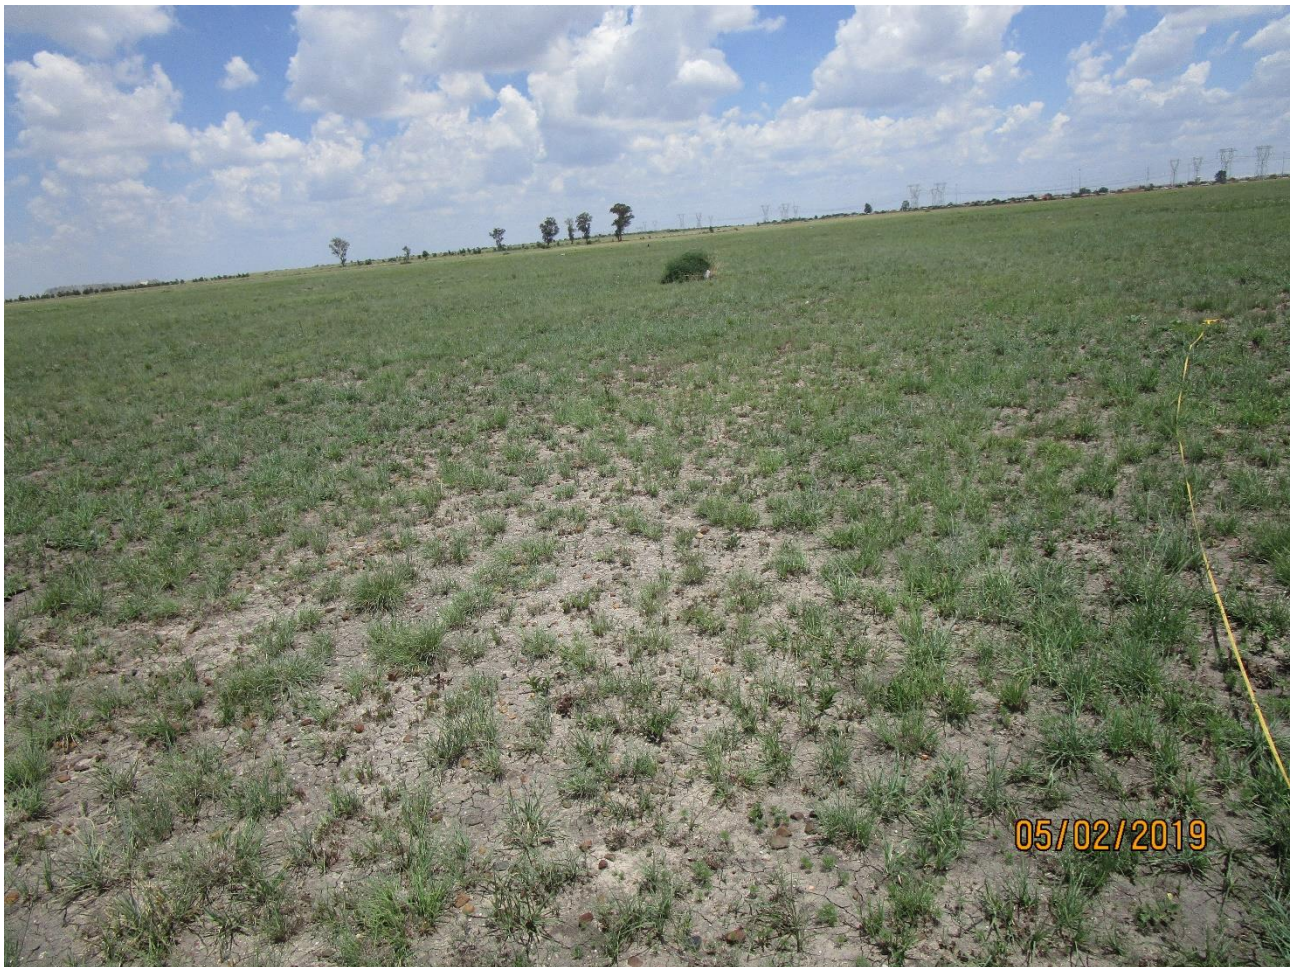
Figure 18: The Wildebeespan area showing short, sparse terrestrial plant species with clay rich soils.

Northeast of the Tailings Storage Facility a non-perennial pan is shown on regional hydrology layers. This area is known as Wildebeespan. Detailed soil and vegetation assessments in this area on the 10th of December 2018 and the 27th of February 2019 did not reflect conclusive wetland indicators although it is likely that moist soil may be elevated during very wet seasons. In some areas soils with high clay content will swell and

may occasionally support facultative wetland species. This moisture is however not sufficient for the area to be classified as a wetland following the definition in the DWS guidelines. Figure 18 shows the characteristics of this area.

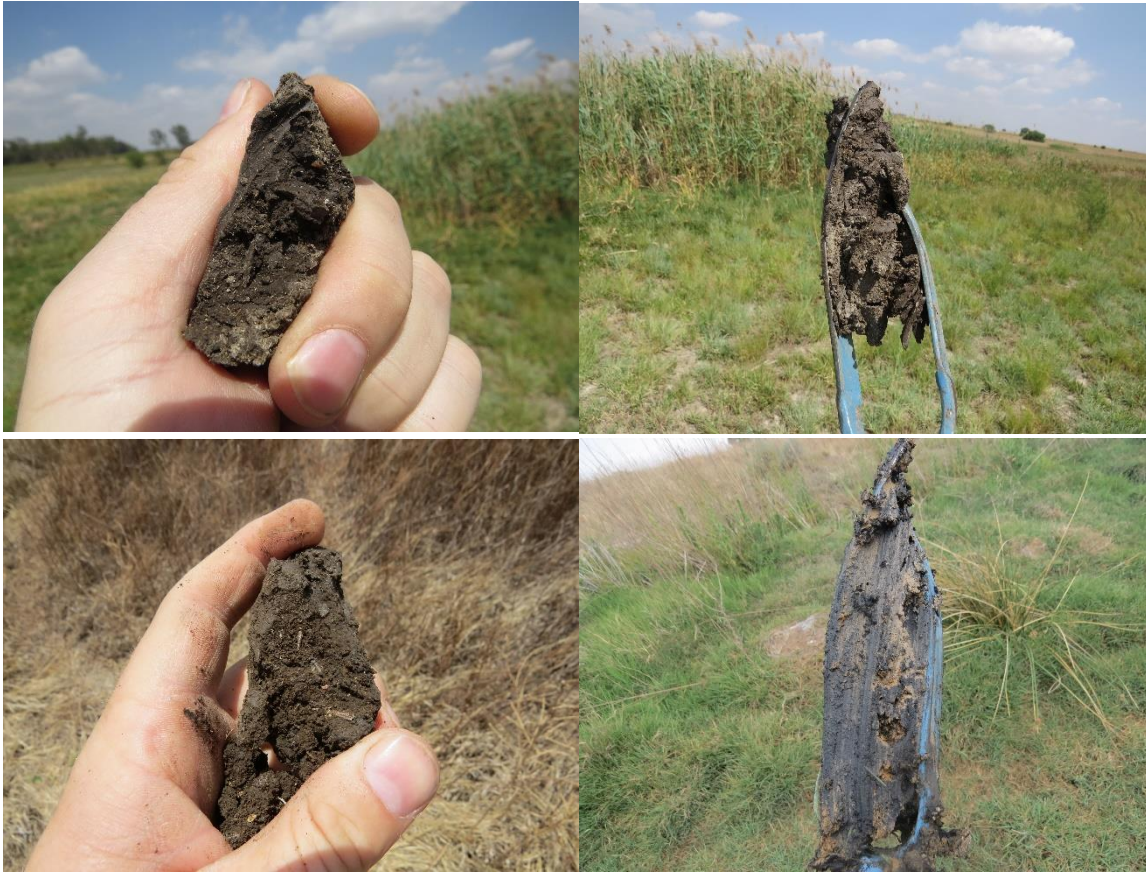
Figure 20: Soil characteristics of the unchannelled valley bottom wetlands on the study site. Note the structured, heavy dark clay

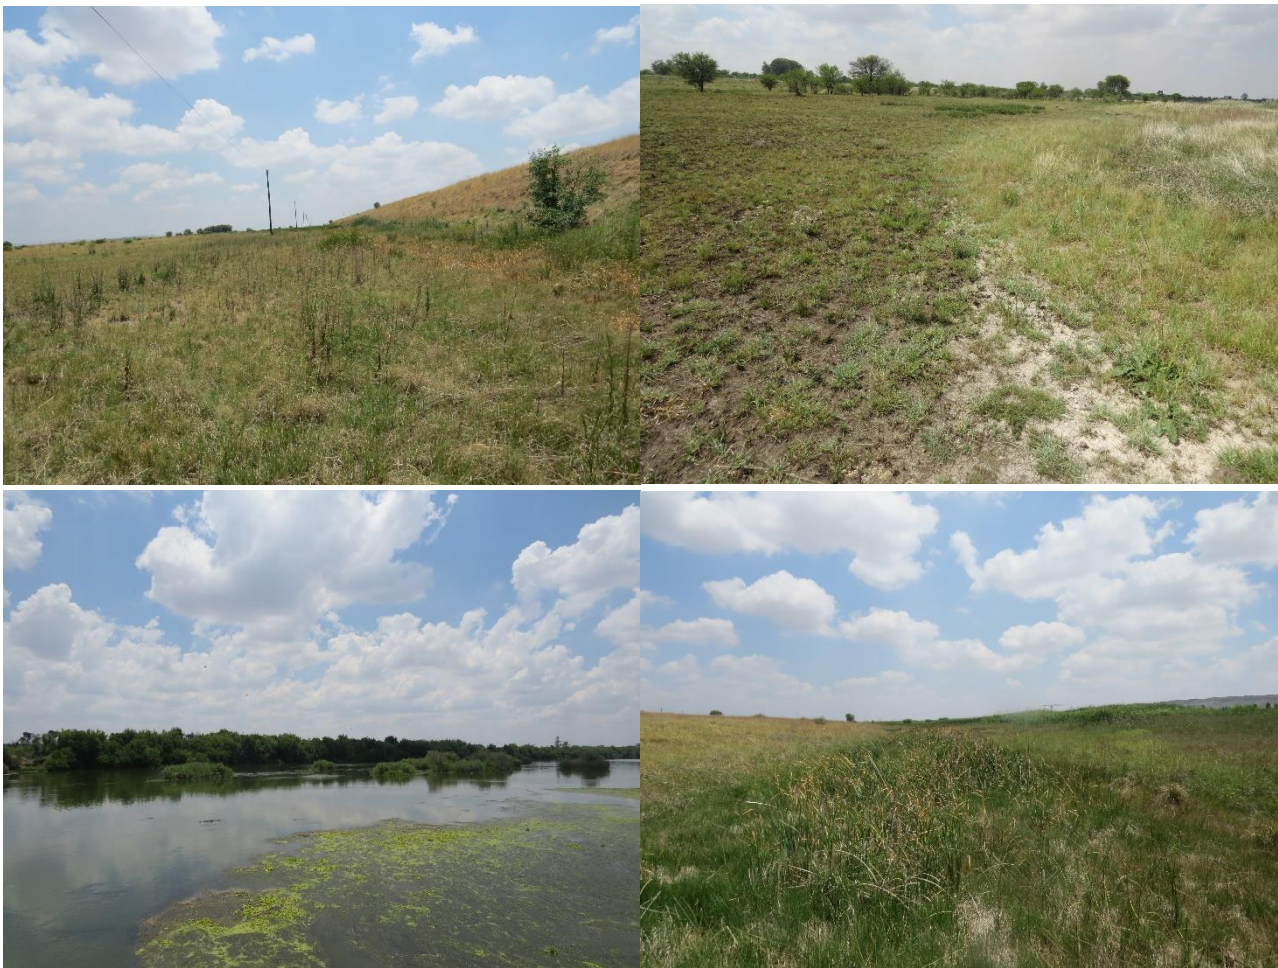
Figure 21: General characteristics of the wetlands and the Vaal River on the study site.

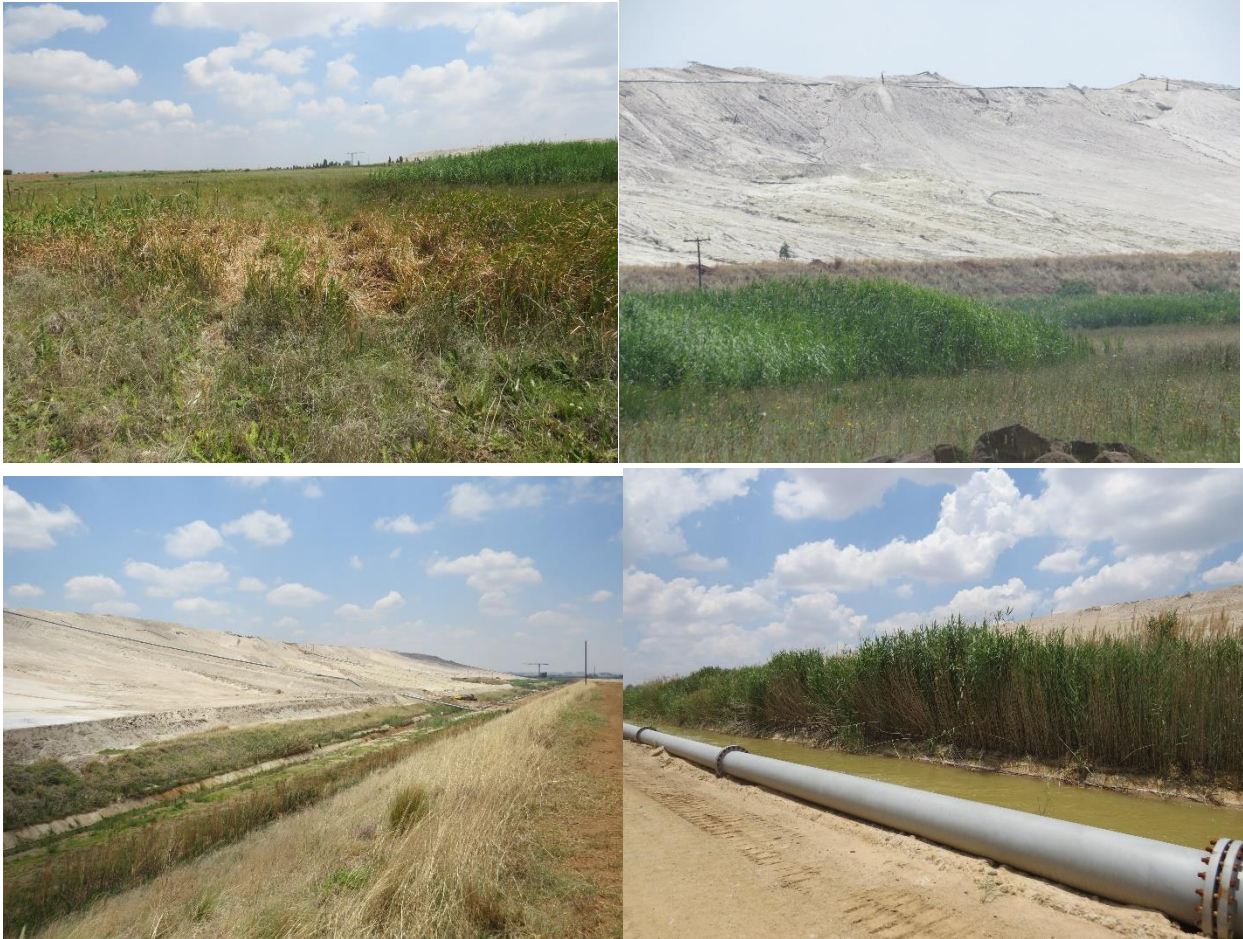
Figure 22: Images of impacts recorded within and surrounding the wetland areas tyre tracks through wetlands, and reclamation infrastructure.

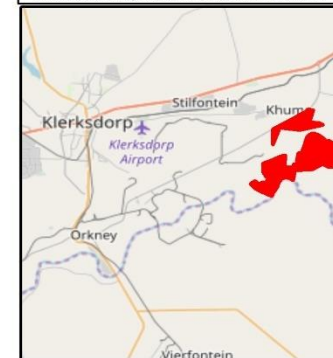
Wetland Delineation & Proposed Infrastructure

Figure 23: The proposed layout relative to wetlands discussed in this report
