**AQUATIC BIODIVERSITY
COMPLIANCE REPORT**

PROPOSED ACORN CITY MIXED USE TOWNSHIP DEVELOPMENT

Specialist Aquatic Biodiversity Compliance Assessment for the proposed development of a mixed township on Portion 27 of the farm Arthursseat 214-KU in the Bushbuck Ridge Municipality, Mpumalanga

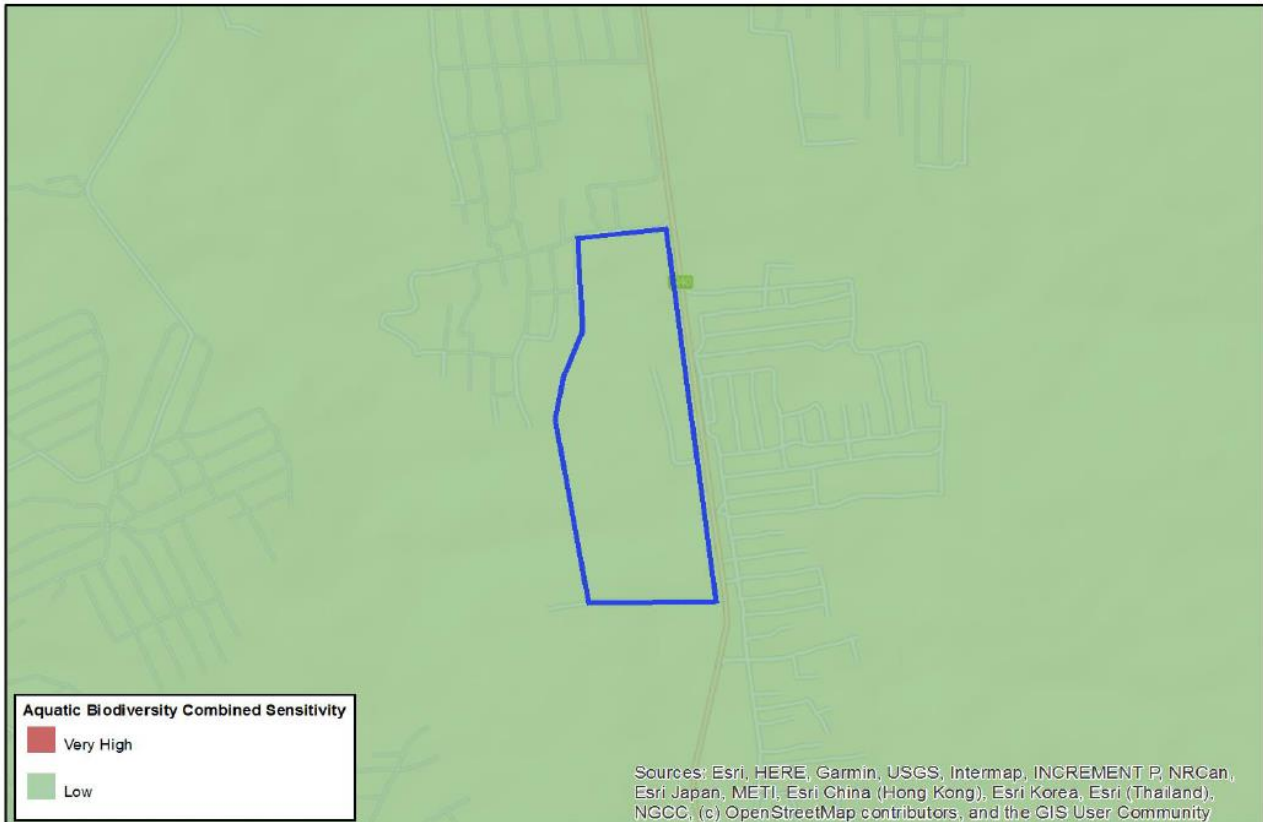
3.2.1 SCREENING OF AQUATIC SITE SENSITIVITY (NATIONAL WEB BASED TOOL)	
<p>Figure 1</p>

<p>Aquatic Biodiversity Combined Sensitivity ■ Very High ■ Low</p> <p>Sources: Esri, HERE, Garmin, USGS, Intermap, INCREMENT P, NRCan, Esri Japan, METI, Esri China (Hong Kong), Esri Korea, Esri (Thailand), NGCC, (c) OpenStreetMap contributors, and the GIS User Community</p>	
SCORE OF AQUATIC SENSITIVITY SCREENING	The development site is located within an area that pose a “Low” level of aquatic biodiversity.
INTERPRETATION OF THE AQUATIC SENSITIVITY SCREENING SCORE	
The Acorn City project area has been identified on the screening tool as being of “Low sensitivity” for aquatic biodiversity, therefore an Aquatic Biodiversity Compliance Statement is applicable.

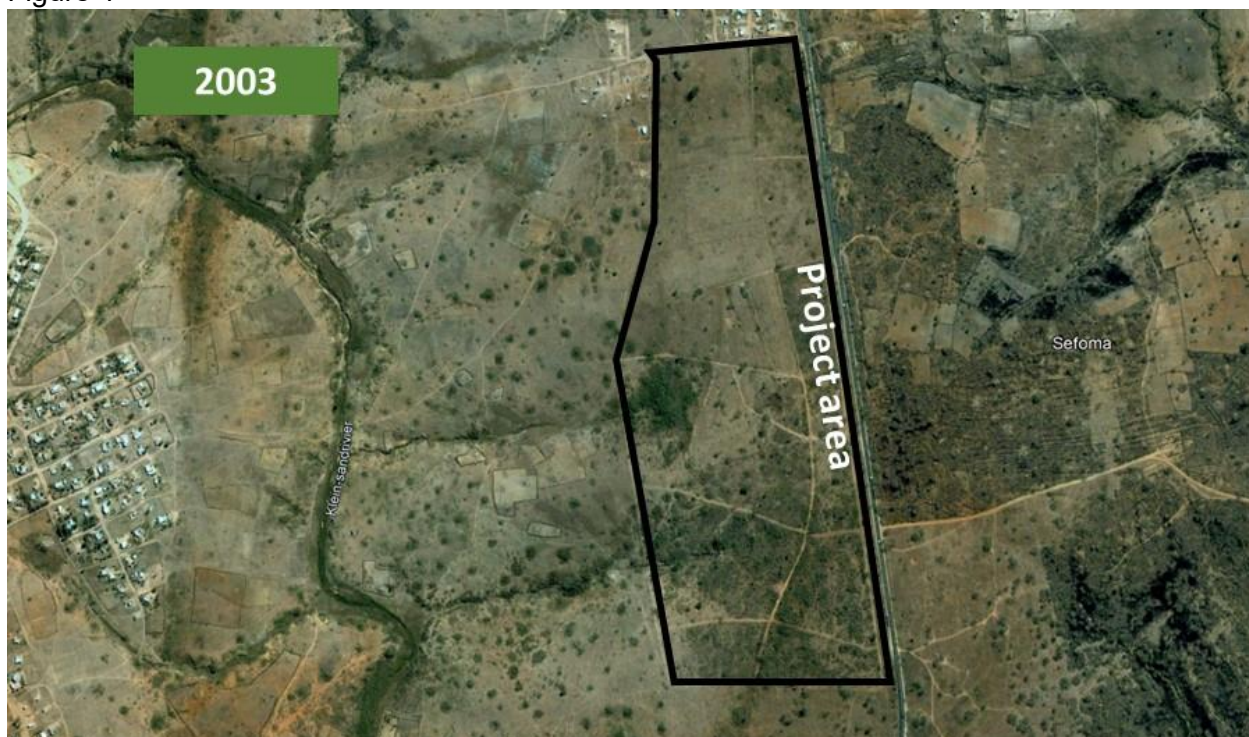
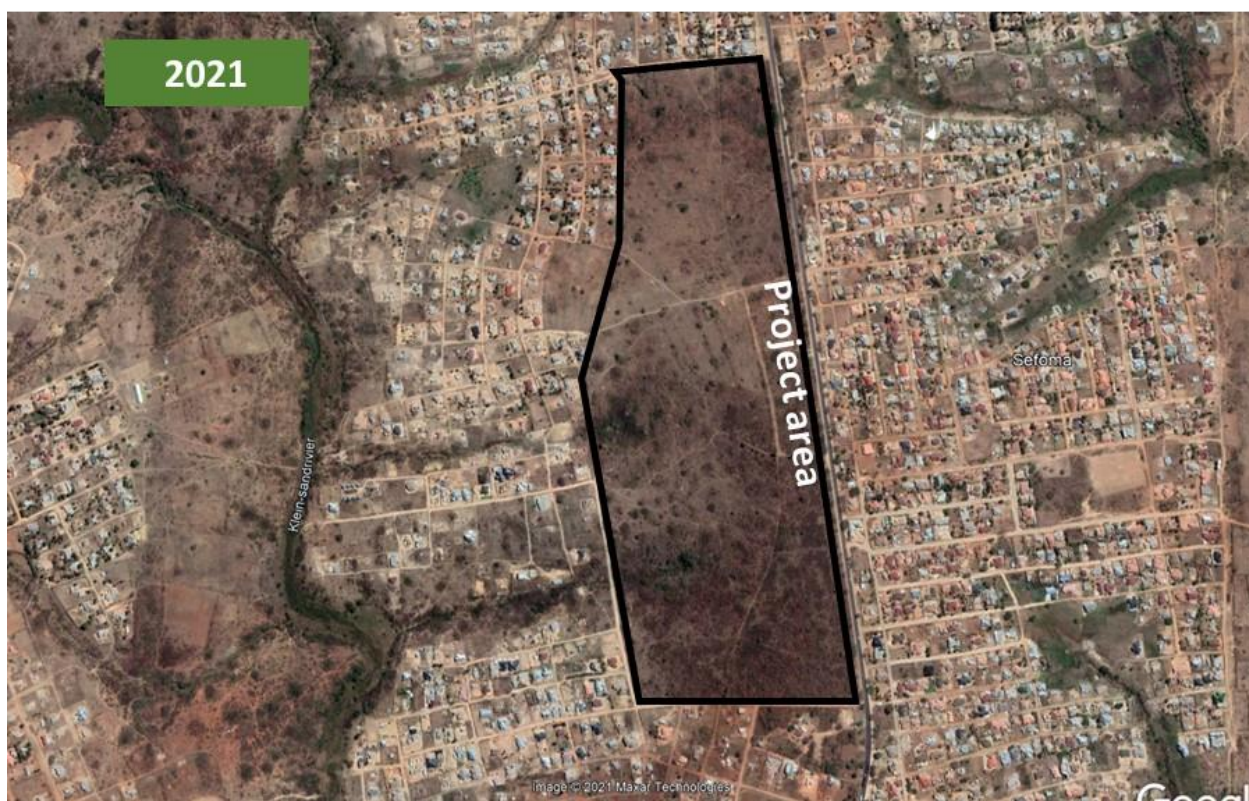
Figure 4

These photos illustrate the substantial change and vast spread of homestead development from 2003 to recent situation (2021) as viewed on the Google Earth time sequence.

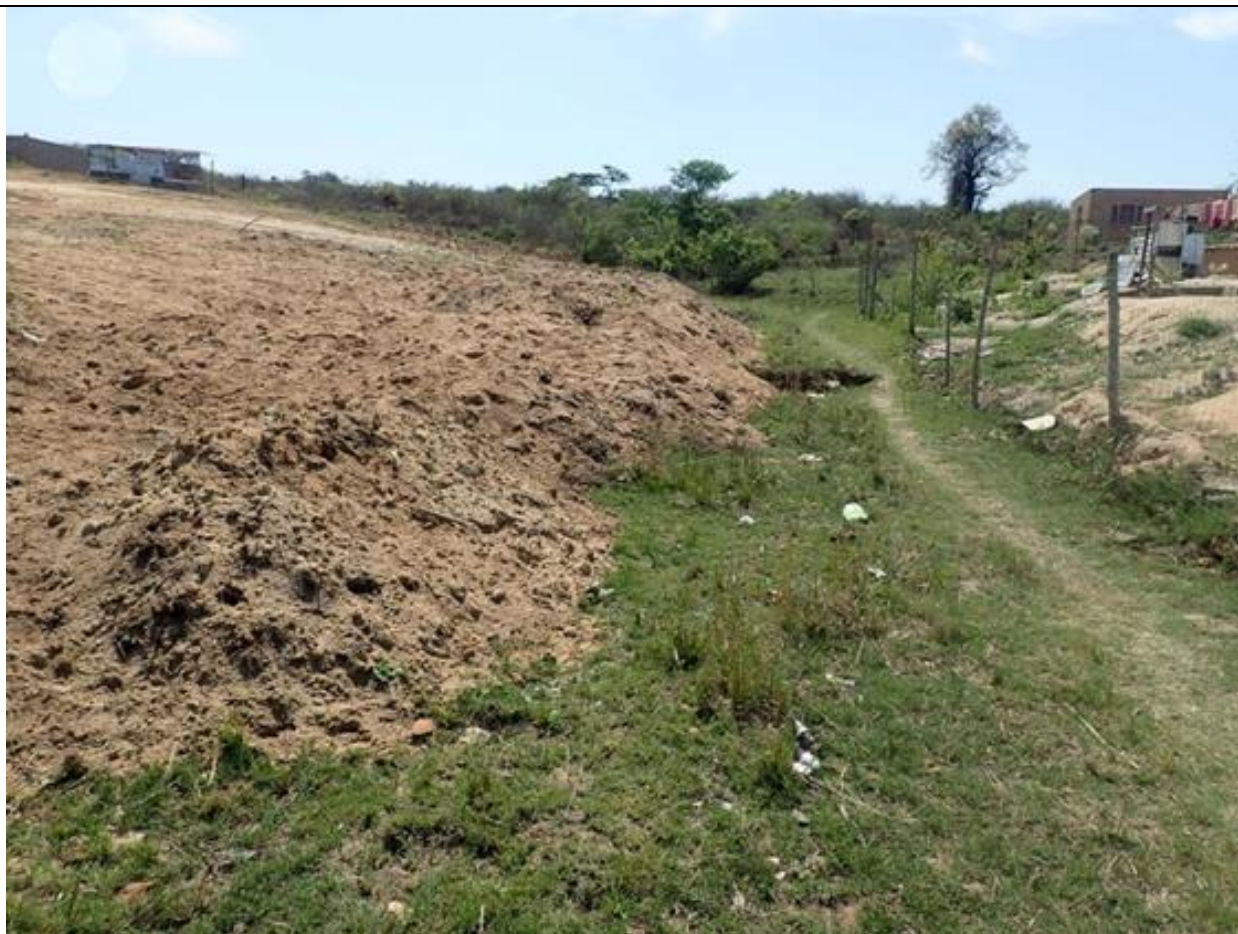
SITE PHOTO REFERENCE NUMBER: 4a

Once the drainage lines leave the area earmarked for the Acorn City development, it deteriorates and most of the natural habitat is degraded by homestead development and other anthropological impacts (Figures 4a, 4f and 4g). Bush clearing, erosion, rubbish dumping and sand mining are some of these impacts that deteriorates the drainage lines considerably (Figures 4d - 4e).

The area downstream of the project area has been transformed in many ways. This photo shows vegetation clearing as well as infilling of a building site right to the edge of the drainage line.

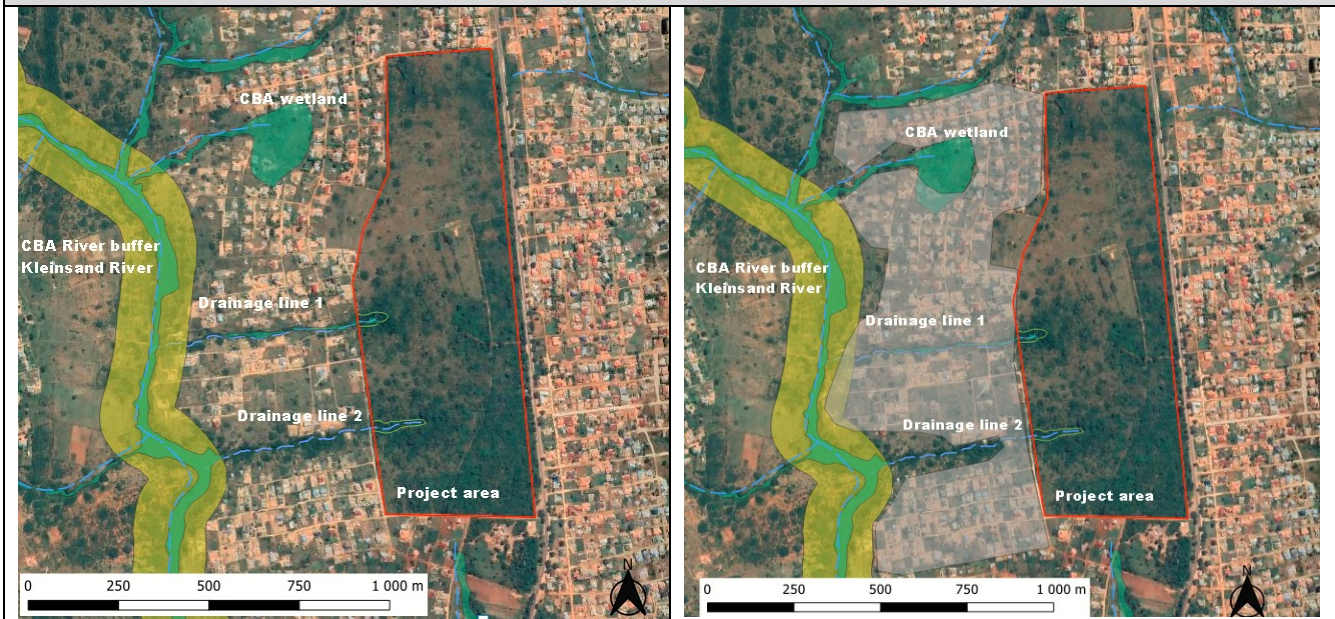
Figure 5: This figure compares two figures of the project area to illustrate: (left) the Critical Biodiversity River and Wetland for the Acorn City Project Area as illustrated by the LUDS programme (BGIS, 2015) for Mpumalanga; (right) the expansion of township development between since the CBAs were established.

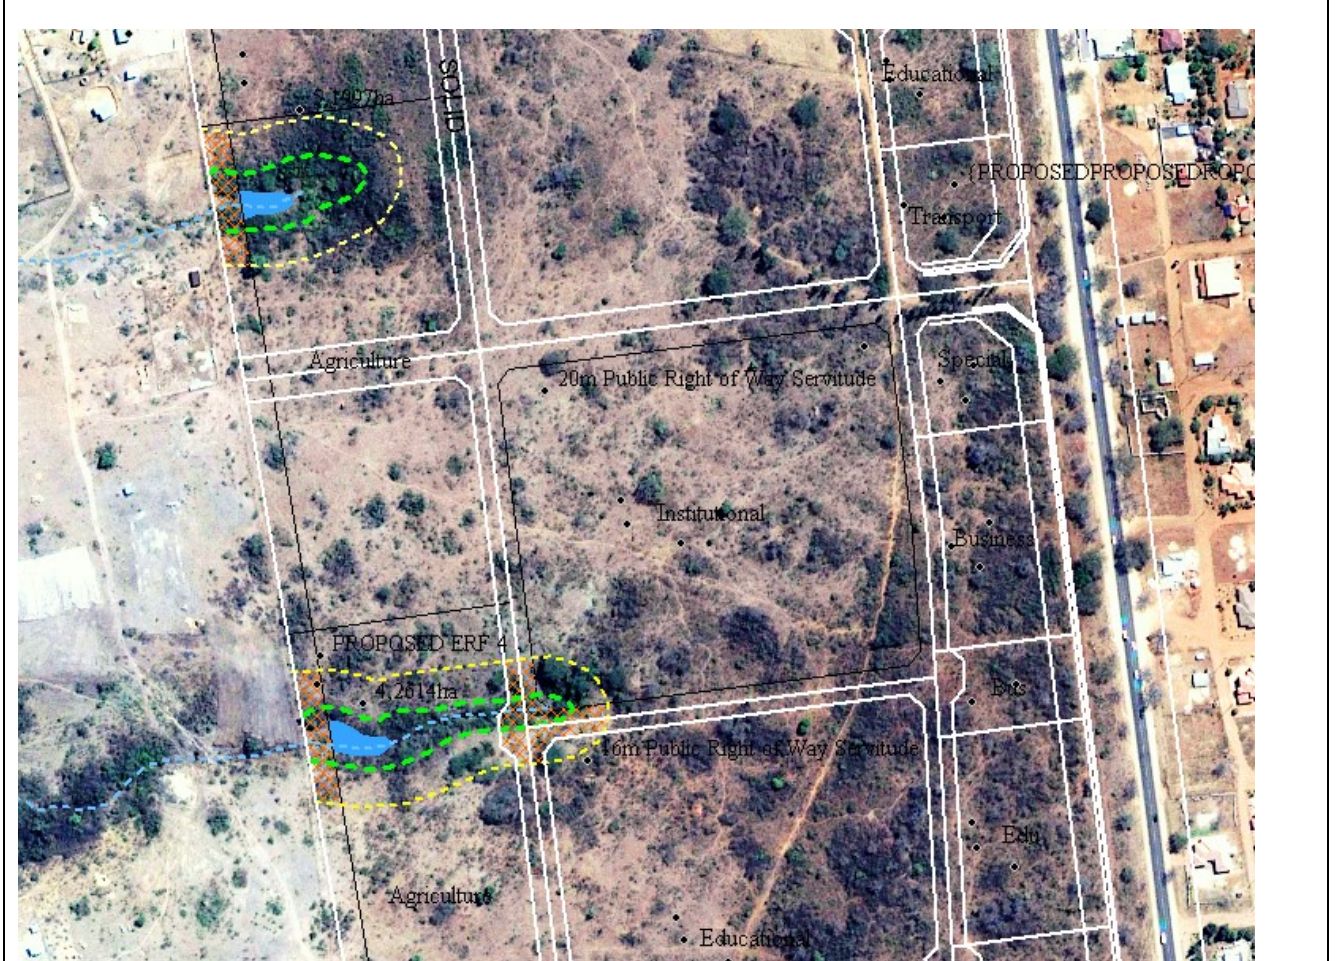
Figure 3: Allowable infrastructure to be installed within the drainage lines and buffer zones.
