FeCr Facility

**CLOSURE DESIGN REPORT FOR THE PROPOSED DECOMMISSIONING AND
CLOSURE OF THE FECR FACILITY: eMALAHLENI LOCAL MUNICIPALITY,
MPUMALANGA PROVINCE**

Project: TA007

January 2022

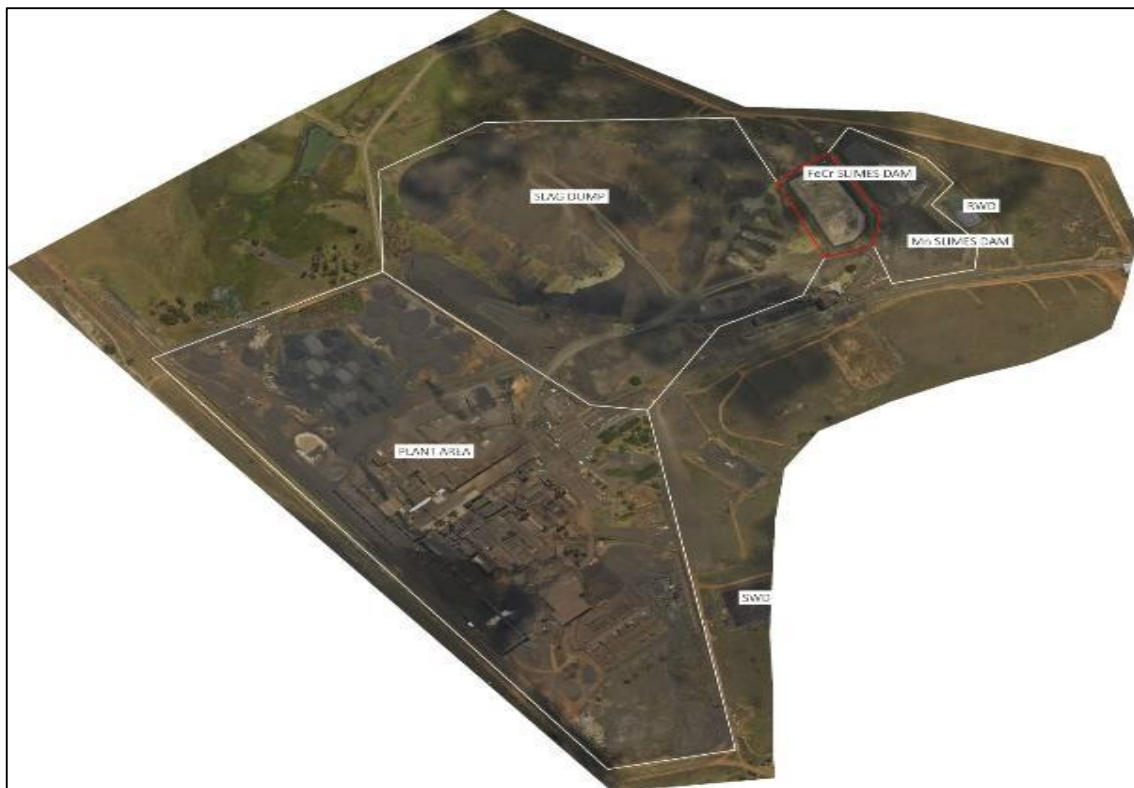
Figure 2: Location of the FeCr Facility Slimes Dam at Transalloys

The FeCr Facility was constructed during June 2007 and the disposal of FeCr Facility slimes ceased during February 2010. The dam is located just to the east of to the historical slag and current arising dump situated north- east of the Transalloys plant. The FeCr Facility Slimes Dam is located just west of the Mn Slimes Dam. Refer to Figure 2.

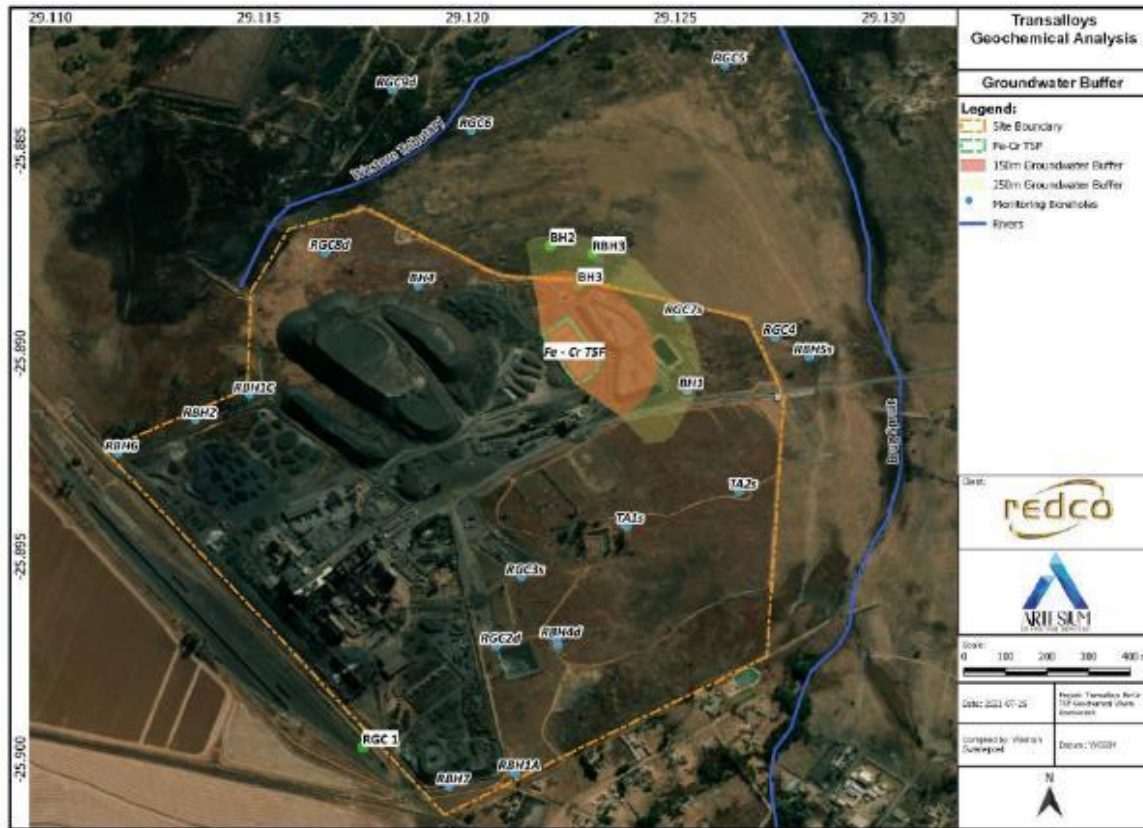
Figure 11: Groundwater use exclusion buffer zone

The results show that advective transport would transport hexavalent chromium under an assumption of constant source leakage over a distance of approximately 34 m over a period of 100 years in the weathered aquifer and transport in the fractured aquifer reach approximately 15 m over a period of 100 years. If no artificial gradient is being caused the Hexavalent Chromium would likely never reach the Brugspruit and its Western Tributary as it is referred to which is the main receptors. See Figure 11.

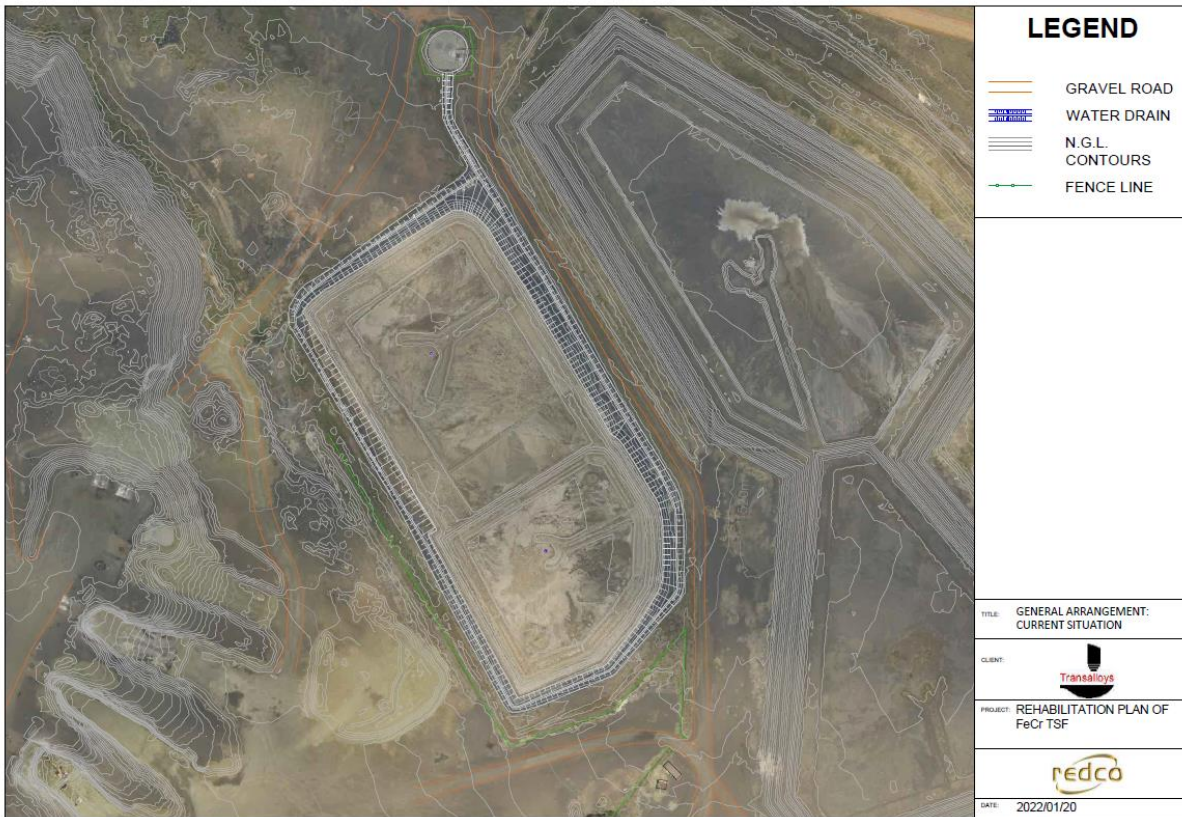
Figure 14: FeCr Facility Tailings Storage Facility – Current Situation

A fence exists to the south and west of the FeCr facility. A road is running along the east side. It was confirmed that these are not hard restrictions and can therefore be removed to allow for the reshaping of the dump.

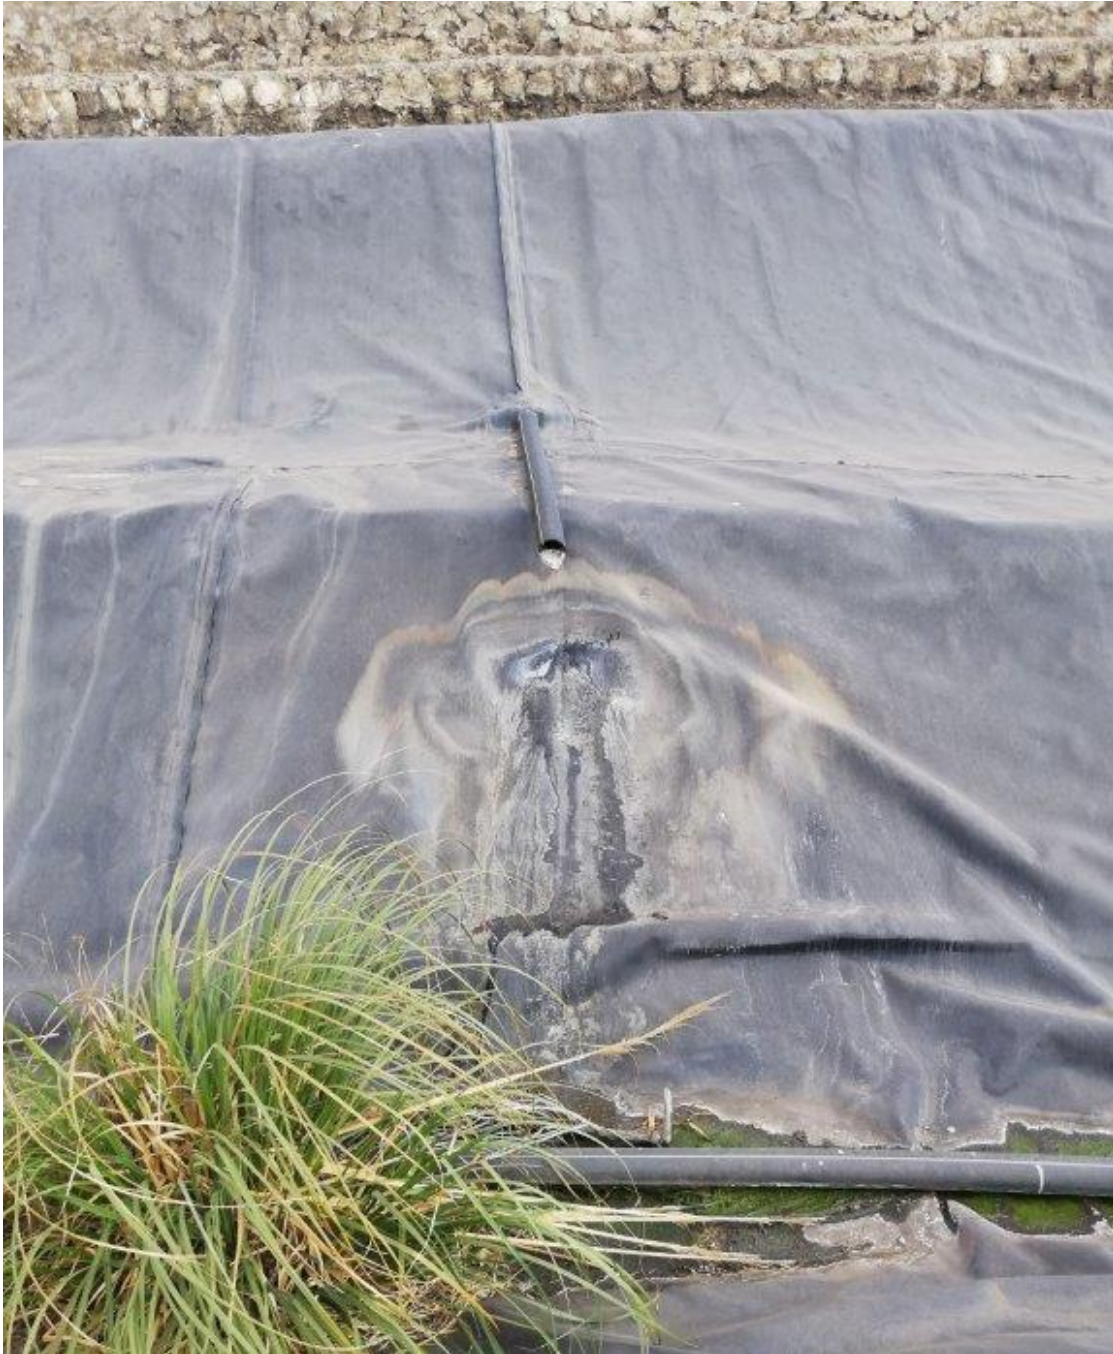
Figure 20: Minor seepage observed from Underdrainage pipes

For the current analysis, it was assumed that no pore pressure will be in the FeCr facility as it has been out of operation since 2010. The dryness and hardness of the material was observed during the site inspection and investigation, with very little outflow from the underdrainage pipes observed. (See Figure 20).

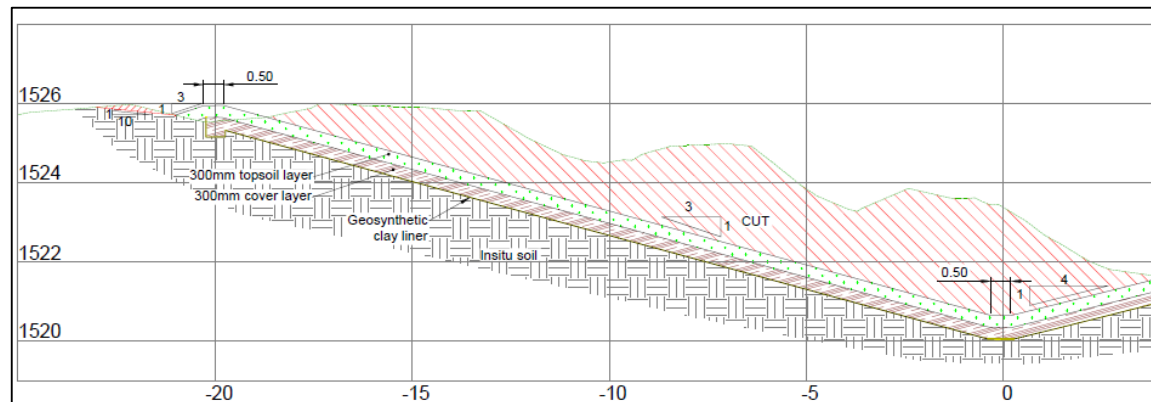
Figure 25: Typical section of Drain 1 taken on Western side of facility

The typical section of the drain used for the calculation of the velocity and flow depth can be seen in Figure 25.

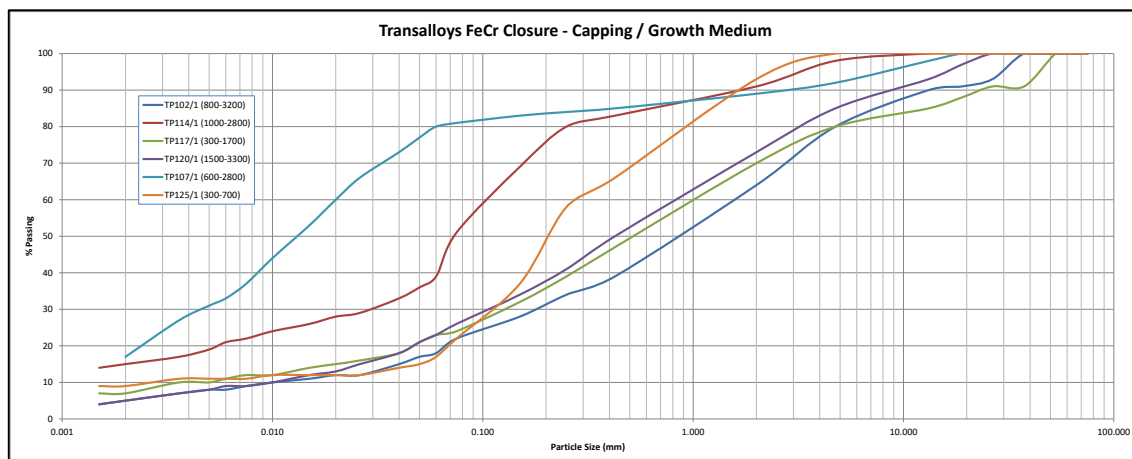
Figure 28: Particle Size Distribution of soil samples

The properties of the soils that are available for capping the facility and to provide a suitable growth medium was obtained from an earlier geotechnical study for the area just north of the facility (Knight Piesold Consulting, January 2017). The particle size distribution (PSD) is illustrated in Figure 28 and some of the properties summarised in Table 18 together with the values for the soil erodibility factor (K).
