**REPORT ON A GEOTECHNICAL SHALLOW SOIL
INVESTIGATION FOR THE PROPOSED INSTALLATION
OF SUBSURFACE FUEL STORAGE TANKS, TZANEEN,
SOUTH AFRICA**

Shallow Soil Geotechnical Investigation

05 July 2010

WH10055 – Tzaneen Diesel Depot

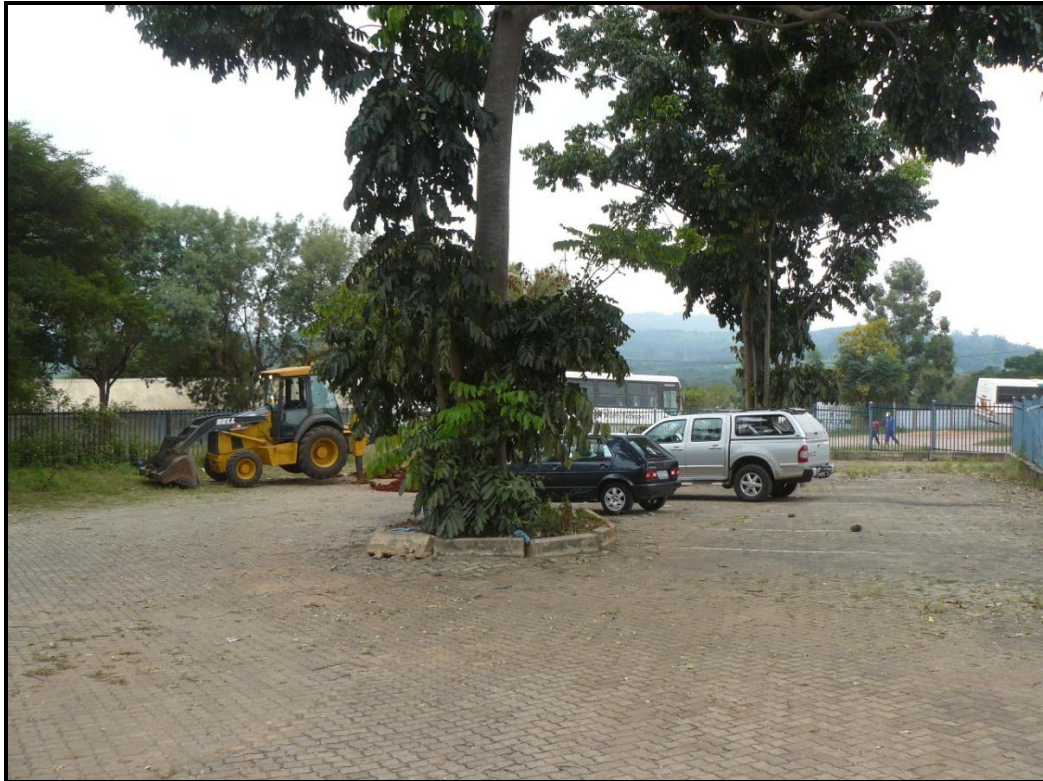
Photograph 1: Area of site earmarked for storage tank installation

parking lot, and is covered with paving and a number of small roofing structures (Photograph 1). It is assumed that the site is fully serviced. The planners should refer to services reports and databases of the local authorities to identify any such structures that may affect the suitability of the site or result in costly relocation of services.

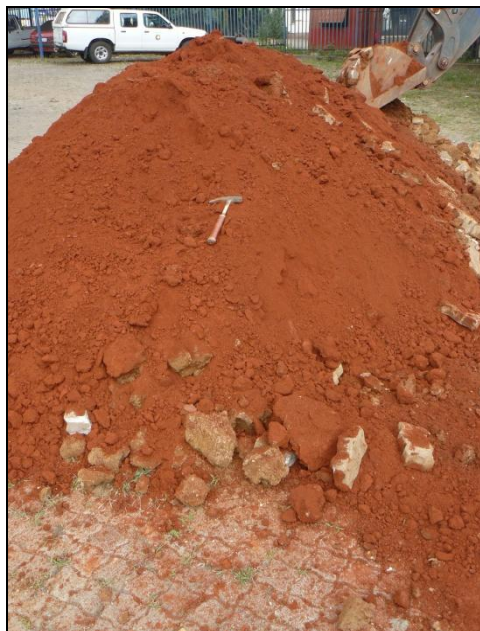
Photograph 3: General nature of the material in the profile

The remainder of the profile consists of bright reddish-brown **fine sandy clayey silty colluvial material**. This material is slightly moist and pinholed, with the consistency varying from medium dense to loose, with scattered black mottles deeper down the profile.

The excavated profile contained scattered black mottles from a depth of 1.40 meters, the slight ferruginization indicating the presence of possible fluctuating shallow seasonal water table.

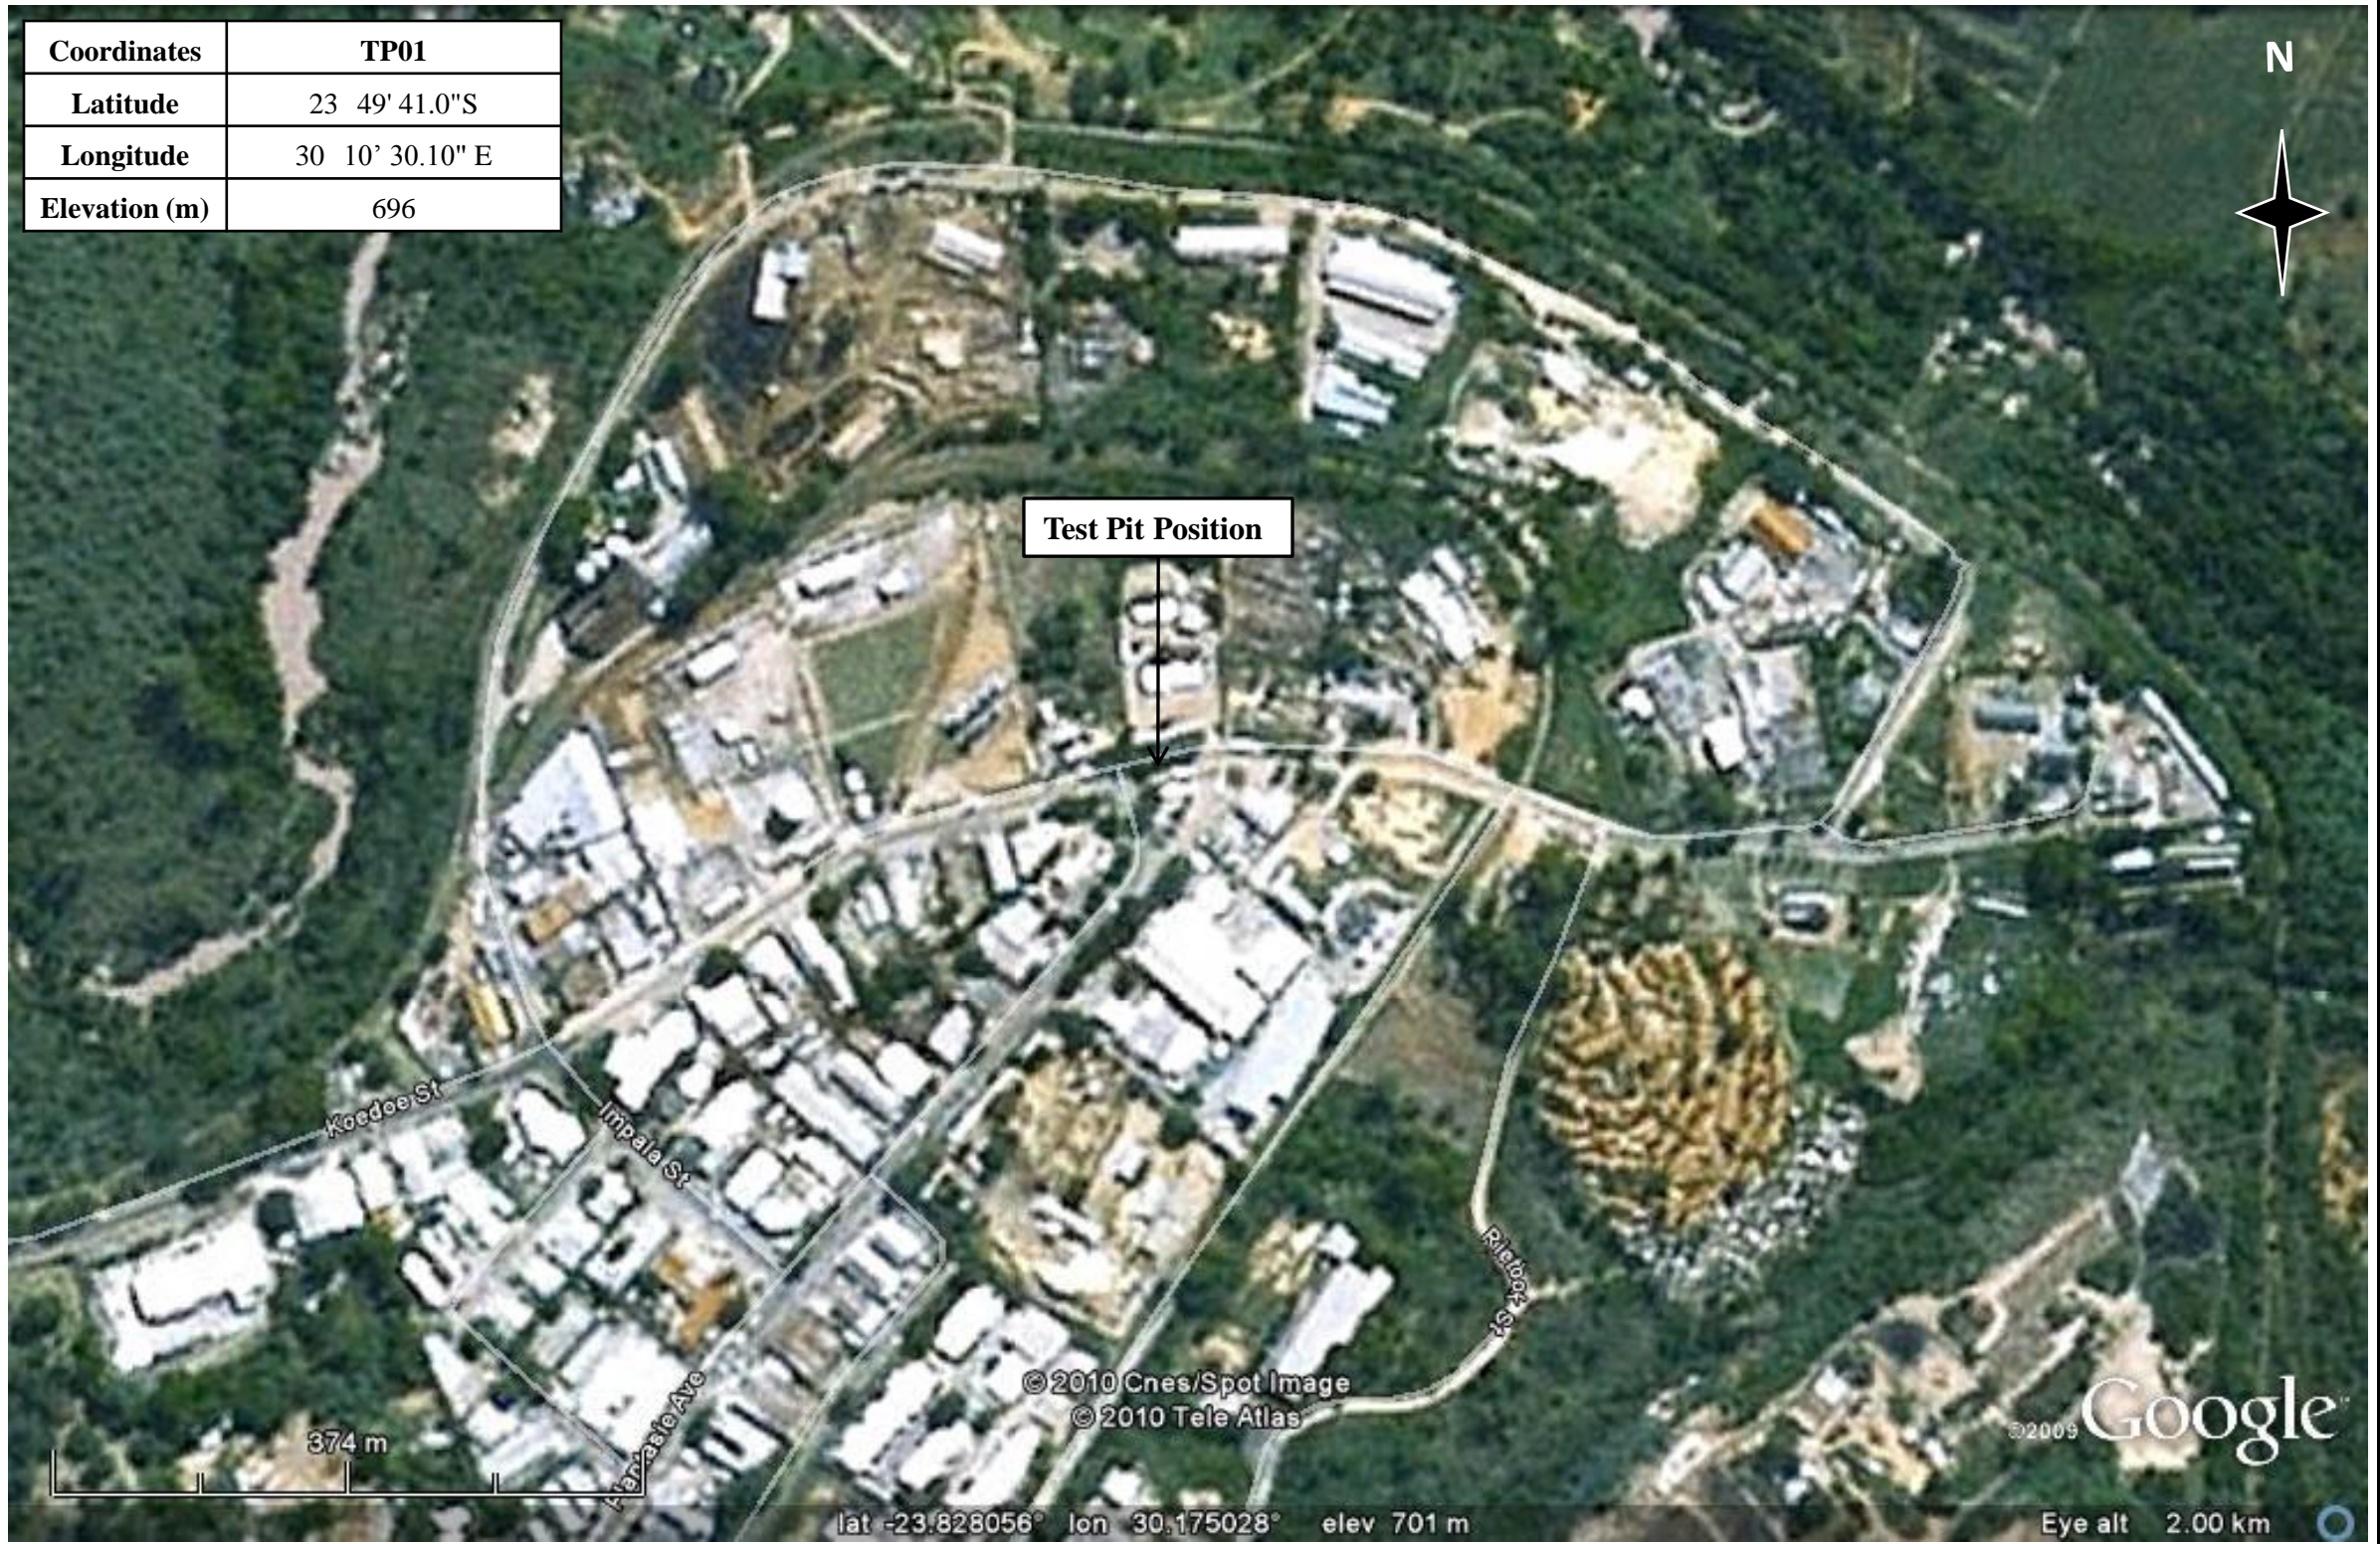
Figure 3: Test Pit Position: Tzaneen Diesel Depot

The test pit was positioned and excavated in order to successfully identify the geotechnical conditions in the area where the subsurface tanks are to be installed. The test pit position is indicated on in Figure 3, Appendix A. The test pit was excavated down to maximum practical excavation depth (the reach of the TLB).

Coordinates	TP01
Latitude	23 49' 41.0"S
Longitude	30 10' 30.10" E
Elevation (m)	696

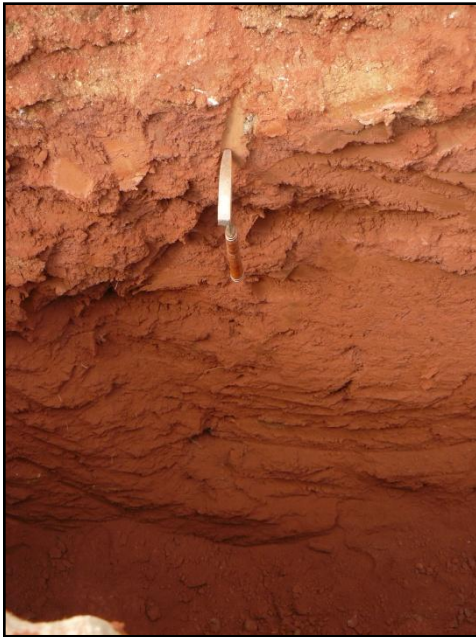
TP01
Photograph

Note: Hole stopped at 2.6m bngl

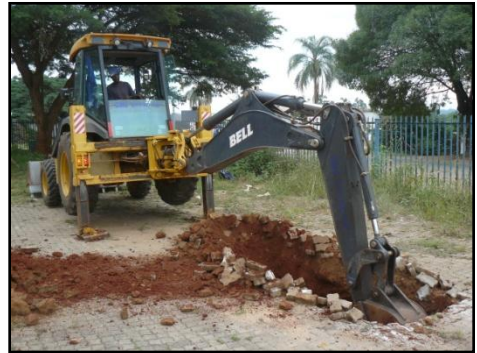
TP01 (a)
Photograph

Note: Excavation of test pit

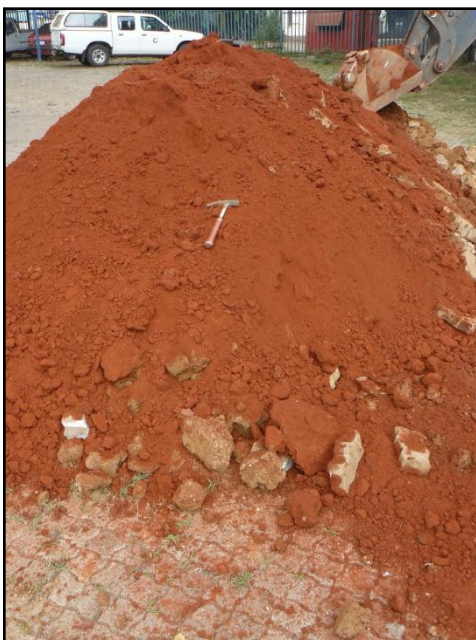
TP01 (b)
Photograph

Note: General nature of material

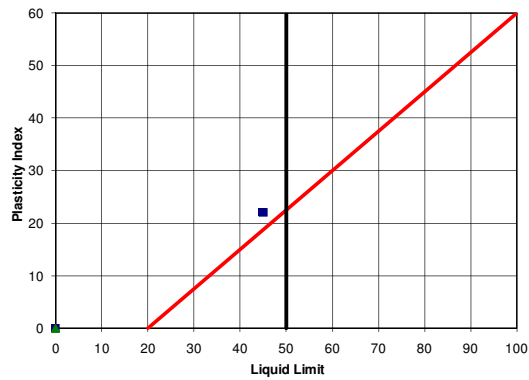
PLASTICITY CHART

- The **sandy silt colluvium** material classify as “CL” according to the Unified

Soil Classification System, indicating silts and clays with a $LL < 50$ and $PI > 7$. These soils generally contain large amounts of sand, silt and clay, with very little gravel. This material has a medium liquid limit, low grading modulus, a non-critical linear shrinkage, medium expected activity and a low plasticity index.
