**Phase I Built Heritage Impact Assessment for the former Port
Edward Police Camp, on Lot 22 Umtamvuna, Port Edward**

**Prepared for: Strategic Environmental Focus (Pty.) Ltd
KwaZulu-Natal
June 2013**

Phase I Built Heritage Impact Assessment for the former Port Edward Police Camp, on Lot 22 Umtamvuna, Port Edward

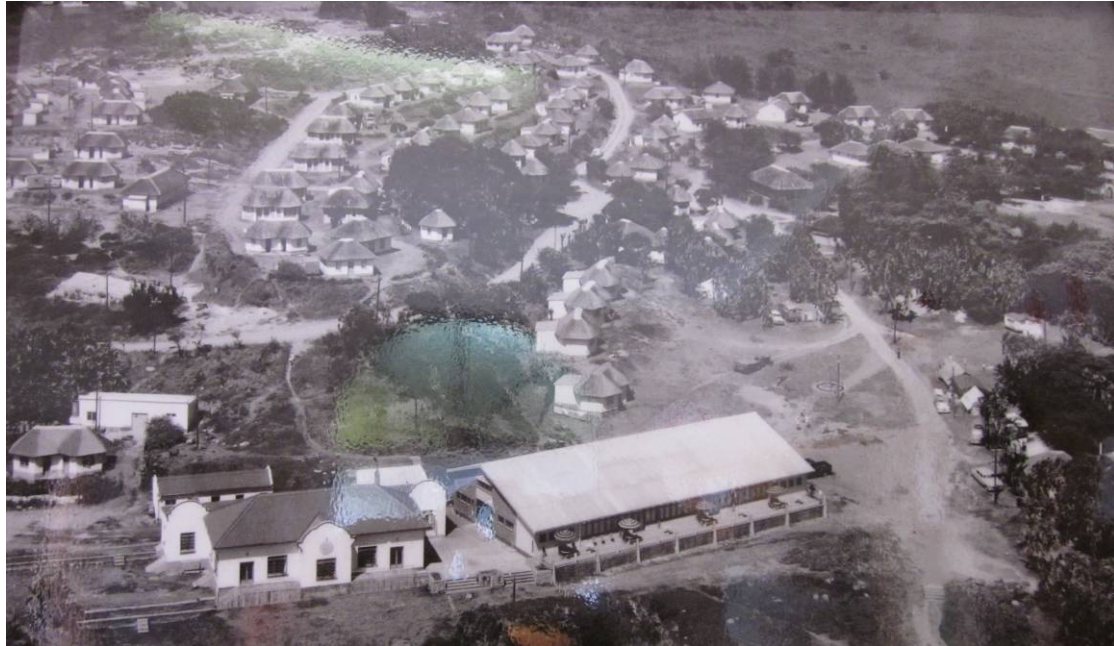
Fig 4: Undated photograph from same source – note that the restaurant / recreation space in the foreground no longer exists, although the large raised pavilion to the right does.

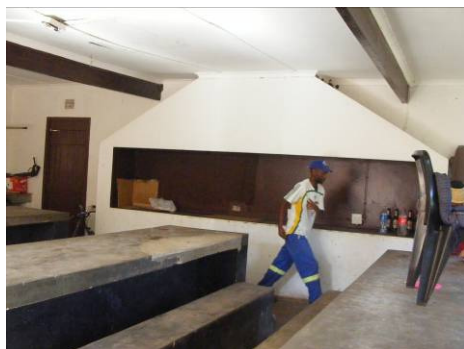
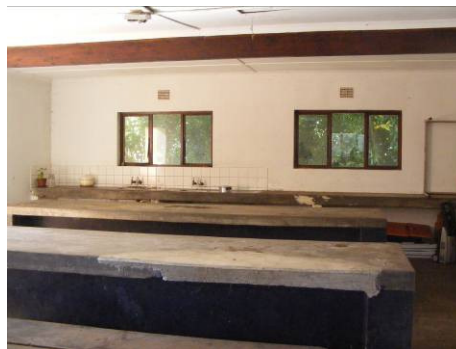
These structures are visible on the 1952 aerial photograph and are, themselves, interesting, though charmless. The main building consists of a hard communal space, with a long cooking shelf, concrete tables and benches, and a scullery area which runs the length of one of the walls. A central door on the northern elevation leads onto an open air passage which has, to each side, a number of small dwelling rooms. It is still in use. The separate and parallel wings which align each side of this open air passage have mono-pitch corrugated asbestos roofs leading out to the edges of the building. It is of masonry construction.

Figs 7&8: Kitchen / communal space in main labour quarters

Whilst the main block is of moderate interest from a labour history perspective, it has little merit architecturally, technologically, historically or scientifically. Although there is evidence of a building in its place on the 1952 aerial photograph, this building does not display the diagnostic features of this date, thus it is not certain that this building is over 60 years old. The other buildings also lack significance and are purely utilitarian structures housing staff in squalid conditions.

Recommendation: Demolition, should it be sought, of the labour quarters is an option, given the limited nature of the significance as well as living conditions in what are ill-maintained buildings.

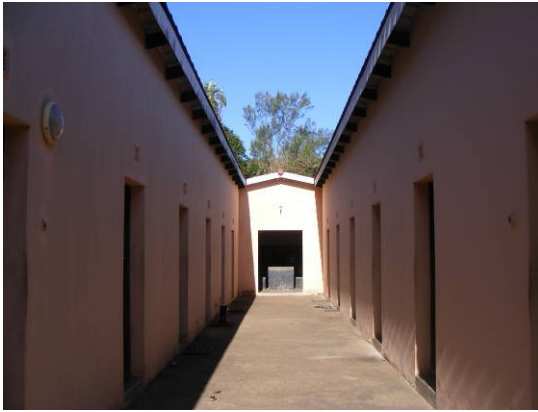
Fig 9: Open corridor, main labour quarters

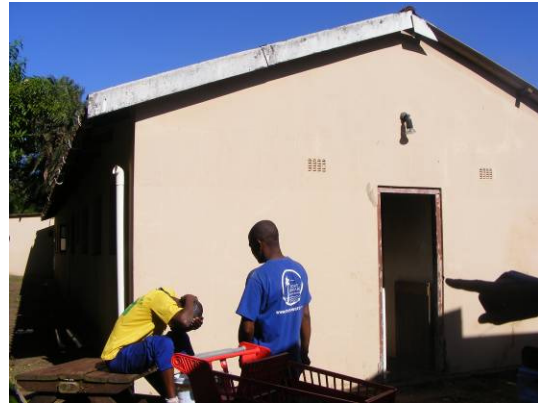
Fig 10: North entrance, second quarters

To the south of this main building is a smaller structure: much the same but consisting of an enclosed central double-loaded corridor of similar construction and roofing.

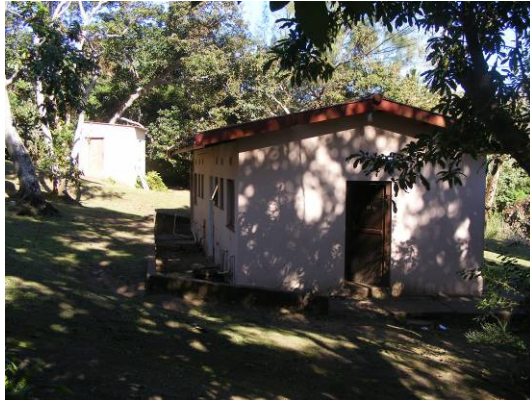
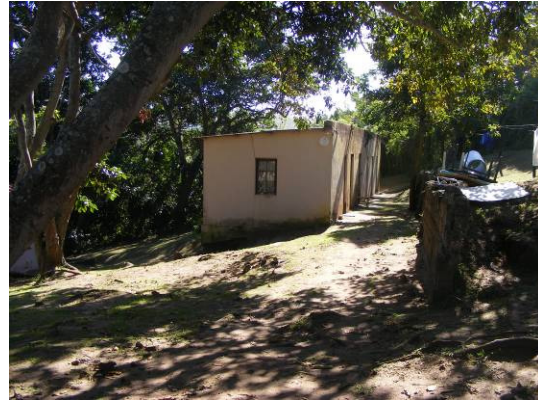
Up on the slopes of the hill are several other small, modest structures which house labour. Their age is indeterminate, although many are made of the distinctive brick from which other structures are comprised. They are dwelling units, sharing similarly charmless cooking and ablution areas.

Figs 11&12: Ablution block and cooking (left) and residential (right)

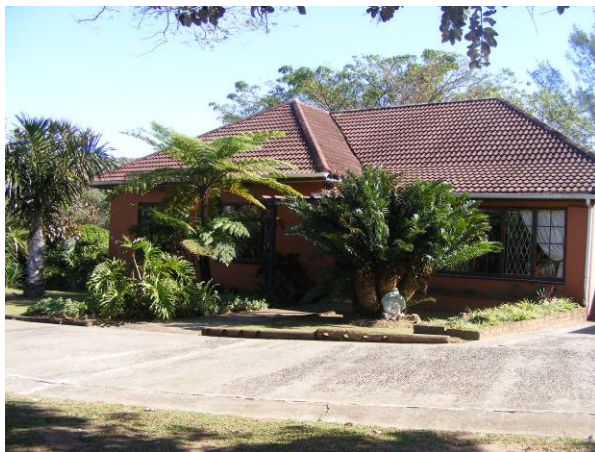
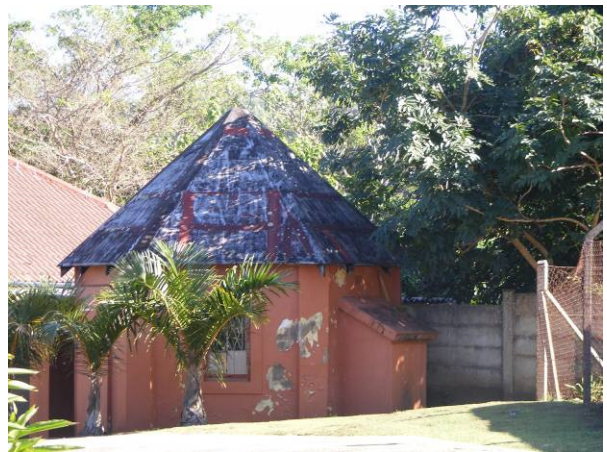
Both of these houses have associated rondawels, with extended additional niches which appear to have originally contained storage shelving, but in the case of one, has been changed into an en-suite. They have distinctively defined corners and this eccentricity means that they perhaps thus stand as some of the earliest buildings on site. The rondawel associated with the house to the north has had its conical roof replaced with an uncomfortable mono-pitch corrugated sheeting roof. The second to the south is derelict.

Figs 13&14: Dwelling (south) south and its associated rondawel: this house appears to have had a Marseille tiled roof from the outset.

The core of these buildings is early, given their place in all the historic photographs. Although it cannot be conclusively proven that they are older than 60 years old, and that they have low significance on all levels, they do contribute to the topophilia and the grain of the site, particularly the recreation area.

Recommendation: It is suggested that these two buildings remain and be reused in the new development, together with their rondawels, as a memory of the texture of this part of the site.

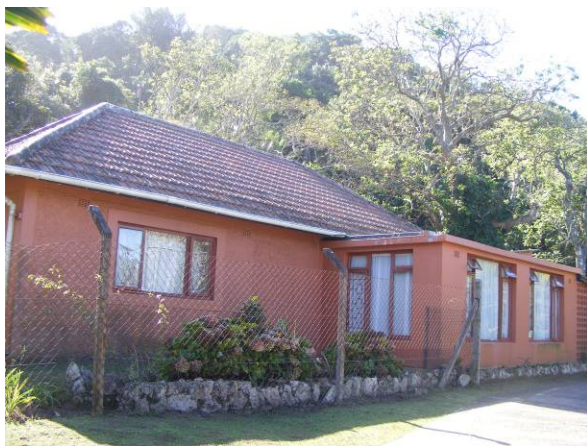
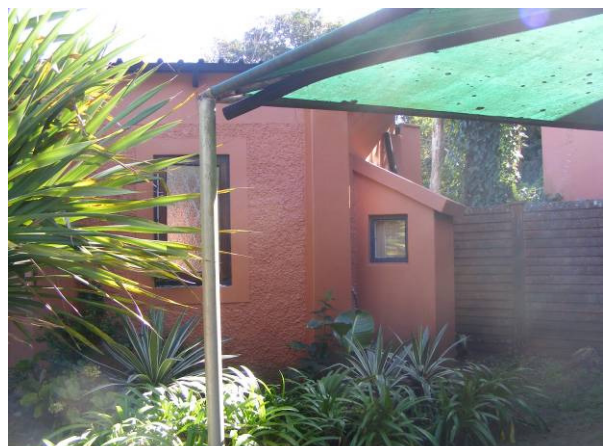
These two more substantial houses are evident on the 1952 aerial photograph: the one to the north was originally thatched with a corrugated sheeting mono-pitch extension to the rear. The thatch has subsequently been altered to Marseille tile (See Fig 3). The more southerly house appears tiled in the historic photographs. The buildings are of conventional construction, with plastered and painted masonry walls, and timber windows. Little additions have occurred on the southerly building, whilst the one to the north has had an extension to the front, as well as patio modifications out of *brise soleil* block.

Figs 15&16: Dwelling to the north: much altered, originally thatched but reroofed in Marseille tiles. Rondawel has mono-pitch corrugated sheeting replace the original conical version

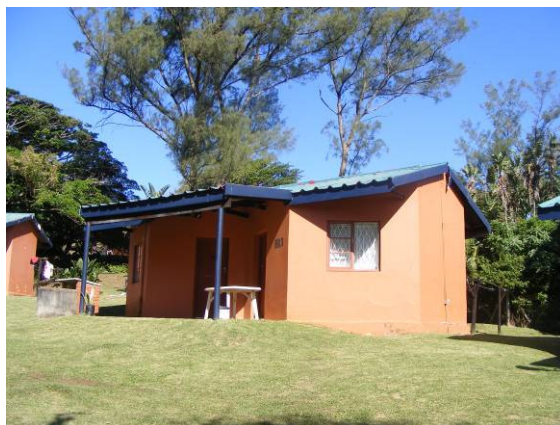
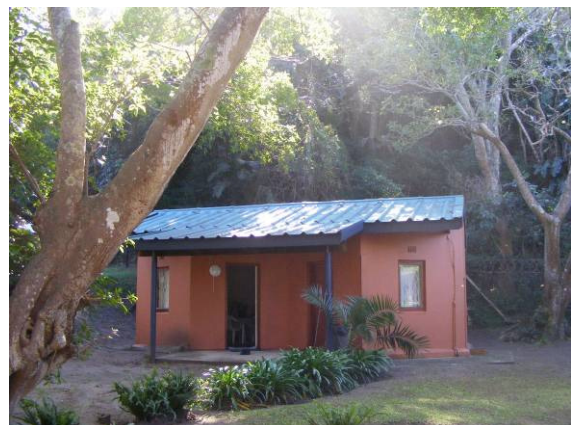
The buildings on site consist of a number of different building forms. Predominant is the conjoined hexagonal rondawel (See figs 17 & 18), which consists of two rooms with an extension at the rear and a veranda tacked onto the front. It appears that this form appeared reasonably early, though at what point it is not clear. Evidently successful as a layout, examples of this building form are found across the site, and its replication in such manner has importance. Other older buildings of the 'cottage form' are found on the elevated roadway leading to the top of the site. These are ill-maintained, and of limited significance (see Fig 19). A further form, which is much more recent, is that in which the plan form is rectangular, but the entrance to the two rooms is emphasised by a shallow, angled recess in the elevation (see Fig 20).

Figs 17&18: Showing hexagonal conjoined units: one on right is in recreation area

Whilst the bulk of the structures are utilitarian and unremarkable, the hexagonal form evidently found favour and was implemented in structures from early on. The orthogonal cottage form represented by H6 is also important in memory of the site.

Recommendation: *Since the hexagonal structure forms so much of a part of the site and its development, it is suggested that a single example be retained for reuse, possibly as a small museum. An appropriate choice would be one of the extant units around the recreation area, given its peripheral position. It is also suggested that unit H6 or similar be retained for the same reason.*

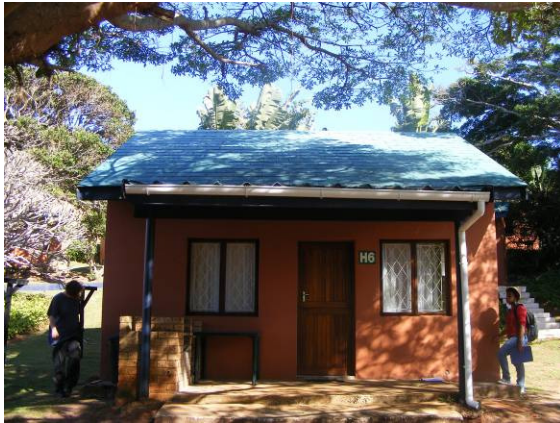
It would appear that the older buildings on this site are those 'cottage' forms, with a central doorway and flanking windows. Despite hearing that some of these were of paper bricks, much prodding and poking of the masonry revealed that they were of conventional construction, many with the endemic yellow rough-grained brick with timber windows, under a double pitched corrugated asbestos roof. Roofs were thatched until at least 1965 (see fig 6), and these were replaced with a rather dour double pitched corrugated asbestos roof at some point, which, to some degree, minimised the organic nature of the buildings.

Fig 19: Older 'cottage' form

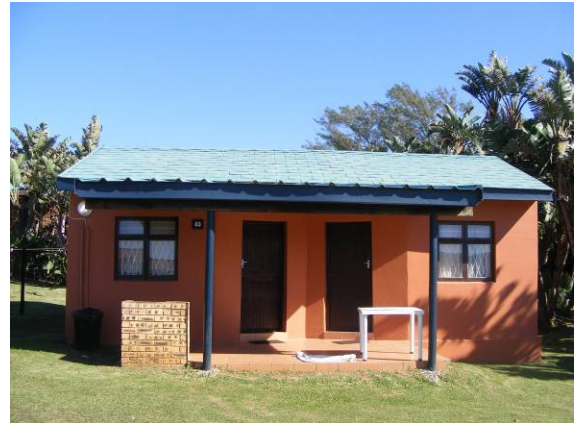
Fig 20: Shallow, recessed entrance

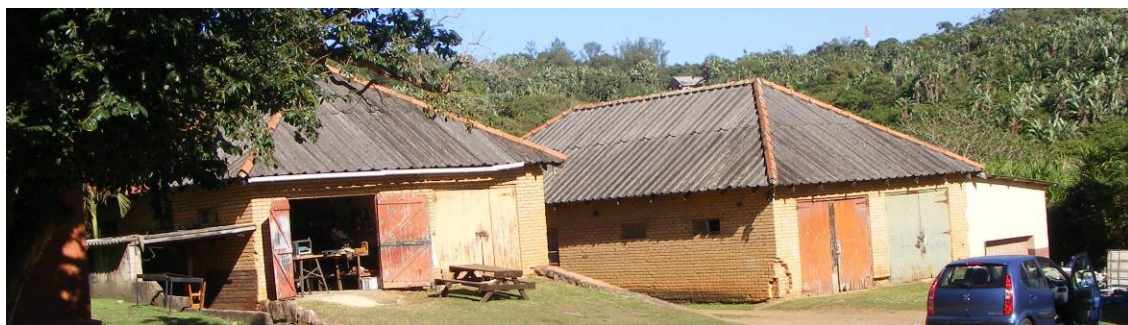
These buildings are hidden, to large degree, from the main operations of the holiday camp and do not form part of any contiguous fabric. It is suspected that these are the oldest buildings on site. They appear evident on the 1952 aerial photograph, and furthermore are comprised of a friable local facebrick with a course texture which is failing in many places. They are also distinguished as having a high lime content. They are essentially large, rectangular farm sheds, and little evidence exists as to their use. It is possible that they date back to pre-1947 and the establishment of the Police Camp, or they could have served as utilitarian buildings in the development of the camp and its many 'modern' facilities, evidence of which is non-existent on the site today.

Fig 21: Utilitarian sheds to the west of the site

Whilst these may be some of the older buildings on site, they are structurally dubious, marginal and peripheral, being located right on the edge of the site and having little discourse with the main development.

Recommendation: Demolition, should it be sought, of the sheds is an option, given the limited nature of the significance, peripherality and the real practicality of reusing what are essentially ill-maintained buildings.

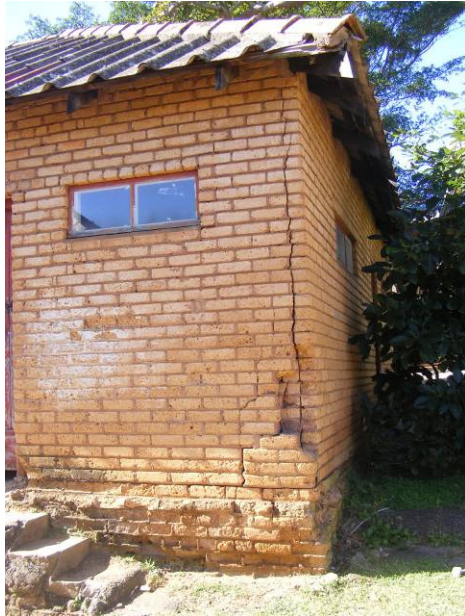
Fig 22: Showing structural cracks to corner of shed

The historic photographs show these as hipped under thatched roofs; today they have a hipped asbestos / fibre cement sheeting roof. Doors and high level horizontal format windows are timber painted. There are some substantial structural cracks to the buildings and much erosion around the foundation / damp proof course level.

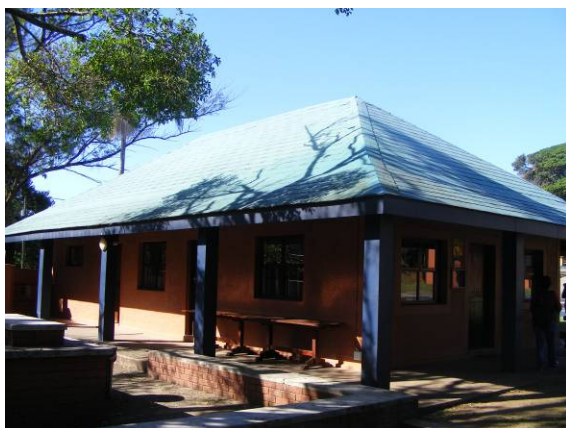
This building, known as the 'Small Hall' is perhaps also one of the early recreational buildings on the site. Under a large hipped roof, what was originally thatched has been latterly reroofed with asbestos shingle. It has a veranda around three sides and faces onto the recreational area. Of conventional construction, it has timber windows.

Fig 23: Small Hall from recreation area

Like the other buildings, this structure is also utilitarian, but well maintained. Its architectural scale contributes to the texture and grain of the site. As communal space, it contributes to memory on the site.

Recommendation: *It is suggested that this building be retained and reused in the new development as part of the recreational precinct and its memory, perhaps reconfigured as a museum.*

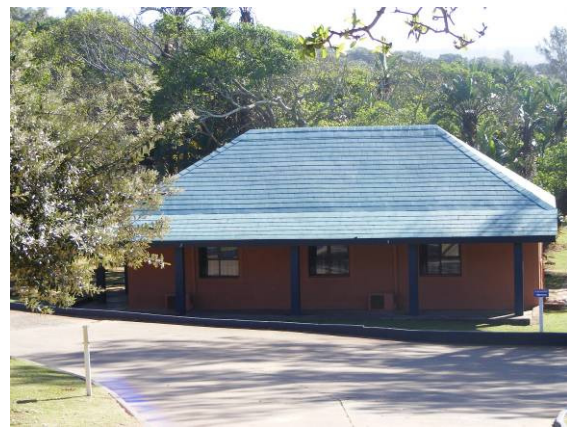
Fig 24: Small Hall from street

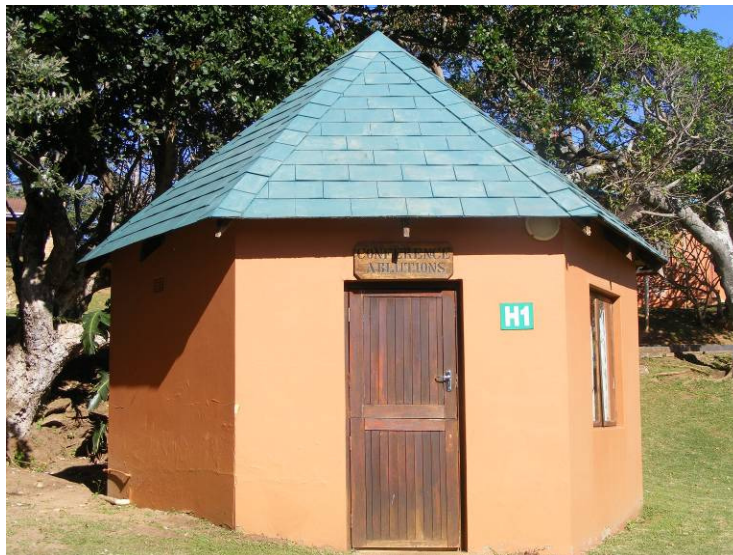
This little building is located opposite the small hall and is perhaps also part of the early construction. It is currently used as an ablution facility. The thatched roof has been replaced by asbestos shingle. Doors and windows are timber, the former most likely a replacement of the original.

Fig 25: Solitary rondawel

Like the other buildings, this structure is also utilitarian, but well maintained. Its architectural scale contributes to the texture and grain of the site. As one of the most enduring structures it contributes to memory on the site.

Recommendation: *It is suggested that this building be retained and reused in the new development as part of the recreational precinct and its memory.*

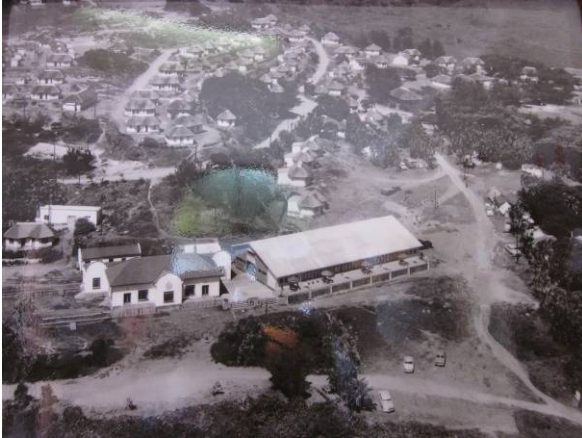
This complex is known to have been commenced towards the early 1950s. The original structure was a modestly gabled thatched roof, of which nothing remains, whether absorbed into the new structure or demolished totally (see figs 26 and 27, and 29). Its replacement is a brash structure of no merit.

Fig 26: Aerial photo showing restaurant complex

The restaurant building has little to recommend it. The recreation building, whilst of an age, is unremarkable and peripheral to the main zone of conservation.

Recommendation: Demolition, should it be sought, is an option, given the limited nature of the significance, peripherality and non-original structure in the case of the restaurant.

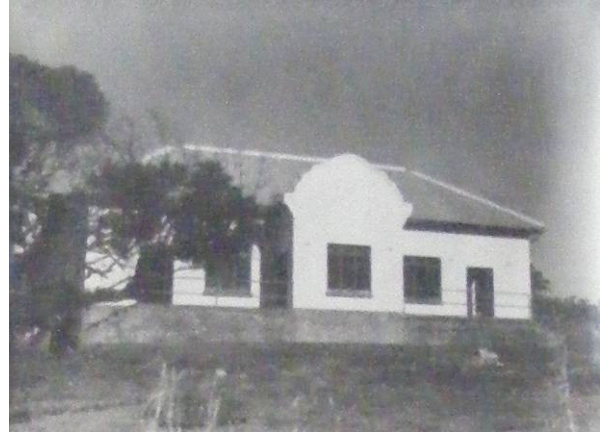
Fig 27: Old restaurant building

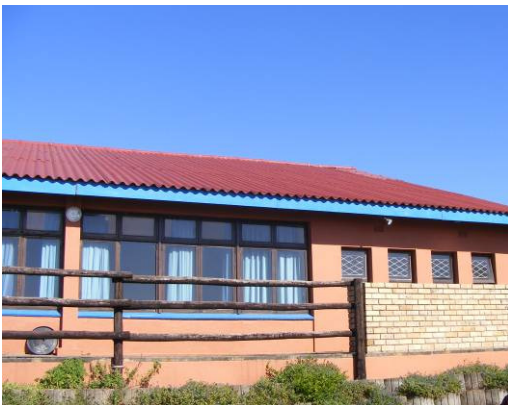
The recreation hall to the rear also appears on old photographs. This is a large structure with a substantial corrugated asbestos double pitched roof, a large deck overlooking the ocean, and a row of timber windows leading out to the deck. It is utilitarian, and simple, of conventional construction: it has little resultant significance and is detached from the restaurant by service spaces rendering it marginal and isolated.

Fig 28: Recreation hall, north west end

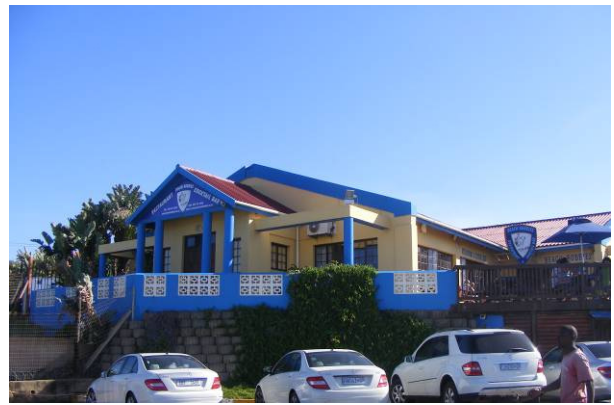
Fig 29: Restaurant – beach elevation

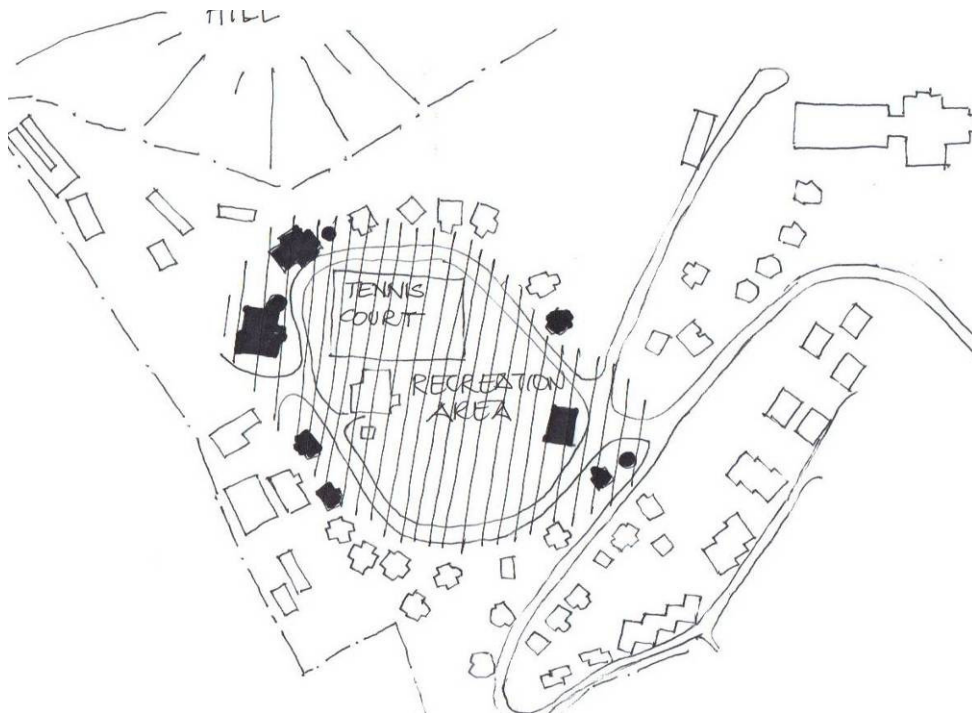
Fig 30: Recommended zone for the creation of a memory park

To this end, the original part of the site, around its central recreation area, could be reworked into an open space or park, retaining the road system in the immediate precinct. Some of the buildings, such as the two dwellings, the small hall, solitary rondawel and representations of the hexagonal rondawel combinations could litter these edges, into which well designed buildings of similar scale and modesty could be inserted. This is made simpler from a design point of view in that it is sunken from the bulk of the site, thus situated in a zone of its own which can be treated independently from an architectural point of view.

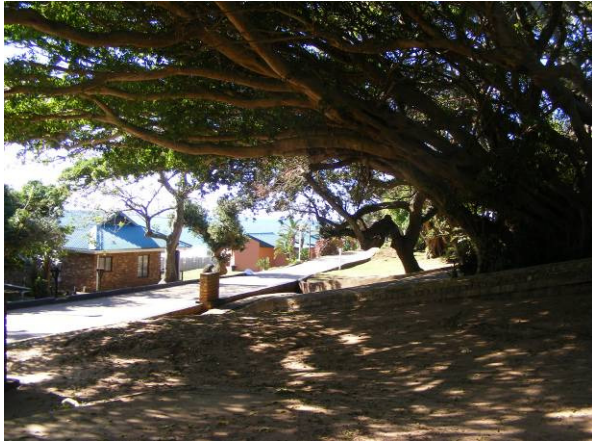
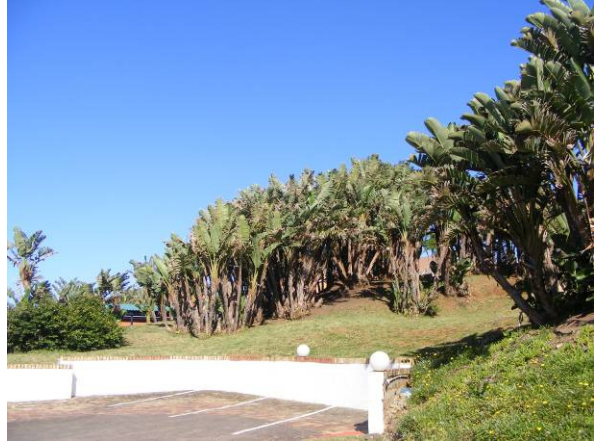
Figs 31& 32: Large fig, hard landscaping, and strelitzia nicolai clumps recommended for retention

Furthermore, as an observation on the rest of the site, it is also important to retain elements of the hard and soft landscape: large clumps of *strelitzia nicolai* as well as established examples of *ficus sp.* should be kept as well as such features such as the lined drain in Fig 31 below.
