**ESTUARINE ECOLOGY IMPACT ASSESSMENT REPORT FOR  
THE CONSTRUCTION OF A FLOATING DRY DOCK AT THE  
DORMAC REPAIR QUAY, BAYHEAD DOCK  
IN THE PORT OF DURBAN**

**February 2014**

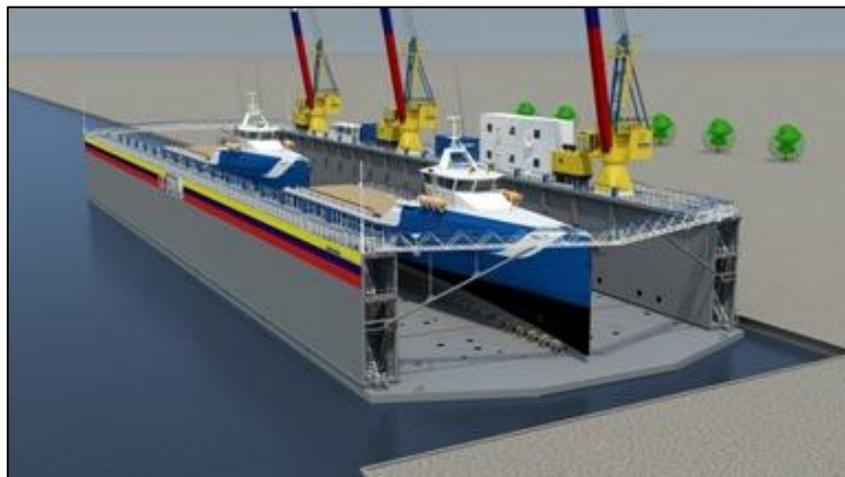
A floating dry dock is an anchored platform with floodable buoyancy chambers and a "U"-shaped cross-section (Figure 3). It is used for dry docking ships during repair and routine maintenance. When valves are opened, the chambers fill with water, causing the dry dock to float lower in the water. The deck becomes submerged, allowing a ship to be positioned over the bilge and keel blocks located on the deck of the dry dock. The walls of the structure are used to give the dry dock stability while the deck is below the surface of the water. When the water is pumped out of the buoyancy chambers, the dry dock rises and the ship is lifted out of the water, allowing work to proceed on the ship's hull.

**Figure 3. Vessels moored in a floating dry dock awaiting repairs (image courtesy of Nestoil).**

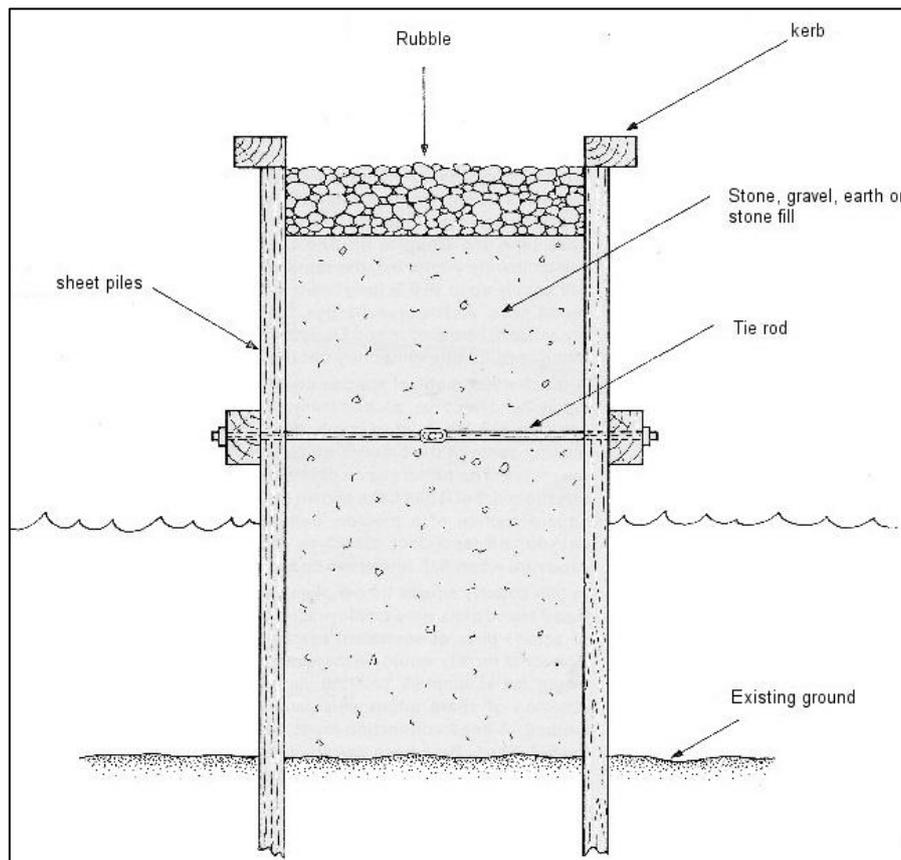
Figure 4. A sheet piling technique (illustration courtesy of [www.trada.co.uk](http://www.trada.co.uk)).

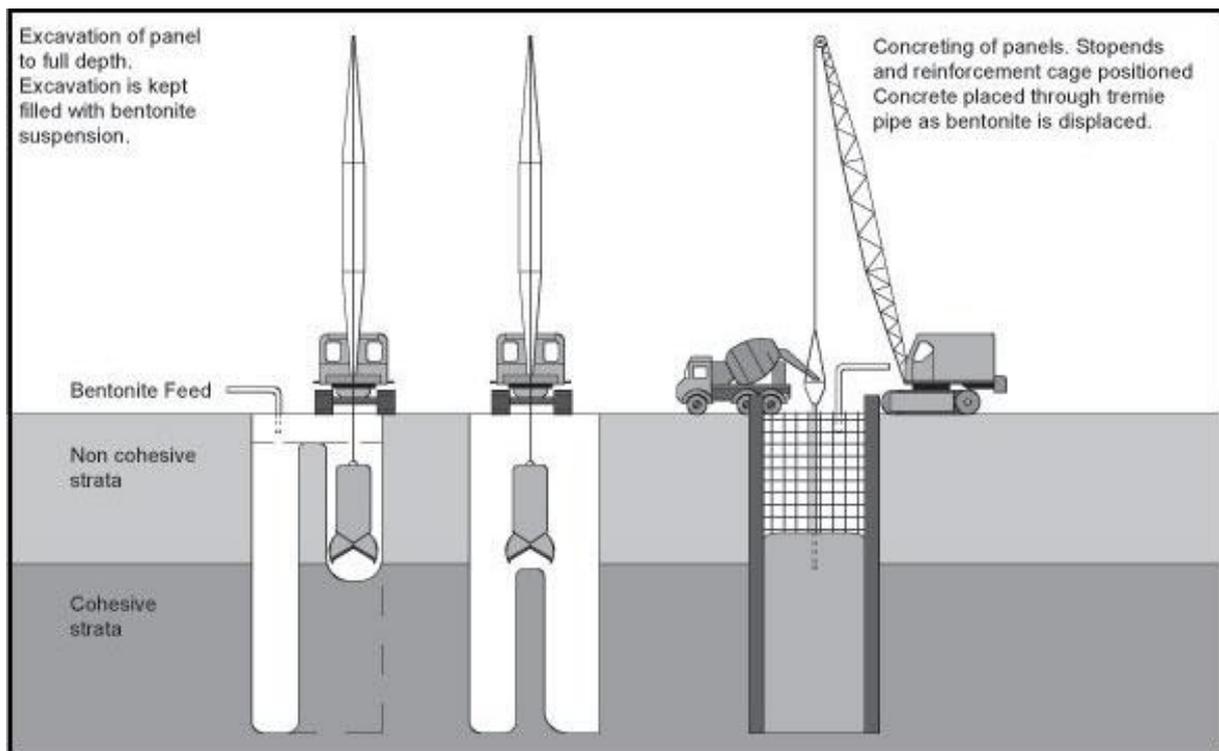
Preceding construction of the diaphragm wall, a pair of guide walls is built using concrete (Figure 5). They mark the area to be dredged and function as a working platform during construction. The inside support wall is demolished following construction of the diaphragm wall. The main wall consists of a number of interlocking panels, which are joined by means of stop-ends. These are placed in the wet concrete to mould the end of the panel and are removed before the concrete sets rock hard. For anchored walls, steel is attached to the reinforcing cage to allow anchors to be installed. Sediment is excavated by means of a grab, which is suspended from a crane. Bentonite slurry is used to top up the trench during the excavation, and a pump located in the trench transports the slurry back to storage tanks during concreting.

Figure 5. The methods used in constructing a diaphragm wall (source: Balfour Beatty Ground Engineering).

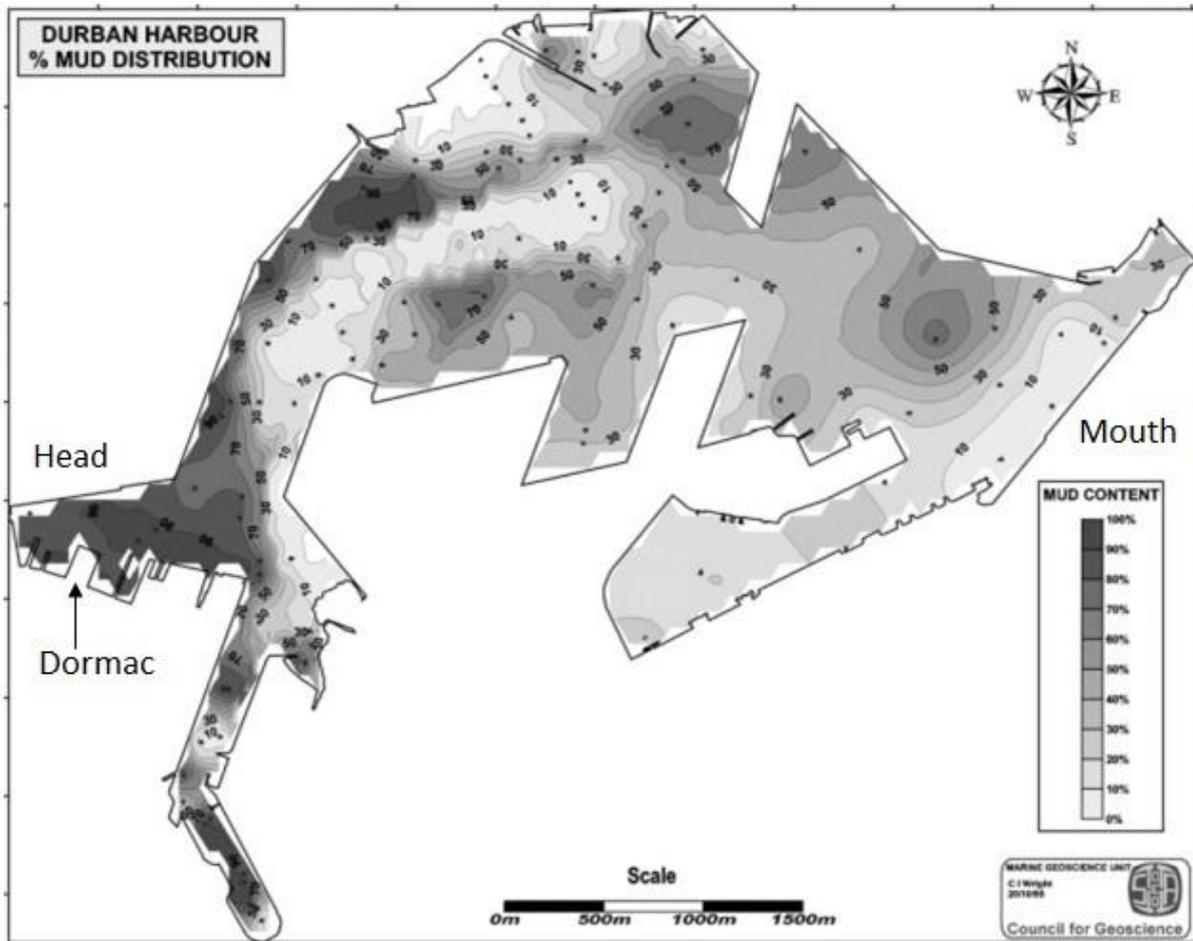
Figure 6. Proportion of mud in sediments of Durban Harbour (adapted from Wright 1996).

Analysis of sediment particle for these samples revealed that fine to medium grained sands predominate adjacent to the Dormac quay (Table 9). These sediments were found to be moderately to poorly sorted. These data are in contrast to Wright (1996) and Newman *et al.* (2008) who reported predominantly fine muds from the Bayhead Dock (Figure 6 & Figure 11A).

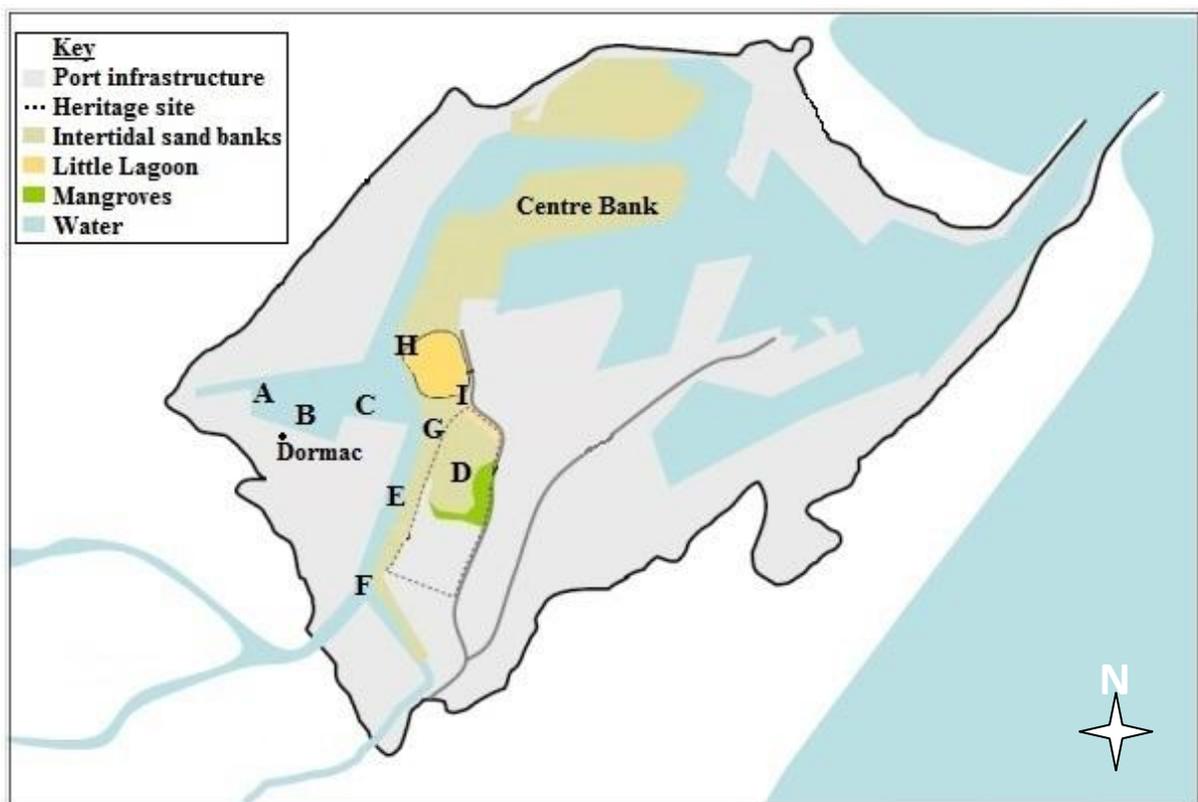
Figure 9. Map showing sites that have been sampled in Bayhead and Little Lagoon. Site specific data used in this report were extracted from Angel and Clark (2008) and Pillay (2002).

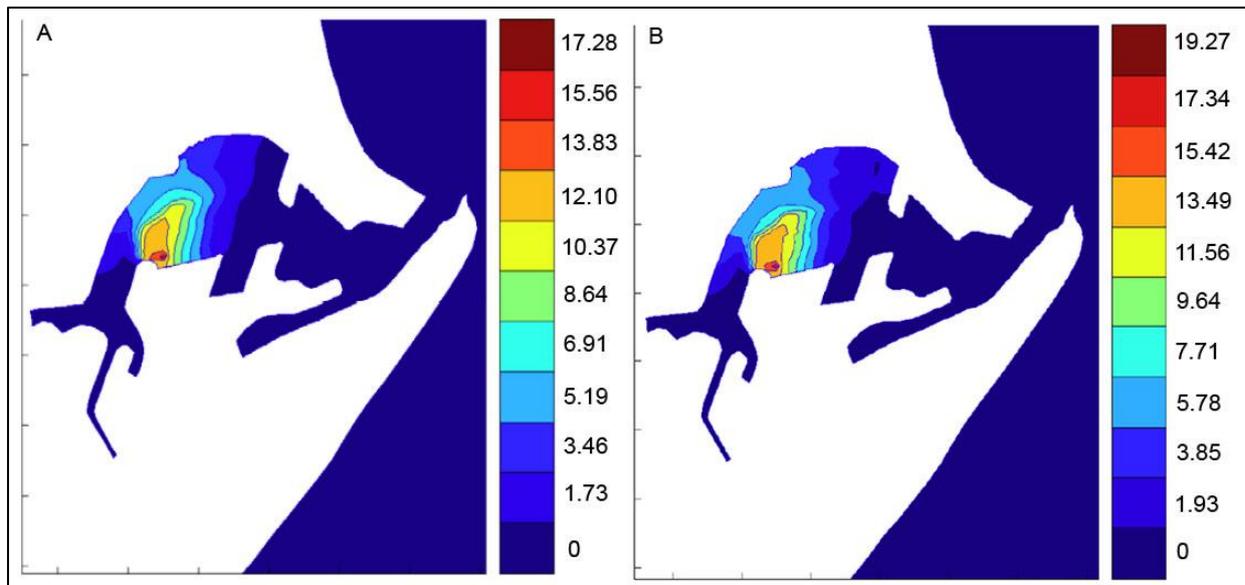
Figure 10. Model simulation data showing the dispersion of sediment during dredging operations at Berth 205 (Source: ZAA 2012). These data show sediment concentrations ( $\text{mg.L}^{-1}$ ) in A) surface and B) bottom layers under worst case scenario conditions (spring tides combined with strong south-westerly winds).

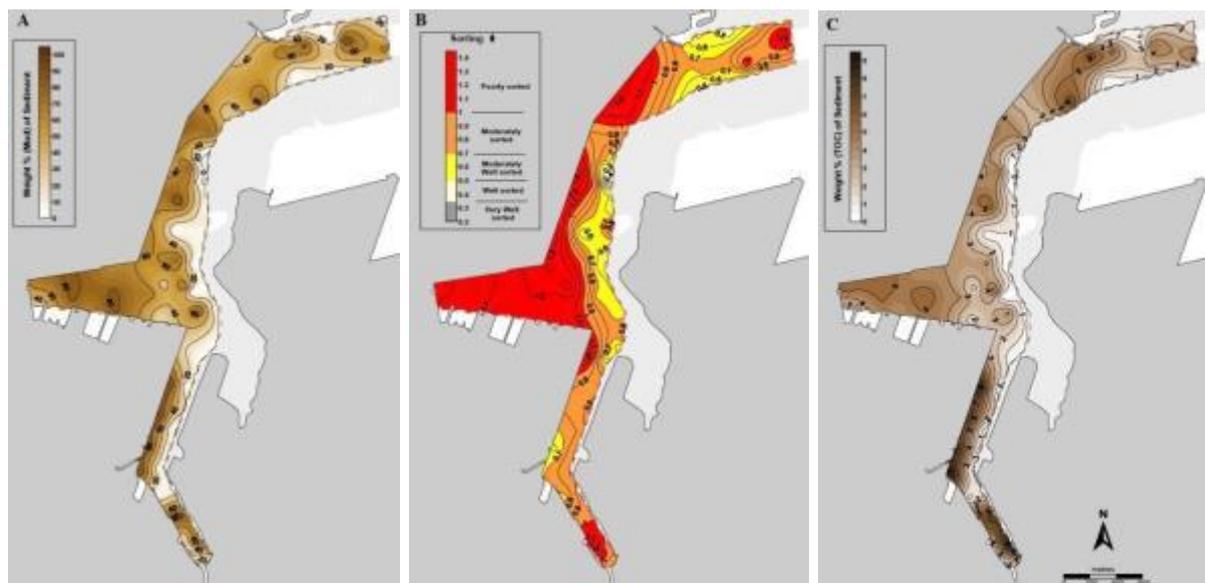
**Figure 11.** Interpolated spatial distribution of A) mud, B) the sorting coefficient and C) Total Organic Content (TOC) of sediment in Durban Bay (adapted from Newman *et al.* (2008) courtesy of CSIR and EMS). On panel A and C, pale colouration indicates a low percentage contribution, while dark colours depict high percentage contributions. On panel B, grey depicts very well sorted, pale yellow well sorted, yellow moderately well sorted, orange moderately sorted and red poorly sorted sediment. Stippled areas are intertidal sandbanks, while areas shaded in white are subtidal estuarine environments.

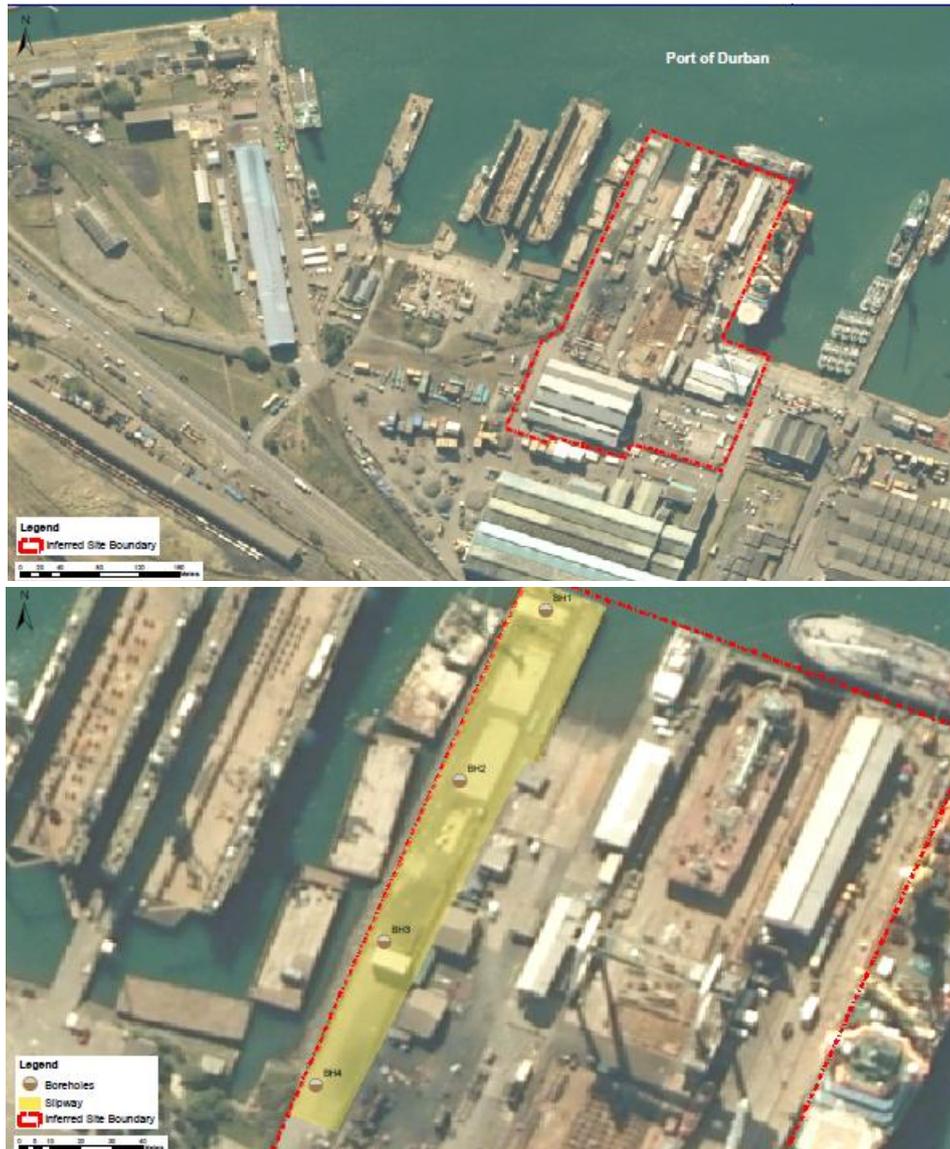
**Figure 12. Locations of boreholes in the Dormac excavation area from which sediment samples were derived as part of the EIA (Source: WSP 2013).**

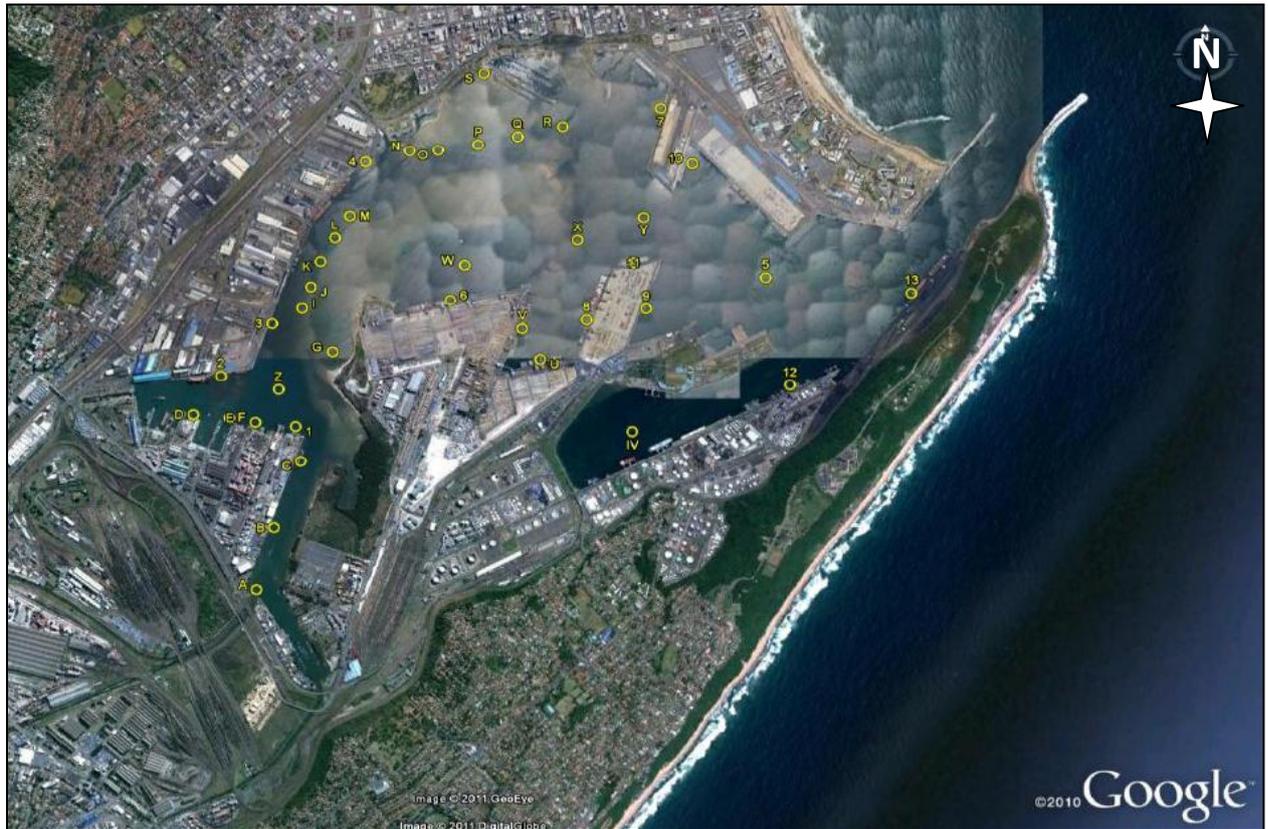
In 2011, the CSIR examined trace metal levels in sediments from 38 sites distributed around the Port of Durban to determine the sediment quality in the Port (CSIR 2011). Sites sampled are depicted in Figure 13.

**Figure 13. Sites tested for trace metals during a recent assessment of sediment quality in Durban Bay (Source: CSIR 2011).**

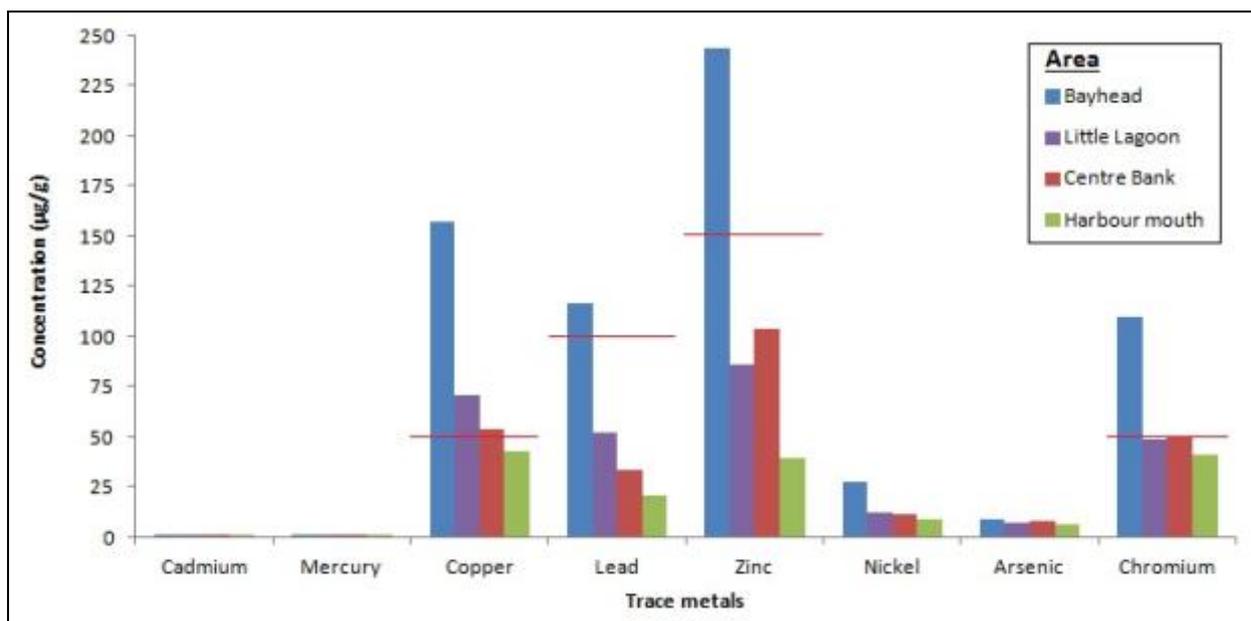
For the purposes of this study, the CSIR sites were grouped into four areas: Bayhead, Little Lagoon, Centre Bank and Harbour mouth. Cadmium and mercury levels were low for all areas, while copper levels were above the action level for all sites barring the Harbour mouth (Figure 14). Lead, zinc and chromium levels were low for at all sites with the exception of Bayhead. In this area, the latter trace metals were found to be above the action level but below the prohibition level.

Figure 14. Trace metal results from a recent assessment of sediment quality in Durban bay (CSIR 2011) which motivated for the testing of sediments adjacent to the Dormac quay. Red lines indicate Action Levels.

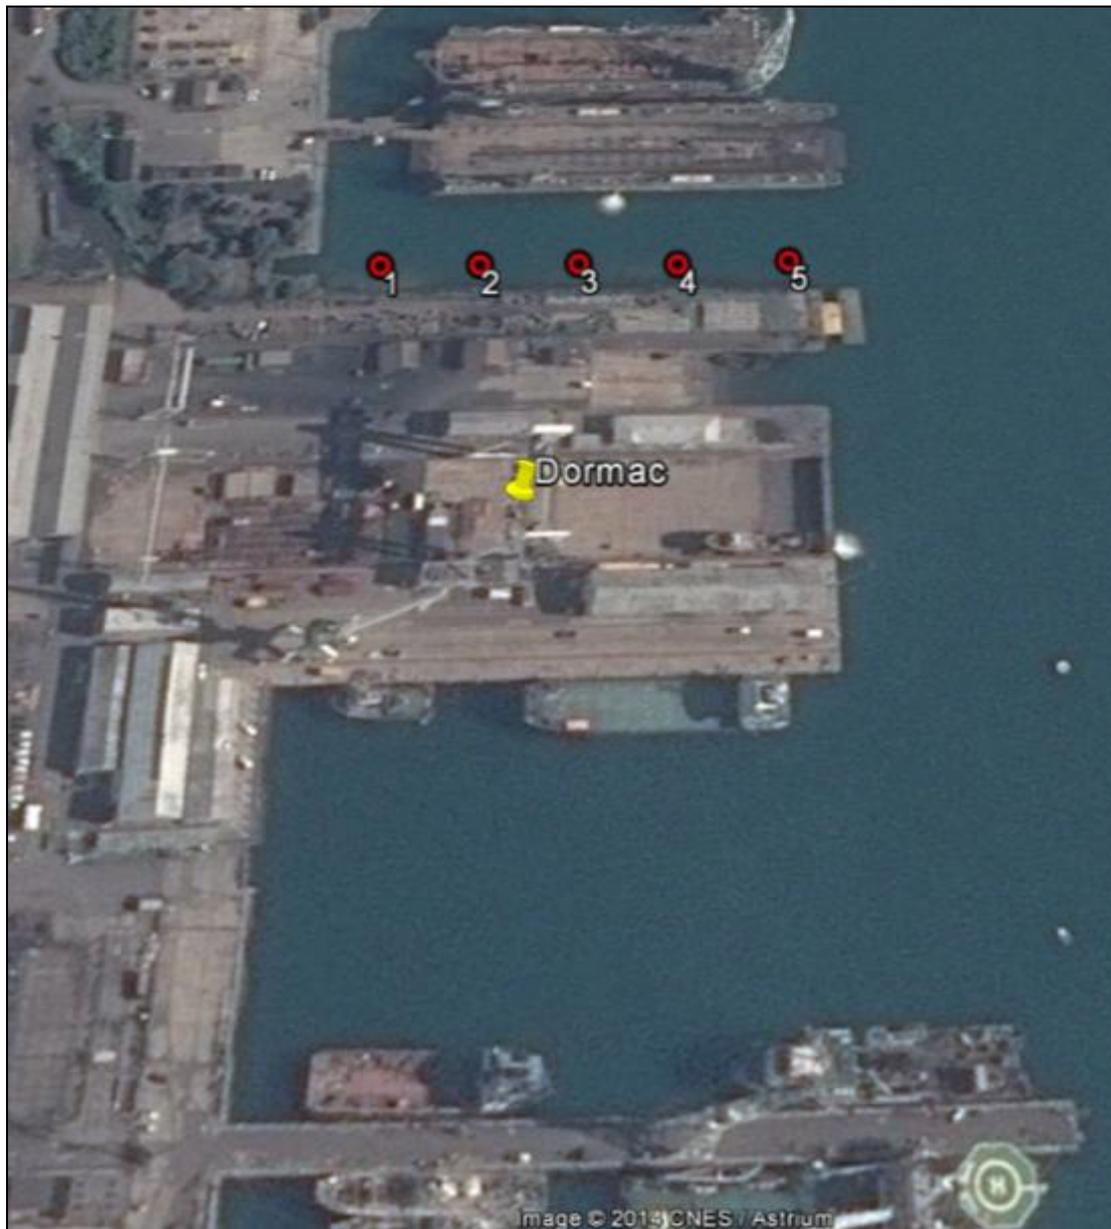
**Figure 15. Location of the five sediment sample sites within the Bayhead Dock parallel to the Dormac quay (Google Earth 2013).**

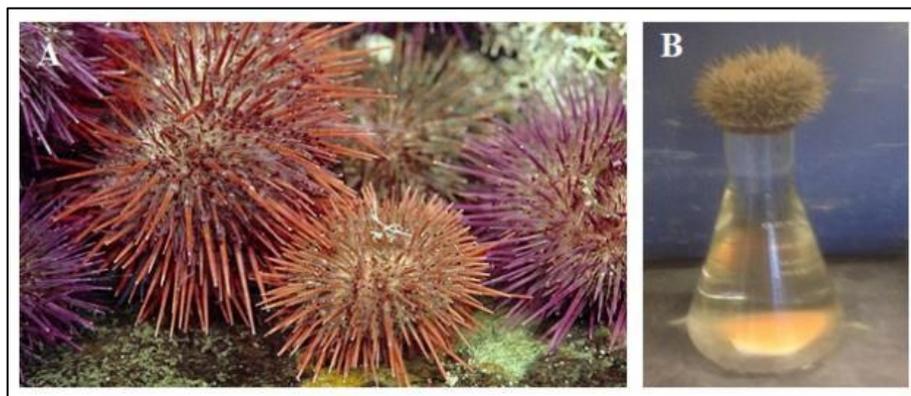
Figure 16. A) *Parechinus angulosus* collected from Kommetjie B) were spawned and gametes were collected in order to perform toxicity tests.

Female urchins were identified by the production of round orange eggs, while males were identified by the production of cloudy, white sperm. Following injection, females were inverted (oral side up) and placed on top of glass conical flasks filled to the brim with 20°C seawater (Figure 16B). Mature eggs were then free to fall from the test to the bottom of the conical flask. On completion of spawning, mature eggs of the four urchins were mixed into one flask.

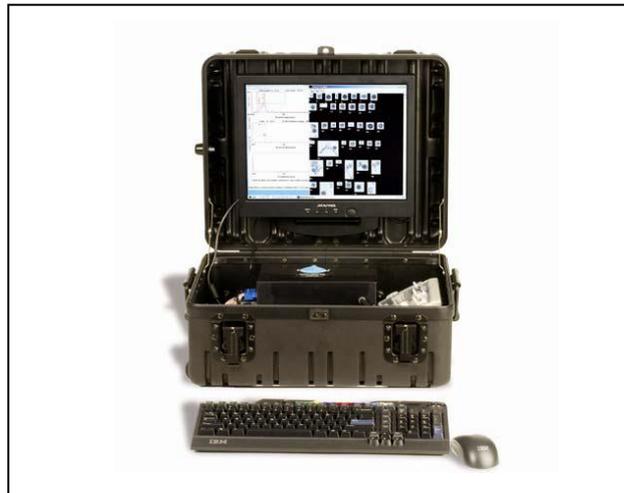
**Figure 17. FlowCAM<sup>®</sup> manufactured by Fluid Imaging Inc., ME, USA.**

Sperm and egg quality and density were determined using a FlowCAM<sup>®</sup> (flow cytometer and microscope) manufactured by Fluid Imaging Inc., ME, USA (Figure 18). The analysis was conducted in auto-image mode with a 10x objective lens and 100 micron flowcell for sperm and 300 micron flowcell for eggs.

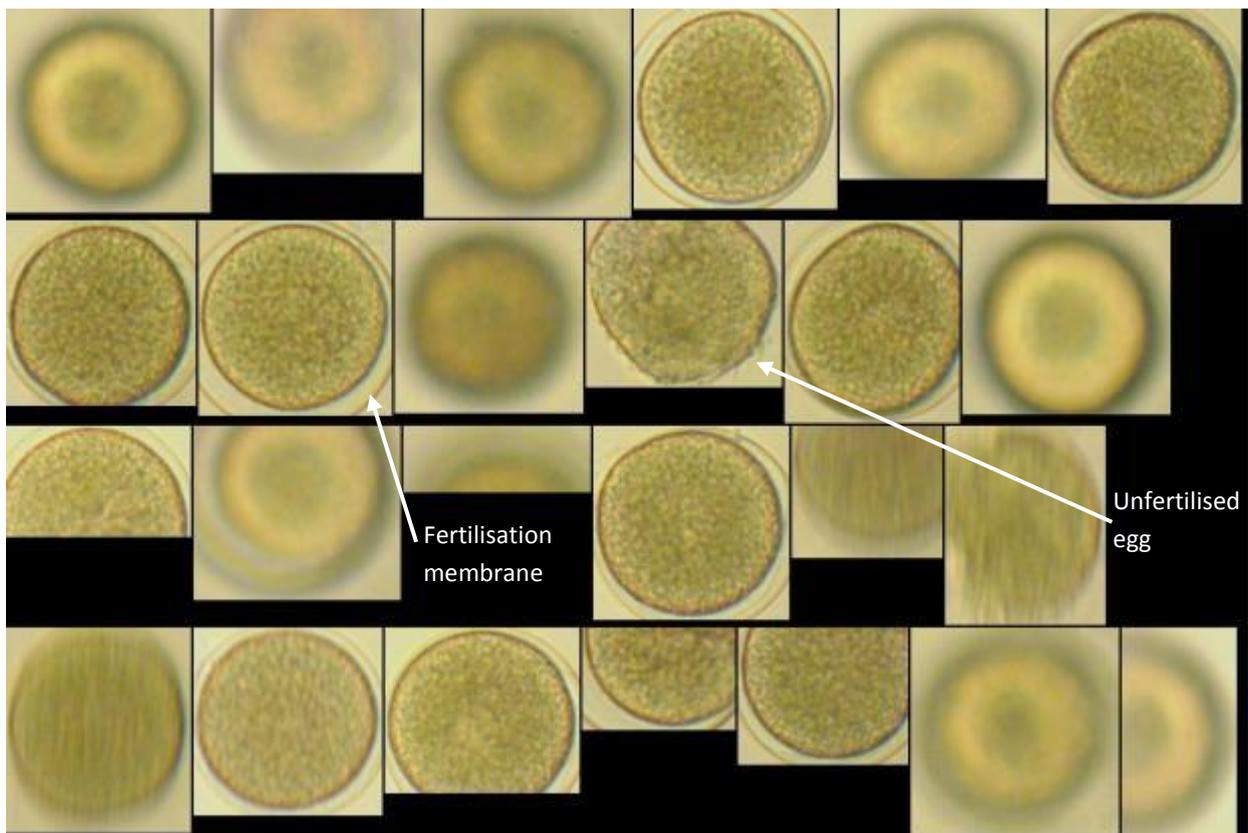
Eggs were inspected on the FlowCAM<sup>®</sup> for evidence of fertilisation, which is indicated by the presence of a clear fertilisation membrane surrounding the egg (Figure 18). Samples were analysed within a 24 hour period, as extended formalin preservation is known to damage the fertilisation membrane. After discarding all unfocused and partial images, a total of 100 eggs per replicate were selected from the images obtained by the FlowCAM<sup>®</sup>. The number of fertilised versus unfertilised eggs was then recorded and fertilization rates were calculated.

**Figure 18.** An example of images captured on the FlowCAM<sup>®</sup> showing fertilised and unfertilised eggs. Fertilised eggs are surrounded by a clear fertilisation membrane which envelops the gamete. Unfocused images were excluded from the count.

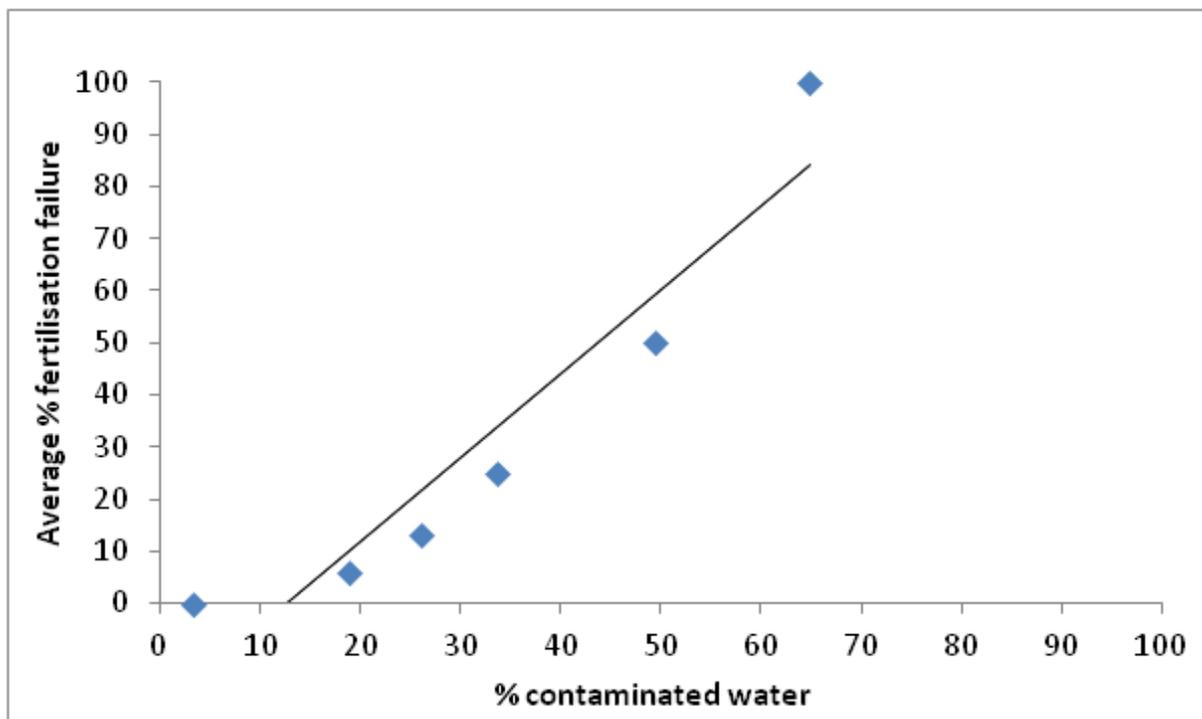
The average percentage failure of sea urchin egg fertilisation increased as the percentage concentration of contaminated seawater increased (Figure 19). The half maximal Effective Concentration (EC<sub>50</sub>) was calculated to be 49%.

**Figure 19. Relationship between average sea urchin toxicity and the concentration of contaminated water (%).**

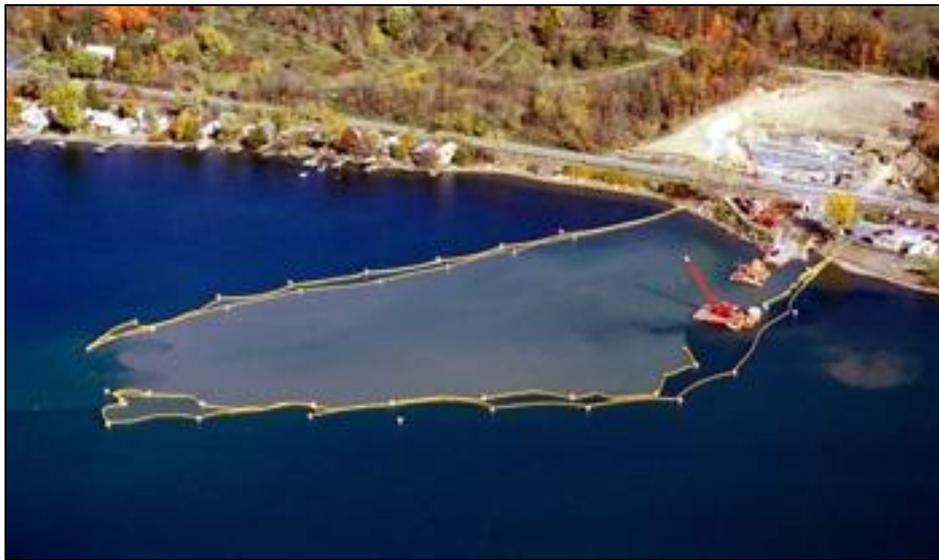
**Figure 20. A silt curtain in use during construction (Source: [www.landmsupplyco.com](http://www.landmsupplyco.com)).**

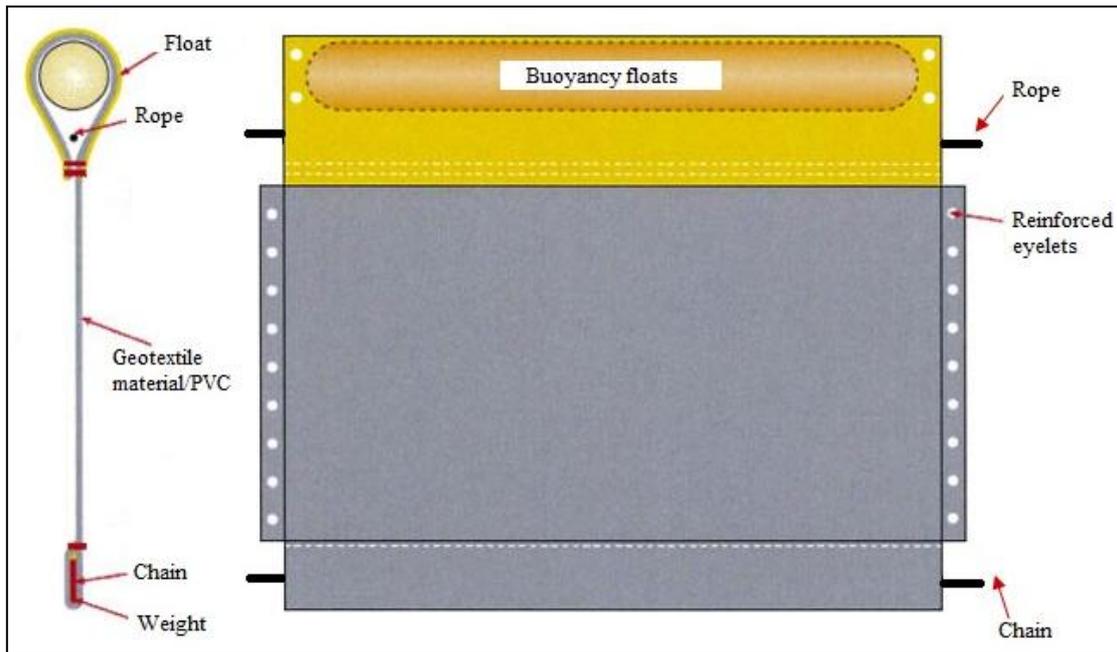
A type 1 silt curtain would be recommended for this project, as this section of the harbour is relatively calm. The skirt can be made out of either a permeable geotextile filter, or an impermeable material. The curtain typically consists of a top floatation device (boom) attached to a skirt that touches the sea floor, preventing sediment from escaping underneath the skirt. The device can be held in place with a bottom ballast chain made of galvanised steel, and curtains are usually connected to each other by means of shackles and reinforced eyelets (Figure 21).

Figure 21. A diagram showing a sheet of silt curtain on the right and a longitudinal section of a silt curtain on the left (Source: modified from [www.aquasol.net.au](http://www.aquasol.net.au)).
