Aquatic Biodiversity Impact Assessment – Wagt Solar Photo- Voltaic (PV) Solar Energy Facility and Associated Grid Connection Infrastructure

**Pixley ka Seme District Municipality,
Northern Cape Province**

Report Date: September 2022

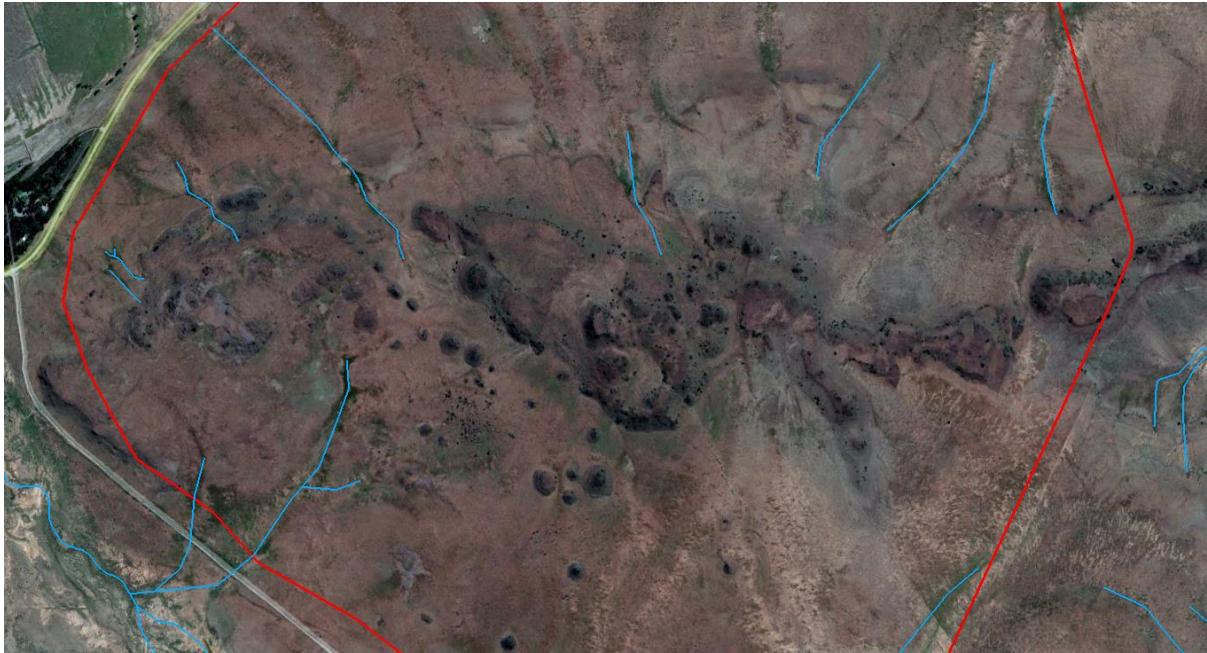
Figure 5-2 Illustration of the alluvial fans (green areas) in wet periods (Google Earth 3/2017)

Figure 5-4). Many of the drainage features presented as alluvial fans that have formed in the low laying areas below mountain slopes or gorges due to the flat topography and low water energy that has resulted in the accumulation of alluvial sediment. These areas are broad presenting as wide floodplain-like features which are difficult to observe in-field and are best seen from satellite imagery (Figure 5-3, Figure 5-5 and

Figure 5-4). These drainage areas are highlighted in times of good rainfall when the vegetation cover is greatest from inundated soils, with an example from March 2017 imagery highlighting the extent of these saturated areas (Figure 5-2). The areas are prone to flooding during large storm events and may remain saturated for several days to weeks, depending on the permeability of the soils and climate conditions. These areas are important for groundwater recharge.

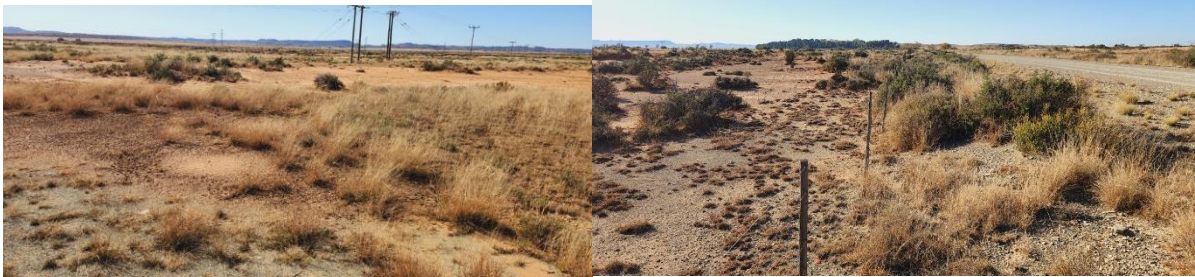
Figure 5-4 Illustration of the ephemeral habitat features of the Western tributary (June 2022)

The on-site assessment of the watercourses presented largely dry conditions, with the numerous ephemeral systems presenting no clear banks or riparian features which is typical for watercourses in an arid region (Figure 5-5 and

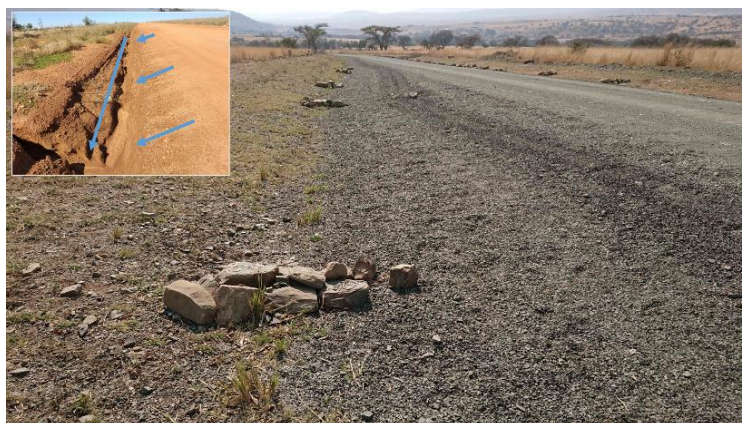
Figure 6-3 Example of road margin erosion prevention

- Energy dissipation, such as stone berms or blocks must be strategically placed along the road margins for the entire road network as surface runoff leaves the roads and enters the surrounding environment with the potential for severe erosion. The steeper the slope of the road, the more regular the berms should be spaced and can be as close as one meter apart where necessary;

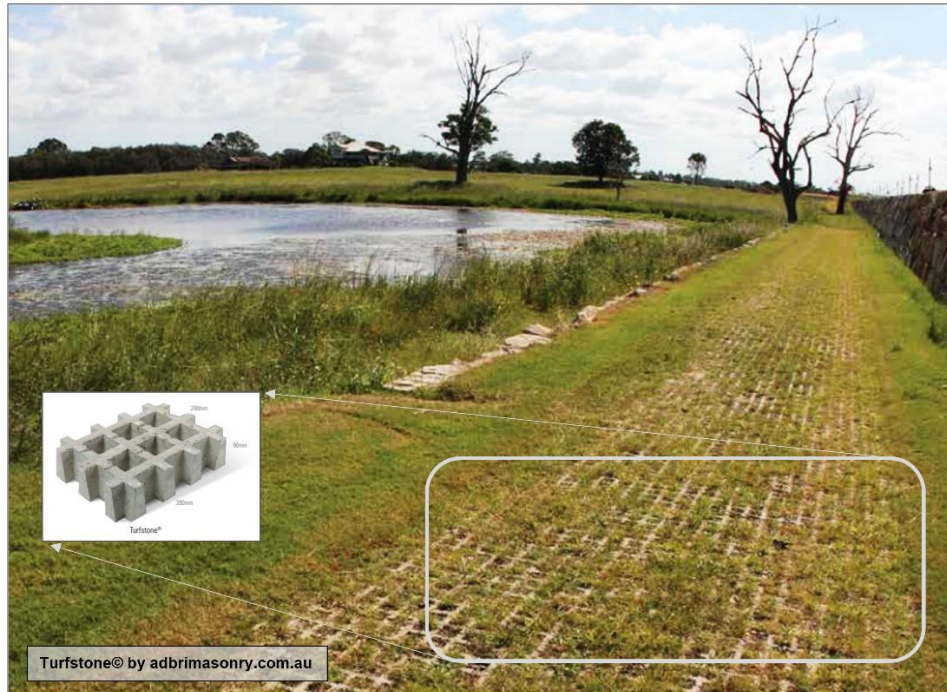
Figure 6-4 Example of permeable paving for roads and habitat maintenance

maintenance on site with the potential for damage to habitat and erosion and thus require permeable paving. The permeable paving provides a stable platform to carry the loads of service vehicles whilst the vegetation growing through the permeable pavers compliments the surrounding vegetation, preventing erosion in these key areas;
