Aquatic Biodiversity Impact Assessment – Fountain Solar Photo- Voltaic (PV) Solar Energy Facility and associated Grid Connection Infrastructure

**Pixley ka Seme District Municipality,
Northern Cape Province**

Report Date: September 2022

The Biodiversity Company

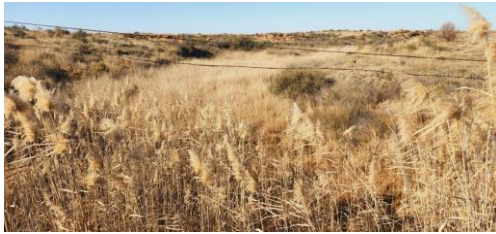
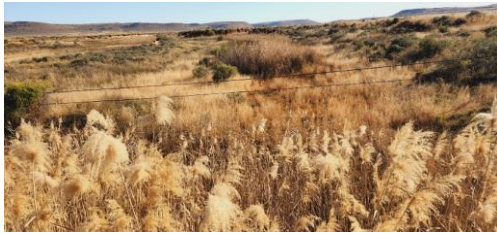
Comments	Upstream Brak River site, upstream and east of proposed infrastructure. The watercourse presented wetland habitat and was dry.	
GPS-coordinates	30°40'42.52"S 24°10'45.43"E	
Brak Down

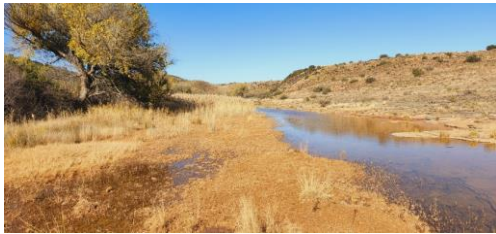
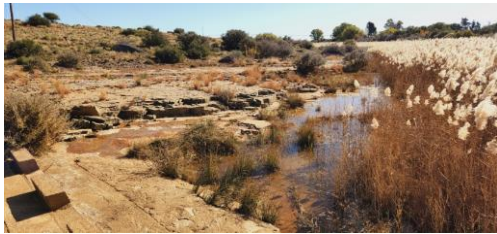
Comments	Downstream Brak River site, downstream of proposed infrastructure and downstream of Brak Mid. The site presented wetland habitat. The site was deemed too shallow and unsuitable for standard aquatic sampling methods and was limited to <i>in situ</i> water quality analysis only.	
GPS-coordinates	30°38'18.43"S 24° 8'12.64"E	
Brak River tributaries		
East Trib Dam

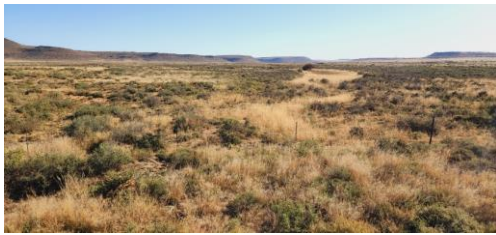
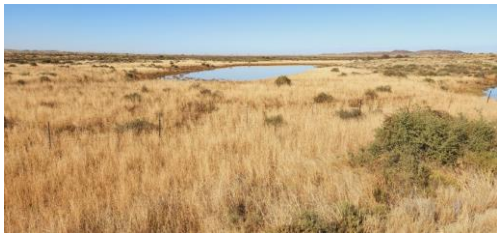
Comments	Located at a Dam on a Brak River tributary to the east of the project area (Eastern tributary). The site is downstream of the Fountain Solar PV1 Footprint and would drain into the Brak River upstream of Brak Mid. The dam had surface water and water quality analysis was conducted at this site.

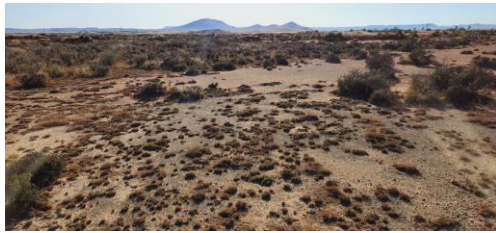
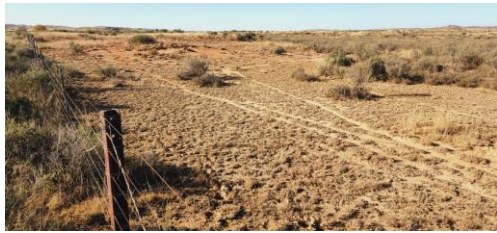
Site	Upstream	Downstream
Comments	Located on the major Brak River tributary within the western portion of the project area. The site assessed the upper portion of this tributary (Western Tributary) that will be traversed by the proposed linear infrastructure (powerlines). This site was presented by a wide drainage area (floodplain) with an inconspicuous channel, which was dry at the time of the survey.	
GPS-coordinates	30°42'39.68"S 24° 6'36.75"E	
West Trib 3

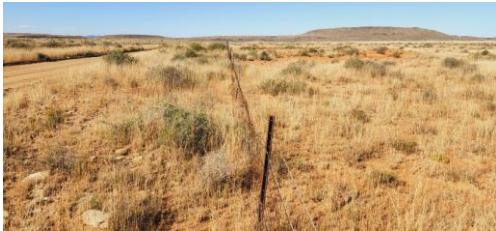
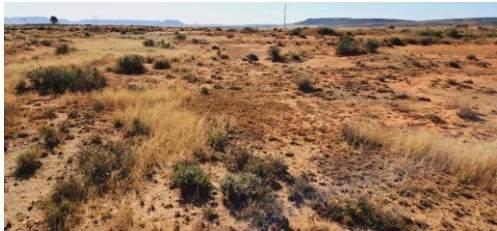
Comments	Located on the Western Tributary in the lower portion of this tributary that will be traversed by the proposed linear infrastructure (powerlines). This site was presented by a wide drainage area (floodplain) with an inconspicuous channel, which was dry at the time of the survey.	
GPS-coordinates	30°38'50.53"S 24° 6'0.03"E

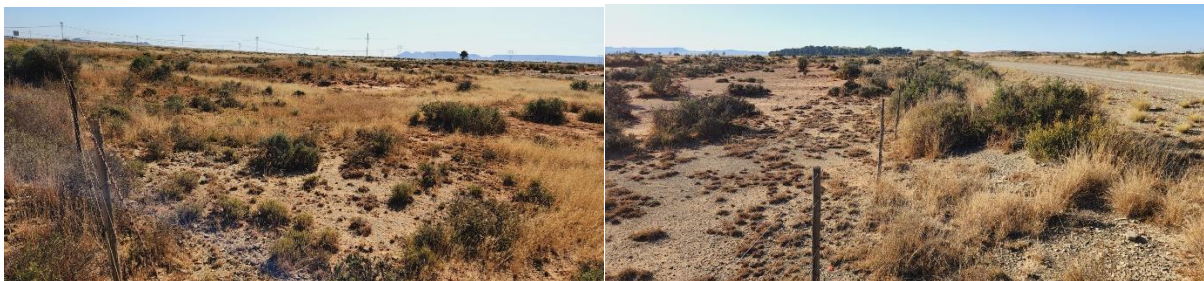
Figure 6-2 Illustration of the ephemeral habitat features of the Western tributary (June 2022)

The on-site assessment of the watercourses presented largely dry conditions, with the ephemeral systems presenting no clear banks or riparian features which is typical for watercourses in an arid region (Figure 6-3 and Figure 6-2). This together with the temporary presence of surface water within these watercourses limited the use of the IHIA method. Therefore, the baseline condition of the watercourses is presented through site photos and satellite imagery. Some level of channel habitat modification has taken place through land use activities however the ecosystems and adjacent terrestrial habitat is considered open and largely unmodified. Baseline impacts within the drainage channels and catchment include instream weirs, farm fences, livestock influence and vehicle tracks which have altered the hydro-dynamics to some degree. Despite their current level of modification and ephemeral nature, the watercourses are sensitive to further modification as these systems do provide drinking opportunities (in times of rainfall) and habitat for foraging, nesting and refugia for terrestrial biota and avifauna. Therefore, the watercourses in the project area are regarded as sensitive environments in relation to changes in habitat integrity, flow and water quality requiring avoidance from the project related disturbance activities and maintenance of baseline conditions.

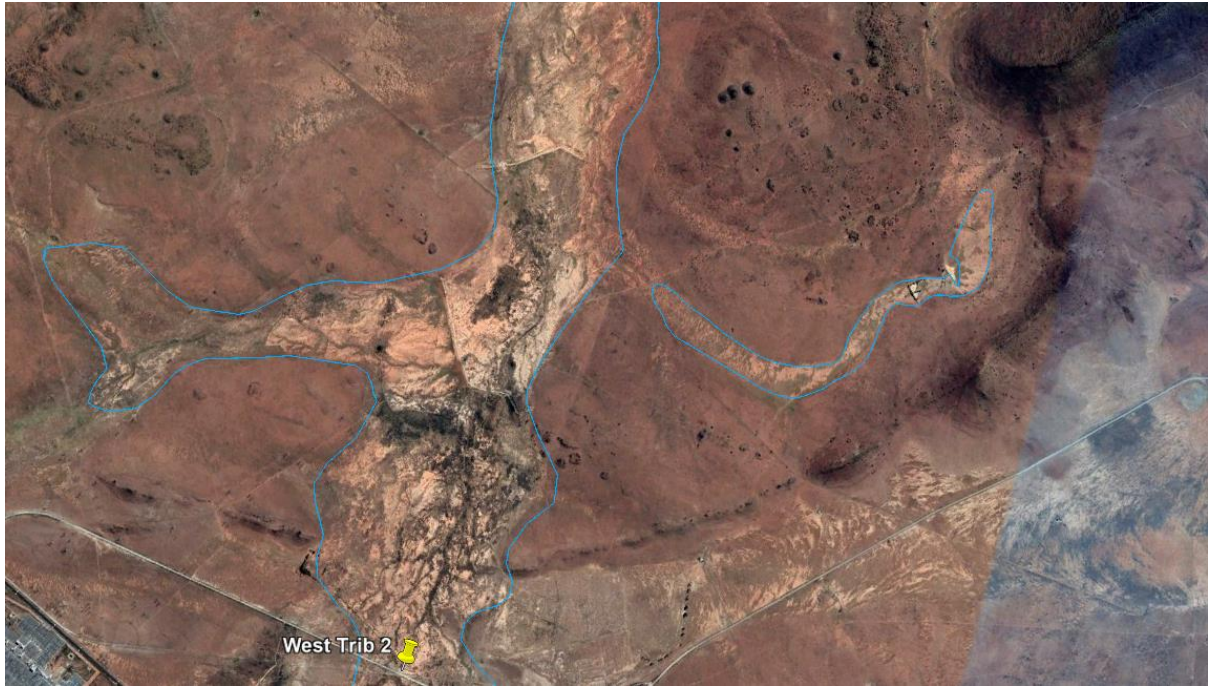
Figure 6-3 Illustration of the catchment condition of the Western tributary (Google Earth)

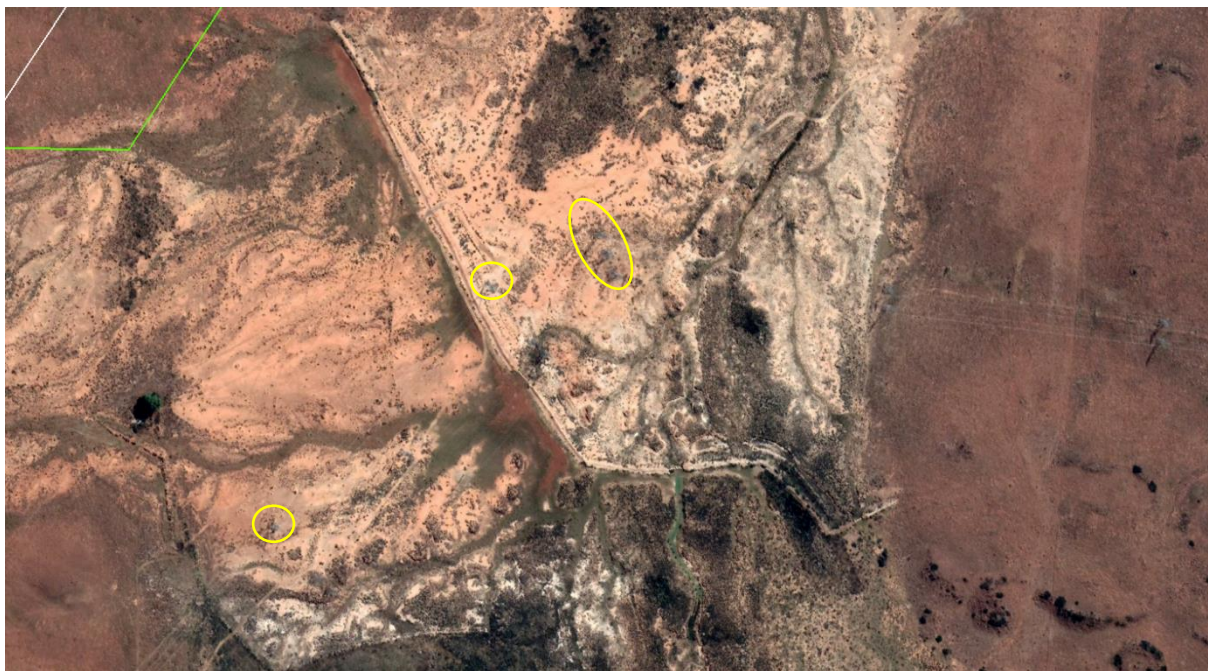
Figure 6-4 Illustration of existing instream weirs structures and powerline pylons (yellow circles) within the drainage features (Google Earth)

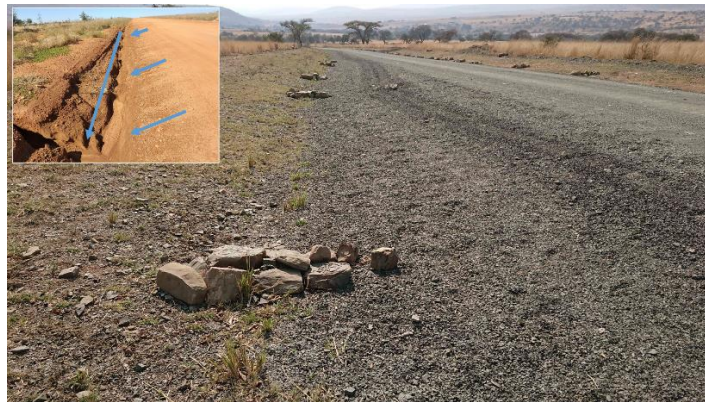
Figure 7-3 Example of road margin erosion prevention

- Landscape and re-vegetate all cleared areas as soon as possible to limit erosion potential;
- Energy dissipation, such as stone berms or blocks must be strategically placed along the road margins for the entire road network as surface runoff leaves the roads and enters the surrounding environment with the potential for severe erosion. The steeper the slope of the road, the more regular the berms should be spaced and can be as close as one meter apart where necessary;

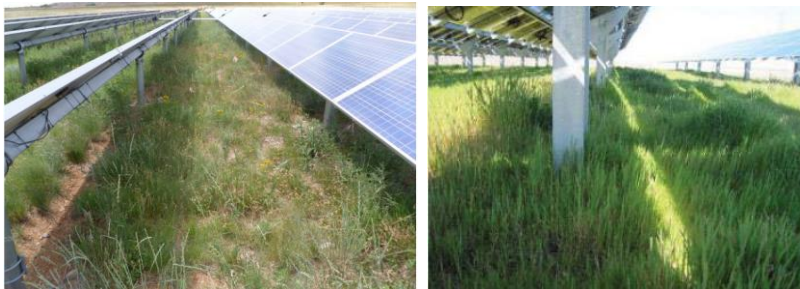
- Indigenous vegetation must be maintained under the solar panels to ensure biodiversity is maintained and to prevent soil erosion (Beatty *et al*, 2017; Sinha *et al*, 2018). This vegetation cover will maintain surface roughness which will assist in maintaining hydrological connectivity through infiltration and subsurface interflow. The photographs below are sourced from these documents;

- The vegetation type to be maintained under the solar panels should be low-growing grasses which reduce the potential impact of fire as shorter grass would lower the intensity of fires. Sheep-grazing should be introduced to assist in maintaining the vegetation to reduce fire risk (Vaverková *et al.*, 2022); and
- Environmental Control Officer (ECO) to provide supervision and oversight of vegetation clearing activities.
