GEOHYDROLOGICAL ASSESSMENT

FOR THE PROPOSED UPGRADE OF THE ROCKY DRIFT WWTW,
MBOMBELA LOCAL MUNICIPALITY, EHLANZENI DISTRICT,
MPUMALANGA

December 2020
DRAFT REPORT

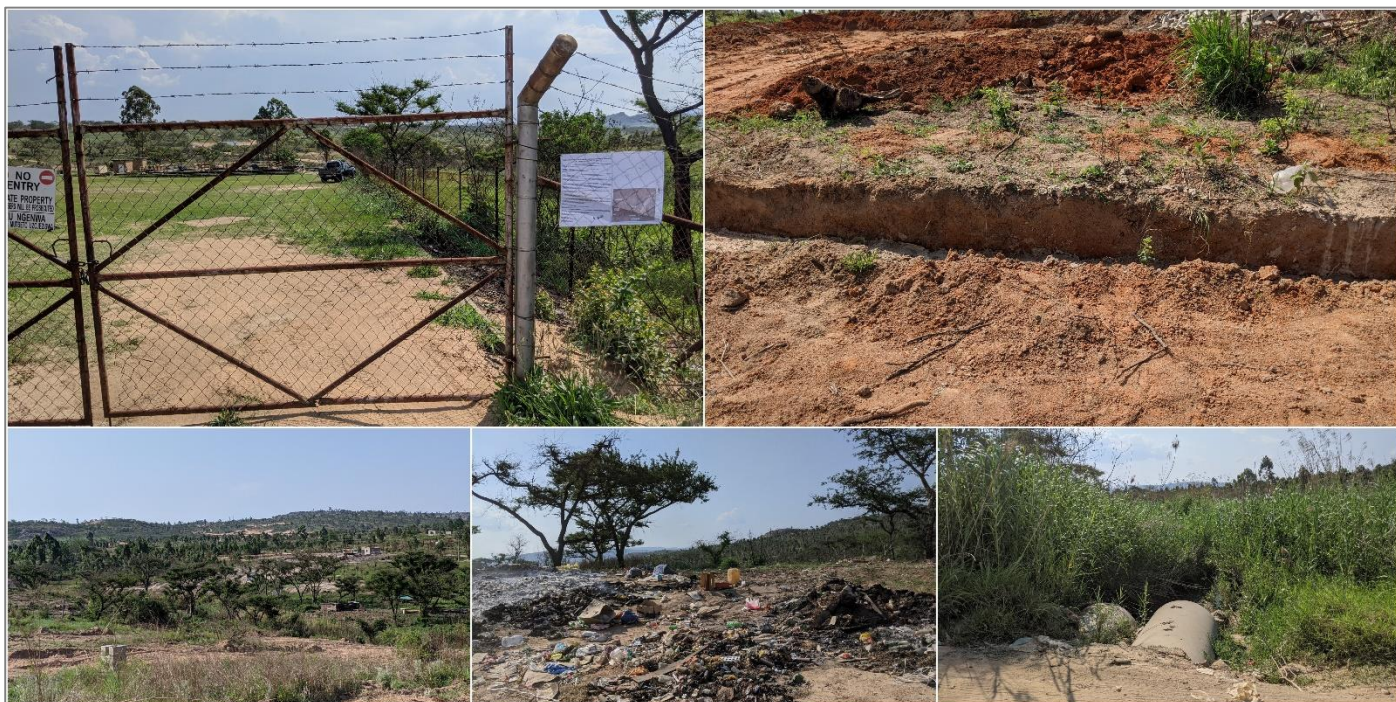
Figure 3 Typical setting of the surrounding site showing extensive disturbances

The site sits on a non-perennial tributary of the Sand, approximately 2.44 km to the north. The site has been significantly modified for settlements, brick/granite factories and agricultural activities. According to desktop information (DWS, 2017), the activities in the area and local land uses have impacted the aquatic system, which have rendered the system as moderately modified. The associated watercourse is predominantly representative of a wetland system, but a site was selected for the analysis of water (in situ) and to collect a water sample. However, this study assessed the reach of the watercourse adjacent to the WwTW (JG Afrika, 2017).

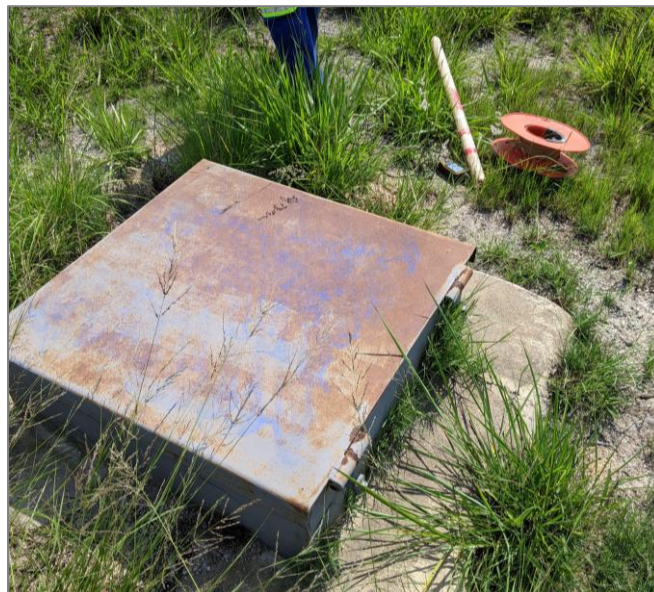
Figure 12 Existing borehole adjacent to Rocky Drift WWTW

It is unnecessary for an observation borehole to be installed to monitor the groundwater quality. There is already a borehole on-site adjacent to the WWTW (Figure 12). This borehole should be tested every 6 months for the WWTW (not the bulk line), to ensure that groundwater contamination does not occur with the addition of more effluent. Focus should also be placed on ensuring the integrity of sensitive surface water resources.
