GEOTECHNICAL INVESTIGATION
REPORT FOR AEP KATHU SOLAR PV
ENERGY FACILITY - GCS-RP/053/2015

Report Prepared for
AEP KATHU SOLAR
(PTY) LTD

Report No
GCS-RP/053/2015

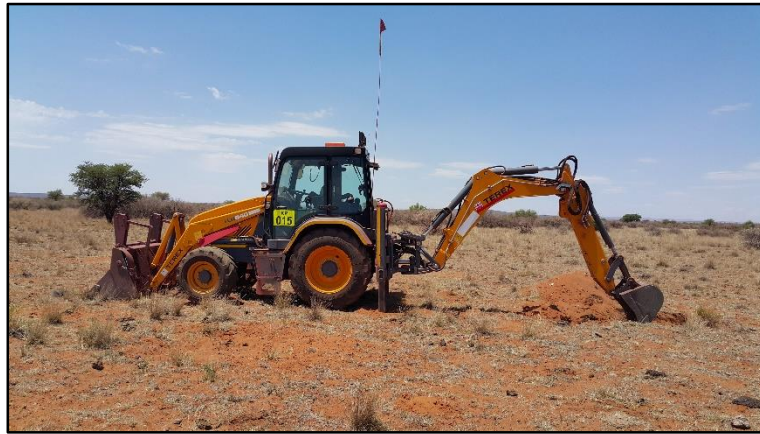
PHOTO 1: TLB USED TO EXCAVATE TRIAL PITS

The fieldwork was conducted from 12 to 14 November 2015. Ten trial pits were planned and eight were excavated across the study (Figure 7), using a TERREX 840 tractor-loader-back-actor (TLB), (Photo 1). The two was not excavated due the consistent soul profile in the area. A total of 3 DCP test (Photo 2) were conducted at representative soil profile locations and 2 soil samples were collected for laboratory testing.

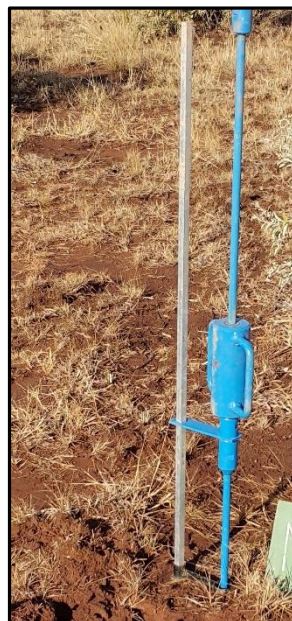
PHOTO 2: DCP TEST

The 3 DCP tests were conducted next to each of the following trial pits; K_TP02, K_TP06 and K_TP8.

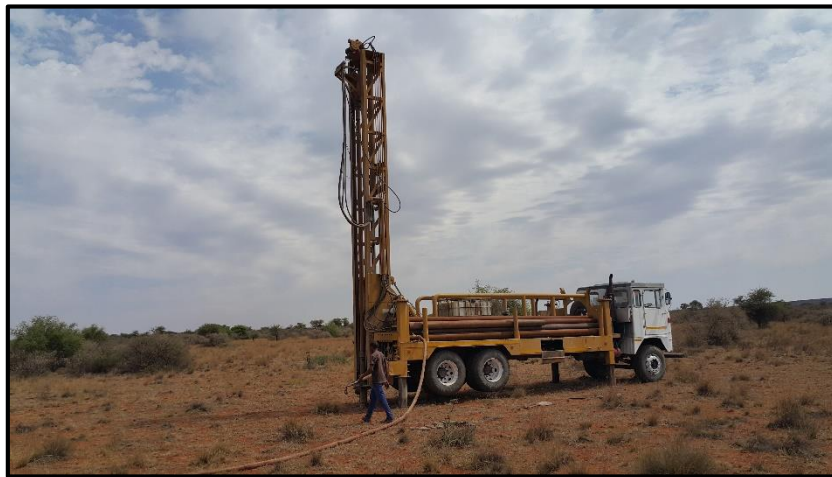
PHOTO 3: PERCUSSION DRILL RIG POSITIONED ON THE DRILLING POSITION, READY TO START DRILLING.

Due to the site potential being underlain by dolomite at depth, a percussion borehole was planned to a depth of 100m to determine the depth at which dolomite bedrock occurs and to evaluate the nature of the overlying blanket material. The borehole was planned and drilled with a truck mounted percussion drill rig (Photo 3) at the position indicated in Figure 8, on the neighbouring farm (Portion 1 of Legoko 460), just south of the site under consideration. This hole was located central to three proposed solar developments, and is deemed to be representative of the local geology on all three sites.

The percussion borehole drilled on site DOL_BH (Figure 8) was planned to 100m but was terminated at 65m in loose pebbles at the base of the Kalahari Formation, in a pebble bed that most likely represent a paleo erosion surface correlated to the African2 erosion surface. This layer of pebbles is widespread throughout the area and is encountered in many boreholes. The reason for the termination of the borehole is that due to the fact that the hole was only planned as an exploratory hole and only a collar casing to 3m was installed. At depth the clays squeezed the drill string and the pebbles dropped in behind the hammer causing the drill to loose rotation and be at risk of locking the drill string up. The alternatives were to use a Cemetrix drill bit and install casing to the bedrock. At that time information regarding two monitoring boreholes drilled by Kumba (BH_A and BH_B in Figure 8) came to light. Chert -rich dolomite were intersected in both these boreholes at depths of 63 and 68m respectively. The intersections of the dolomite bedrock and the pebble layer is indicated in Table 7, indicating that borehole DOL_BH was terminated very close to the upper contact of the dolomite. The borehole intersections also define the thickness and nature of the blanketing overburden above the dolomite

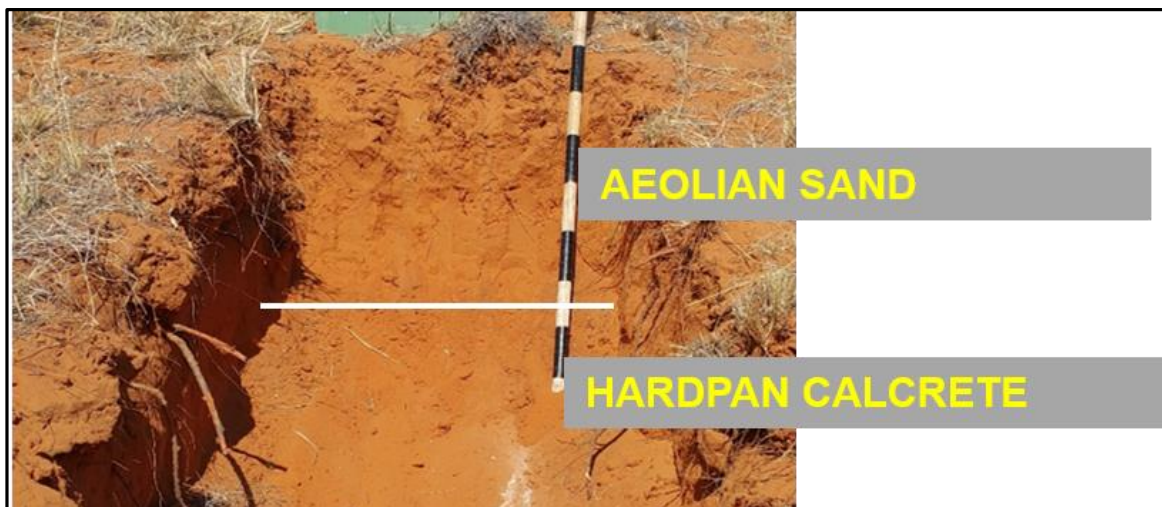
PHOTO 4: AEOLIAN SAND WITH HARDPAB CALCRETE

The north western and central part of the proposed Kathu Solar Facility is underlain by a thin aeolian sand cover overlying hardpan calcrete (Figure 9) The profile is encountered in trial pits K_TP02, and K_TP04 and consist of;

Dry, orange brown, very loose, intact, uniform silty sand, AEOLIAN (Kalahari Sand) with grass roots., overlying dry, orange brown, very loose, intact, uniform silty sand, AEOLIAN (Kalahari Sand), overlying HARDPAN CALCRETE. The TLB refused on hardpan calcrete at a depth of 0.5m, see Photo 4 and Table 2.

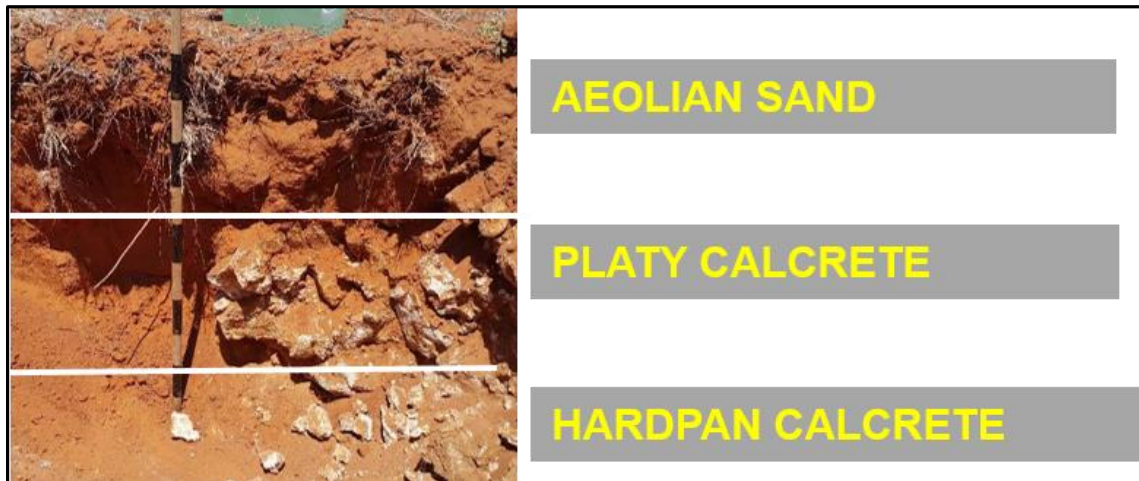
PHOTO 5: HILLWASH PROFILE

The largest part of the central area of the site is underlain by aeolian sand with platy calcrete overlying hardpan calcrete. The platy calcrete is an indication of localized surface weathering of the hardpan calcrete. This soil profile was encountered in trial pit K_TP09. The TLB refused at 0.6m on the Hardpan Calcrete (Photo 5 and Table 3).

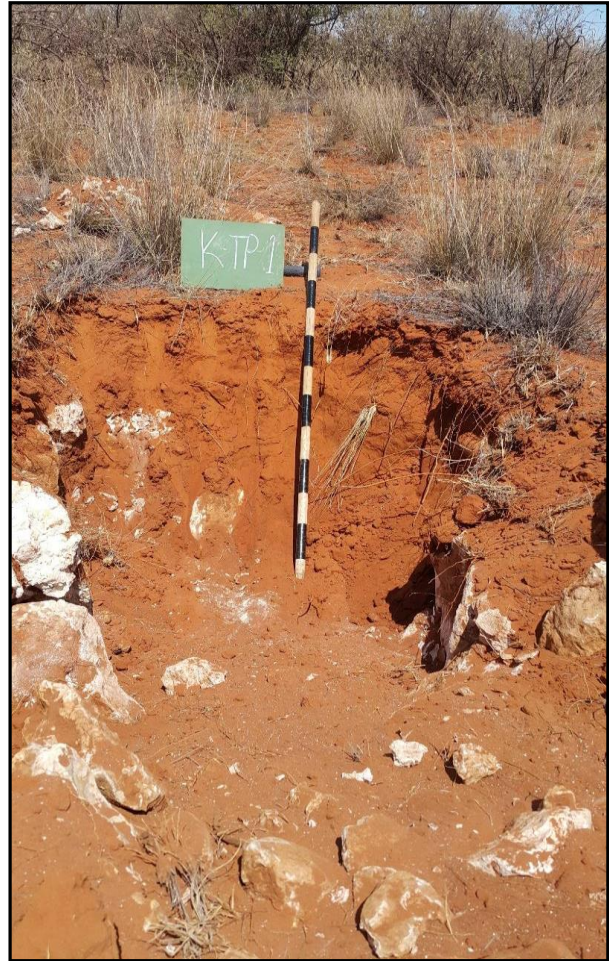
Profiled by C de Beer
Diameter
Depth 0,80
Type: Trial Pit

Profile	Depth to (m)	Description
	0,30	Dry, orange brown, very loose, intact, uniform sity sand, AEOLIAN (Kalahari Sand) with grass roots.
	0,80	Dry, orange brown, very loose, intact, uniform sity sand, AEOLIAN (Kalahari Sand) with sparse BOULDER CALCRETE
	End of Hole @ 0.80 m. TLB refusal on HARDPAN CALLCRETE. No groundwater encountered.

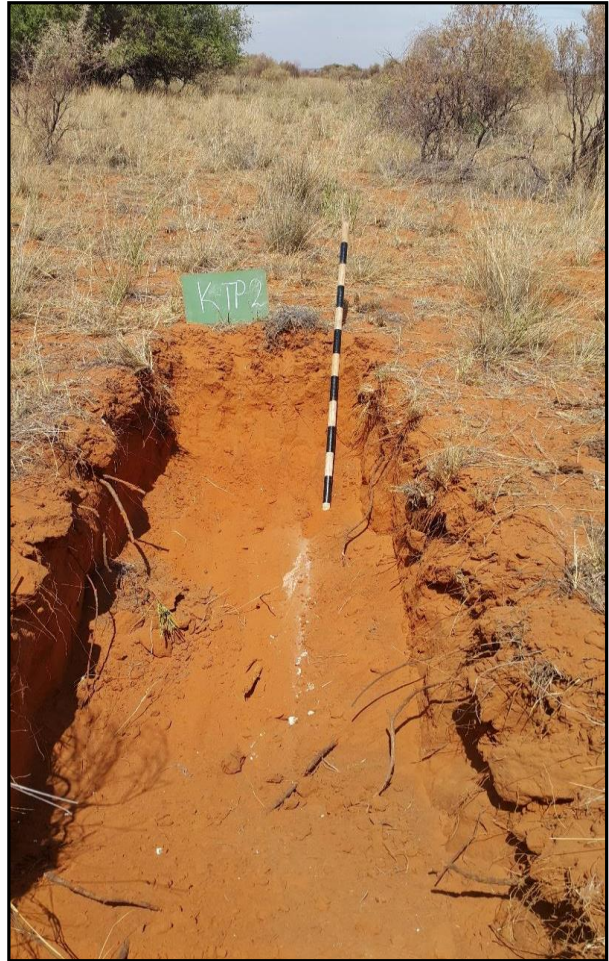
Profiled by C de Beer
Diameter
Depth 0,50
Type: Trial Pit

Profile	Depth to (m)	Description
	0,50	Dry, orange brown, very loose, intact, uniform sity sand, AEOLIAN (Kalahari Sand) with grass roots.
		End of Hole @ 0,50 m. TLB refusal on HARDPAN CALLCRETE. No groundwater encountered.

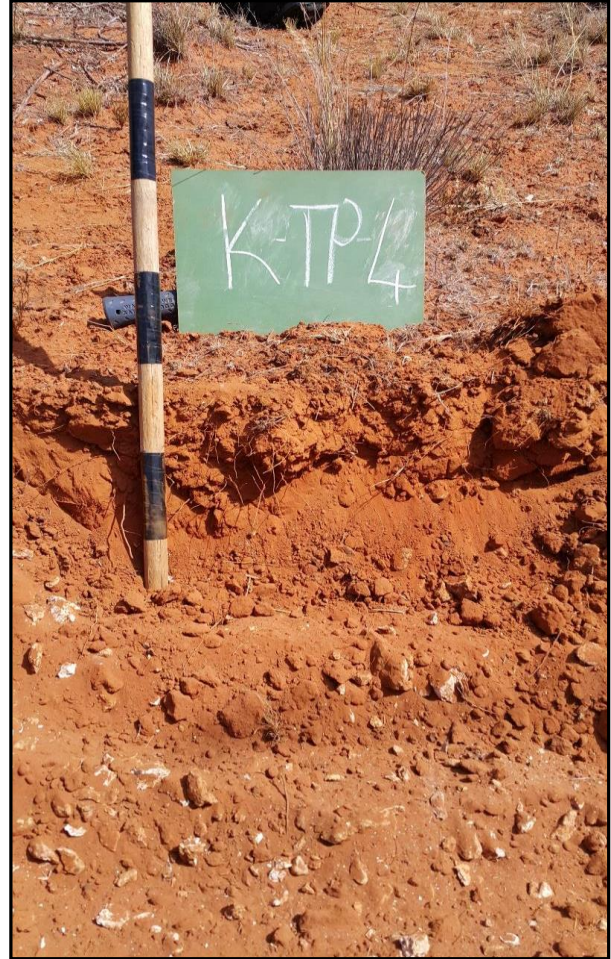
Contractor Kathu Profile
Machine Terrex 840TLB
Operator Jafta

Soil Profile Description

0,50	Dry, orange brown, very loose, intact, uniform sity sand, AEOLIAN (Kalahari Sand) with grass roots.

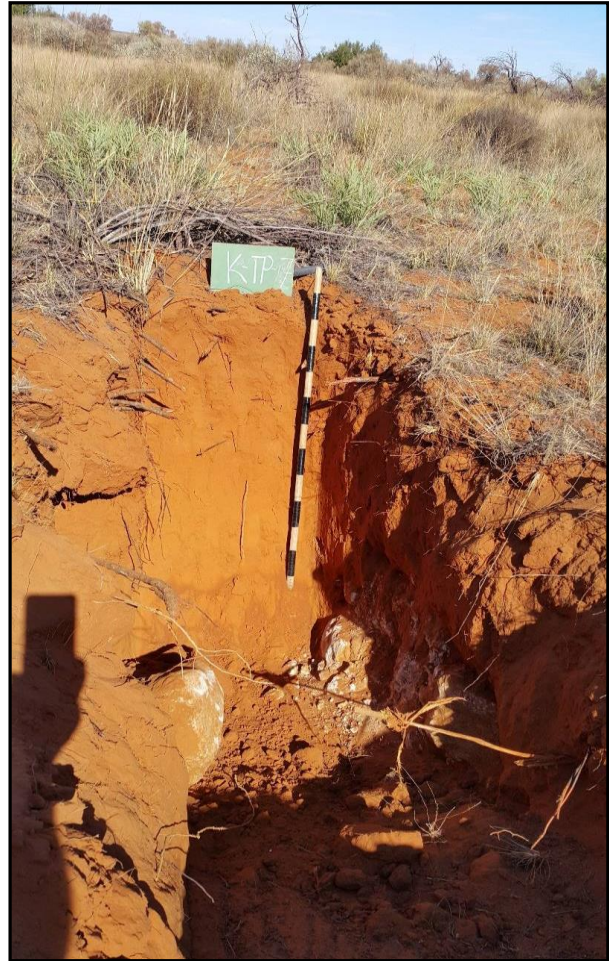
Co-coordinates:
X-coord 27,76444° E
Y-coord 023,12041° S
Z-coord 1244

Profile	Depth to (m)	Description
	0,30	Dry, orange brown, very loose, intact, uniform sity sand, AEOLIAN (Kalahari Sand) with grass roots.
	1,30	Dry, orange brown, very loose, intact, uniform sity sand, AEOLIAN (Kalahari Sand) with sparse BOULDER CALCRETE
		End of Hole @ 1,30 m. TLB refusal on HARDPAN CALLCRETE. No groundwater encountered.

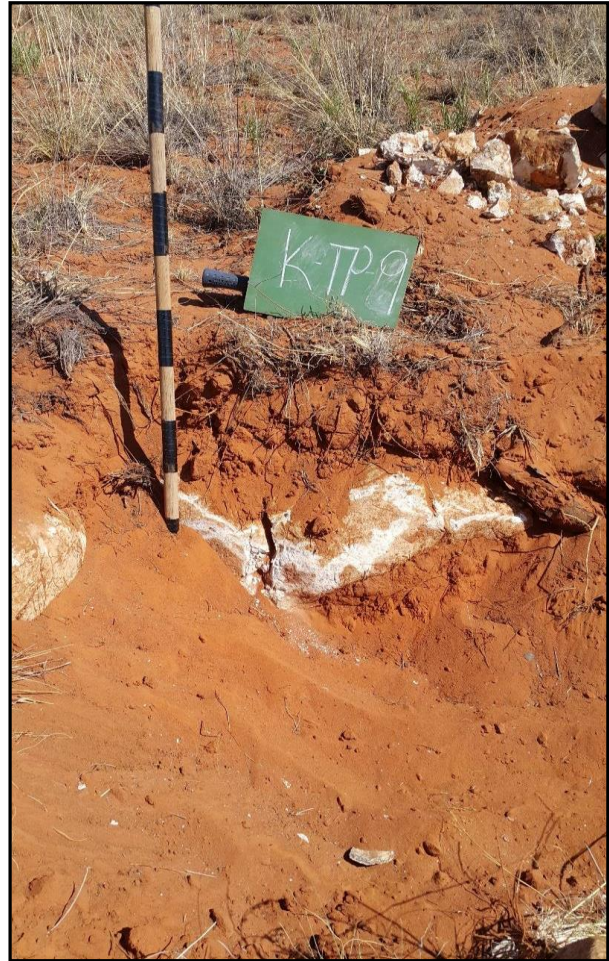
Contractor Kathu Profile
Machine Terrex 840TLB
Operator Jafta

Soil Profile Description

Profile	Depth to (m)	Description
	0,20	Dry, orange brown, very loose, intact, uniform sity sand, AEOLIAN (Kalahari Sand) with grass roots.
	0,60	Dry, orange brown, very loose, intact, uniform sity sand, AEOLIAN (Kalahari Sand) with weak to medium strong PLATEY CALCRETE
	End of Hole @ 0.60 m. TLB refusal on HARDPAN CALLCRETE. No groundwater encountered.

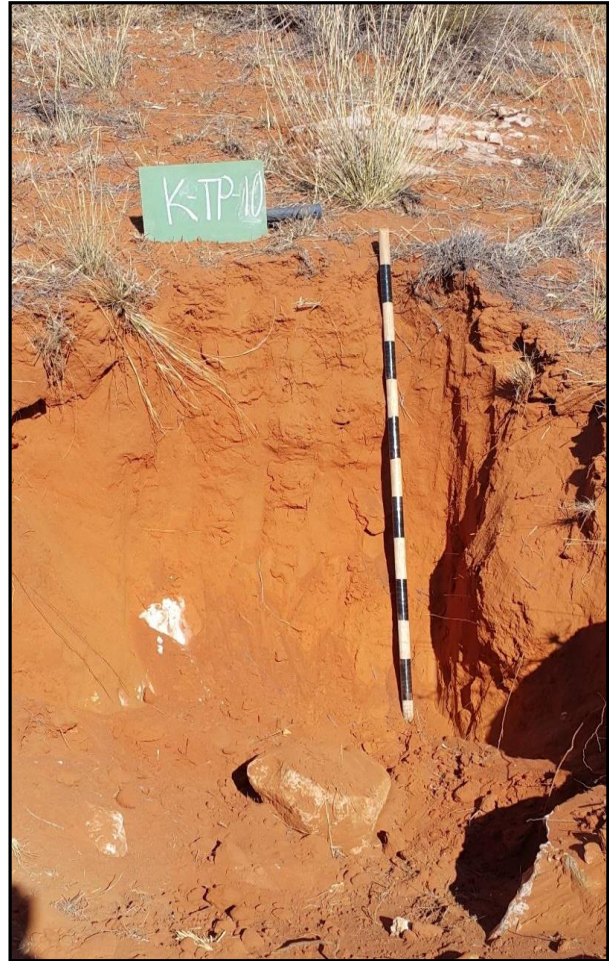
Profiled by C de Beer
Diameter
Depth 1,10
Type: Trial Pit

Contractor Kathu Profile
Machine Terrex 840TLB
Operator Jafta

Soil Profile Description

Profile	Depth to (m)	Description
	0,30	Dry, orange brown, very loose, intact, uniform sity sand, AEOLIAN (Kalahari Sand) with grass roots.
	1,10	Dry, orange brown, very loose, intact, uniform sity sand, AEOLIAN (Kalahari Sand) with sparse BOULDER CALCRETE
