**PROPOSED AEP KATHU SOLAR (PTY) LTD SOLAR DEVELOPMENT
NEAR KATHU, NORTHERN CAPE**

**SPECIALIST STUDY:
WATER RESOURCES ASSESSMENT STUDY**

December 2015

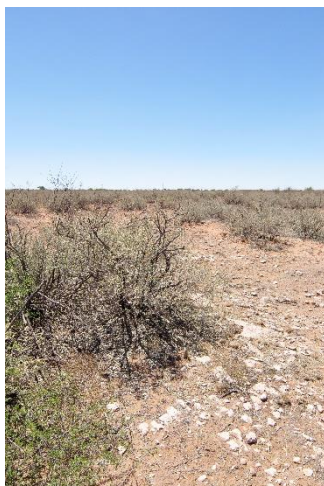
Plate 1: A small pan located in the northern portion of the study area. Note the hard pan carbonate (limestone) in the foreground

The pans are typical of this flat landscape where runoff accumulates in these depressions (Plate 1). The depressions have formed through the dissolution of the underlying limestone creating these endorheic systems (i.e. inflow but no visible surface outflow) and are thus karst (lime) related systems (Plate 2). This was confirmed by the soil specialist that indicated that large areas within the study area were covered by hard pan carbonates.

PES Site 1– 27.744527S; 23.106589E (DD.dddd WGS84)

The Present Ecological State (PES) assessment was conducted although no instream vegetation was observed, with the pan colonised by typical grass and shrub species from the region. In the Level 3 Riparian Vegetation Response Assessment Index (VEGRAI, Kleynhans *et al.* 2007), PES scoring system (see table below), the non-marginal woody vegetation thus dominated the overall PES score (B/C = Near Natural / Moderately Modified). The score was lowered due to the presence of grazing, trampling and encroachment by the surrounding shrubs.

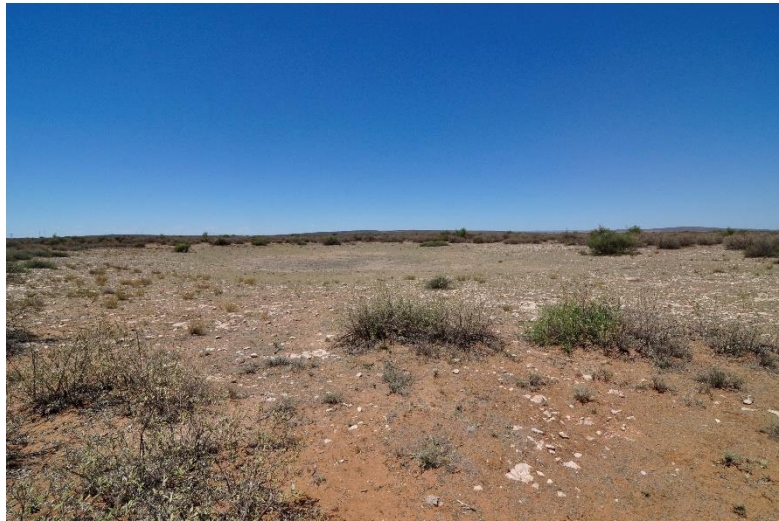
Plate 2: One of the larger pans showing located in the southern portion of the study area

PES Site 2 – 27.758615S 23.108379E (DD.dddd WGS84)

Present Ecological State (PES) Site 2 was situated south of PES Site 1 within a larger pan. No marginal or instream vegetation or other associated aquatic biota have been observed in this system due to its ephemeral nature. The PES score (See Level 3 VEGRAI assessment results below) was B = Near Natural, but this was due to additional impacts such as existing tracks, livestock tracks and grazing that have affected the this system.
