ENVIRONMENTAL IMPACT ASSESSMENT

PROPOSED CONSTRUCTION AND IMPLEMENTATION OF A PHOTOVOLTAIC POWER PLANT ON THE REMAINING EXTENT OF KLONDIKE NO 670 NEAR VRYBURG IN THE NORTH WEST PROVINCE.

AGRICULTURAL SCOPING REPORT 17 March 2016

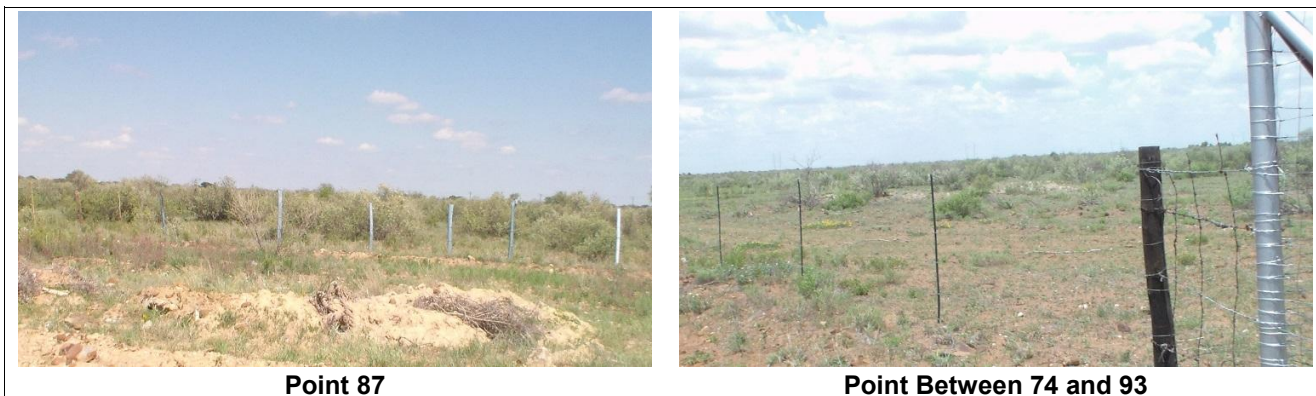
Figure 7: Route of the proposed connecting line

The photos in Figure 7 show the soil surface and vegetation on the alignment to the sub-station.
