**Bloemsmond 4 PV  
Near Upington, Northern Cape**

***Aquatic Specialist Study***

Bloemsmond Solar 4 (Pty) Ltd  
June 2019

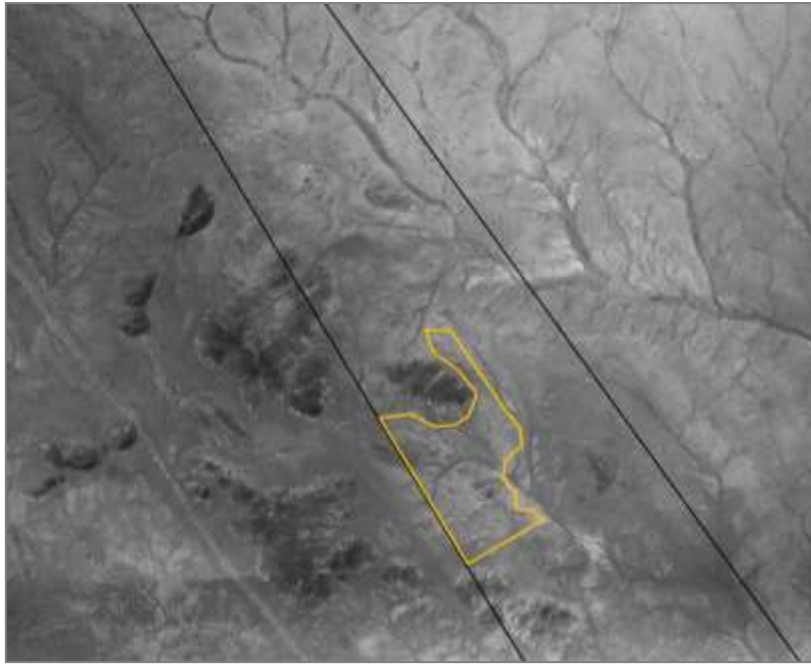
**Figure 5. Historical aerial photo (1964) showing the approximate layout of Bloemsmond 4 (yellow line)**

The oldest historical aerial image that could be obtained was from 1964. This shows that the site within Bloemsmond Farm, and Bloemsmond 4 in particular is very similar in appearance to the present day (Figure 5). There has been little to no development at the site. The drainage lines appear to be located in much the same position as their current location.

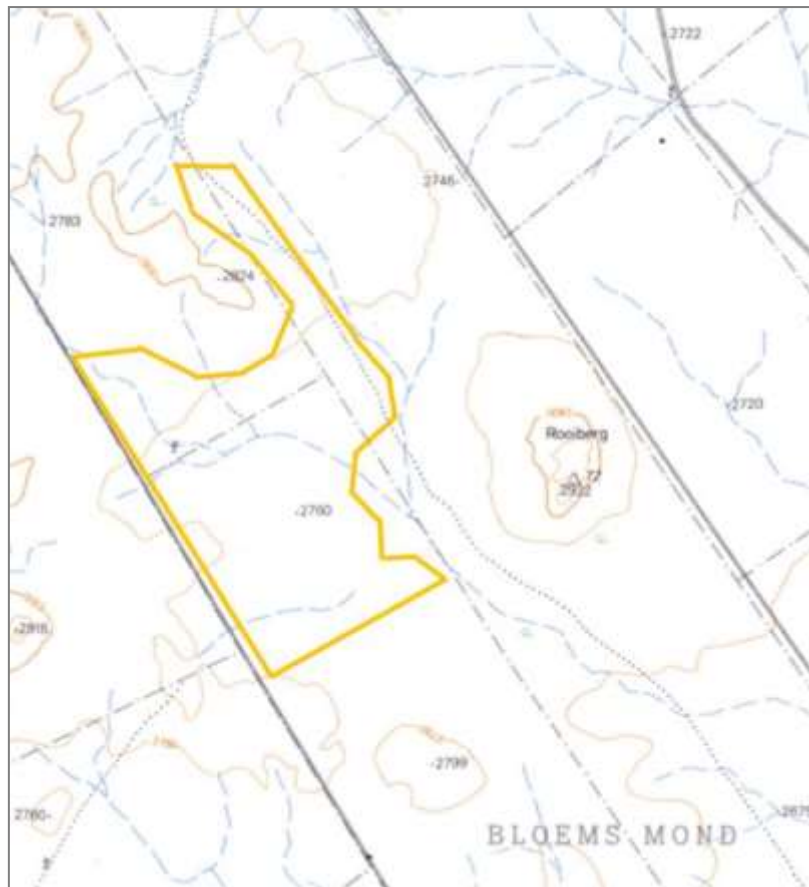
Figure 6. Historical topographic map (1970) showing the approximate layout of Bloemsmond 4 (yellow line)

The topographic map from 1970 indicates the koppie located to the south-east of Bloemsmond 4 is named Rooiberg (Figure 6). The layout of Bloemsmond 4 has been designed to avoid the koppie to the north and a large drainage line leading south-east approximately along the centre of the farm. The topographic map indicates a drainage line flowing south-east within the proposed array's footprint. This drainage line is also evident in the historical aerial image (Figure 5).

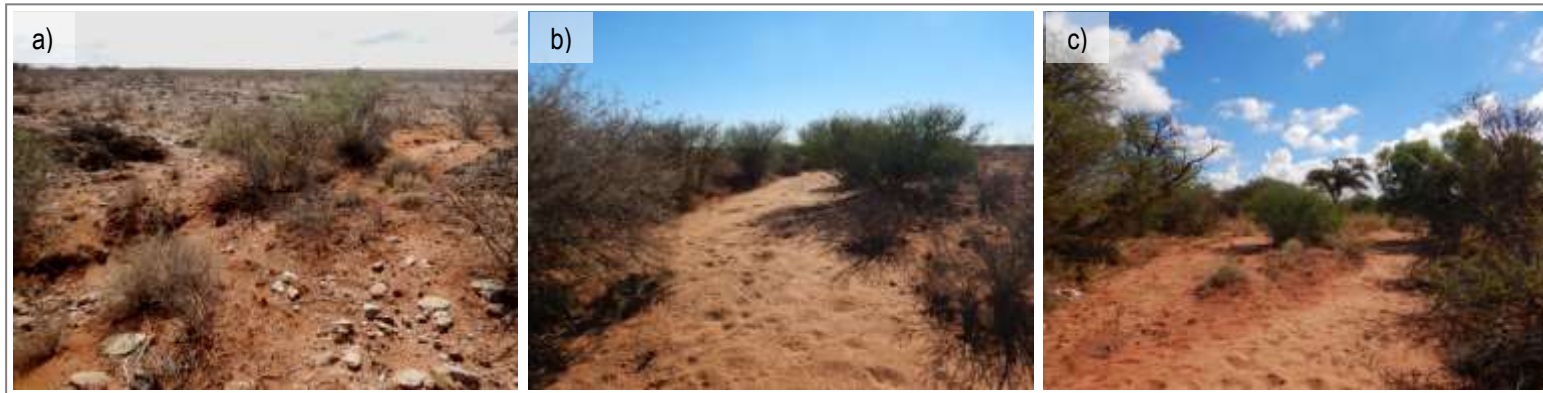
Figure 7. Example of drainage lines typical of Low (a), Moderate (b) and High (c) sensitivity at Bloemsmond Farm

Each system was determined to be of low, moderate or high sensitivity based on observations in the field and using satellite imagery. An example of typical drainage lines allocated these scores is provided in Figure 7. Buffers ranged depending on sensitivity with Low at 10m, Moderate at 20m and High at 30m.

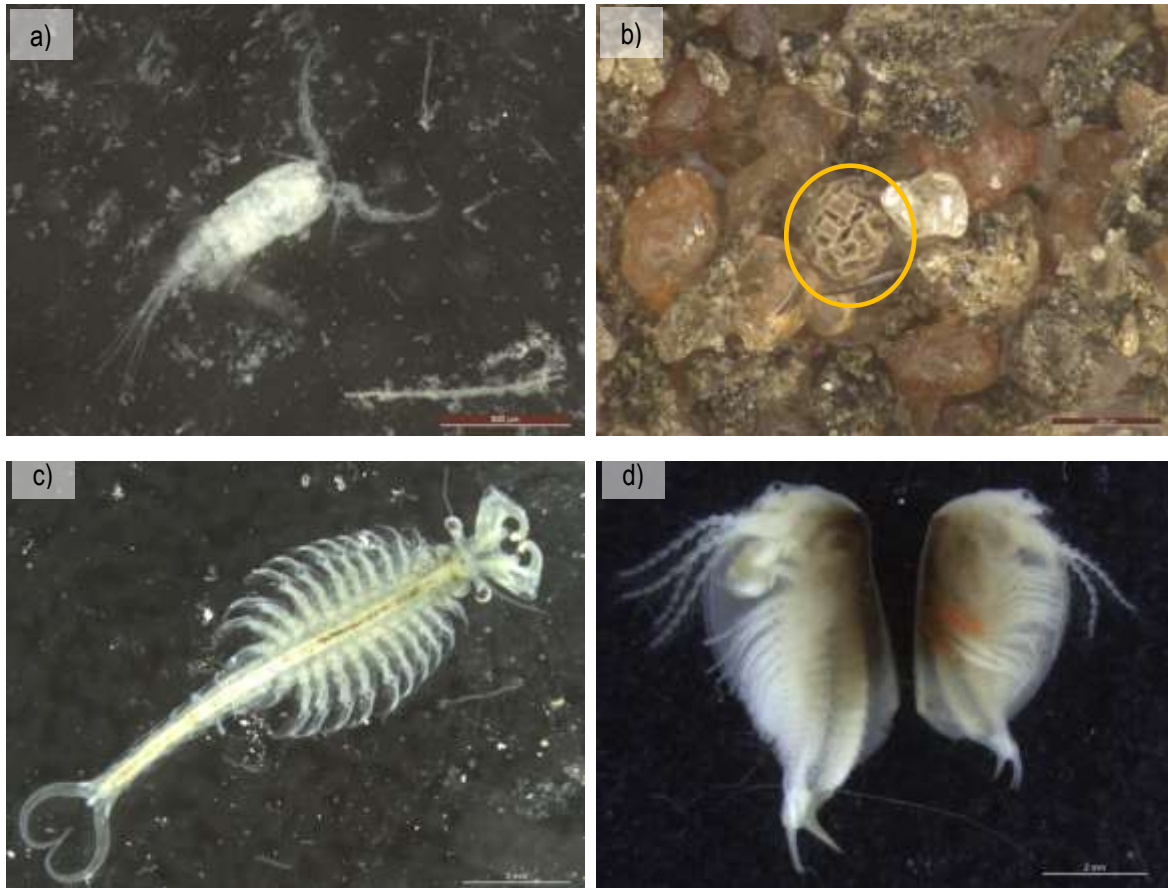
Figure 11. Images of a copepod (a), anostracan (fairy shrimp) egg circled in sediment (b), an adult fairy shrimp (*Branchipodopsis tridens*) and male and female clam shrimps (*Leptestheriella* sp.; d).

The 0.2mm diameter eggs produced by these crustaceans rest in the sediment of pans and pools for extended periods (> 20 years) until they are stimulated to emerge following rewetting (Figure 11b). Development occurs rapidly so that reproduction occurs 4 – 7 days following rewetting, before the pool has a chance to dry out. If the sediments of these pools are disturbed or excavated, the egg bank could be lost. If the hydrological regime is altered from ephemeral to permanent inundation (e.g. through pumping in borehole water) the loss of desiccation phase interrupts the life cycle and these crustaceans can no longer persist.

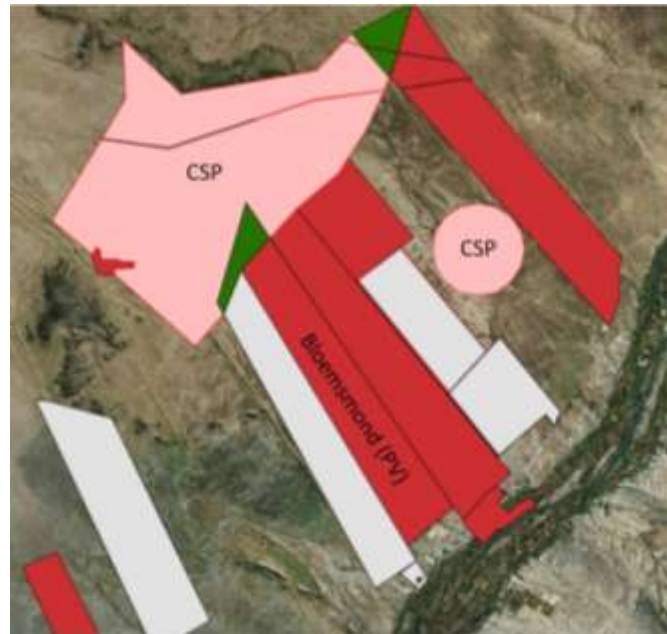
**Figure 12. Map showing the location of DEA-registered PV (red) and CSP (pink) projects at the cadastral unit scale in the vicinity of Bloemsmond Farm.**

A total of 5 PV arrays (Bloemsmond 1 – 5) have been planned for Bloemsmond Farm. In all cases specialists have been consulted upfront regarding the proposed layout of PV arrays through the provision of sensitivity maps. At Bloemsmond Farm this has ensured that the impacts affecting medium and high sensitivity watercourses (particularly pans and large wooded drainage lines) will be kept to the absolute minimum, with other impacts being unavoidable access roads crossing watercourses. This is also very important for maintaining a degree of connectivity at the landscape level, as drainage lines are frequently used for movement and other functions by a wide range of animals. They also provide additional habitat for wildlife occurring along the Orange River. A large proportion of sensitive habitat at the site will be left intact between solar arrays which will provide corridors for wildlife. Additional cumulative impacts will be related to the construction of gridlines assessed in this study. It is likely that further gridlines will be required to connect the range of other PV developments in the area.
