**Bloemsmond 5 PV
Near Upington, Northern Cape**

Aquatic Specialist Study

Bloemsmond Solar 5 (Pty) Ltd
June 2019

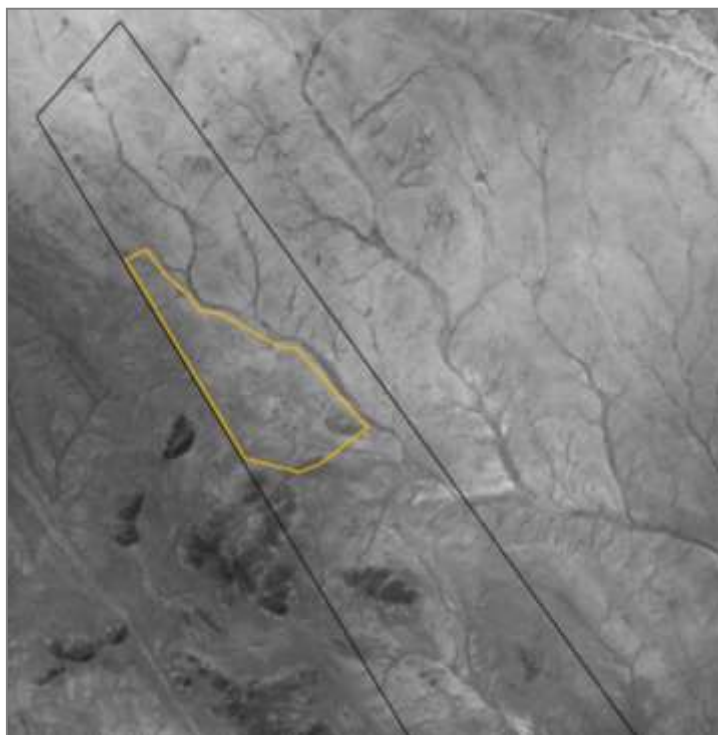
Figure 5. Historical aerial photo (1964) showing the approximate layout of Bloemsmond 5 (yellow line)

The oldest historical aerial image that could be obtained was from 1964. This shows that the site within Bloemsmond Farm, and Bloemsmond 5 in particular is very similar in appearance to the present day (Figure 5). There has been little to no development at the site. The drainage lines and pans appear to be located in much the same position as their current location.

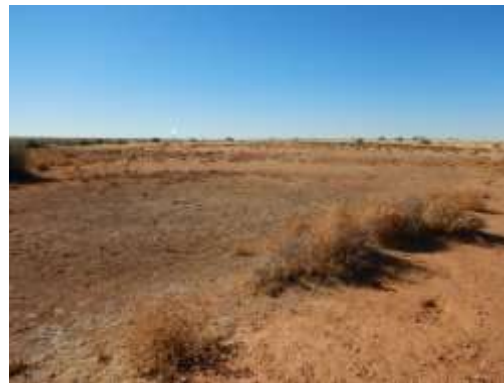
Figure 7. A typical pan located on Bloemsmond Farm.

All ephemeral pans are considered High sensitivity sites and are allocated a 50m buffer around the perimeter. They play an important role in providing standing (lentic) water following rainfall which supports drinking and feeding requirements for a wide range of taxa. They support specially adapted crustaceans (branchiopods) which convert detritus and algae into an important source of protein for birds. Very little is known about the taxonomy and distribution of the branchiopods of arid pans. Water infiltration from pans also replenishes ground water (Figure 7).

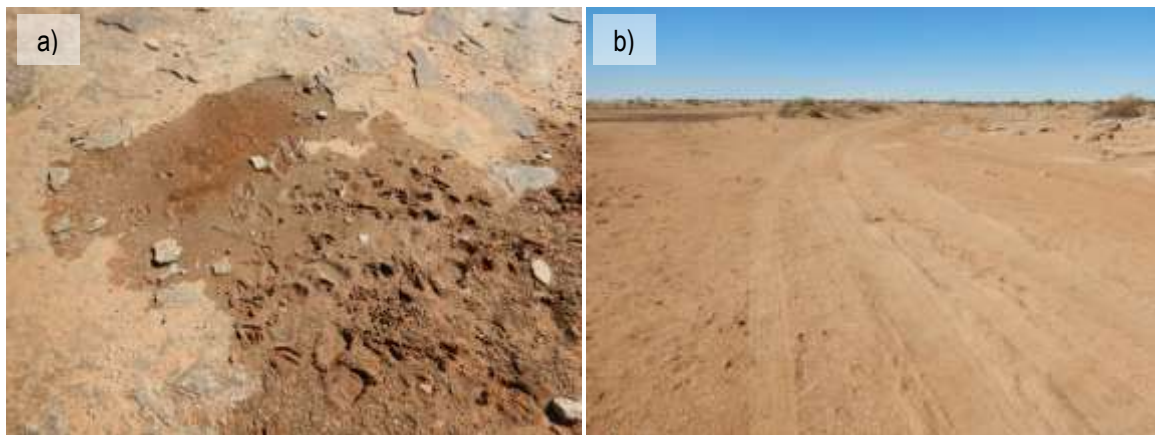
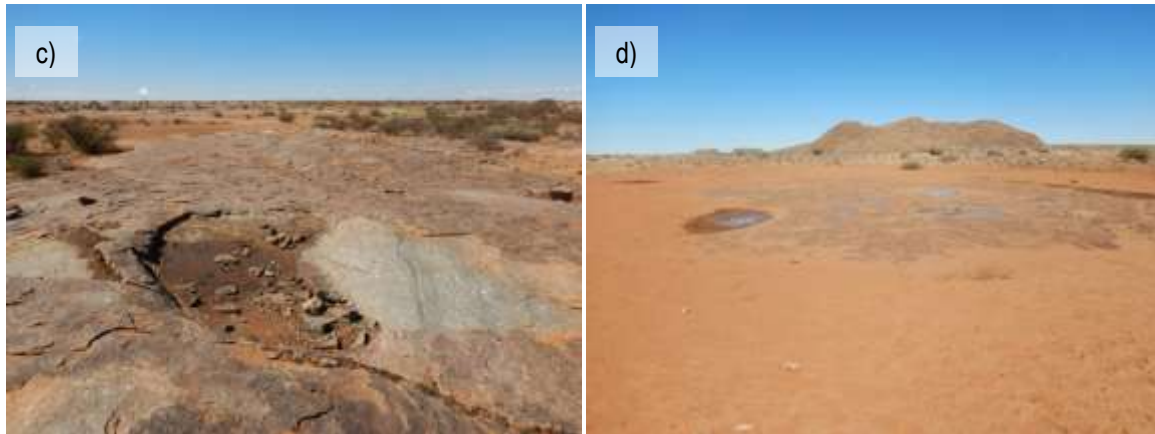
Figure 9. Pictures of different areas within the large pan complex in Bloemsmond 5 showing a) numerous animal tracks to a small pool, b) the dirt track crossing the pan complex, c) rocky areas where water pools following rains, and d) pans with small areas of water following rainfall.

A little standing rainwater was observed in rock pools (Figure 9 a, c and d) and pans within the pan complex at Bloemsmond 5. There was evidence that many animals utilize this standing water due to the abundance of fresh tracks observed at the site (Figure 9 a).

Branchiopods were collected from rock pools and mud sediments from pans within Bloemsmond 5. The fairy shrimps and clam shrimps identified in this study were collected from the shallow rock pool shown in Figure 9 c. The species identified are likely to be found elsewhere on Bloemsmond Farm and surrounding areas in any suitable habitat such as pans, or on rocky substrates where water pools after rainfall.

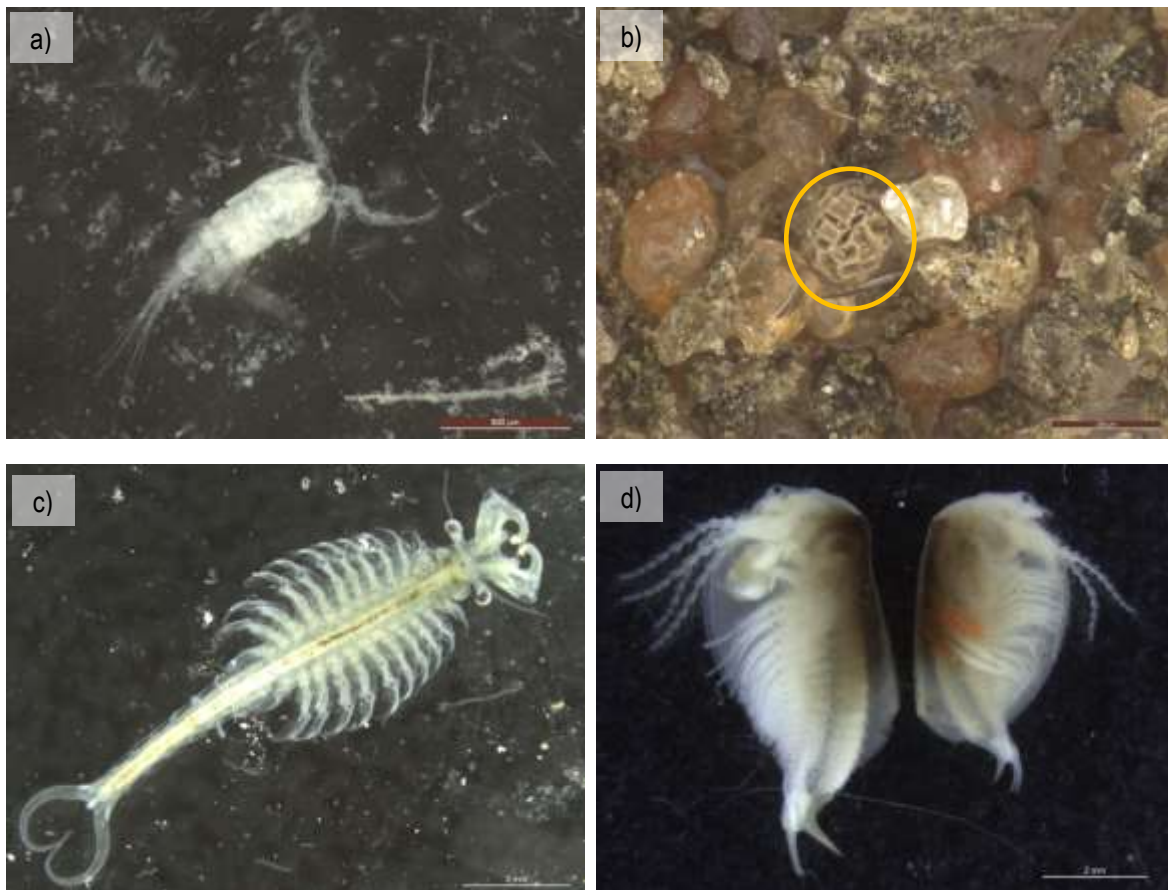
Figure 10. Images of a copepod (a), anostracan (fairy shrimp) egg circled in sediment (b), an adult fairy shrimp (*Branchipodopsis tridens*) and male and female clam shrimps (*Leptestheriella* sp.; d).
