**Bloemsmond Grid Connection Infrastructure  
Near Upington, Northern Cape**

***Aquatic Specialist Study***

Bloemsmond Grid (Pty) Ltd  
June 2019

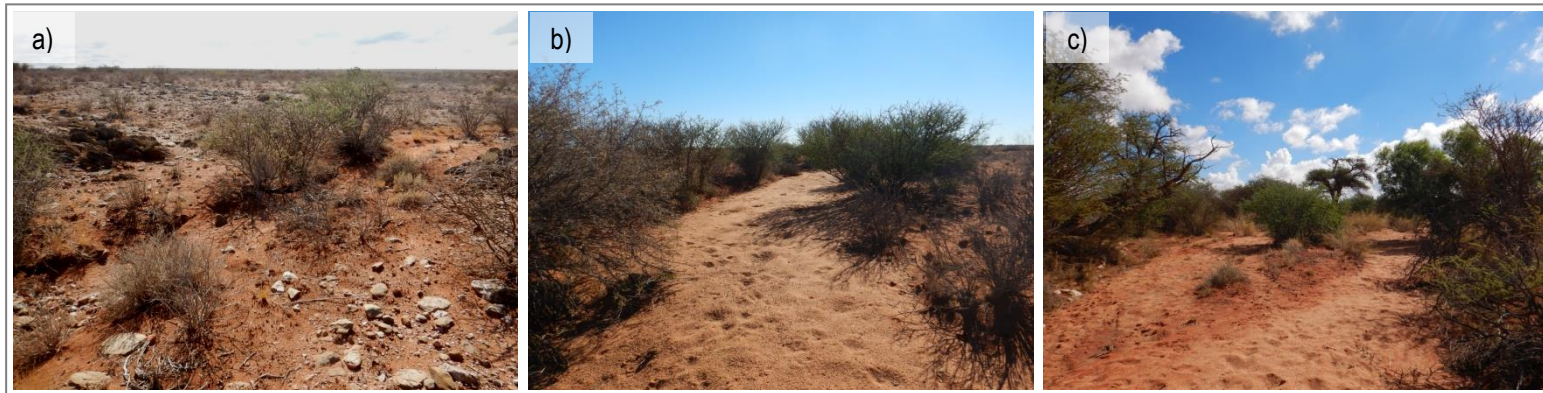
Figure 5. Example of drainage lines typical of Low (a), Moderate (b) and High (c) sensitivity at Bloemsmond Farm 455

Each system was determined to be of low, moderate or high sensitivity based on observations in the field and using satellite imagery. An example of typical drainage lines allocated these scores is provided in Figure 5. Buffers ranged depending on sensitivity with Low at 10m, Moderate at 20m and High at 30m.

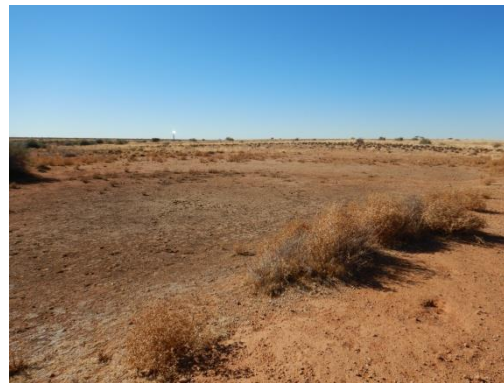
Figure 6. A typical pan located on Bloemsmond Farm 455.

All ephemeral pans are considered High sensitivity sites and are allocated a 50m buffer around the perimeter. They play an important role in providing standing (lentic) water following rainfall which supports drinking and feeding requirements for a wide range of taxa. They support specially adapted crustaceans (branchiopods) which convert detritus and algae into an important source of protein for birds. Very little is known about the taxonomy and distribution of the branchiopods of arid pans. Water infiltration from pans also replenishes ground water (Figure 6).

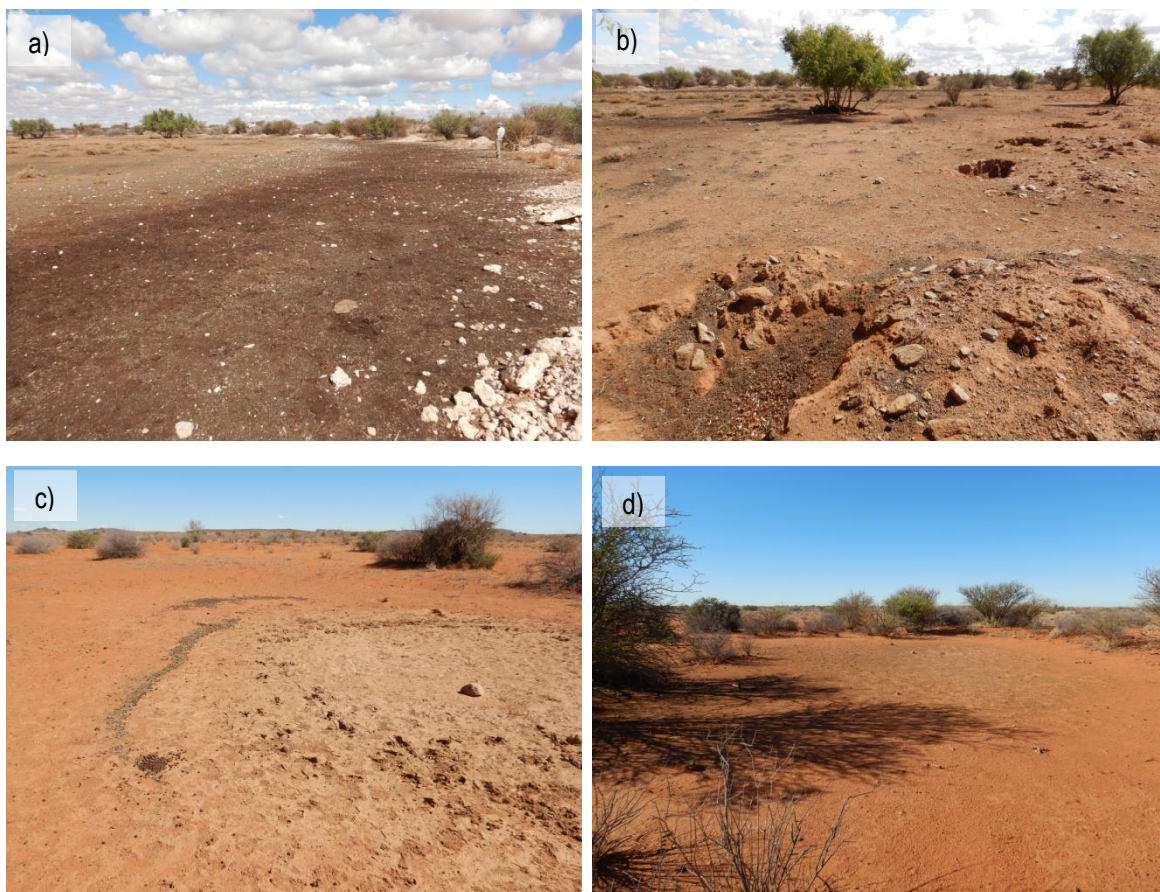
**Figure 10. Photos showing the larger pan within the Bloemsmond Collector – Upington MTS Alternative B (a), and the holes that have been dug around the perimeter (b), one of the small connected pans from the B4BC and B5BC Eastern Alternative corridors (c), and one of the smaller pans within the Bloemsmond Collector – Upington MTS Alternative B (d).**

The two smaller pans located within the Bloemsmond Collector – Upington MTS Alternative B were similar in size and condition to the two pans located within the B4BC and B5BC Eastern Alternative corridors (Figure 10 d). However, they are not part of a larger drainage system and are therefore likely to be endorheic, predominantly receiving water from rainfall. The PES of these two pans was also classified as **A, Natural**.

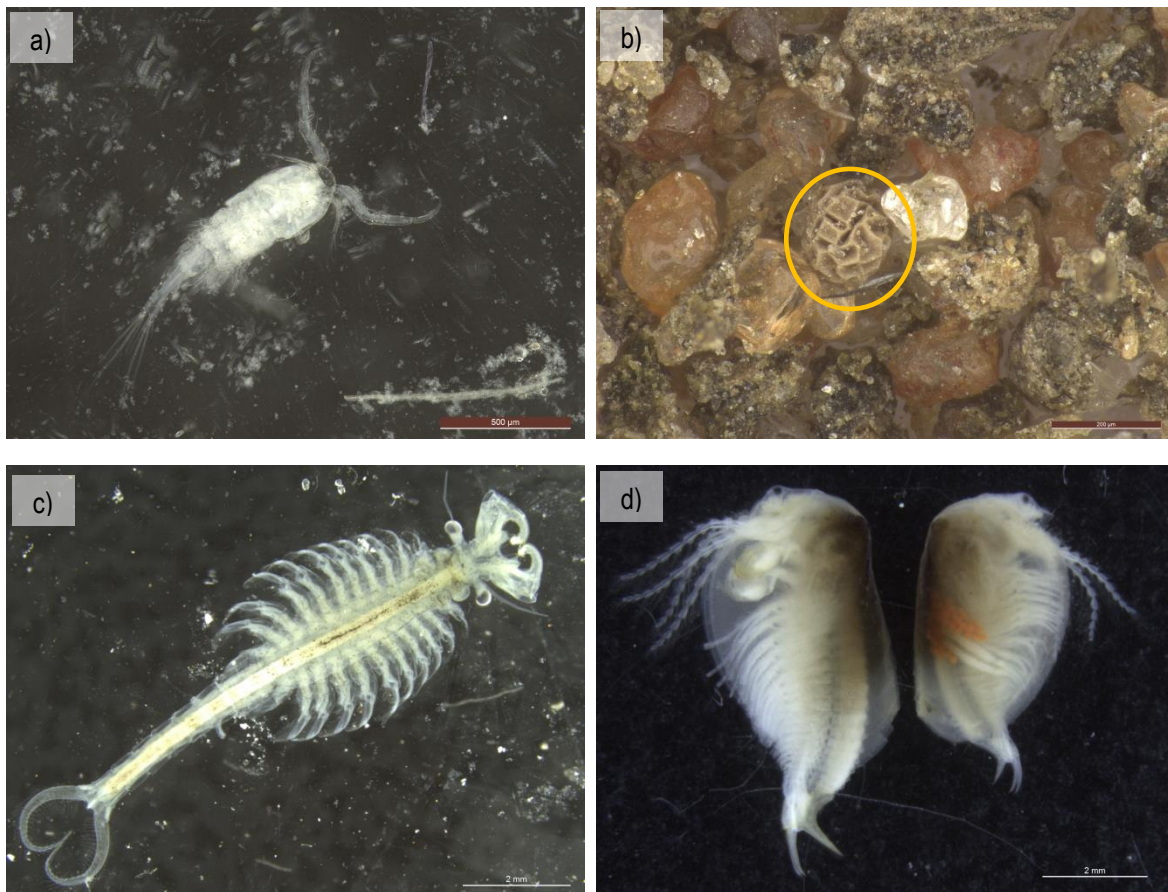
Figure 11. Images of a copepod (a), anostracan (fairy shrimp) egg circled in sediment (b), an adult fairy shrimp (*Branchipodopsis tridens*) (c), and male and female clam shrimps (*Leptestheriella* sp.; (d).
