Site Sensitivity Verification (SSV) Report

For the Proposed Casteel Dam Safety Rehabilitation
Project, Farm Kasteel 231-JU, Bushbuckridge,
Ehlanzeni District, Mpumalanga Province

Report date: 20 June 2023

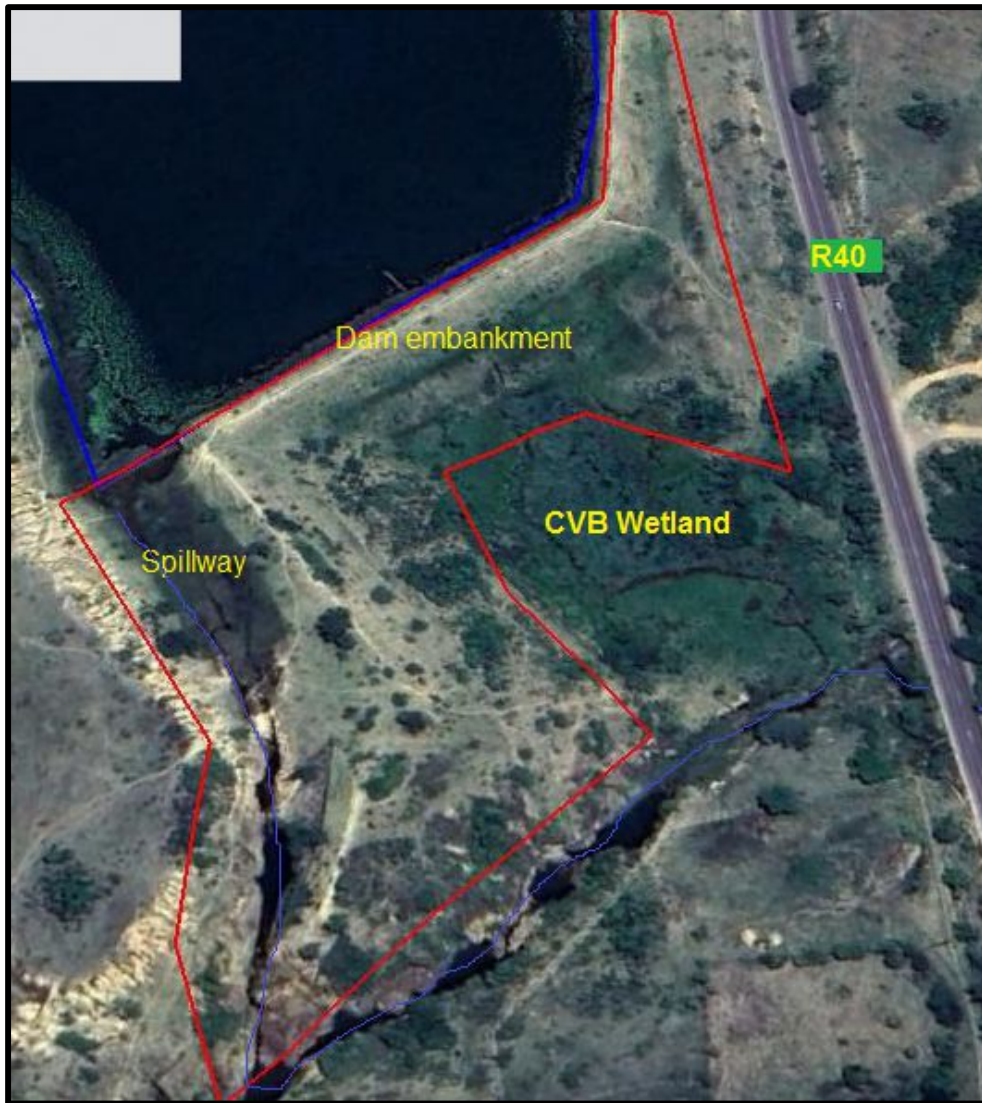
Figure 7: Rehabilitation works area superimposed on Google Earth Satellite imagery showing the site is covered in disturbed veld/open bushland, a CVB wetland and the Tlulandziteka River. The area has been disturbed in the past by the construction of the dam.

The rehabilitation works area (Figure 7) has been transformed and comprises the existing Casteel Dam embankment, spillway channel and downstream slope. The upstream slope of the dam embankment, spillway and inner banks comprise hydrophytic vegetation (i.e., reeds). The main embankment and downstream slope comprise disturbed Granite Lowveld veld (i.e., re-established veld grass, low density Sicklebush) and a Channelled Valley Bottom Wetland below the dam embankment.

Indigenous trees are mainly present below the dam embankment i.e. *Acacia tortillas* / Umbrella thorn and numerous *Sclerocarya birrea*/Marula trees (national protected). Three protected plant species have been recorded onsite i.e., Marula (nationally protected), Barberton Aloe and Thick Leaved Gladiolus (provincially protected). The area west of the spillway channel is degraded through slope/embankment erosion. The dam wall is also infested with termites.

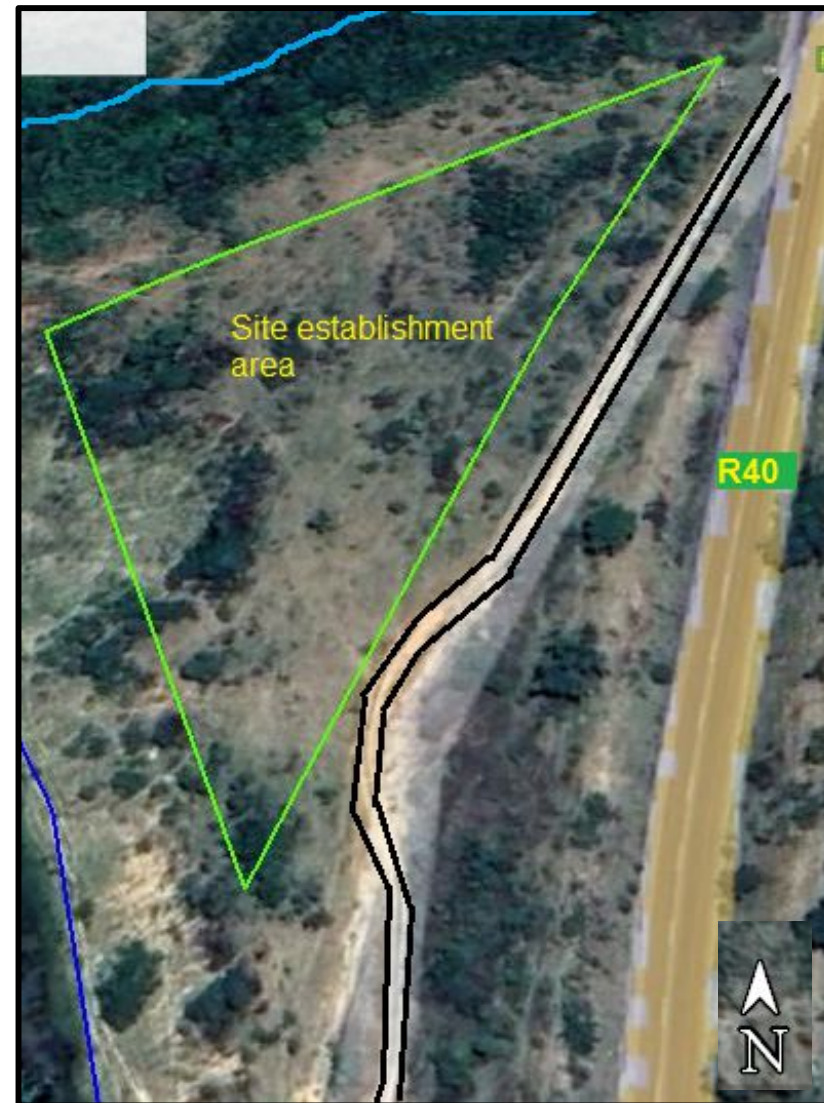
Figure 6: Site establishment area superimposed on Google Earth Satellite imagery showing the area is covered in veld/open bush land. Past disturbance is evident.

The site establishment area (Figure 6) is situated just west of the R40 Bushbuckridge/Acornhoek Road north east of the dam. The area is used for cattle grazing and several footpaths are evident throughout the site. The area is covered in disturbed Granite Lowveld bush with a moderate level of alien infestation. The vegetation mainly comprises veld grass, thick stand of Sicklebush (indicative of previously disturbed soils) and many small to medium sized Marula trees. This specific area has a higher population of Barberton Aloe.

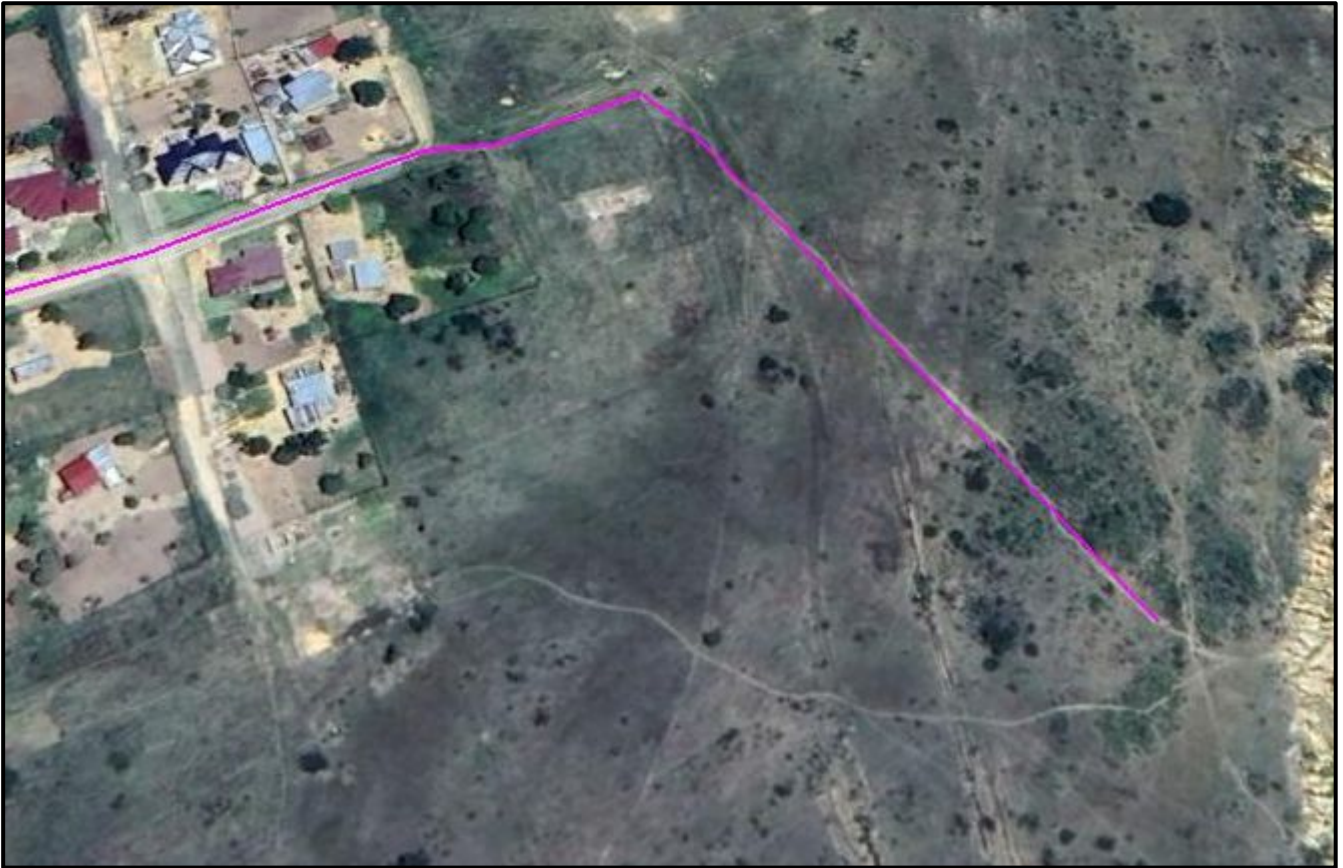
Figure 8 Proposed alternative access road required west of the dam to access the spillway channel on the right embankment.

The existing gravel road from the R40 is completely transformed. The area west of the spillway where the alternative access road is proposed (coming from Casteel settlement) are modified old lands previously used for subsistence crops but now lie fallow (Figure 8).

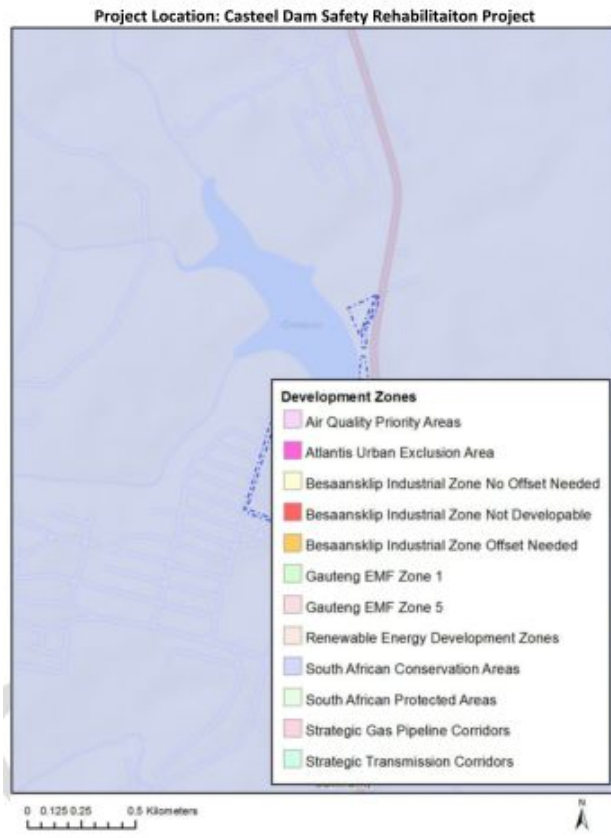
Figure 9 STR Restrictions, Exclusions Map

According to the STR, the project site falls within a South African Conservation Area (**Figure 9**).

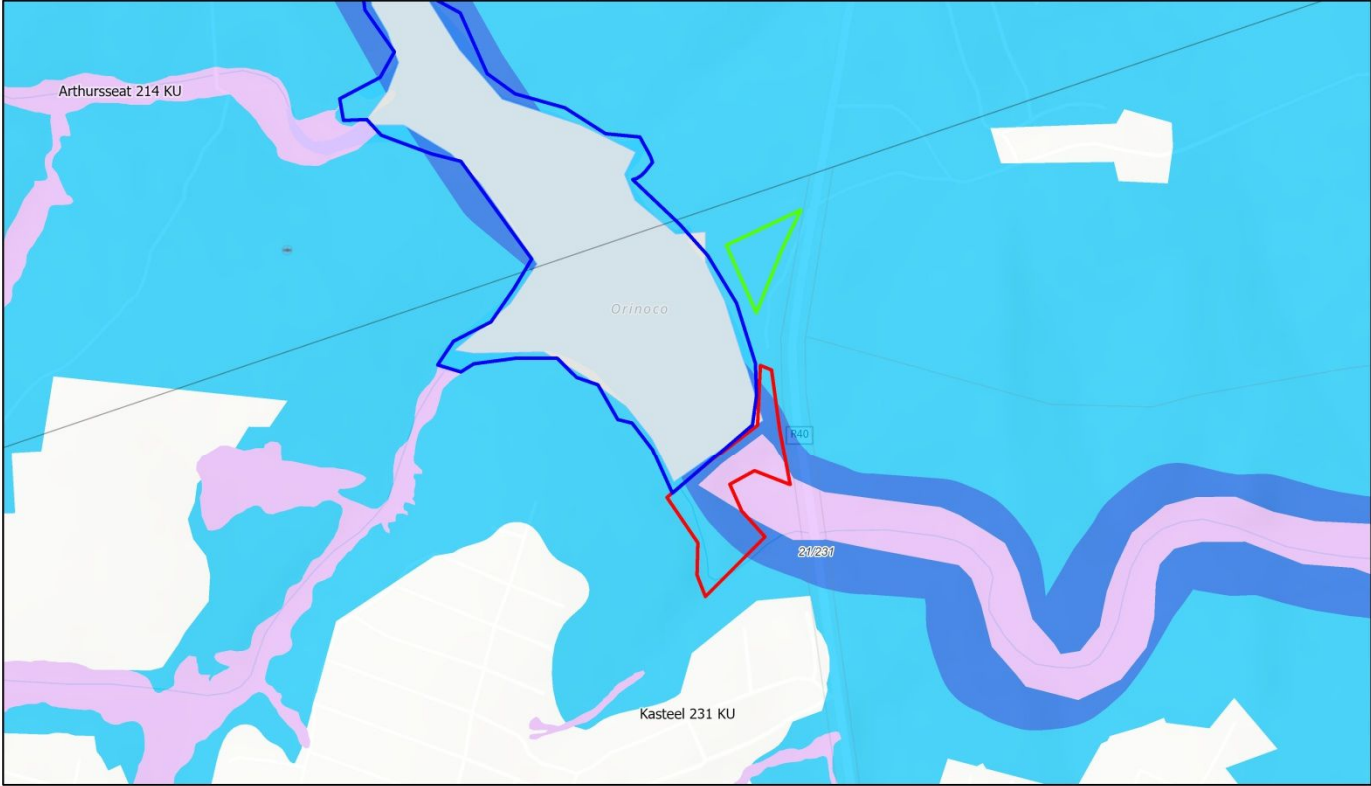
Figure 14: 2019 EDM Bioregional Plan Freshwater CBA Map Spatial Dataset superimposed on the project site. The site falls within a CBA Aquatic River, ESA (important sub catchment and wetland) and dam.

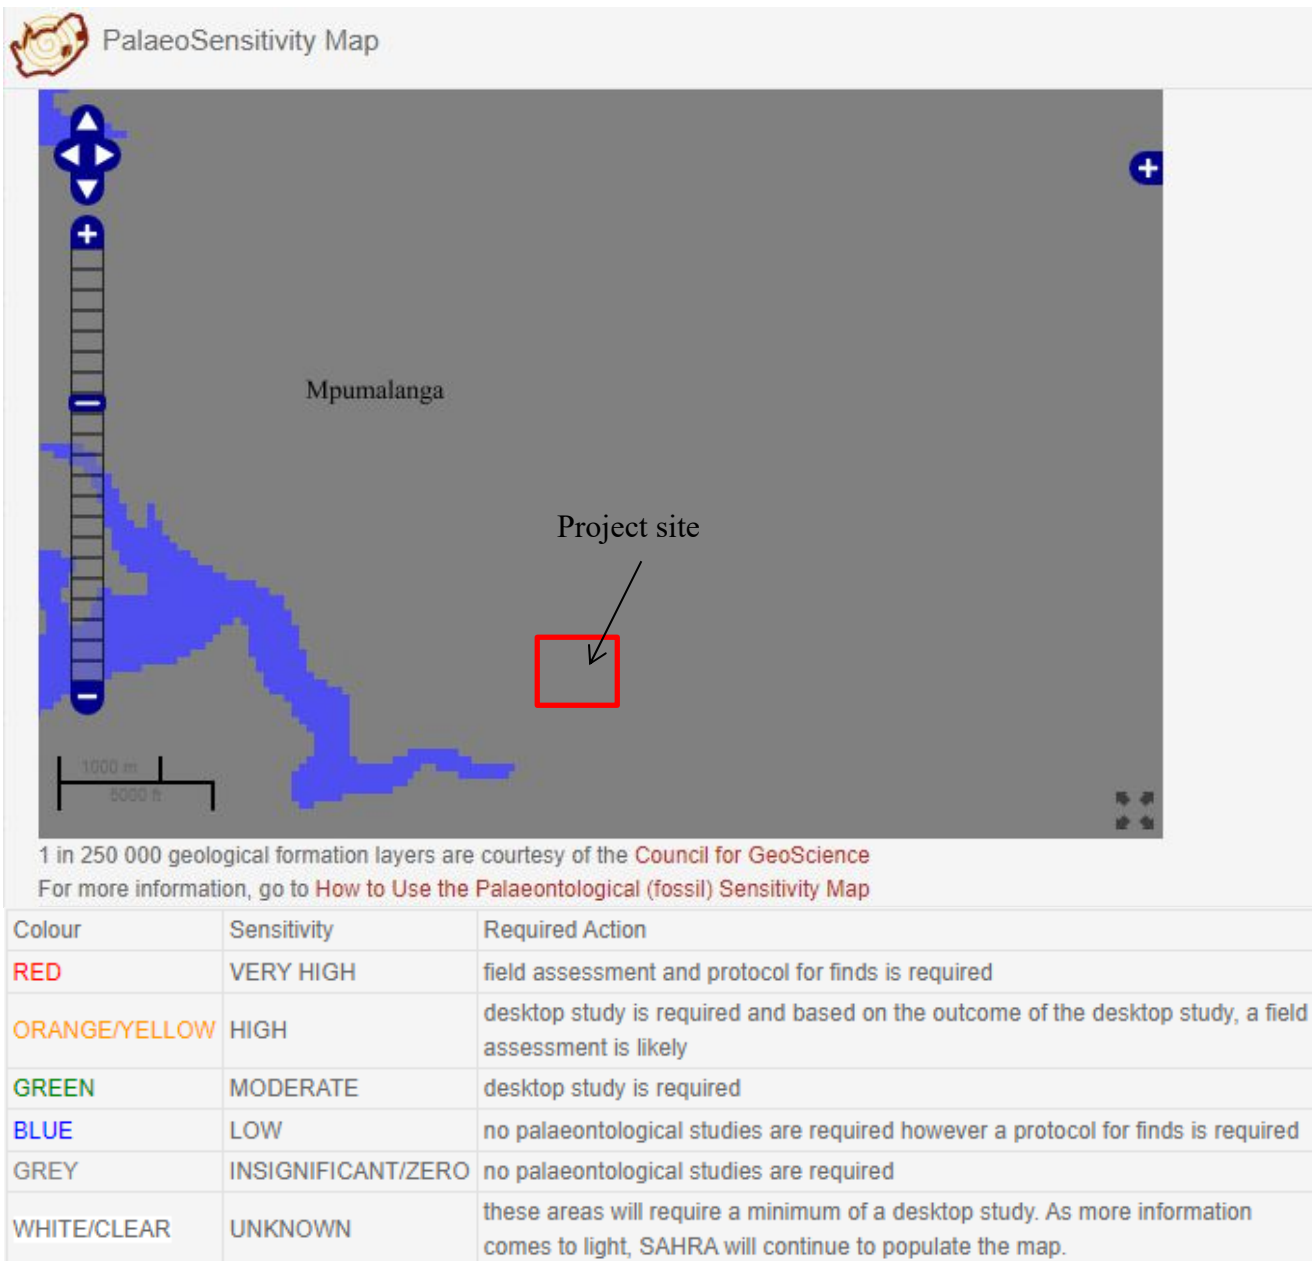
Figure 18: Project site location superimposed on the SAHRIS Palaeontological Sensitivity Map illustrating that the site overlaps with a ‘grey’ area containing insignificant/zero fossil heritage.

However the STR was found to be incorrect since the SAHRIS Palaeontological (Fossil) Sensitivity Map shows that the site is of insignificant/zero ‘Palaeontology Sensitivity’ (**Figure 18**) based on the underlying sensitive geological formation as set out in the 1: 250 000 Geological Formation Maps as provided by the Council of Geoscience and requires no palaeontological studies.

According to the Geological Formation Map the site is underlain by Archaean Granite Gneiss Basement Formation (i.e. Cuning Moor Tonalite) which has no fossil heritage. The rock types and age of the Archaean Granite and Gneiss include intrusive granitoids, gneisses and migmatites. The Cuning Moor Tonalite lithology comprises grey, medium-grained equigranular tonalite. The EAP therefore refutes the ‘moderate’ Palaeontology sensitivity theme and should be recorded as ‘insignificant’. No Palaeontology Study is therefore required for the project.

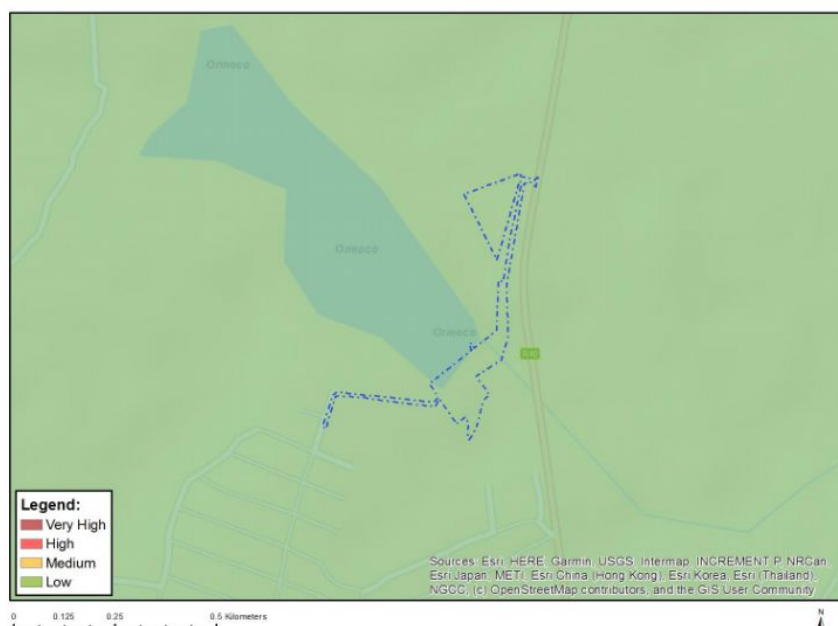
Figure 21 STR Defence Theme Map

According to the STR the site has a low ‘Defence Sensitivity Theme’ (Figure 21). No Defence assessment is required due to the low sensitivity. GNR 320 assessment protocols for defence themes states if the sensitivity is low no further assessment is required.
