**PROPOSED CONSTRUCTION AND IMPLEMENTATION OF
GAETSEWE SOLAR DEVELOPMENT NEAR KATHU,
NORTHERN CAPE**

APPLICANT:
K2018091758 (SOUTH AFRICA) (PTY) LTD

**AGRICULTURAL ENVIRONMENTAL IMPACT
ASSESSMENT REPORT
NOVEMBER 2018**

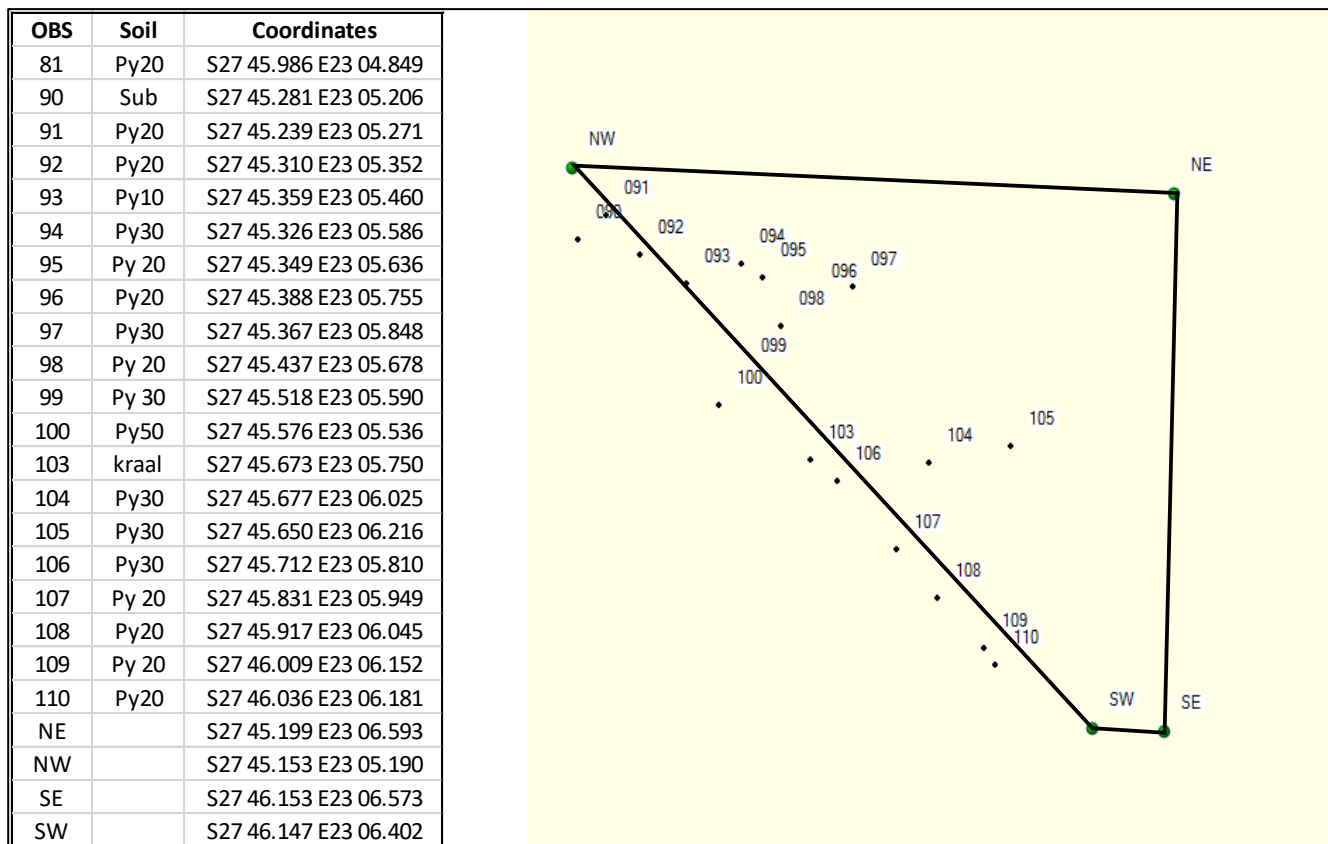
Figure 9: Soil survey Gaetsewe

On 7 June 2018, the site was visited to conduct a reconnaissance survey of Gaetsewe, as illustrated by Figure 8. The details of the survey appear in the representative field forms in Table 2.

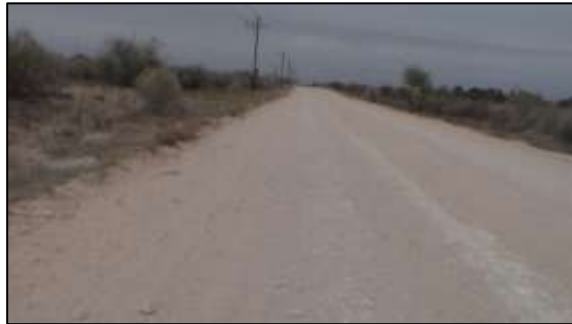
Access road Alternative: This is an existing road in daily use, tarred from N14 up to a where it diverts towards Reitzhof Agricultural Holdings. The rest of the stretch is a dirt road for access by local owners to Kathu. The agricultural potential of soil on which the road is constructed is low and its influence on drainage very low. With proper maintenance, the road could be an asset for the landowners.

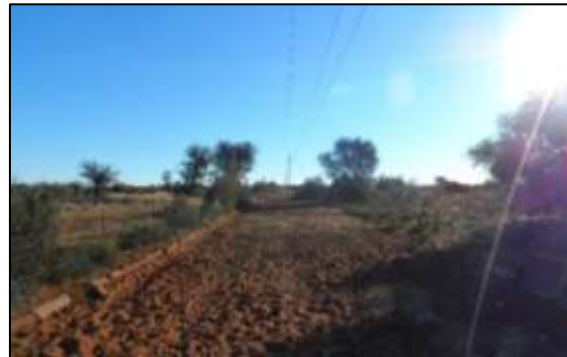
Overhead transmission line: The soil is of very low agricultural potential due to hard carbonate near or at the top of the surface. This is an existing service road. The AEP Legoko facility (already authorised), will use this same alignment.

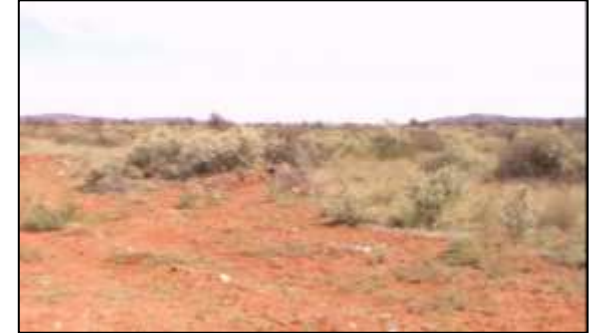
Sekgame Switching station: The location for the switching station is west of the N14. The area is used for grazing and is of the same low potential soil as the proposed site. Parallel to the N14 and close to this site, a major water pipeline was installed. Excavations to the trench showed limiting rocks close to the soil surface, confirming the shallow depth to be expected on site.

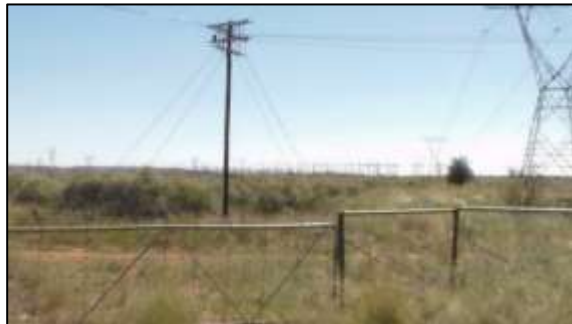
Ferrum Substation: Two 275 kV overhead transmission lines connect to this Eskom substation. One transecting Bestwood Agricultural Holdings and the other over Legoko.

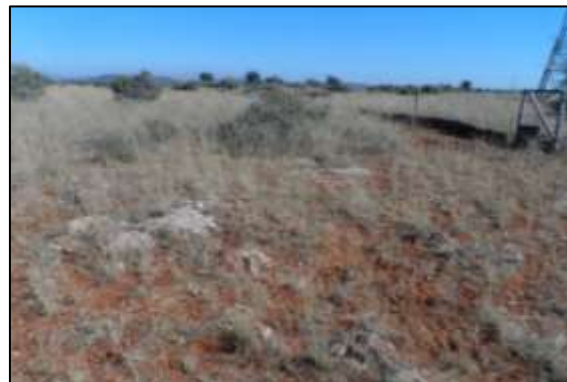
Gaetsewe Substation: This is situated at OBS 90 in the North Western corner of the site. Soil has very low potential (less than 30 cm on hard carbonate depth limiting layer).

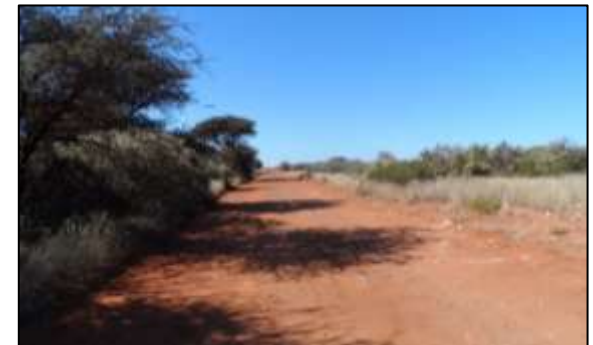
Preferred Access road: This is an existing dirt road, which exits from the N14 and is in daily use. The soil is of low agricultural potential.

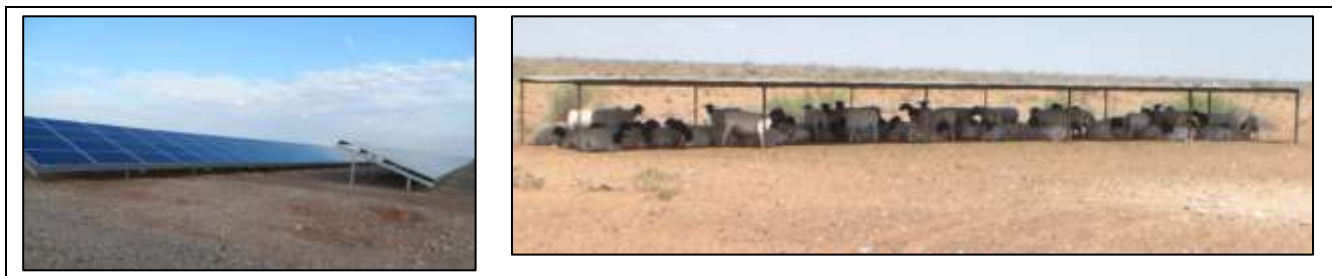
Figure 16: Ground clearance under PV panels in comparison with shelter provided to sheep.

The PV panels' ground clearance limit the height of livestock. Sheep would be better suited for the grazing under the panels, or calves between 3 and 7 months. With a conversion ratio of 4½ sheep to 1 LSU, 100 sheep are the equivalent of the 20 LSU presumably lost.

The 52 sheep under the shelter in Figure 16 gives an indication of the space needed for half the herd recommended above.

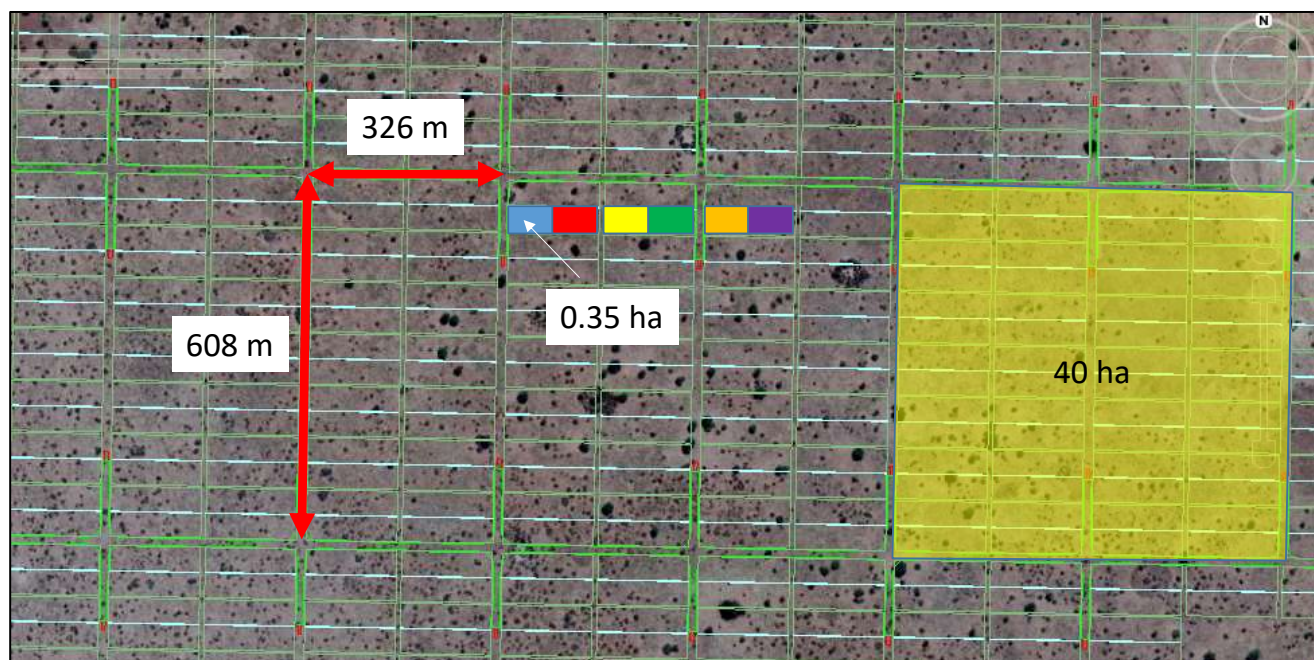
Figure 17 PV footprint as skeleton for camp outlay

The footprint of the PV facility forms the skeleton of a camping system, as indicated in Figure 17. With the use of electrified fencing, the partitioning of any number and size of camps required, can be carried out by one labourer herding the stock. Watering would be portable troughs.

The camps will be confined to the borders of the service roads, which ensure no interference with the service traffic.

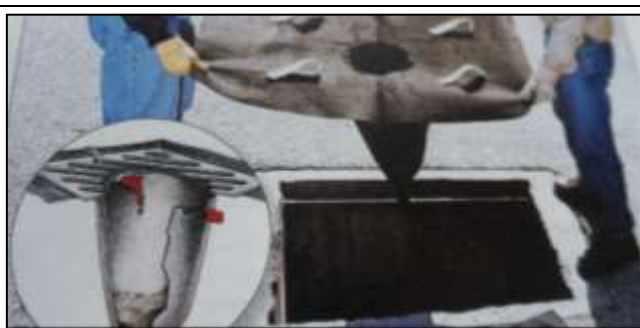
Ultra-Drain Guard

The following is handy to have available

Mitigation: Refuelling normally takes place in the laydown area. Proactive measures must be taken which include constructing a designated area where refuelling can take place. This area must have an impervious floor with low wall that will keep the spillage inside. This area should be cleaned with absorbent material on a regular basis. The use of cut-off drains must be incorporated to divert upslope clean storm water around the site into a natural drainage system. On the down slope, polluted water must be collected via a cut-off drain into a leachate collection and recovery system. When spillage accidentally takes place, it should be removed and replaced with unpolluted soil. The clean soil can be sourced from excavations nearby. The polluted soil must be piled at a temporary storage facility with a firm waterproof base and is protected from inflow of storm water. It must have an effective drainage system to a waterproof spillage collection area. Contaminated soil must be disposed of at a hazardous waste storage facility.
