ENVIRONMENTAL IMPACT ASSESSMENT

**PROPOSED CONSTRUCTION AND IMPLEMENTATION OF
HOTAZEL SOLAR DEVELOPMENT, NORTHERN CAPE**

ABO WIND HOTAZEL PV (PTY) LTD

**AGRICULTURAL IMPACT REPORT
NOVEMBER 2018**

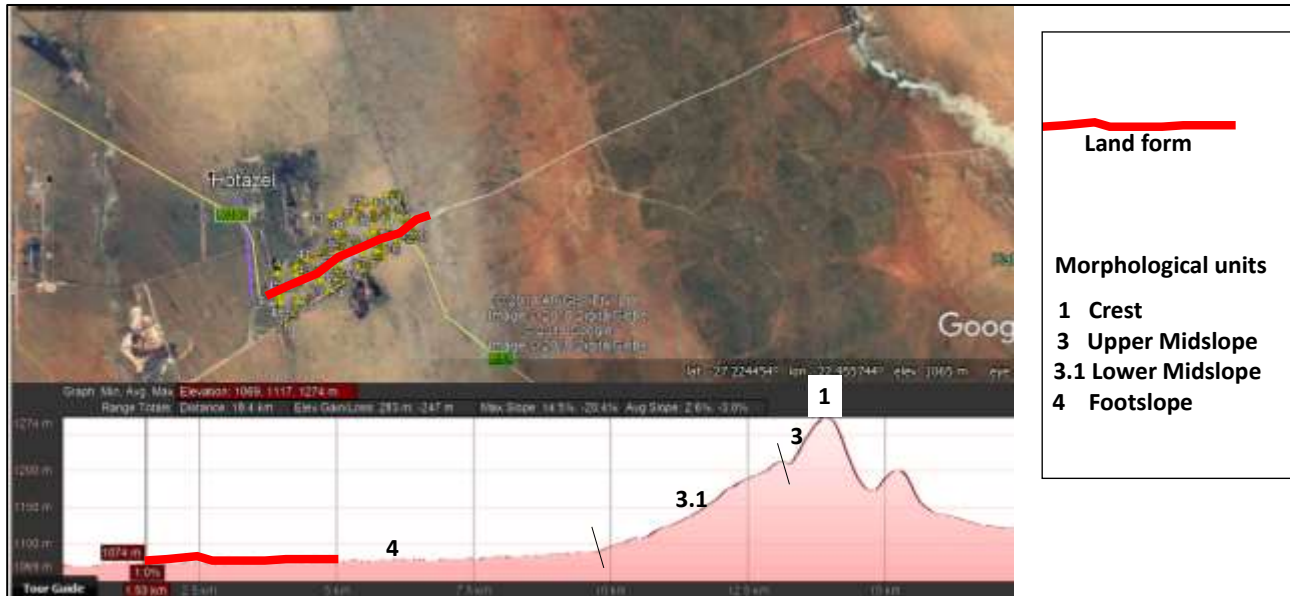
Figure 3: Topographical map.

The terrain slope can be calculated using the difference in vertical height (20 m) divided by difference in horizontal distance (4000 m) X 100. The slope is 0.5%.

It is expected to find deeper soils on concave soils with water locked soils at foot slopes and valley bottoms.

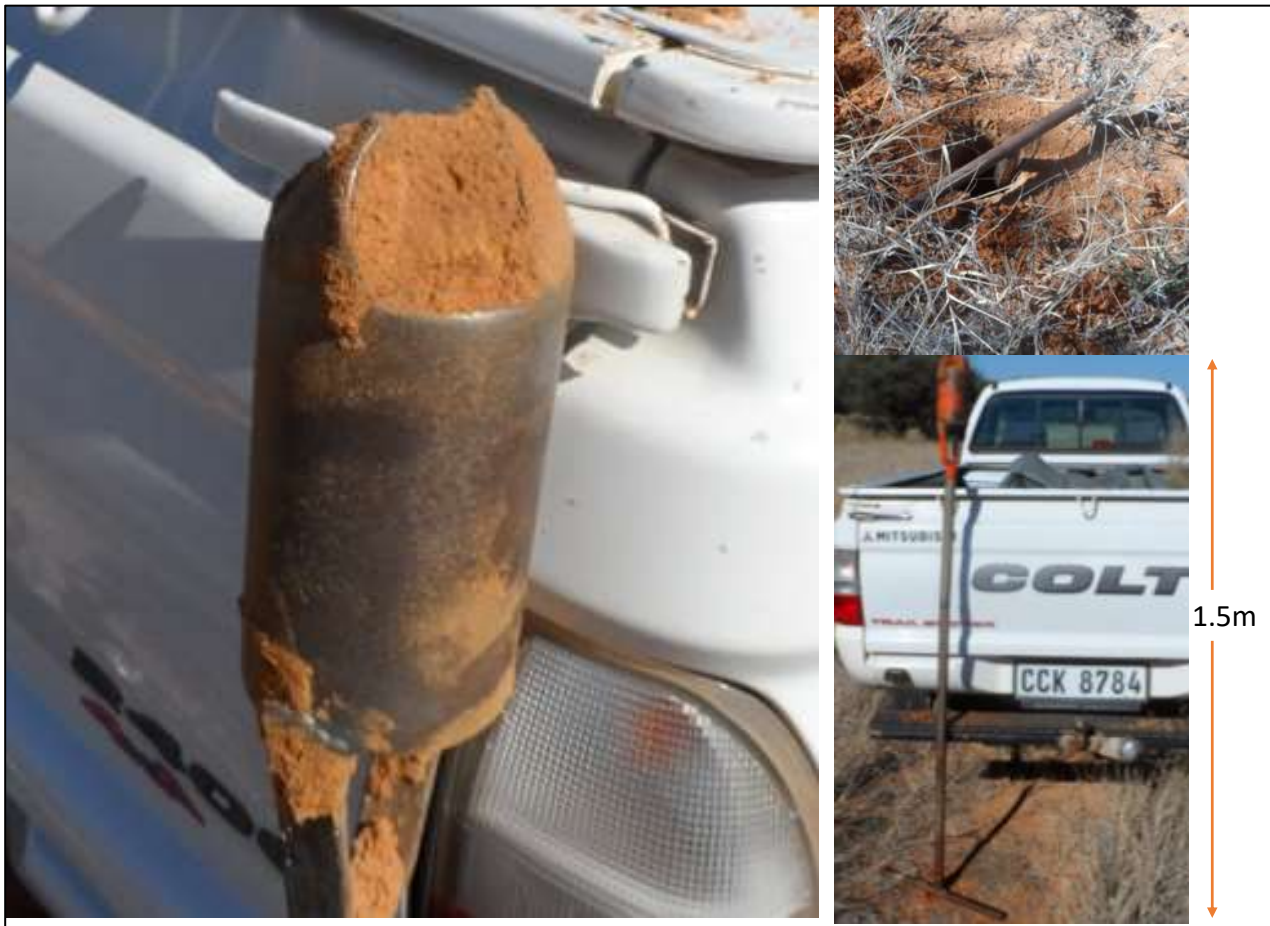
Figure 7: Hand held auger with soil sample

The soil sampling was done with a hand auger and textural analysis by finger method. Soil was augered to a depth of 1.2m. No restrictions were encountered to even 1.5 m. Some points showed colouring differences from 800mm (see Figure 7) but not noted as a specified horizon.

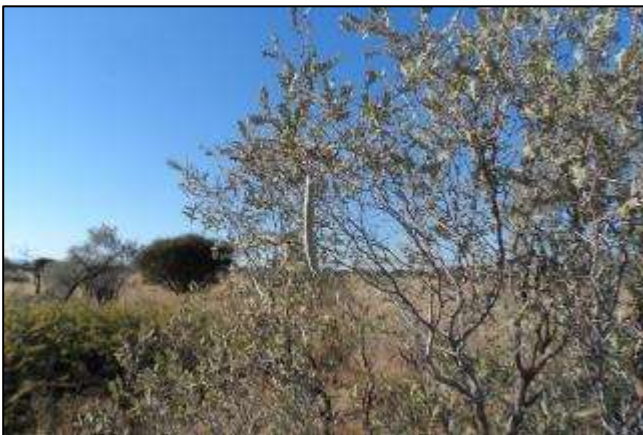
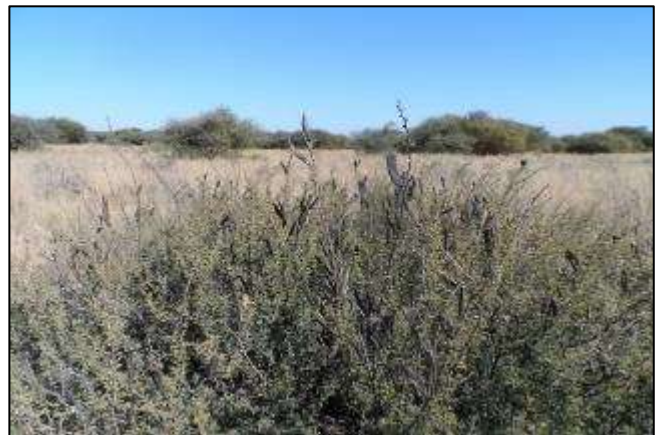
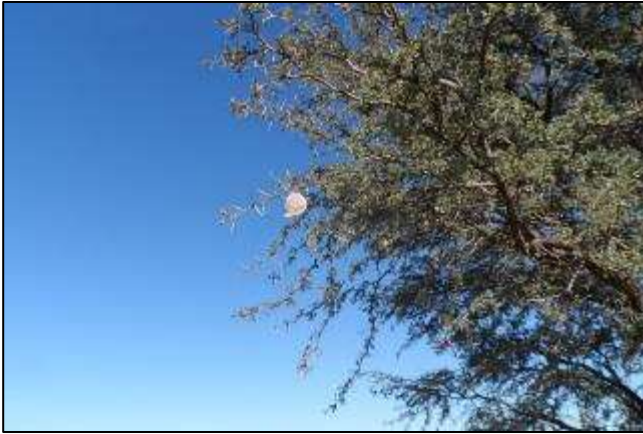
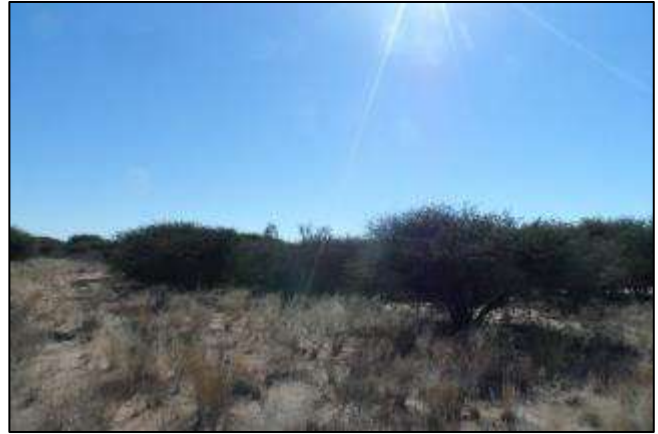
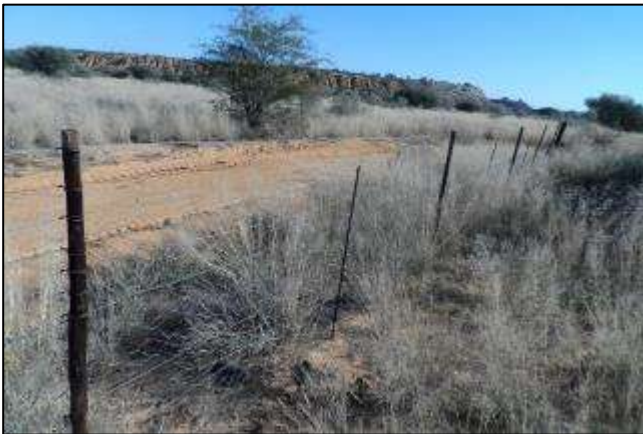
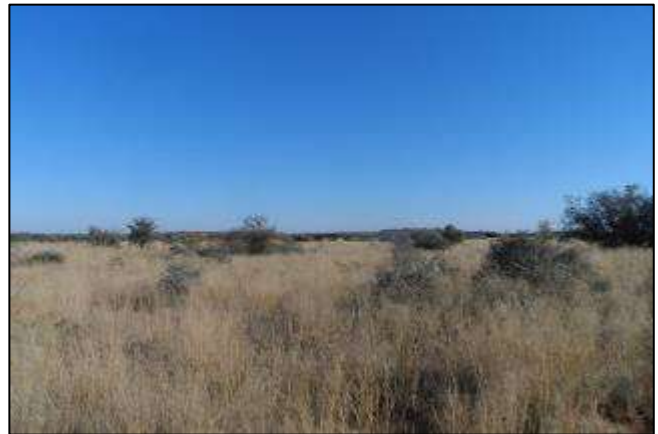
Figure 9: Vegetation

A veld condition assessment by visual acknowledgement was done simultaneous with the soil survey. The photos in Figure 9 show the veld condition. The vegetation type is Savanna (Kathu biome). The composition of the grazing varies from open grass with low to heavy encroachment of Black Thorn acacia (*Acacia mellifera*), as can be seen in Figure 9. Encroachment takes place when veld is over-grazed or where construction took place.

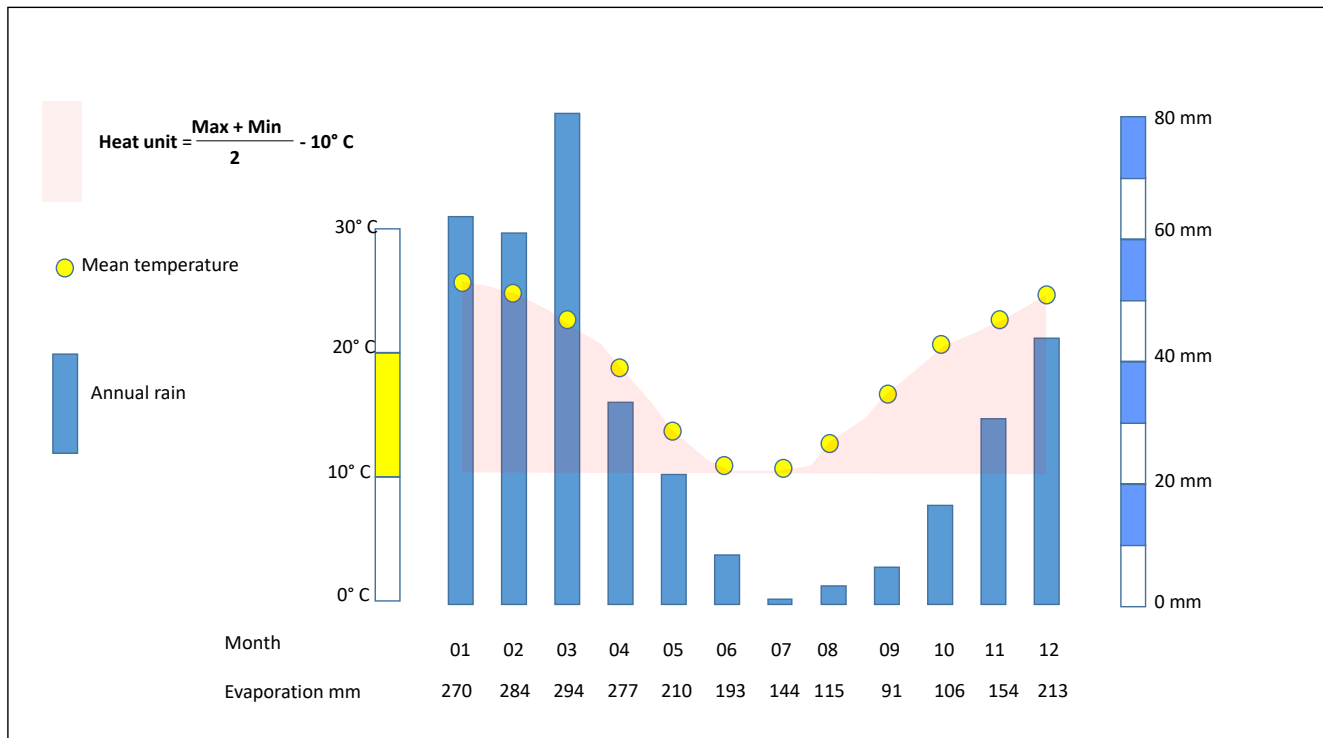
Figure 11: Climatic interaction of rain, temperature and evaporation.

Figure 11 shows the interaction of rain and temperature expected for the specific site.

A crop requires specific elements to yield successfully at the end of its growing season, of which heat and moisture are the most important. The time when these elements are required, are of significant importance.

As an example, maize is usually planted when 650-850 heat units can be expected for a minimum period of 61 days, thus, during the summer months. The peak of the rain season on site is in March, the end of the growing season. This is also when the highest evaporation is recorded. In Figure 11, the yellow dots show the mean temperature and the red zone the expected heat units. The required planting date and necessary follow up rain combination is not found.

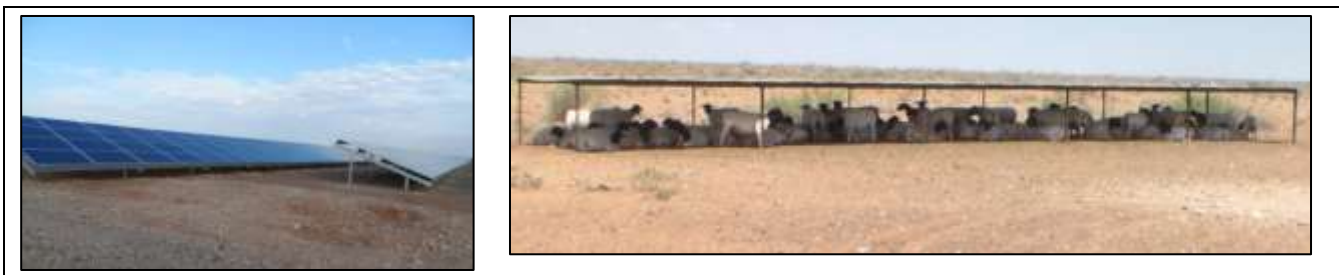
Figure 15: Ground clearance under PV panels in comparison with shelter provided to sheep.

The PV panels' ground clearance limit the height of livestock. Sheep would be better suited for the grazing under the panels, or calves between 3 and 7 months. With a conversion ratio of 4½ sheep to 1 LSU, 100 sheep are the equivalent of the 21 LSU presumably lost.

There are 52 sheep under the shelter in Figure 15. This gives an indication of the space needed for half the herd recommended above.

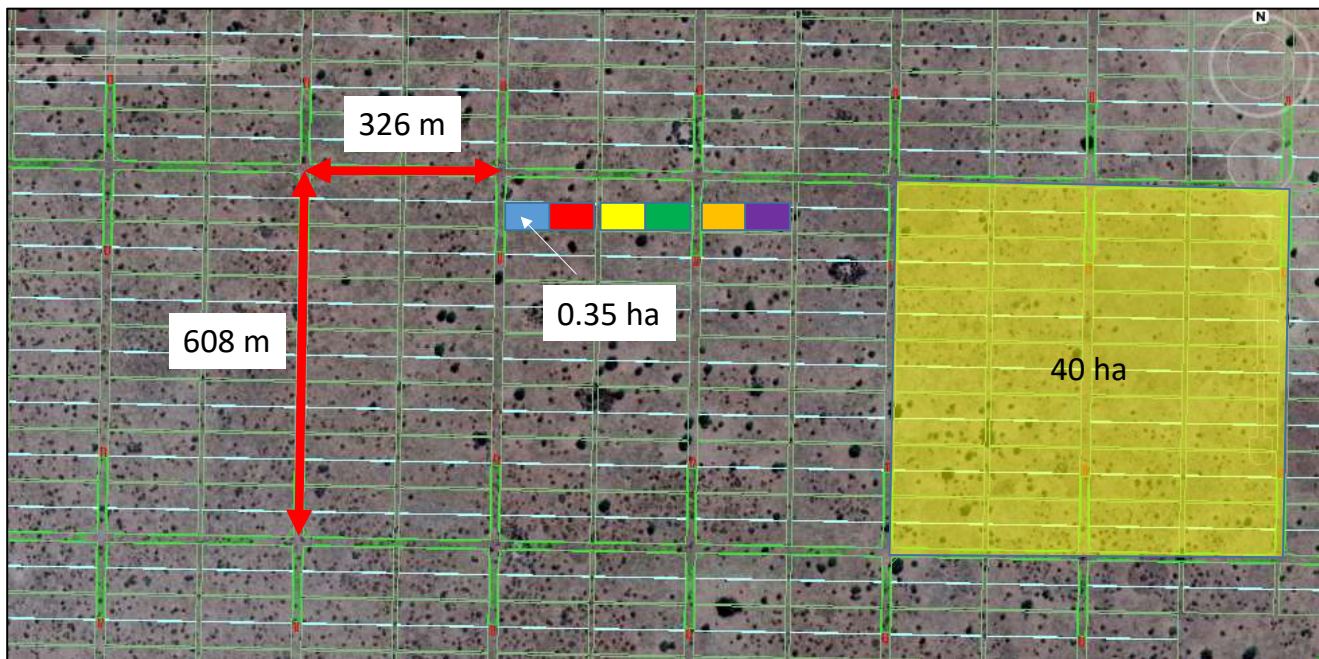
Figure 16 PV footprint as skeleton for camp outlay

The footprint of the PV facility forms the skeleton of a camping system, as indicated in Figure 16. With the use of electrified fencing, the partitioning of any number and size of camps required, can be carried out by one labourer herding the stock. Watering would be portable troughs.

The camps will be confined to the borders of the service roads, which ensure no interference with the service traffic.

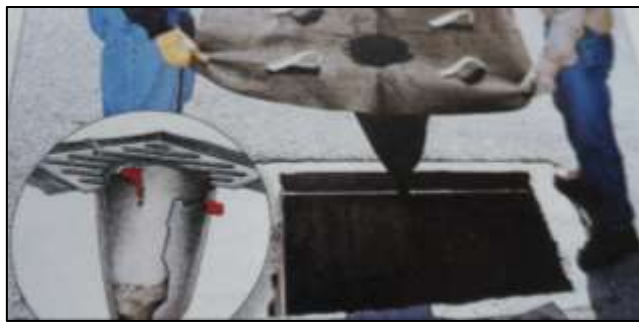
Ultra-Drain Guard

The following is handy to have available

Mitigation: Refuelling normally takes place in the laydown area. Proactive measures must be taken which include constructing a designated area where refuelling can take place. This area must have an impervious floor with low wall that will keep the spillage inside. This area should be cleaned with absorbent material on a regular basis. The use of cut-off drains must be incorporated to divert upslope clean storm water around the site into a natural drainage system. On the down slope, polluted water must be collected via a cut-off drain into a leachate collection and recovery system. When spillage accidentally takes place, it should be removed and replaced with unpolluted soil. The clean soil can be sourced from excavations nearby. The polluted soil must be piled at a temporary storage facility with a firm waterproof base and is protected from inflow of storm water. It must have an effective drainage system to a waterproof spillage collection area. Contaminated soil must be disposed of at a hazardous waste storage facility.

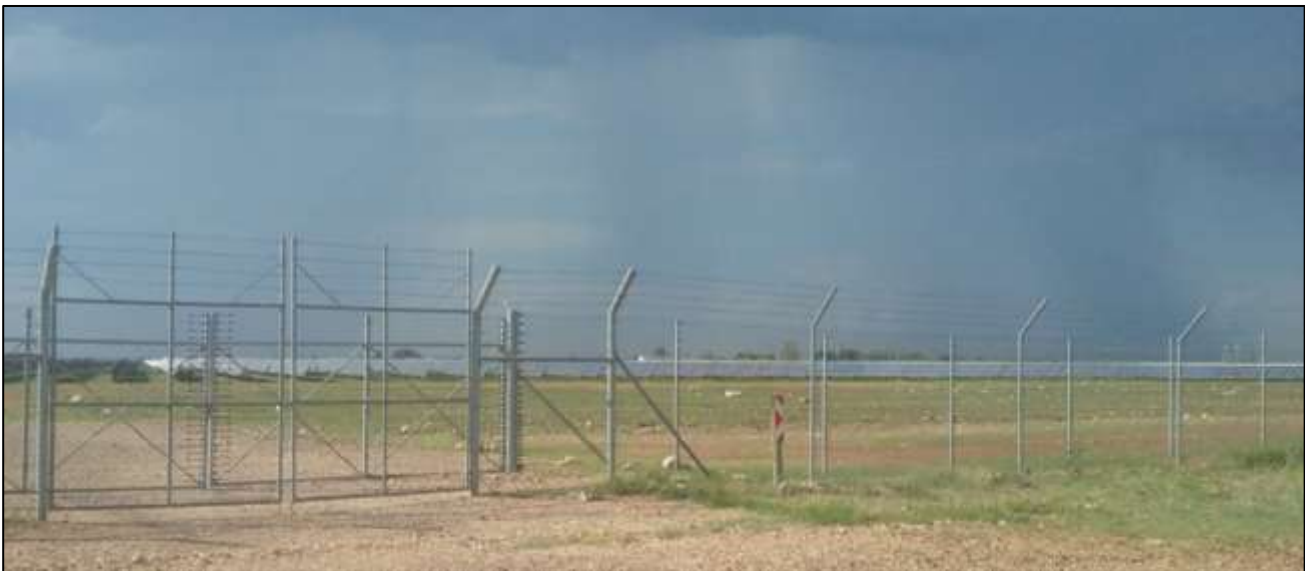
Figure 19: Completed facility

The region already has an industrial character because of the mining activities and high power gridlines. The proposed solar facility will tap directly into these lines. The increasing intensified farming methods influence the perspective on “agricultural character”. With their low height above soil level, the solar panels could be mistakenly perceived as a horticultural venture under shade net. If sheep were allowed to graze among the panels, the character would be close to agricultural. This should only be considered if the project owners are comfortable that the grazing will not cause damage to project infrastructure. Alternatively, livestock can be grazed within the fenced off area, that does not contain infrastructure. The image below depicts large tracts of unutilised land within the fenced off area.
