# PROPOSED CONSTRUCTION AND IMPLEMENTATION OF BLOEMSMOND 4 SOLAR DEVELOPMENT, NEAR UPINGTON, NORTHERN CAPE

APPLICANT: Bloemsmond Solar 4 (Pty) Ltd

# AGRICULTURAL ASSESSMENT REPORT JUNE 2019

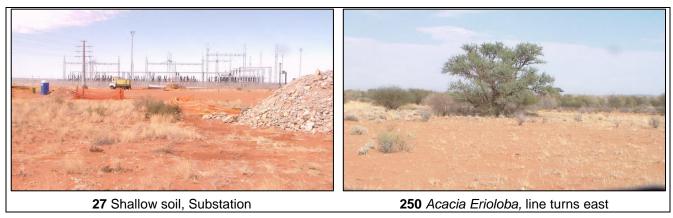
Figure 12: Photos along the grid connection alternative routes

Soil and vegetation is of very low agricultural value. Predominately the soil is less than 35 cm deep, limited by rock or hard carbonate sub strata with a sandy texture. The plant cover is sparse with large bare areas. Grasses have poor grazing value and medium encroachment of *Rhigozum trichotomum* was noted.

As with Alternative **a**, soil and vegetation is of very low agricultural value. Predominately the soil is less than 35 cm deep, limited by rock or hard carbonate sub strata with a sandy texture. Large areas of surface rocks appear. The plant cover is sparse with large bare areas. Grasses have poor grazing value and medium encroachment of *Rhigozum Trichotomum* was noted

Figure 11 shows a map of the proposed alternative alignments and observation points. Photos of the various observation points appear in Figure 12.

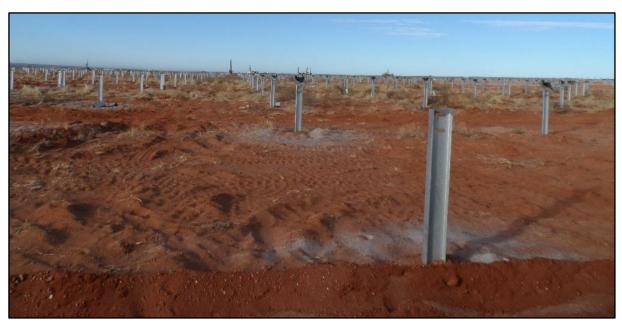
Figure 13: Status of vegetation during construction of mounting systems.

The Bloemsmond 4 Solar facility aims to use either driven / rammed piles, or ground / earth screws mounting systems, which will minimise the clearing of vegetation. Figure 13 shows a nearby construction site where these methods are used.

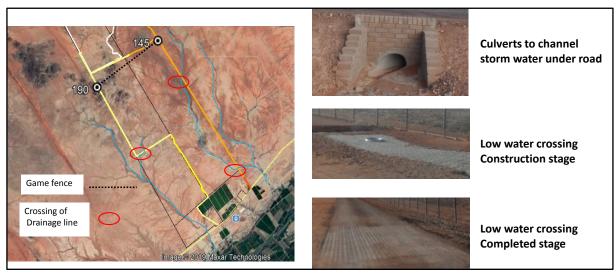
Figure 14: Sensitivity of crossing drainage line

To avoid the change of drainage patterns, storm water should be channelled from one side of the road to the other with the lowest risk of blockage possible. This can be accomplished with the use culverts. Figure 14 shows positions where drainage lines will be crossed by the access roads and examples of culverts to be constructed.
