**WATERCOURSE AND AQUATIC ECOLOGICAL  
ASSESSMENT AS PART OF THE WATER USE LICENCE  
APPLICATION PROCESS FOR VARIOUS ACTIVITIES FOR  
THE EKLAND SAFARI LODGE, NEAR LOUIS TRICHART,  
LIMPOPO PROVINCE**

**Aurecon Environmental Services**

**August 2019**

**Prepared by:** Scientific Aquatic Services  
**Report author:** C. du Preez  
**Report reviewers:** K. Marais (Pr. Sci. Nat)  
S. van Staden (Pr. Sci. Nat)  
**Report reference:** SAS 219148  
**Date:** August 2019

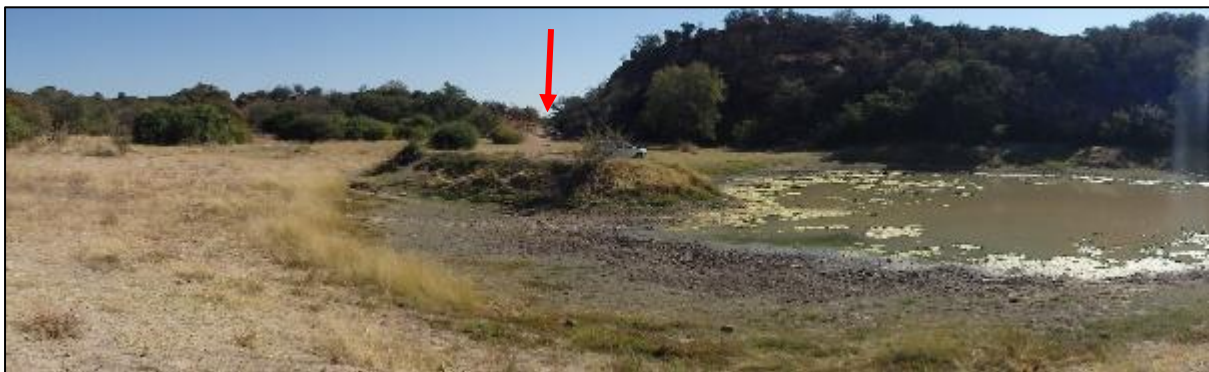
**Figure 11: The pan wetland located in an enclosed sandstone outcrop. Access to the wetland is through a corridor indicated by the red arrow.**

A pan wetland (hereafter referred to as pan wetland 1) is associated with Focus Area 1, positioned in a bench<sup>3</sup> landscape setting in an enclosed sandstone outcrop, with only one entry point. The proposed Lion Lodge development (Figure 9) is located approximately 150m north west of the delineated boundary of pan wetland 1. Access to pan wetland 1 is through a natural sandstone corridor south of the development site (Figure 11).

Pan wetland 1 lacks vegetation except for the edges of the pan where grasses were dominant (Figure 11). As a result, no obligate or facultative floral species associated with the seasonal and permanent zones of the pan were identified. The wetland buffer consists of mixed woodland, where *Senegalia burkei* forms prominent thickets at the foot of the outcrop where runoff enters into the pan wetland. Due to the high evaporation rate of this area, surface water is only present in the pan for short periods of time annually.

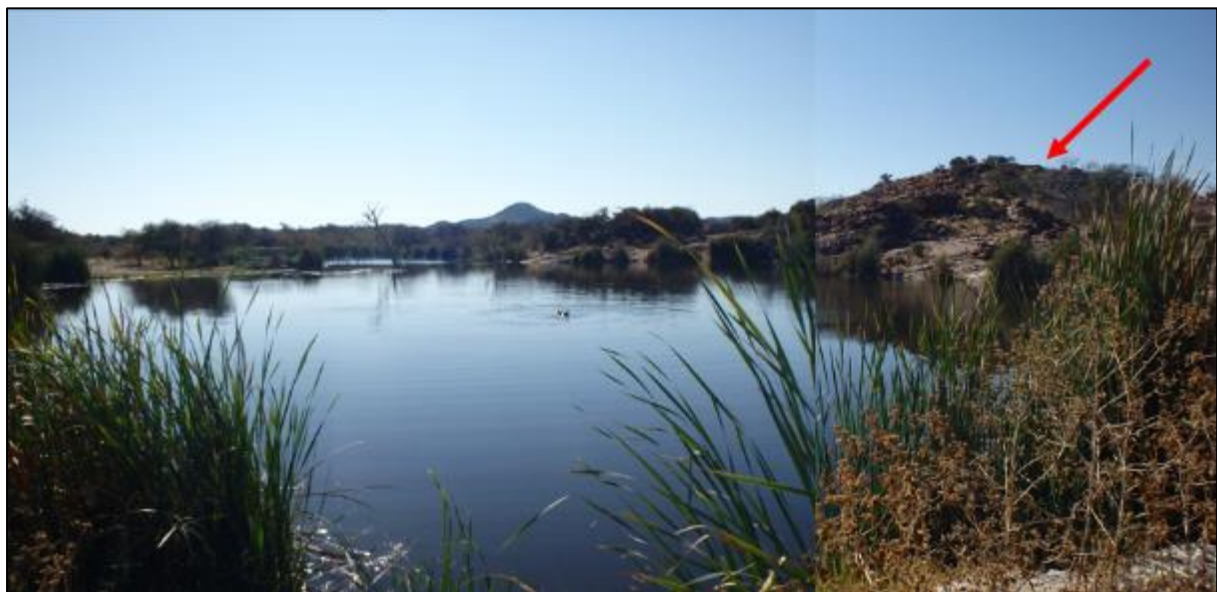
Figure 14: A photograph taken atop the dam wall. Dam 1 is bounded by a sandstone outcrop (red arrow).

A sandstone outcrop forms the eastern boundary of Dam 1, while the dam wall (constructed from calcareous materials) forms its south western boundary (Figure 14). Seepage below the dam wall has created a permanently inundated area where the reed species *Typha capensis* has established.

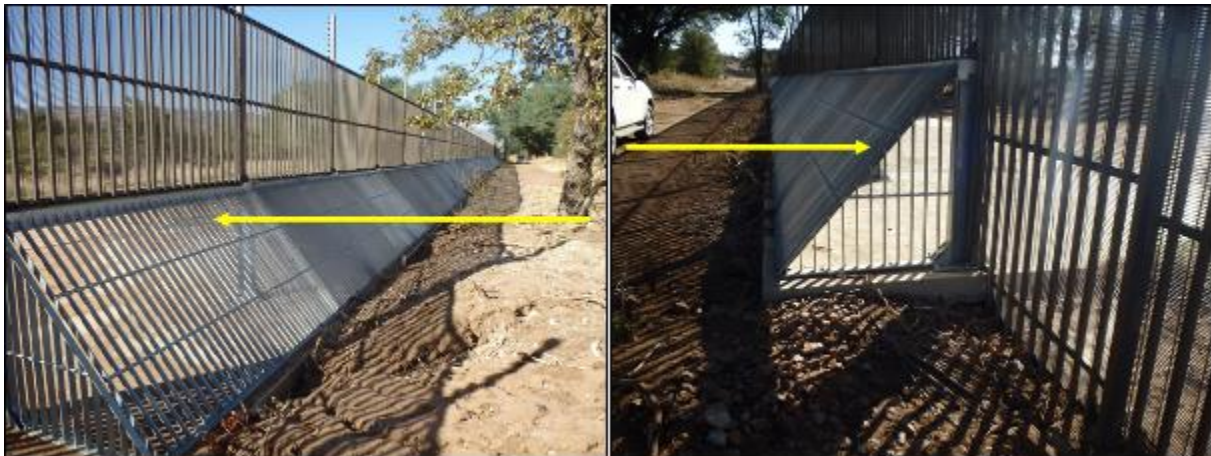
**Figure 15: A grid and concrete base forms part of the study area boundary fence which crosses the Mutamba River. The yellow arrow indicates the direction of flow.**

The boundary fence of the study area traverses the Mutamba River, which flows through the study area in a north easterly direction. The boundary fence traversing the river is constructed out of palisade, which utilises concrete foundations. Furthermore, a large steel grid structure with a fine mesh size has been installed (Figure 15). The grid atop the concrete base allows for flow through the fence when surface flow is present (only during high rainfall events), however the spacings between the palisade bars is limited (approximately 100mm), therefore faunal movement will be critically constrained, and debris will likely get trapped along the fence during a flood event.

This fence was constructed late 2018, which entailed clearing of riparian vegetation and compaction of soils (Figure 16). As the fence line is patrolled regularly, the fence corridor is maintained clear of vegetation, which has resulted in erosion and likely scouring at the base of the concrete slab during a flood event (Figure 15, left photograph).

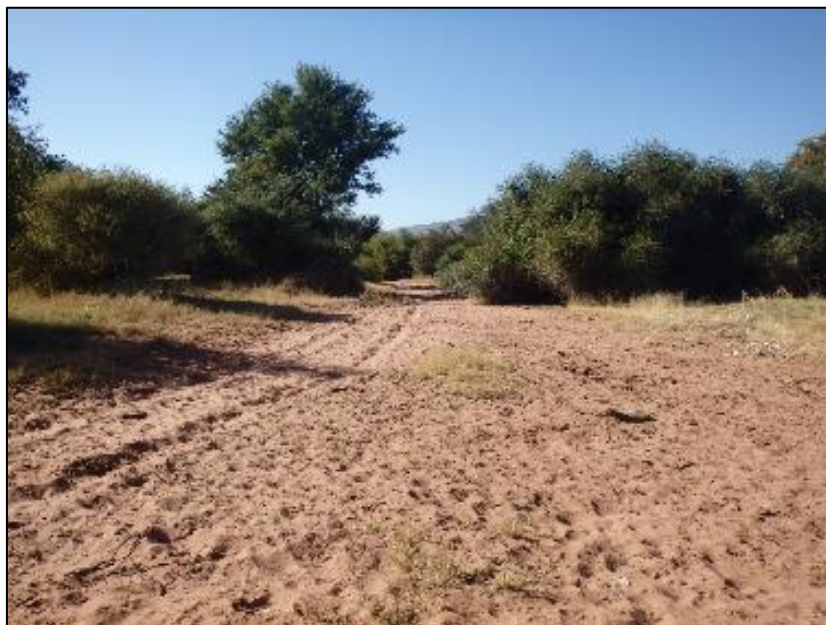
**Figure 17: The active channel of the Mutamba River upstream of the fence is characterised by deep red alluvial soils, with dense riparian tree species located within the marginal zone of the river.**

The upstream portion of the Mutamba River is less disturbed than the fence crossing. The Mutamba River is an episodic river with the bed characterised by deep alluvial soils (Figure 17) which often contains baseflow. A distinctive change in vegetation structure and abundance, as well as diversity, was noted in the marginal and non-marginal zone compared to the surrounding terrestrial zones. The marginal riparian zone of the river hosts a variety of tree species (such as *Combretum imberbe*, *Schotia brachypetala*, *Gymnosporia senegalensis* and *Senegalia nigrescens*).

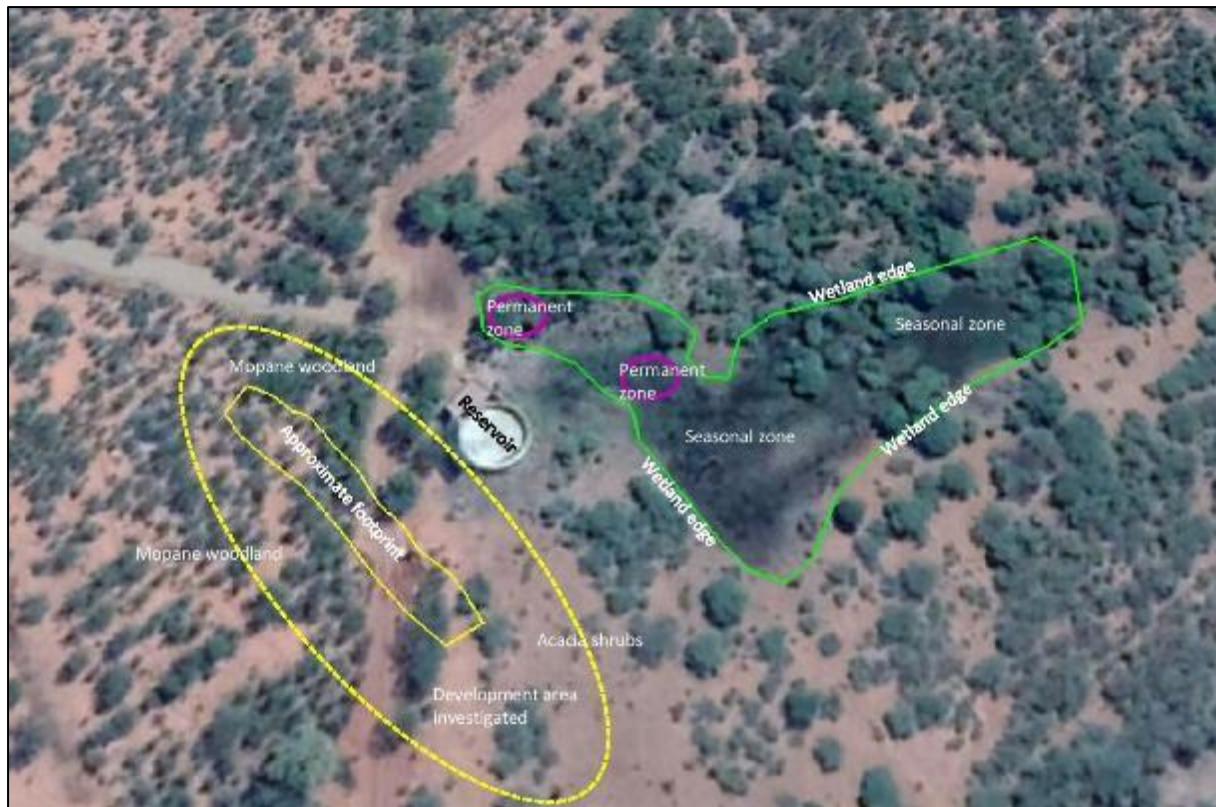
Figure 18: Delineation of the wetland flat as per the wetland delineation and vegetation verification report (van der Walt, 2018).

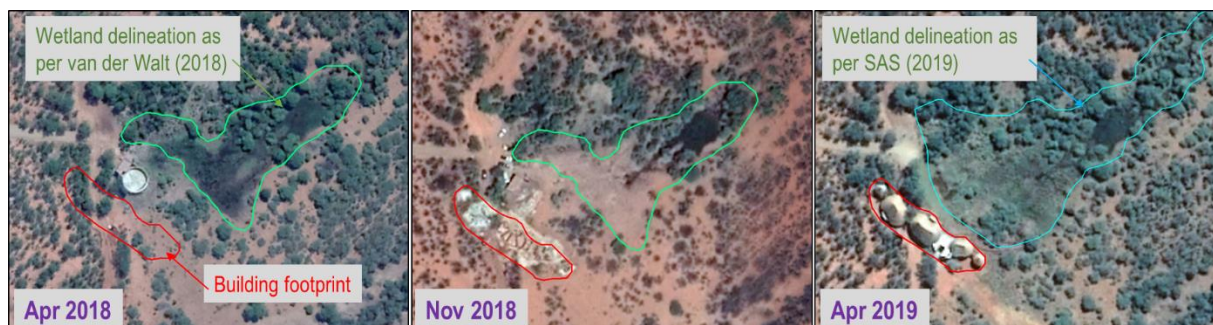
Figure 19: (Left) the proposed building footprint relative to the delineated wetland by van der Walt (2018); (center) the construction footprint and delineated wetland during the construction phase; (right) the constructed buildings relative to the anthropogenically extended wetland, delineated by SAS (2019).

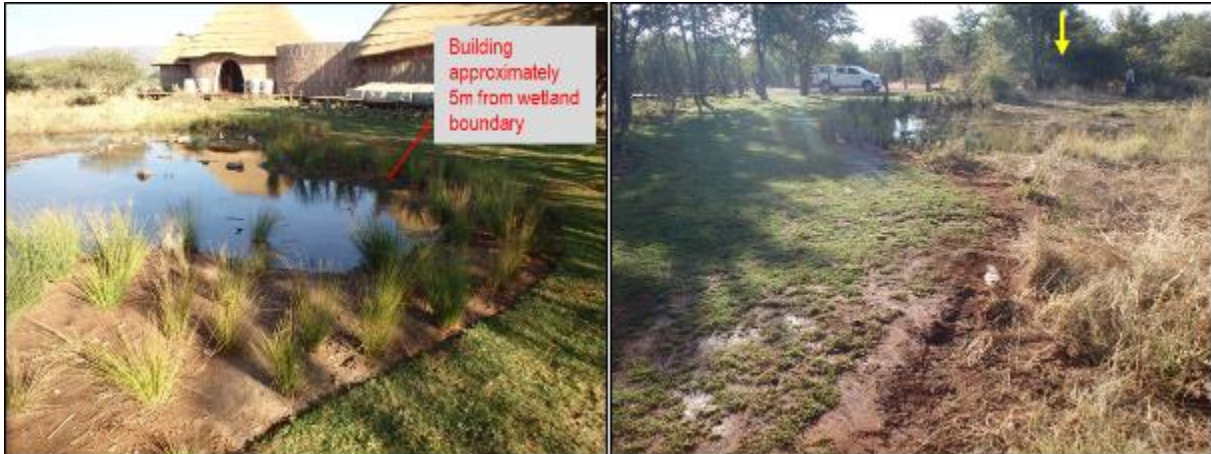
**Figure 20: (Left) the delineated boundary of the wetland as per the SAS site visit in July 2019, is within 5m from the constructed building; (right) the locality of the eye of the spring indicated by the yellow arrow, from where the groundwater is piped.**

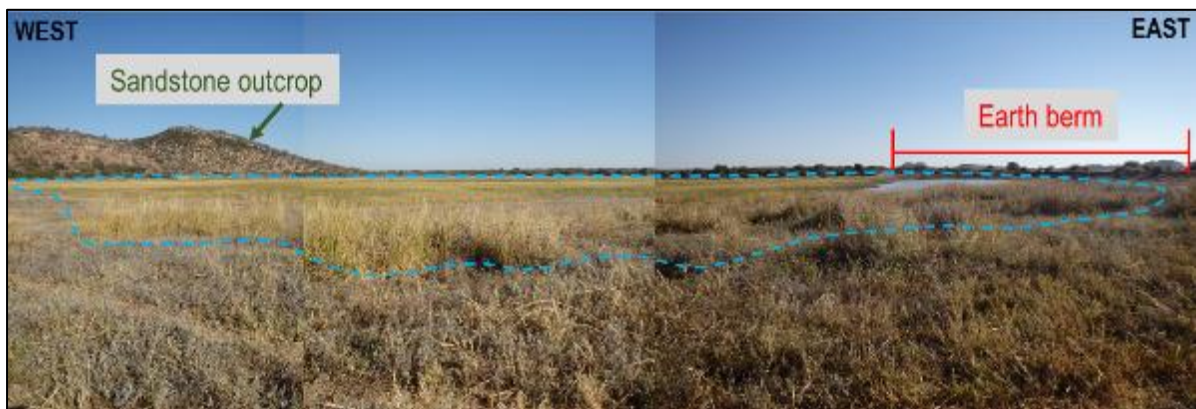
**Figure 21: Pan wetland 2 (blue dashed line) located at the foot of a sandstone outcrop and is bounded by an earth berm on its eastern boundary.**

A large pan wetland (hereafter referred to as ‘pan wetland 2’) is located in Focus Area 5 (Figure 21). Pan wetland 2 is located at the eastern foot of a sandstone outcrop. Pan wetland 2 is fed by an ephemeral drainage line (EDL) noted to have riparian vegetation, flowing into the wetland on its north western boundary. An earth berm was constructed along the eastern boundary, allowing water to reside in the wetland for a longer period. This limits throughflow of water to the downstream EDL.

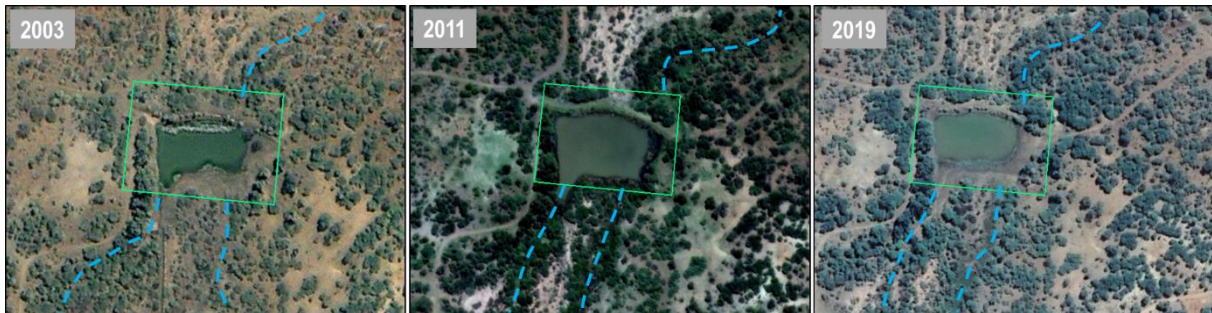
**Figure 23: Digital satellite imagery of Dam 2 within an ephemeral drainage line (blue dashed line), in 2003 (left), 2011 (center) and 2019 (right).**

An artificial impoundment (hereafter referred to as ‘Dam 2’) is located in an ephemeral drainage line (EDL) noted to have riparian vegetation in Focus Area 6. Water ponds in the dam before it flows into the downstream reach of the EDL. Digital satellite imagery shows that Dam 2 has surface water all year round (Figure 23). No outlet from the dam releasing water into the downstream EDL was noted, although seepage below the dam was evident. A pipe outlet was noted to transfer water into Dam 2, thus it is considered likely (although unconfirmed at the time of this assessment) that groundwater is pumped into Dam 2 (Figure 24).

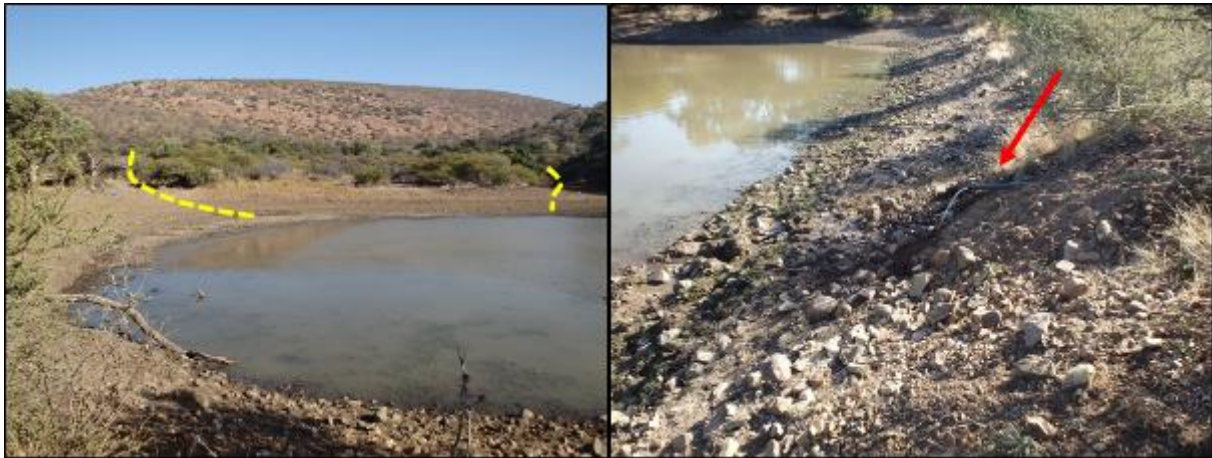
**Figure 24: (Left) the EDLs (yellow dashed lines) upstream of Dam 2; (right) the red arrow indicates the pipe releasing water into Dam 2.**

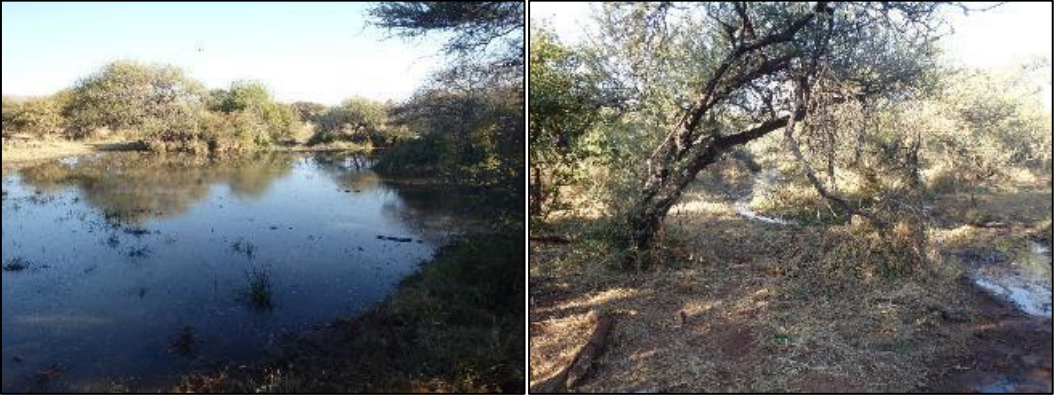
<p>(Left) The wetland has a large permanent zone, relative to its seasonal and temporary zones; (Right) terrestrial woody vegetation encroaches into the wetland (e.g. <i>Colophospermum mopane</i> and <i>Vachellia tortilis</i>) implies that this zone is not saturated for long periods of time.</p>	
<p><b>PES discussion</b></p>	<p><b>PES Category: B/C (Largely natural with modifications)</b>                  This wetland is deemed to be largely natural as the construction activities occurred outside the NEMA regulated zone of the wetland. No edge effects nor residual edge effects from the construction phase were noted to impact on the wetland. Modification to the hydroperiod occurred by increasing the extent of the wetland towards to building footprint.</p>	<p><b>EIS discussion</b></p>	<p><b>EIS Category: High</b>                  This wetland is considered of high ecological importance due to its hydro-functional importance, but also due to its direct human benefits (for tourism and aesthetical purposes). The intact terrestrial buffer zone of the wetland hosts a variety of species, to which the wetland provides water during high rainfall periods.</p>

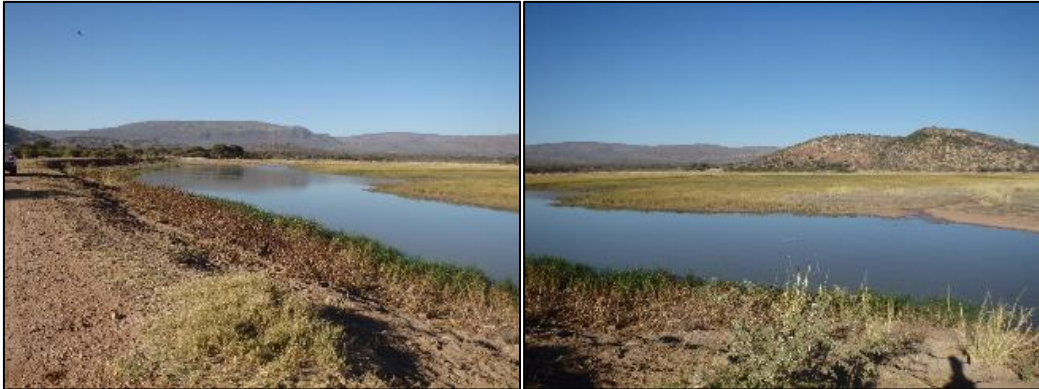
<p>(Left) the large earth berm located on the north eastern boundary of the pan wetland; (right) sandstone outcrops bound the southern edge of the pan. The permanent zone of the wetland is extensive, which allows for obligate sedge species to inhabit the pan wetland.</p>	
<p><b>PES discussion</b></p>	<p><b>PES Category: C (Moderately modified)</b>                  Other than the earth berm on the north eastern boundary of this pan wetland, no other anthropogenic impacts were noted. The berm has changed the hydrological regime of this pan, allowing for water to reside in the pan for longer periods rather than discharging into the downstream EDL. The longer inundation period resulted in a monoculture of obligate sedge species to establish in the pan, rather than host a diversity of obligate and facultative wetland species.</p>	<p><b>EIS discussion</b></p>	<p><b>EIS Category: Moderate</b>                  This pan wetland is considered of ecological importance due to its hydro functionality. Additionally, it is considered to be of importance for direct human benefits (for tourism and recreational activities). As the pan in itself does host a high diversity of species, it is also connected to the larger drainage system in the study area and functions as a migratory corridor. Additionally, it has ecological importance in terms of biodiversity support.</p>

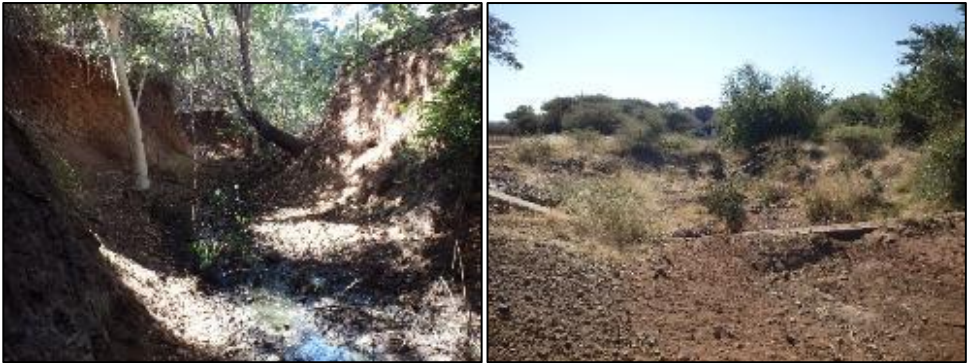
<p>Figure A: (Left) highly incised EDL below the earth berm in Focus Area 7; (right) erosion noted at the spillway located in Focus Area 7.</p>
<b>Risk Assessment outcome &amp; Business Case:</b>	
<b>LOW</b>	
The downstream reaches of the EDLs (below the earth berms) are eroded, and rehabilitation of the earth berms and these EDLs are proposed. The rehabilitation activities (primarily the revegetation of the earth berm and infilling of erosion gullies) were determined to pose a Low risk significance to the EDLs, provided that the mitigation measures as stipulated in Section 7.1.2 are implemented. In order to prevent further degradation to the EDLs it is considered imperative that the rehabilitation activities be implemented to increase the ecological functionality and condition and to ensure connectivity of the EDLs to the larger Mutamba River system.

<b>c) Habitat and biota</b>	Although not necessarily large enough by themselves to support significant populations of larger animals, habitat along the EDLs remains largely intact and representative of the natural vegetation type. The riparian vegetation consisted of primarily of young tree species of <i>Gymnosporia senegalensis</i> and <i>Combretum mossambicensis</i> . It is thus deemed likely that the EDLs do provide important refuge and migratory corridors for smaller mammals and avifauna, but lack in adequate provision of aquatic habitat and thus biota.
<b>d) Topography: Geomorphology and sediment balance</b>	The geomorphology of the upstream reaches of the EDLs are largely intact. Significant erosion of the downstream reaches of the EDLs just below the earth berms were noted (Figure A - left). Erosion was also noted at the spillway associated with the earth berm of Focus Area 7 (Figure A - right). This is due to the lack of vegetation on the earth berms and the naturally high erodibility of the soils within the study area. Despite erosion noted within the EDLs, no significant deposition of sediment was observed.

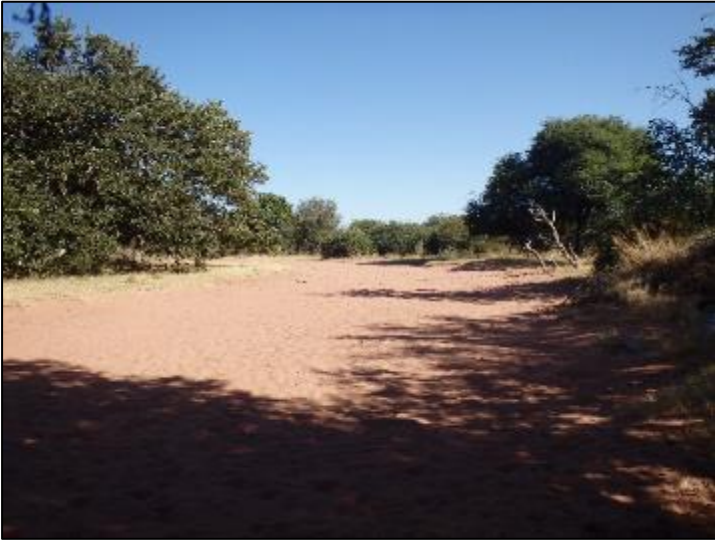
**Table 11: Results of the assessment of the Mutamba River, upstream of the boundary fence crossing (approximately 800m upstream of Focus Area 3).**

Riparian Vegetation Response Assessment Index	
	VEGRAI score	The Mutamba River is considered to have a true riparian zone, based on the higher vegetation density compared to the terrestrial upland areas. The riparian zone is also dominated by riparian trees, shrubs and grasses.

84.6 (Category B; Largely natural with few modifications)	Dominant riparian species observed within the system is the <i>Faidherbia albida</i> (Ana tree) and <i>Grewia flava</i> (Velvet raisin). The non-marginal zone comprises <i>Combretum apiculatum</i> (Red bushwillow), <i>Senegalia nigrescens</i> (Knob thorn) and <i>Sclerocarya birrea</i> subsp. <i>caffra</i> (Marula). Marula trees are protected under The National Forests Act, 1998 (Act No. 84 of 1998).
		The river at the assessment site has undergone very few disturbance, such as a small recreational picnic area, however, upstream crossings over the river are prevalent which is typical of ephemeral systems.
	VEGRAI comparison to RQIS PES (DWS, 2014) data	
The VEGRAI classification can be considered as borderline similar to the RQIS PES (DWS, 2014) Riparian-wetland zone habitat integrity class classification of High (Section 4.2, Table 3).

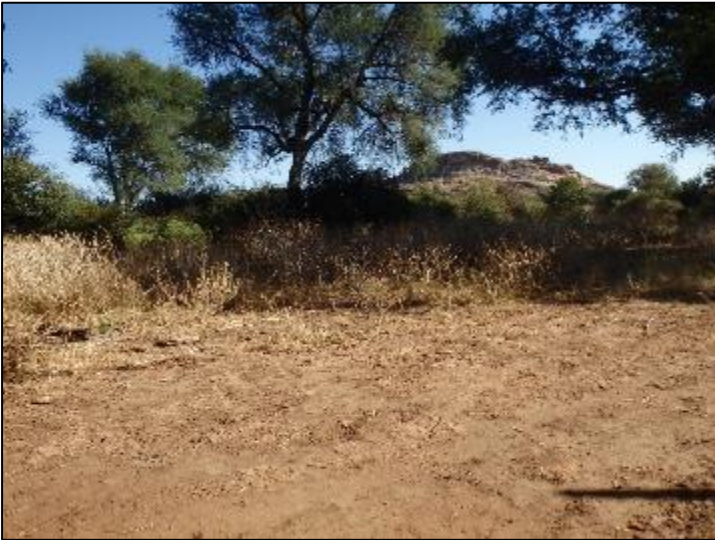
**Table 12: Results of the assessment of the Mutamba River at the boundary fence crossing in Focus Area 3.**

<b>Riparian Vegetation Response Assessment Index</b>	
	<b>VEGRAI score</b>	The construction of the boundary fence in the river resulted in the loss of riparian vegetation and alien and invasive species have invaded the immediate upstream and downstream area of the crossing. Alien vegetation species such as <i>Onopordum acanthium</i> were noted immediately upstream of the crossing, while all riparian vegetation has been removed between the boundary fence crossing and the N1 road. Despite this, the vegetation upstream and downstream of this crossing is considered largely natural. It must also be noted that the disturbance to the vegetation component of the river in focus area 3 has been an ongoing occurrence as part of the N1 road reserve maintenance activities.

79.7 (Category B/C; Largely natural with modifications)	
	<b>VEGRAI comparison to RQIS PES (DWS, 2014) data</b>	
	The VEGRAI classification (Largely natural with modifications) at this site differs from the classification provided by the RQIS PES (DWS, 2014) Riparian-wetland zone habitat integrity class classification of High (Section 4.2, Table 3).	
<b>Key Drivers of System Change</b>		
The study area is located in a largely untransformed area; however, some agricultural activities are located adjacent to the river (limited), thus the river does receive runoff from crop irrigation.		
<b>Business Case</b>		
The operation of the boundary fence crossing in focus area 3 poses a Low risk significance to the instream flow (when present) of the river, however, any debris collected at the crossing after a rainfall event must be removed to ensure flow connectivity during high flow periods. Additionally, the fence crossing will likely have an insignificant effect on the downstream water quantity and quality of the Mutamba River. It is imperative that the spacing of the palisade fence balustrades be increased to ensure migratory connectivity for biota within the river. Alien and invasive species were noted at the fence crossing, which must be removed and disposed of as part of the rehabilitation of the construction and operational footprint of the fence crossing.

<b>Algal proliferation:</b>	The system was dry at the time of the assessment.	
<b>Depth profiles:</b>		
<b>Flow condition:</b>		
<b>Riparian zone characteristics:</b>		
<b>Signs of pollution:</b>	None observed.

As the concrete and grid fence crossing in the Mutamba River (Focus Area 3) is an existing structure, only the operational phase was assessed as part of the risk assessment. Based on the onsite conditions at the time of the field assessment, no significant impact to the Mutamba River due to the presence of the fence in the river was noted and the operational risk significance of the fence is considered 'Low'. It is strongly advised the steel grid structure atop the concrete base (focus area 3) be spaced a minimum of 150mm between the balusters to allow free movement of smaller faunal species through the fence (thus allowing for migratory movement), but still maintain security of the reserve.
