**PROPOSED REHABILITATION OF CASTEEL DAM**

**EIA Specialist Report:  
Aquatic Biodiversity Specialist Assessment**

**Field Survey: 22<sup>nd</sup> August 2022  
Draft Report V1.0: 9<sup>th</sup> October 2022**

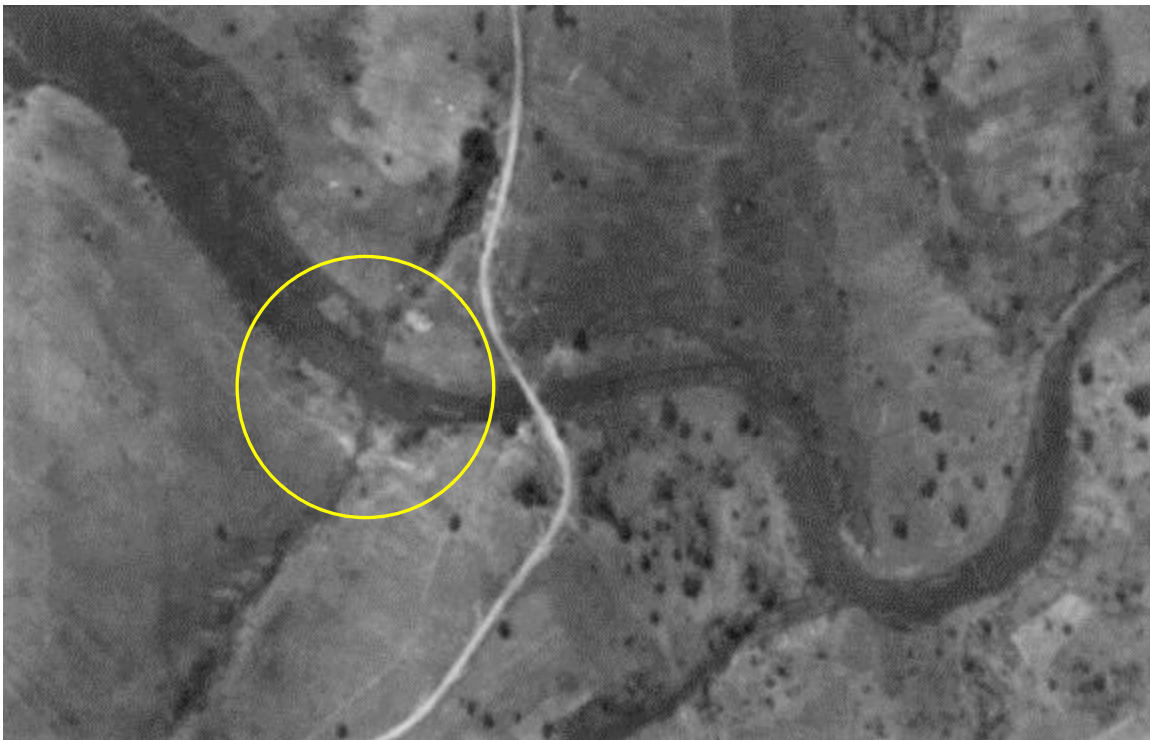
**Figure 6-3. Aerial Photograph of Casteel Dam Area in 1944**

**Valley Bottom Wetland with Channel.** Examination of an aerial photograph taken in 1944, before the construction of Casteel Dam, shows that the watercourse at the dam site comprised a Valley Bottom Wetland (Figure 6-3). The wetland was wider upstream of the R40 road crossing, which suggests a natural hydraulic control near the road crossing. A geological fault line runs through the site where the dam is now located (Figure 6-3). The field survey for this report found that the wetland downstream of the dam comprised a Channelled Valley Bottom Wetland characterised by the Lowveld Reed *Phragmites mauritianus* and the grass *Leersia hexandra*. Photographs of this wetland are shown in Figure 6-4. The wetland was about 70 m wide and extended to the confluence with the Thulanziteka River, a distance of ~1.8 km. The size of this wetland downstream of Casteel Dam was ~12.6 hectares.

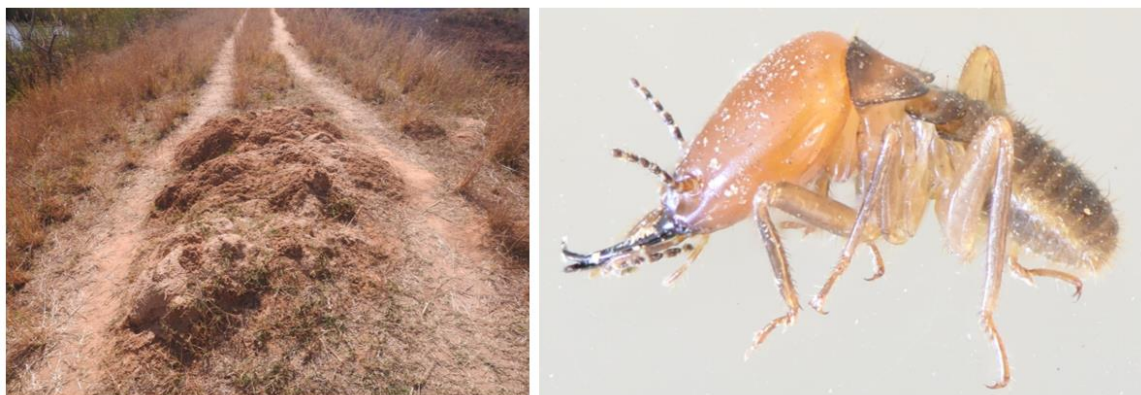
**Figure 6-8. *Macrotermes* sp. (Termitidae) on Casteel Dam**

Casteel Dam wall was colonised by fungus growing termites comprising the genus *Macrotermes* sp. (Figure 6-8). The presence of termites in the wall has significant implications for the structural stability of the wall.

Casteel Dam is at risk of failure because of gully erosion that is working its way towards the spillway (Figure 6-5D), and because the wall is compromised by infestation of termites (Figure 6-8). Furthermore, the structural stability of the wall is potentially compromised by woody vegetation that has colonised the wall. The project description available when this report was prepared provided no details on these aspects other than the “*the spillway donga will be rehabilitated*” and that “*termites will be controlled*”. The current donga is ~8 m deep and would need significant civil works to ensure that further erosion is adequately controlled. Furthermore, controlling termites does not address the structural problems that are likely to have already taken place within the existing wall. The ecological implications of dam failure would be catastrophic and irreversible and so the intensity of this impact was rated as *Critical (-6/7)*. Dam failure would result in high sediment loads in the watercourse and permanent scarring of the landscape, so duration was rated as *Beyond Project Life (6/7)*. The spatial extent of dam failure could extend at least to the confluence with the Tlulandziteka (Sand) River and was therefore rated as *Local (3/7)*. The probability of dam failure in the absence of mitigation was considered to be *Probable (4/7)*. However, implementing the proposed mitigation measures should reduce the probability of this impact from *Probable (4/7)* to *Improbable (2/7)*. The residual significance dam failure was rated, with moderate confidence, as **Negligible (-)**.

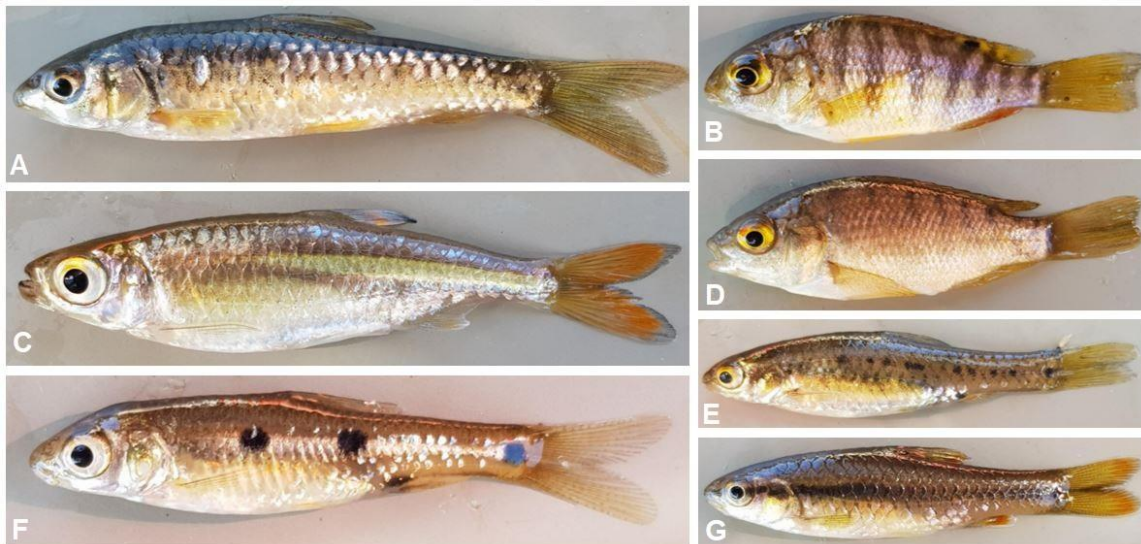
**Figure 6-14. Photographs of Fish Species at C2**

The Present Ecological State of fish at Site C2 in August 2022 was rated as Category B (Appendix F). A total seven species of fish was recorded in 9 minutes of electro-fishing. Photographs of the seven species of fish are shown in Figure 6-14. The number of fish was not recorded because of high numbers of small individuals and the limited time available. The Catch per Unit Effort was therefore not calculated but is likely to have been over 1,000 per hour, which is considered *very high*. The composition was dominated numerically by *Micralestes acutidens*, *Enteromius annectens* and *Oreochromis mossambicus*. All individuals recorded were small (<6 cm). The most sensitive species recorded was *Enteromius eutaenia*, which was present in moderate abundance. No alien fish species was recorded.

[A] *Labeobarbus marequensis*; B) *Coptodon rendalli*; C) *Micralestes acutidens*; D) *Oreochromis mossambicus*; E) *Enteromius trimaculatus*; F) *Enteromius annectens*; G) *Enteromius eutaenia*].
