# AQUATIC ECOLOGICAL AND WETLAND ASSESSMENT

TRANSALLOYS, LOCATED

NEAR EMALAHLENI IN THE MPUMALANGA PROVINCE

FEBRUARY 2019

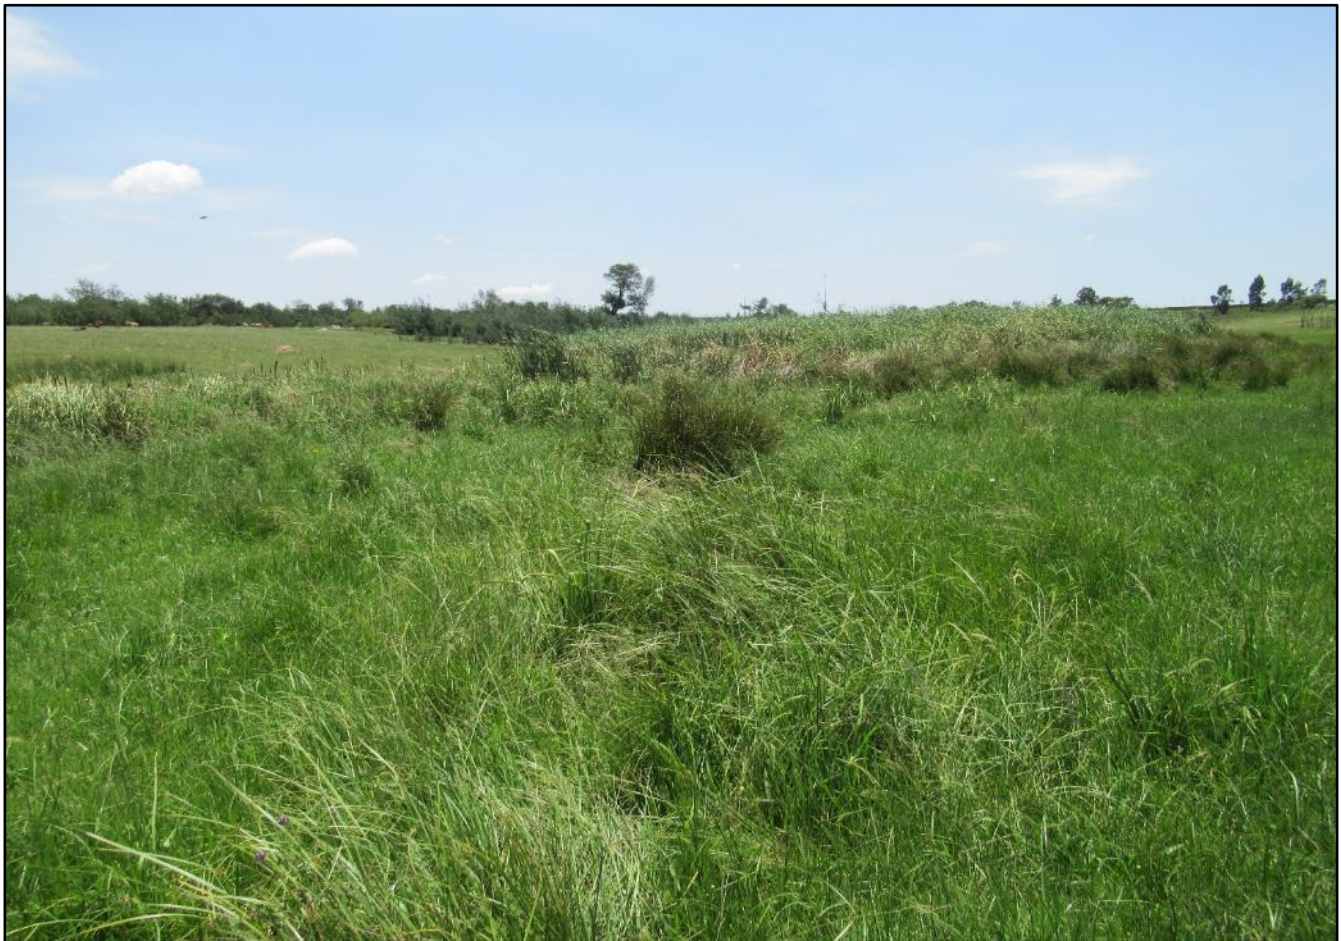
Hydrophytic riparian vegetation consisted of mainly of *Typha capensis* and *Cyperus spp.* Others included *Juncus spp.* (**Figure 13**).

**Figure 13:** Overall view of hydrophytic vegetation associated with the watercourses in the study area.

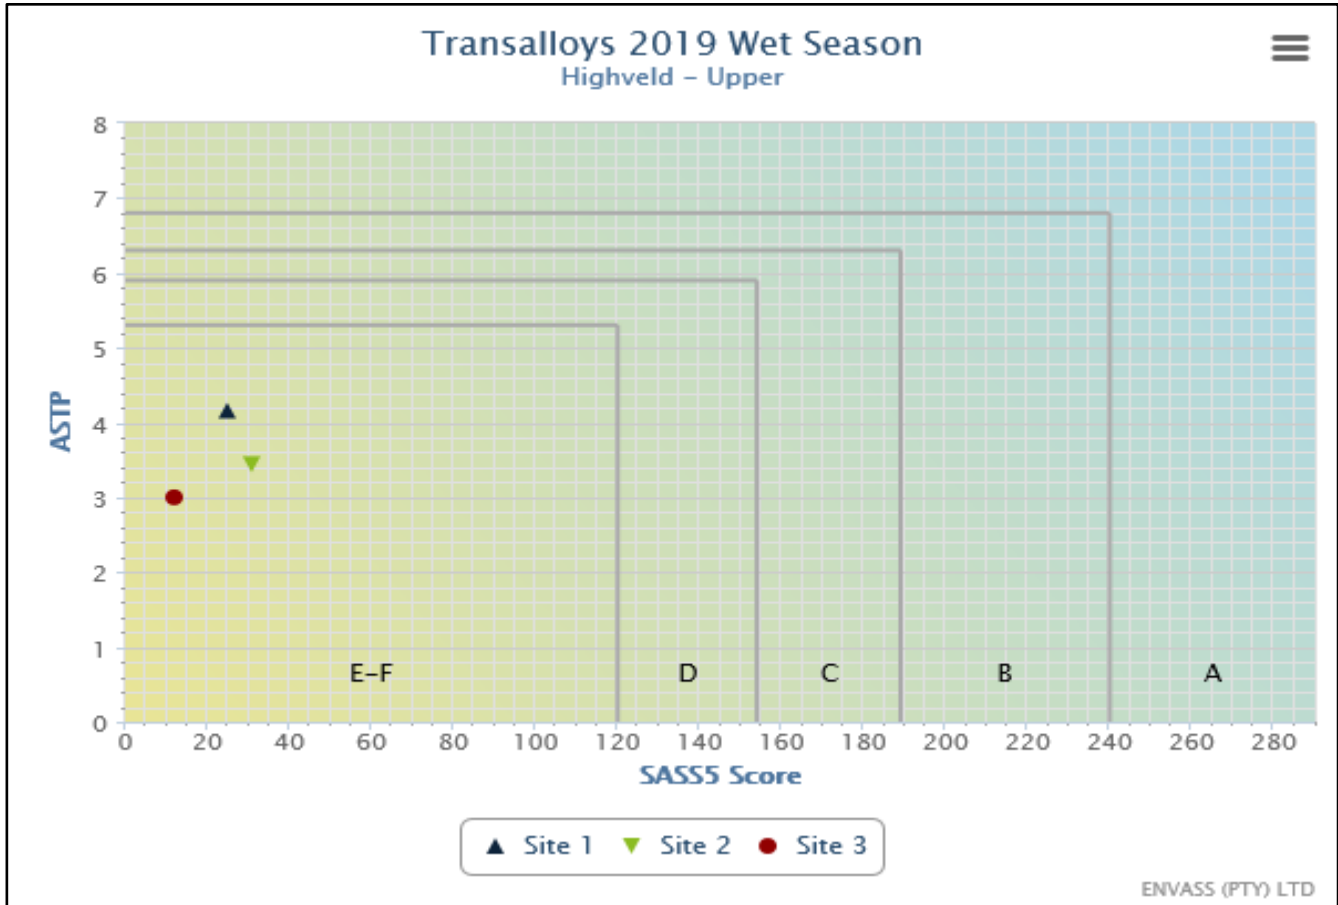
**Figure 14:** SASS 5 Classification using biological bands calculated from percentiles from Dallas (2007) for the all 3 study sites at Transalloys in accordance with the Highveld Upper Ecoregion as reference.

SASS5 scores for all three sites (Brugspruit and its tributary) were found to be in a **seriously modified (Category E/F)** (Figure 14). The presence of highly pollution tolerant organisms indicates the pressure from extensive pollution upstream on both these systems. The high abundance and occurrence of *Culicidae* indicates that this system is heavily transformed.

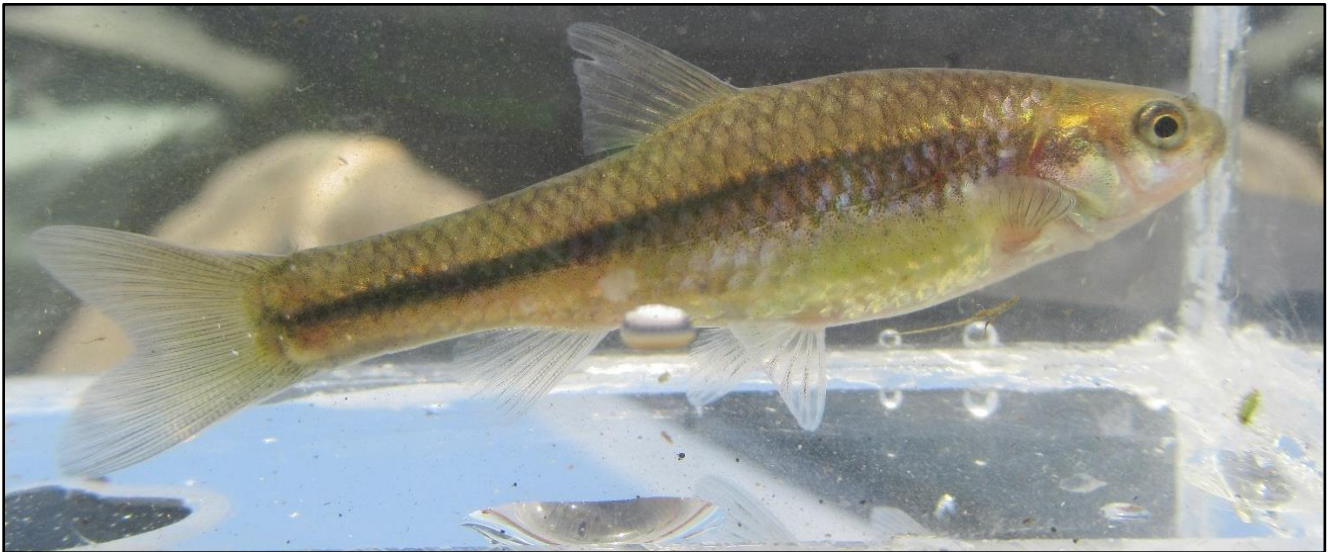
**Figure 15:** *Enteromius anoplus* (Chubbyhead barb) sampled at site 2 downstream of Transalloys in the Brugspruit.

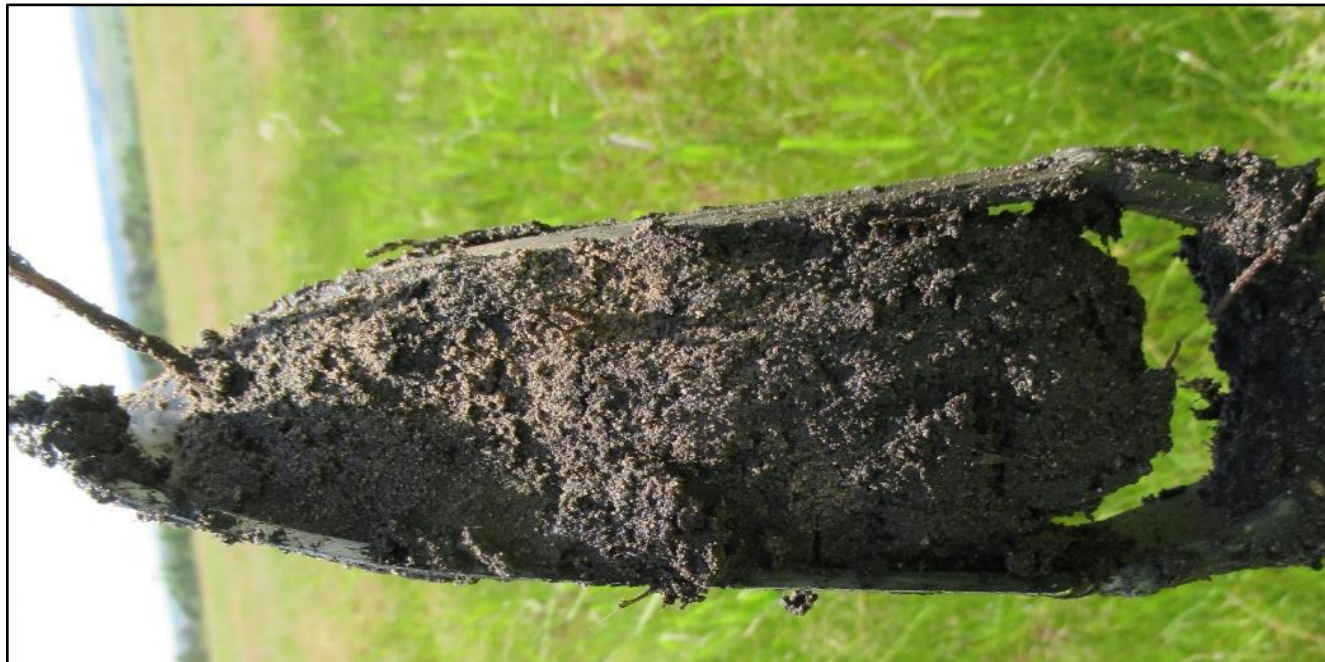
**Figure 18:** Hydric soils included a Sandy Clay Loam soil form associated with the wetland areas.

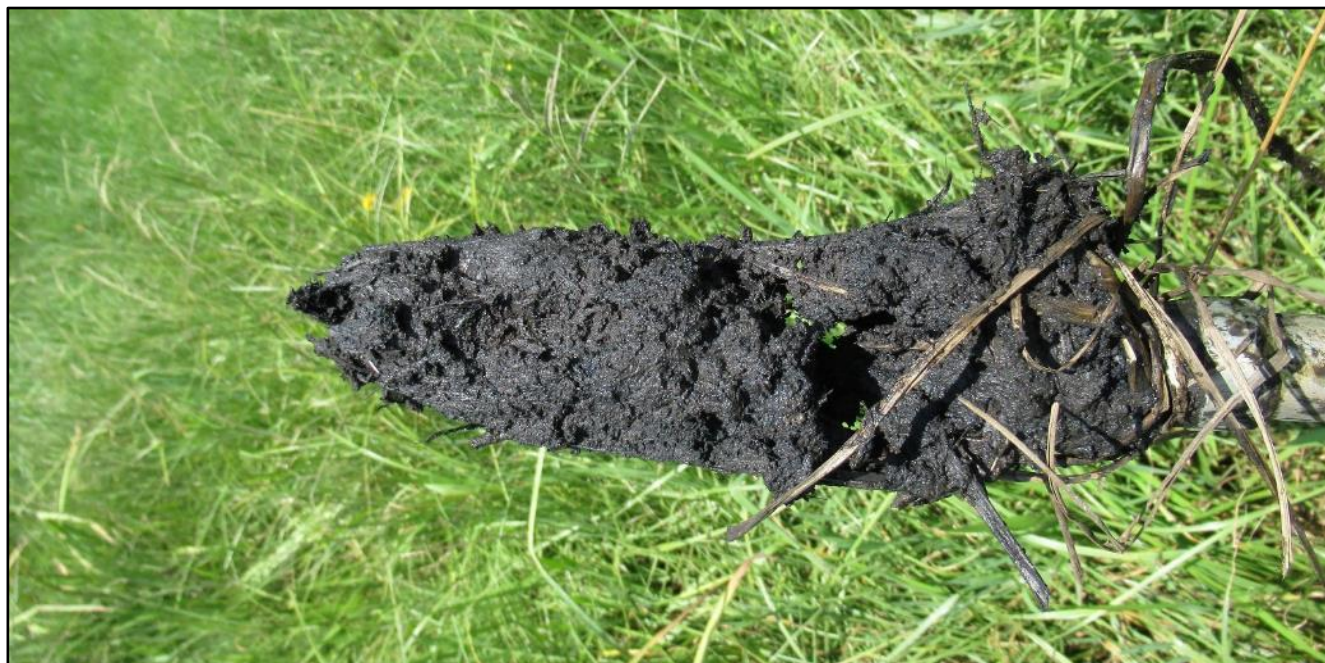
**Figure 19:** Hydric soils included Katspruit soil form associated in the wetland areas.

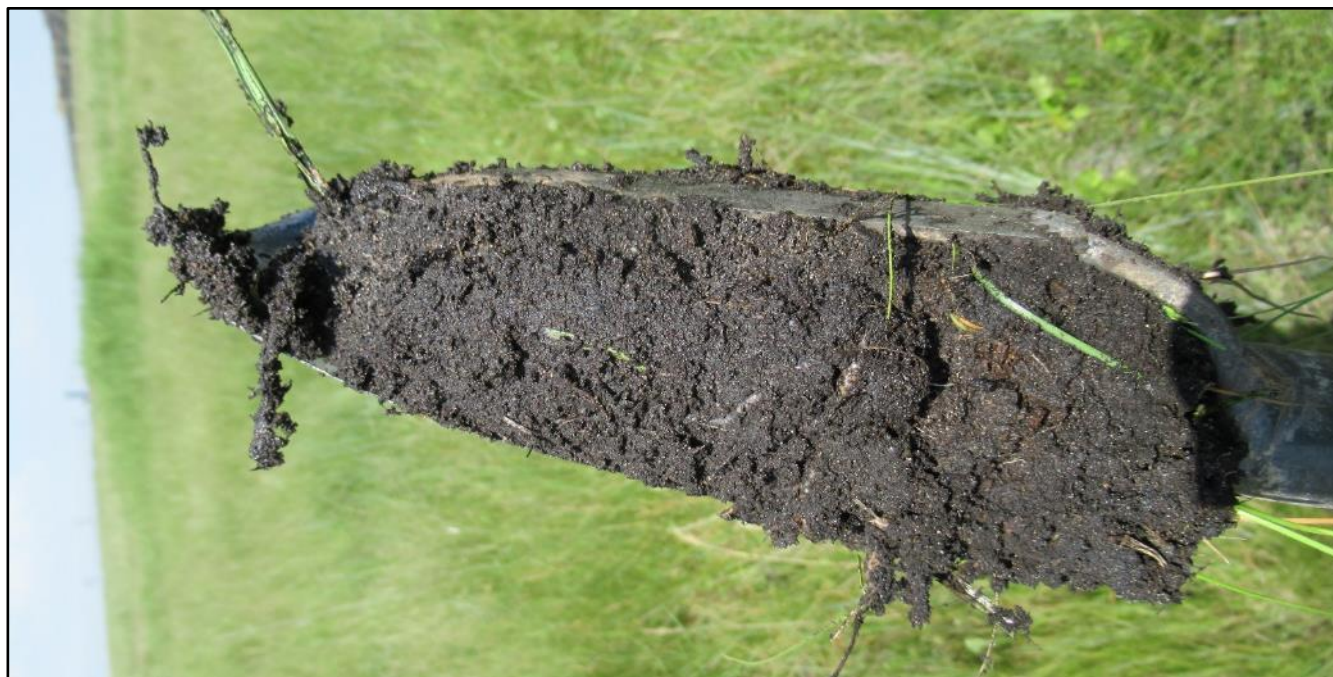
**Figure 20:** Organic matter found and associated with hydric characteristics and wetland conditions.

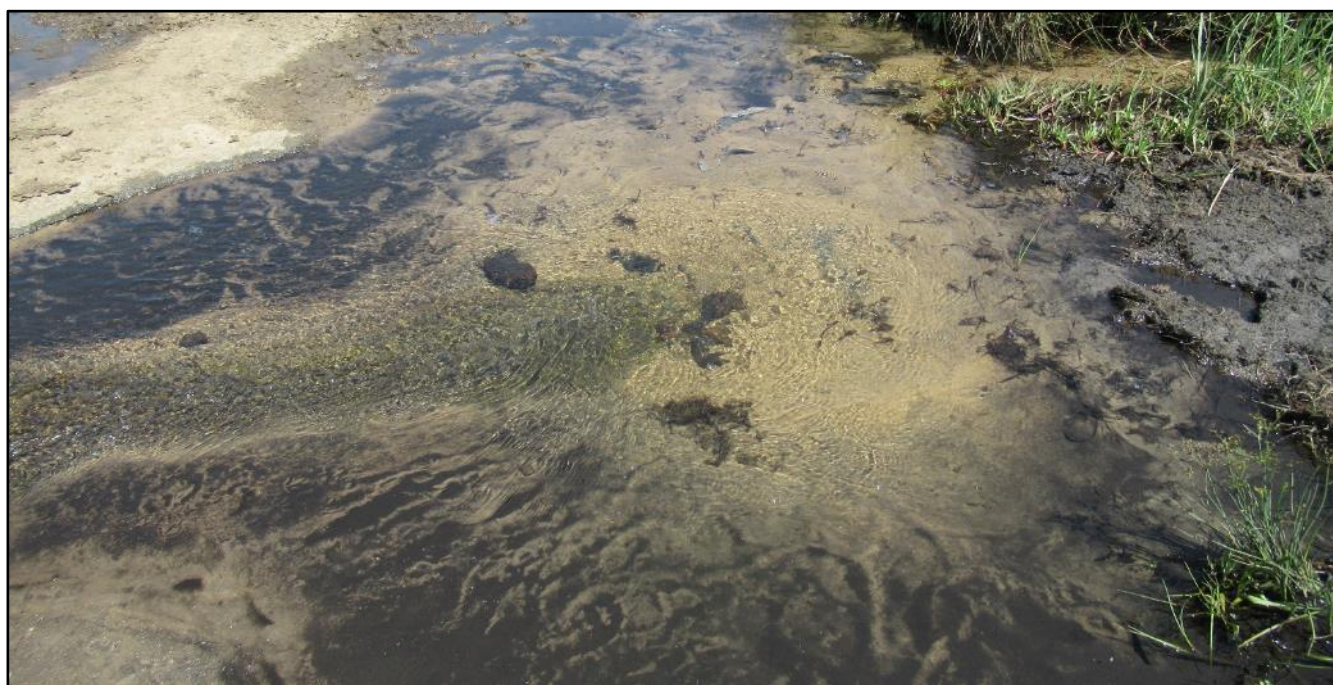
**Figure 21:** Alluvial soils associated with the channel areas.

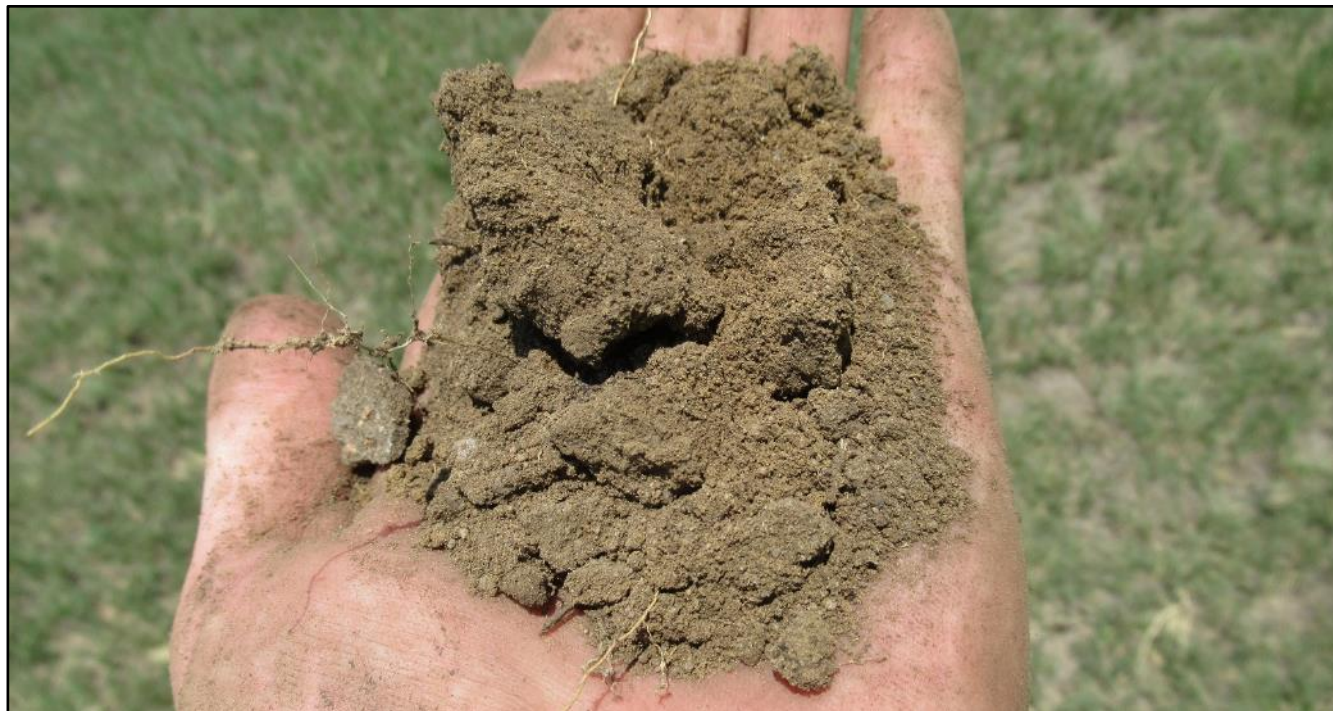
**Figure 22:** Clovelly soils were identified and dominant outside of the wetland system within the grasslands.

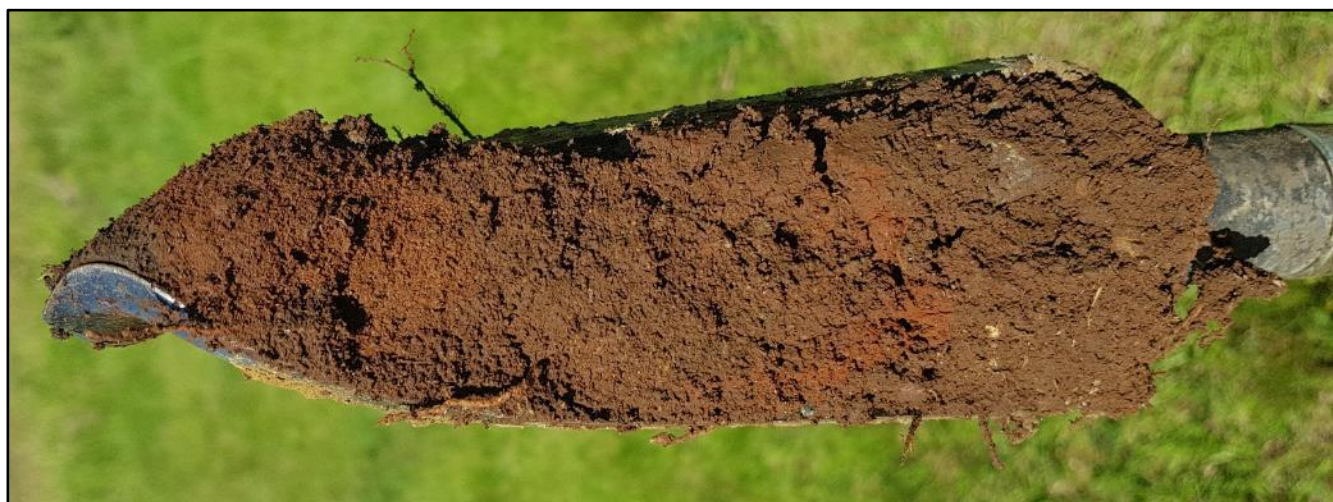
**Figure 23:** Hutton soils were identified and dominant outside of the wetland system within the grasslands.

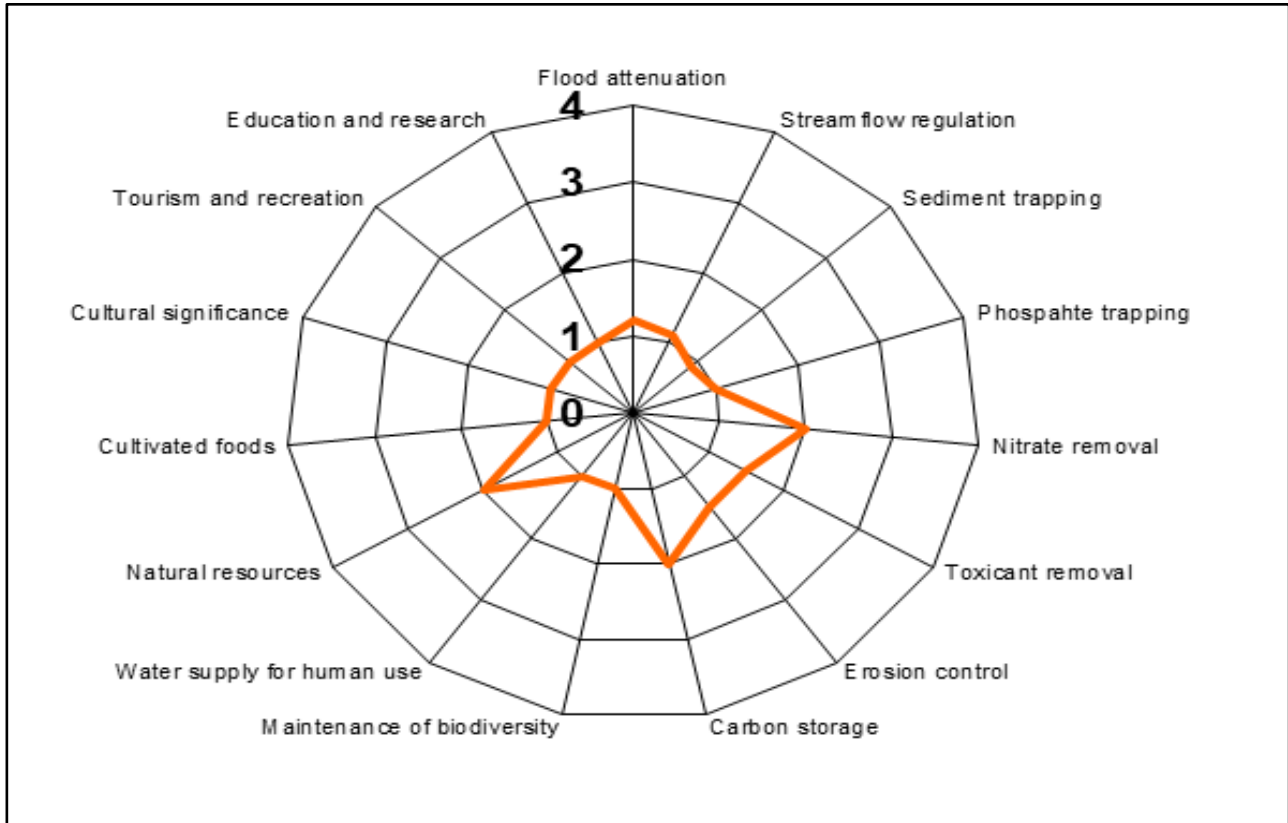
The seepage wetland (HGM1) was identified within the study area above one of the channelled valley bottom wetland (HGM2). The seep wetland received generally bad score, indicating that this wetland is largely modified functioning systems. According to the functional assessment flood attenuation; damming; the maintenance of biodiversity; and the provision of natural resources are the predominant attributes provided by these wetlands to the surrounding landscapes, this is due to the Transalloys stockpiles within this wetland system (**Figure 26**).

Figure 26: WET-Eco Services results for HGM 1

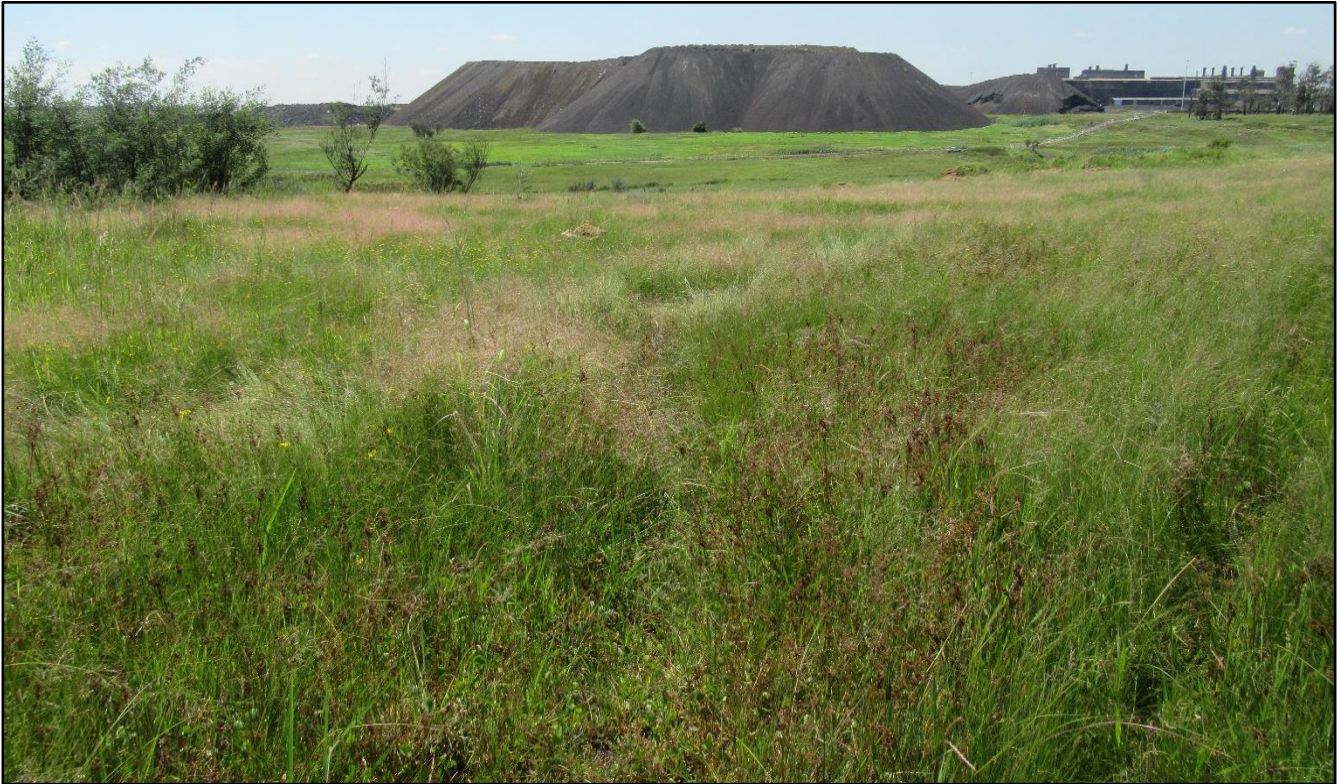
The seep wetland system was assessed in terms of health and were found to be categorised as **largely modified (Category D)** (**Table 26**). The majority of the indigenous vegetation within the development footprint and the surrounding area is modified (**Figure 27**).

**Figure 27:** Seepage wetland (HGM 1).

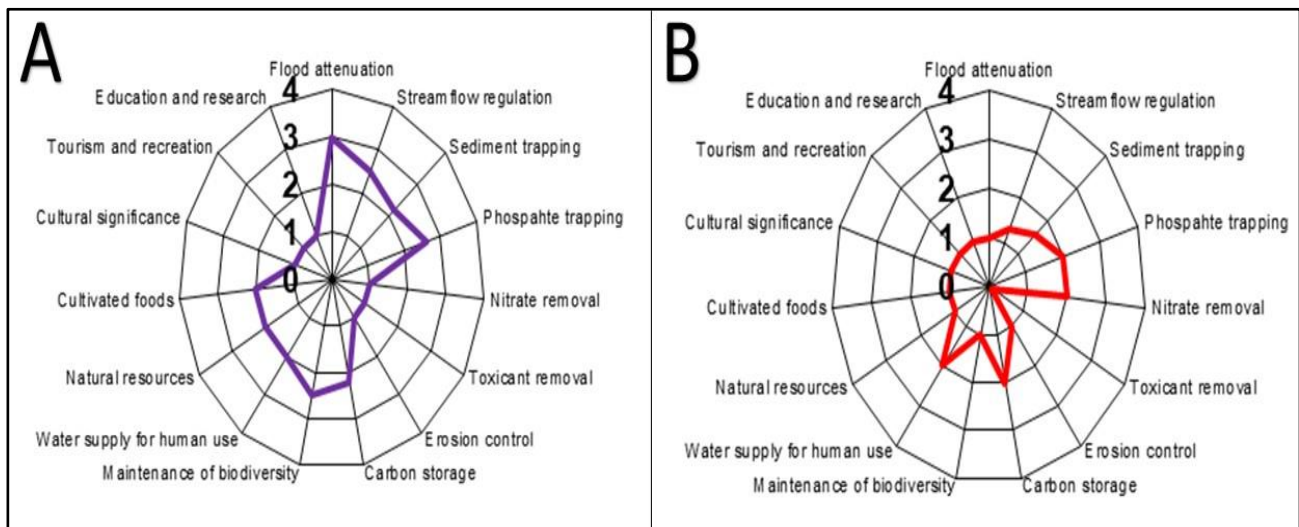
Despite the modified nature of the wetlands they still provide a number of functions to the larger landscape, particularly with regard to flood attenuation; sediment trapping; erosion control; the maintenance of biodiversity; and the provision of natural resources.

Figure 28: WET-Eco Services results for (A) HGM 2 and (B) HGM 3.

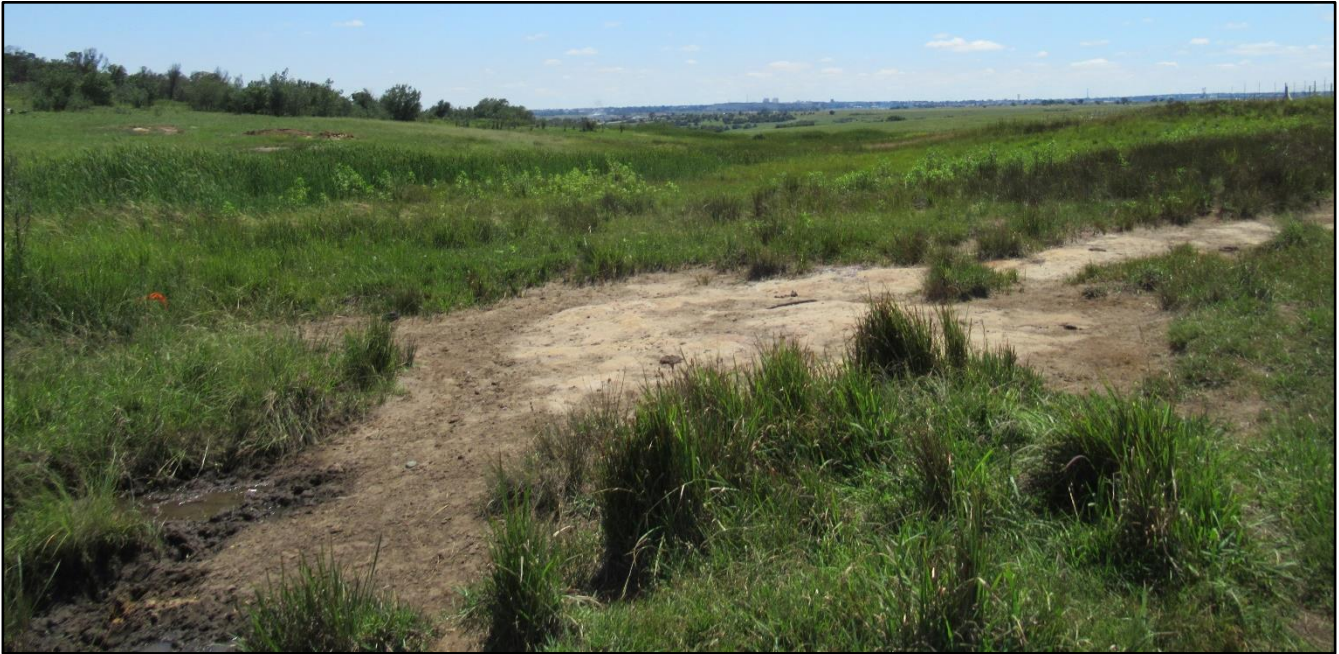
erosion gullies in the majority of these systems. This results in a negative impact on the wetlands ability to maintain biodiversity.

**Figure 29:** Channelled valley bottom wetland (HGM 2).

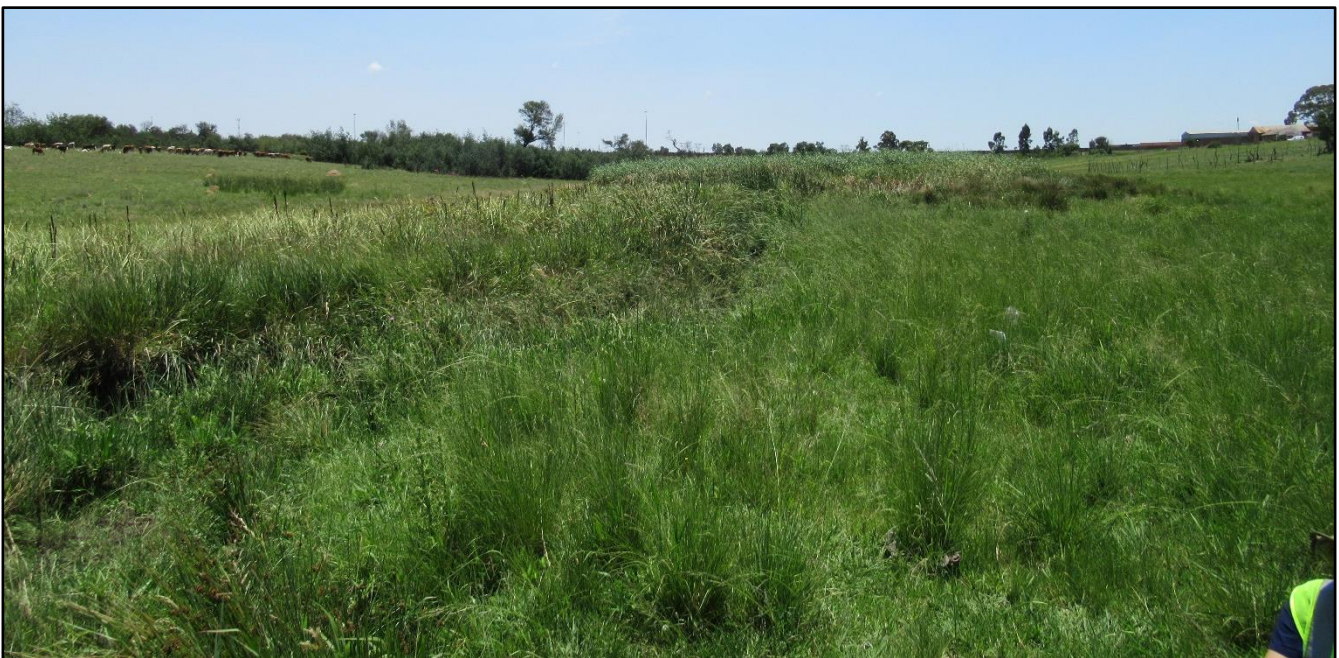
**Figure 30:** Channelled valley bottom wetland (HGM 3).
