Wetland Baseline & Risk Assessment for the Transalloys Solar Photovoltaic (PV) Facility

Emalahleni, Mpumalanga Provinces

August 2022

The Biodiversity Company

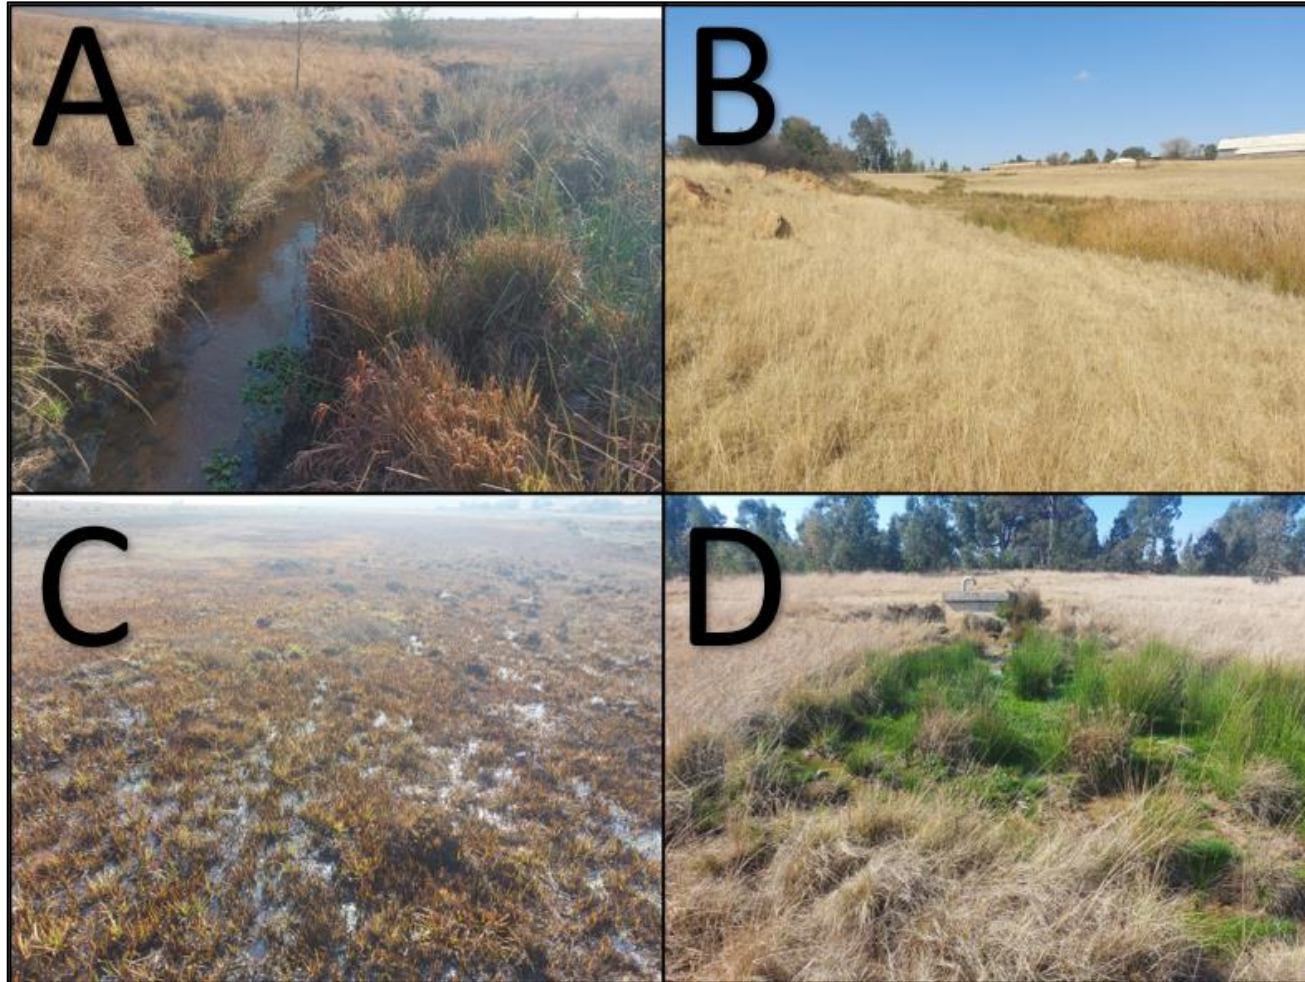
Figure 3-6 *Photographical evidence of the different wet areas found within the 500 m regulated area, A) Channelled valley bottom. B) unchannelled valley bottom wetlands, C) Hillslope Seep, and D) Artificial wetland.*
