PROJECT TITLE

Proposed Establishment of a Cemetery within the Dannhauser Local Municipality, KwaZulu-Natal

1.	TERMS OF AGREEMENT AND SCOPE OF SERVICES	1
2.	CODES OF PRACTICE AND STANDARDS	1
3.	REFERENCED INFORMATION	2
4.	INVESTIGATION ACTIVITIES	2
4.1	TEST PITTING AND PROFILING	3
4.2	DCP TESTING	3
4.3	PERCOLATION TEST	3
5.	DESCRIPTION OF THE STUDY AREA	4
6.	CLIMATIC CONDITIONS	8
7.	GENERAL GEOLOGY	9
7.1	DURNACOL GEOLOGY	10
7.2	TRY AGAIN GEOLOGY	13
8.	GROUNDWATER SEEPAGE IN TEST PITS	15
9.	SOIL LABORATORY RESULTS	15
10.	DISCUSSION	16
10.1	PROPOSED DEVELOPMENT	16
10.2	EXCAVATABILITY FOR THE GRAVE SITES	16
10.3	LEACHATE MIGRATION	17
10.4	BASAL BUFFER ZONE	17
10.5	SOIL WORKABILITY	18
11.	RATING OF CEMETERY SITE	19
11.1	HANBURY AND HALL (1990) AND DIPPENAAR ET AL. (2018)	19
11.2	COUNCIL FOR GEOSCIENCES CEMETERY GUIDELINES	22
12.	CONCLUDING REMARKS	22
13.	REFERENCES	23

This report referenced 066-2133-01.R01 provides the results of the geotechnical and hydrogeological investigation. Included in the report will be recommendations in terms of suitability for use as a cemetery site, aquifer contamination risk.

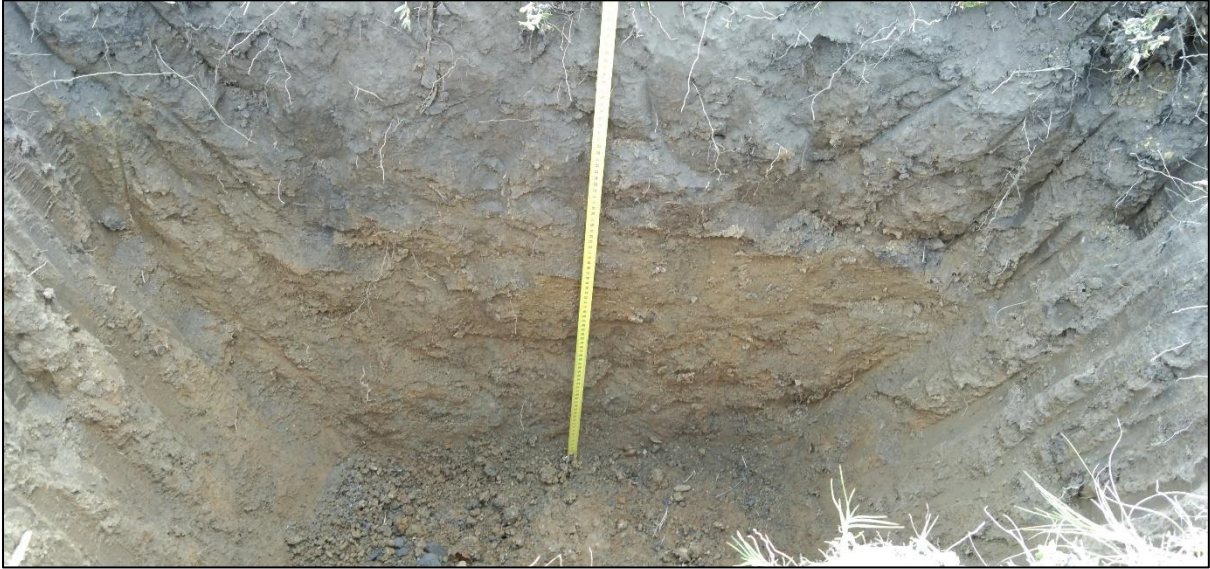
The **colluvial** material can be described as slightly moist, pale brown to light brown, firm, fine grained, silty CLAY with roots and vegetation. The colluvial soils extended to approximate depths in the range 0.5m to 0.7m begl (Refer to test pit profiles for exact depths).

The **residual** material can be described as moist, pale brown to orange, firm, intact, silty CLAY with cobbles and pebbles. The cobbles and pebbles appear to be from dolerite rock. The residual material extended to approximate final depth of 1.9m begl (Refer to test pit profiles for exact depths).

Weathered dolerite rock was only encountered in PN101 from an approximate depth of 1.7m begl. The dolerite rock can be described as brown to pale yellow, completely to highly weathered, fine to medium grained, highly fractured, soft rock.

Photograph 4: Material Encountered in TP101

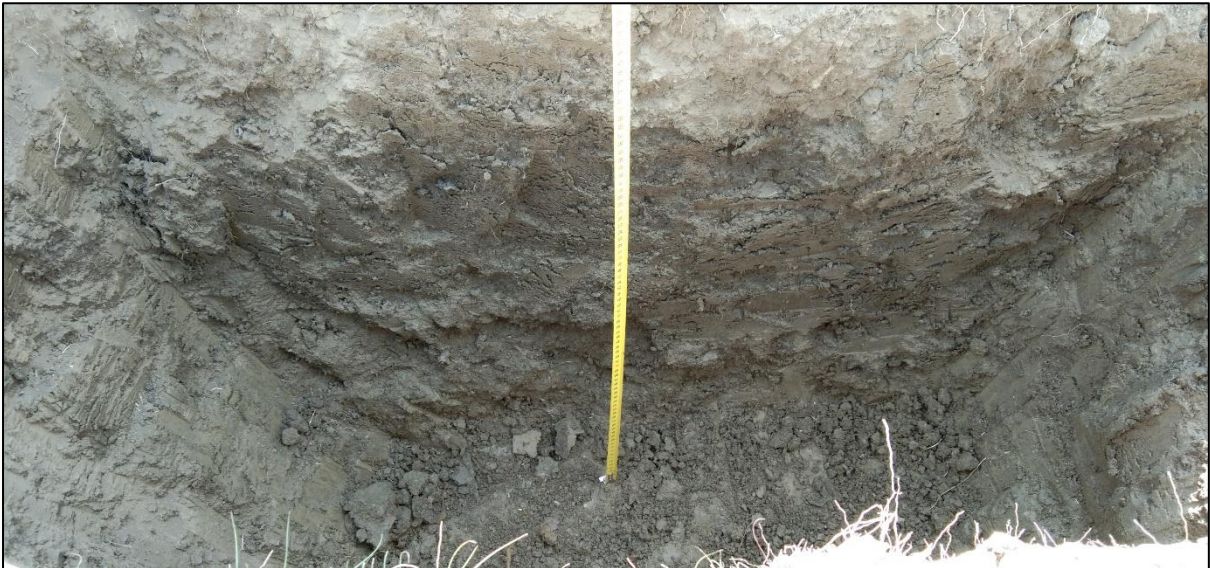
Photograph 5: Material Encountered in TP103

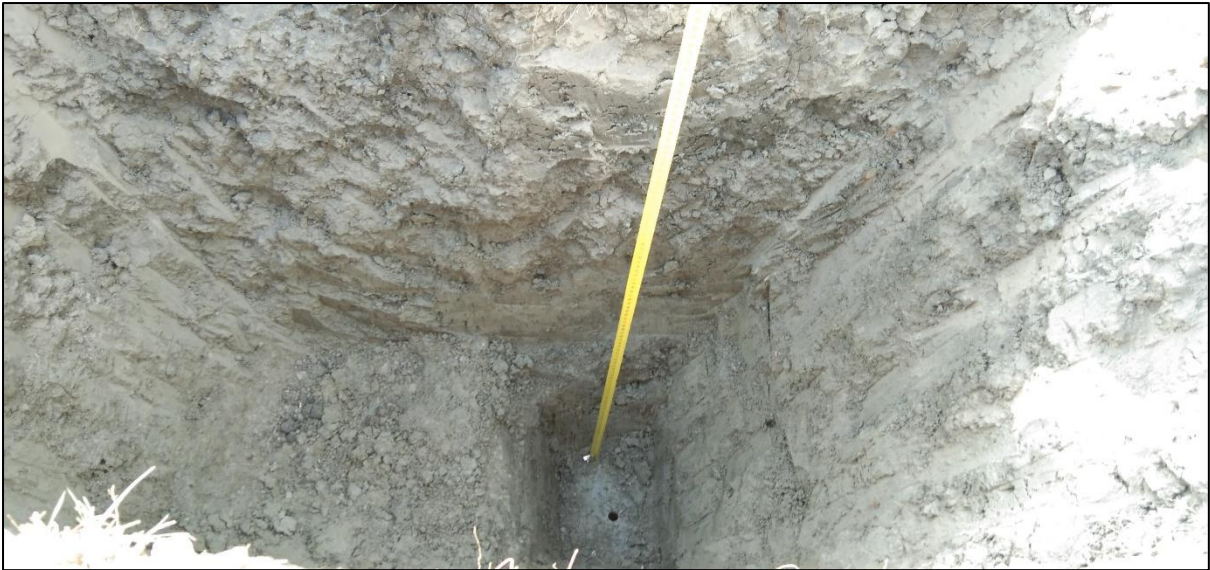
Photograph 6: Material Encountered in TP105

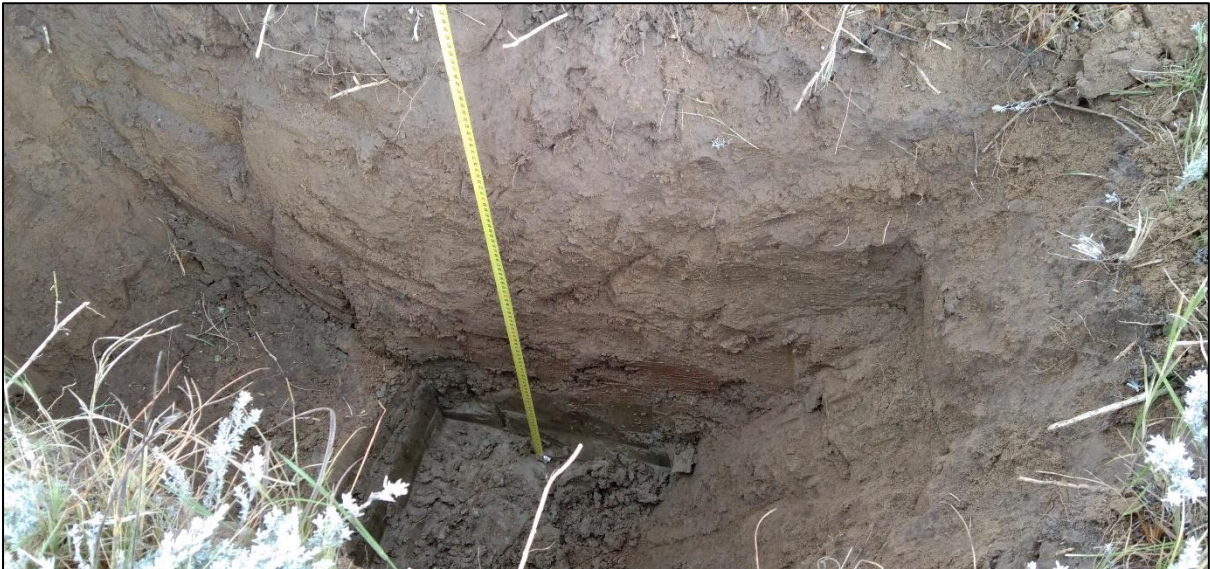
The **colluvial** material can be described as slightly moist, pale brown to light brown, firm, fine grained, silty CLAY with roots and vegetation. The colluvial soils extended to approximate depths in the range 0.5m to 0.7m begl (Refer to test pit profiles for exact depths).

The **residual** material can be described as moist, pale brown to orange, firm, intact, silty CLAY with cobbles and pebbles. The cobbles and pebbles appear to be from dolerite rock. The residual material extended to approximate final depth of 1.8m begl (Refer to test pit profiles for exact depths).

Photograph 7: Material Encountered in TP203

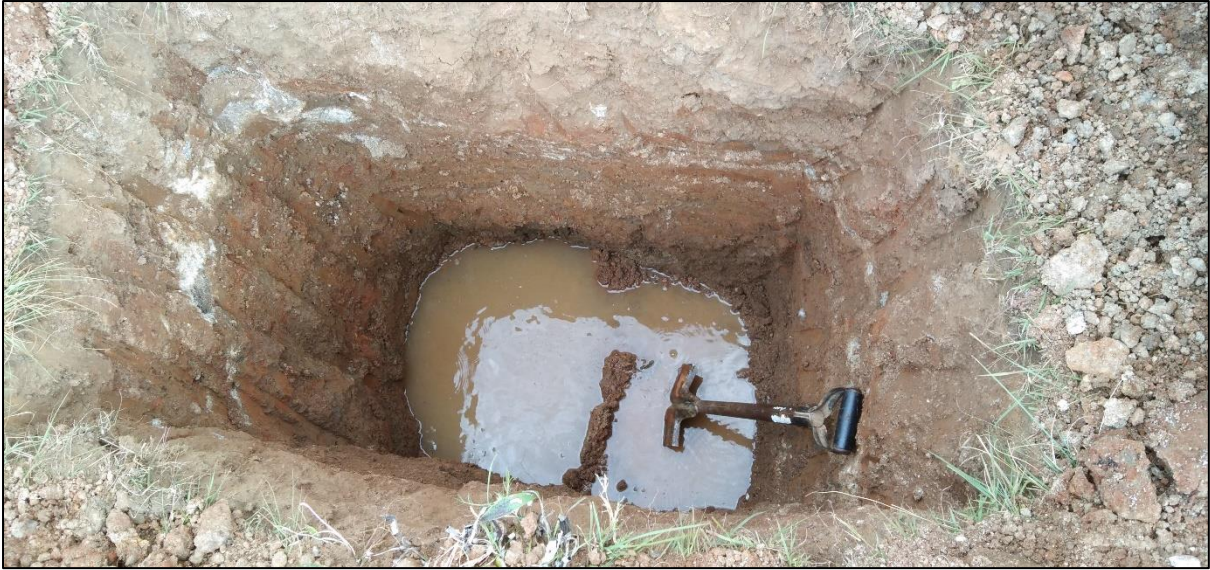
Photograph 8: Water Seepage and Material Encountered in TP205

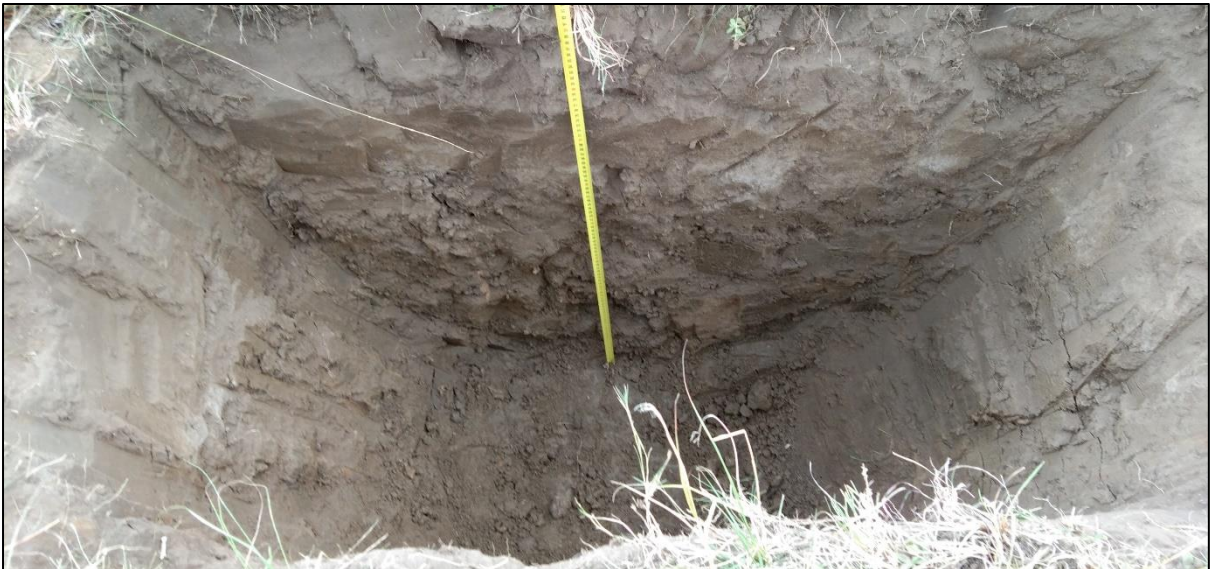
Photograph 9: Material Encountered in TP207

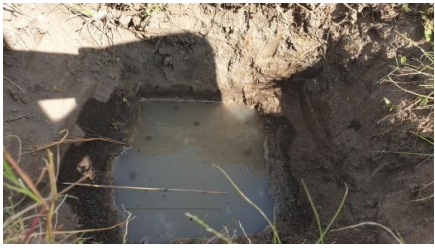
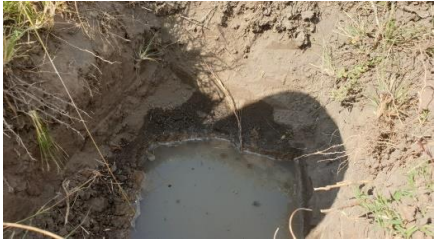
PROFILE NUMBER - Percolation Test P101

Percolation Test Drop After 2 Hours of Soaking - 119mm/11.9cm

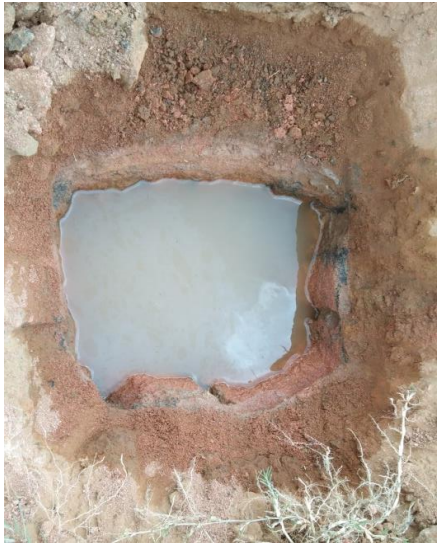
PROFILE NUMBER - Percolation Test P201

Percolation Test Drop After 2 Hours of Soaking - 96mm/9.6cm

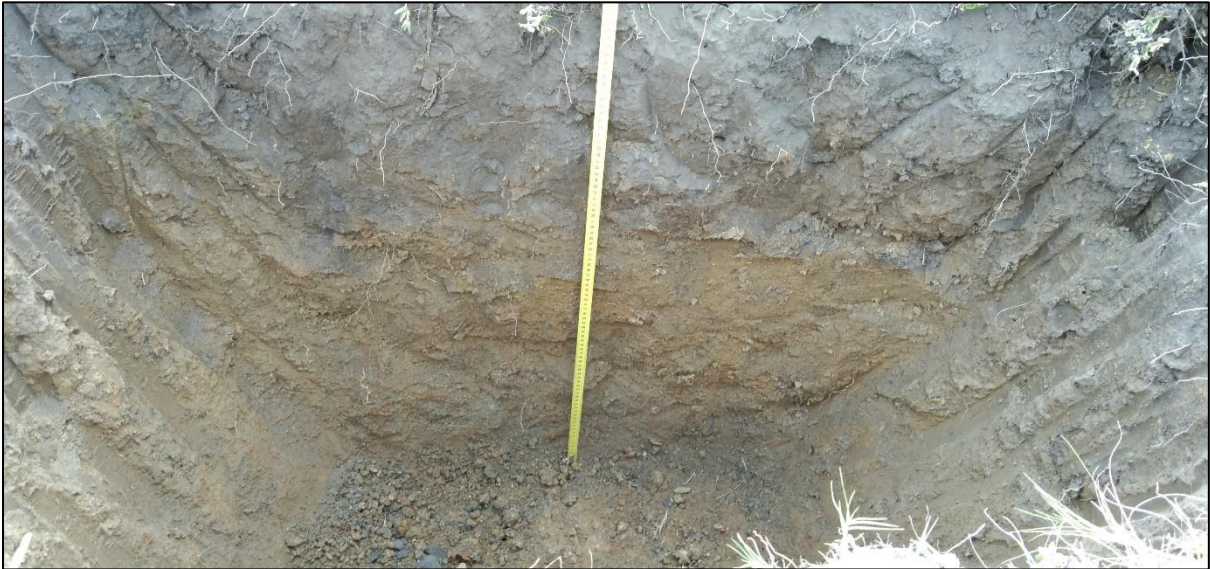
Photograph 4: Material Encountered in TP101

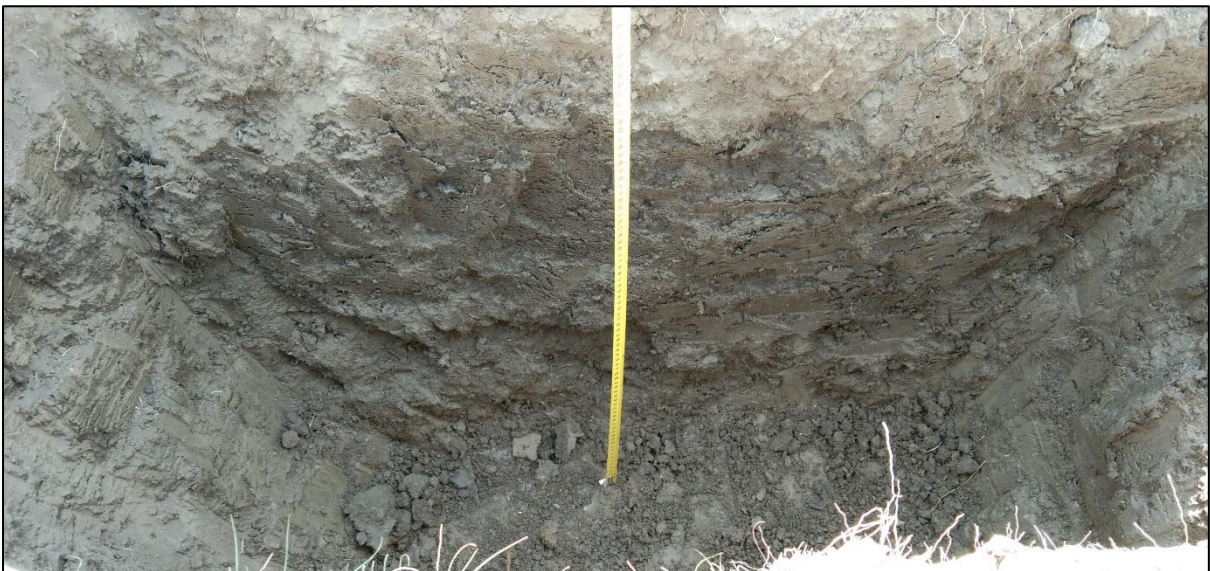
Photograph 5: Material Encountered in TP103

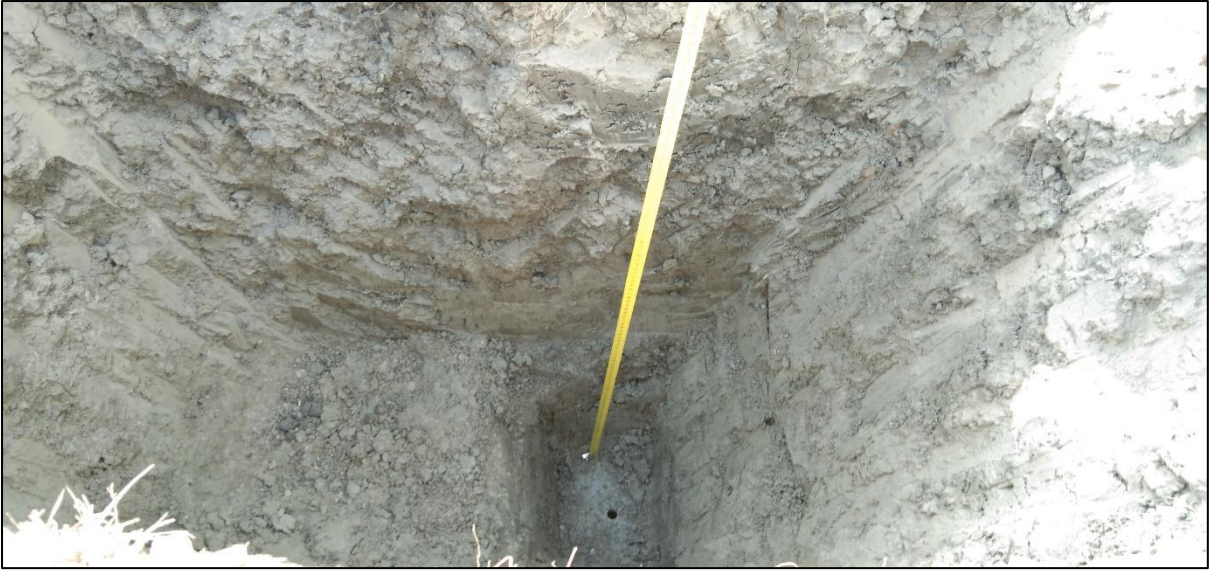
Photograph 6: Material Encountered in TP105

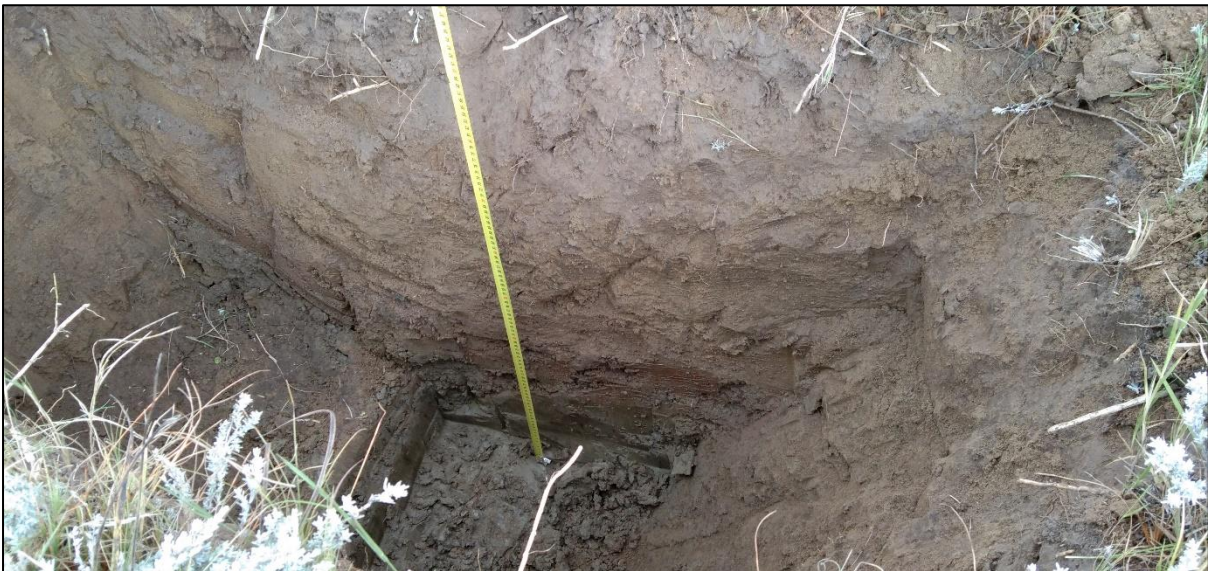
Photograph 7: Material Encountered in TP203

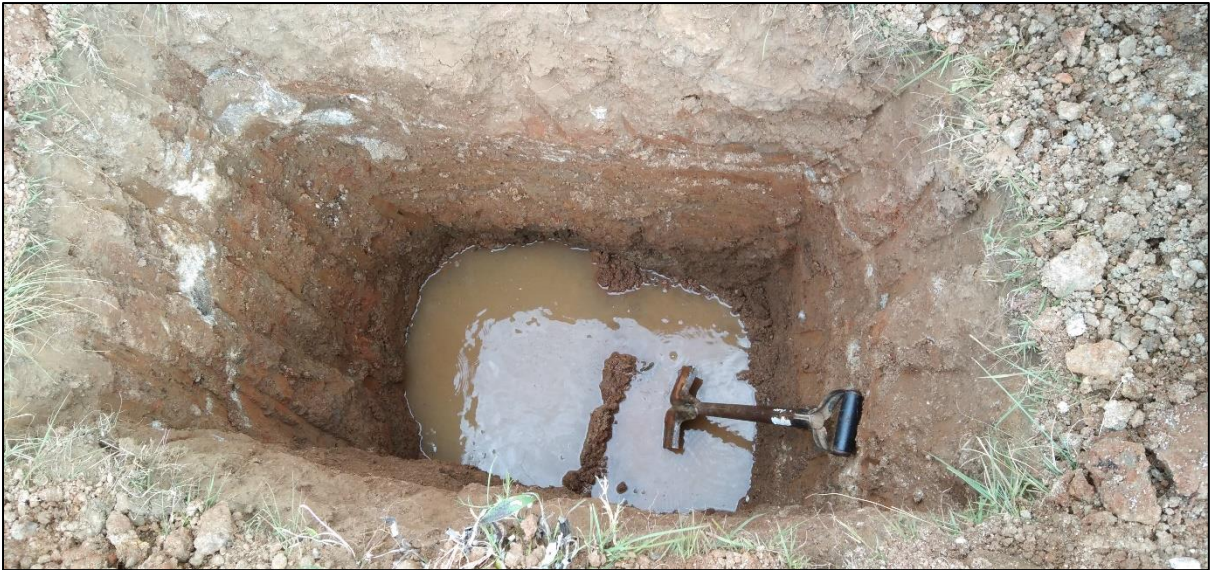
Photograph 8: Water Seepage and Material Encountered in TP205

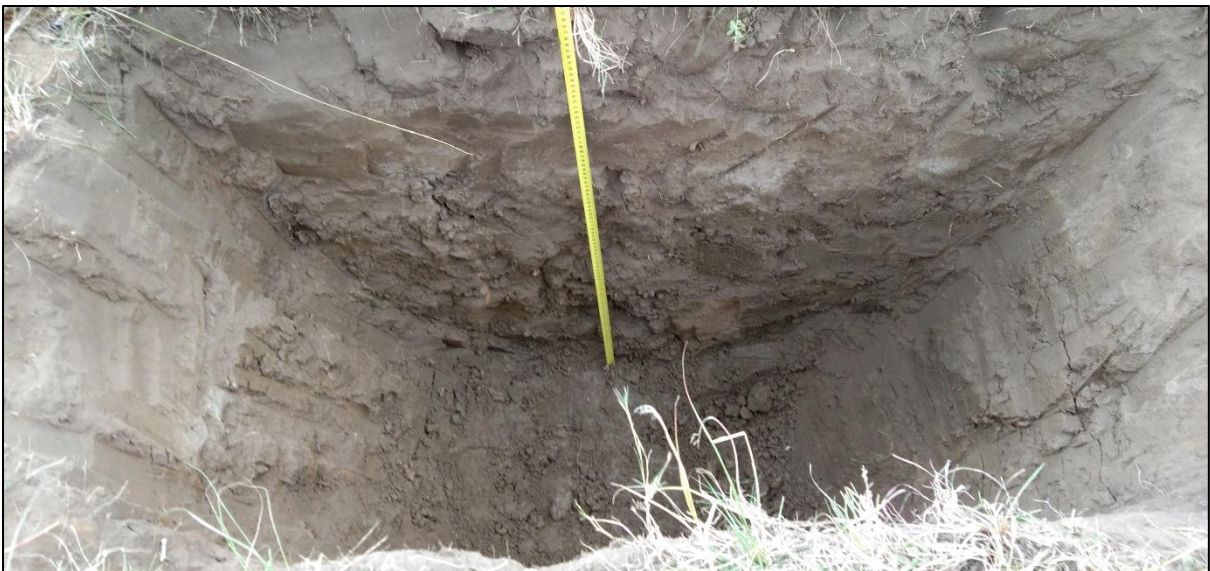
Photograph 9: Material Encountered in TP207

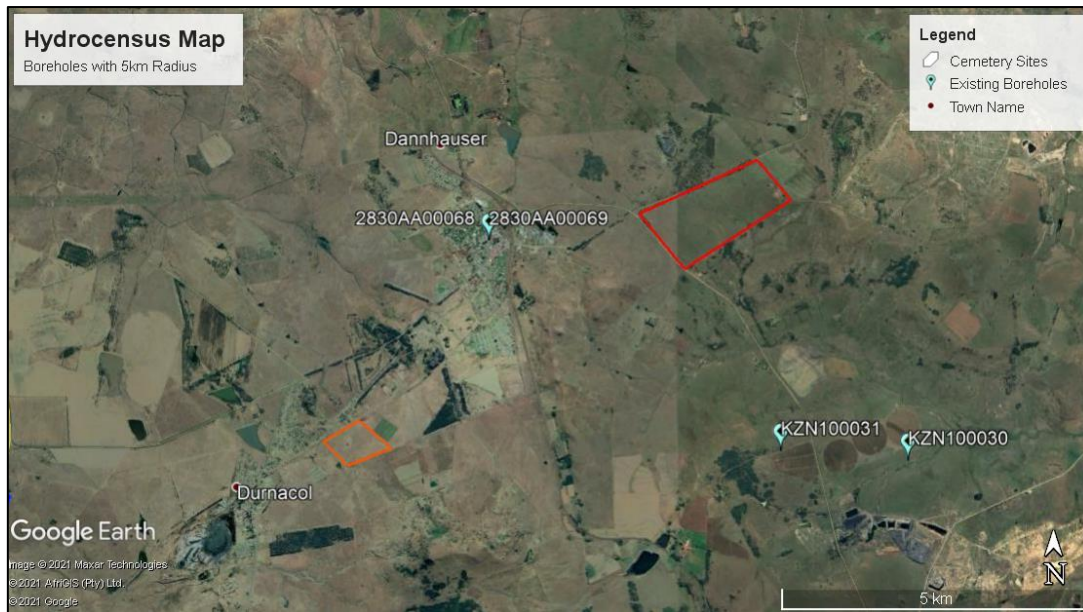
Figure 10: Hydrocensus within a 5km radius

Durnacol Site and Try Again Site with 4km to 5km Radius					
Borehole ID	Latitude	Longitude	Water level (m begl)	Depth of BH (m begl)	Water Strike Depth (m begl)
2830AA00069	-28.01407	30.05808	15.24	92.65	82.29
2830AA00068	-28.01406	30.05807	60.96	104.85	66.14
KZN100030	-28.04613	30.12727	0.15	51.00	
KZN100031	-28.04468	30.10614	16.50	52.00
