SAVANNAH ENVIRONMENTAL

SOIL AND AGRICULTURAL POTENTIAL INFORMATION FOR THE PROPOSED PAULPUTS CSP PROJECT, NEAR POFADDER, NORTHERN CAPE

Report Number GW/A/2016/11

April 2016

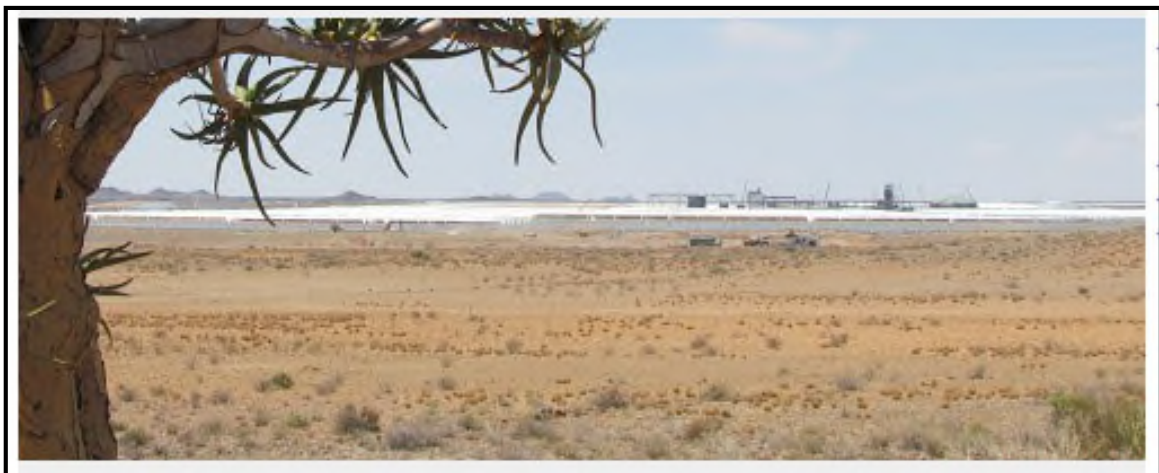
Figure 2 Natural vegetation in study area

The photo above shows clearly the sparse nature of the vegetation present in the vicinity of the proposed project. The climatic restrictions mean that this part of the Northern Cape is suited at best for grazing and here the grazing capacity is very low, around 40-50 ha/large stock unit.

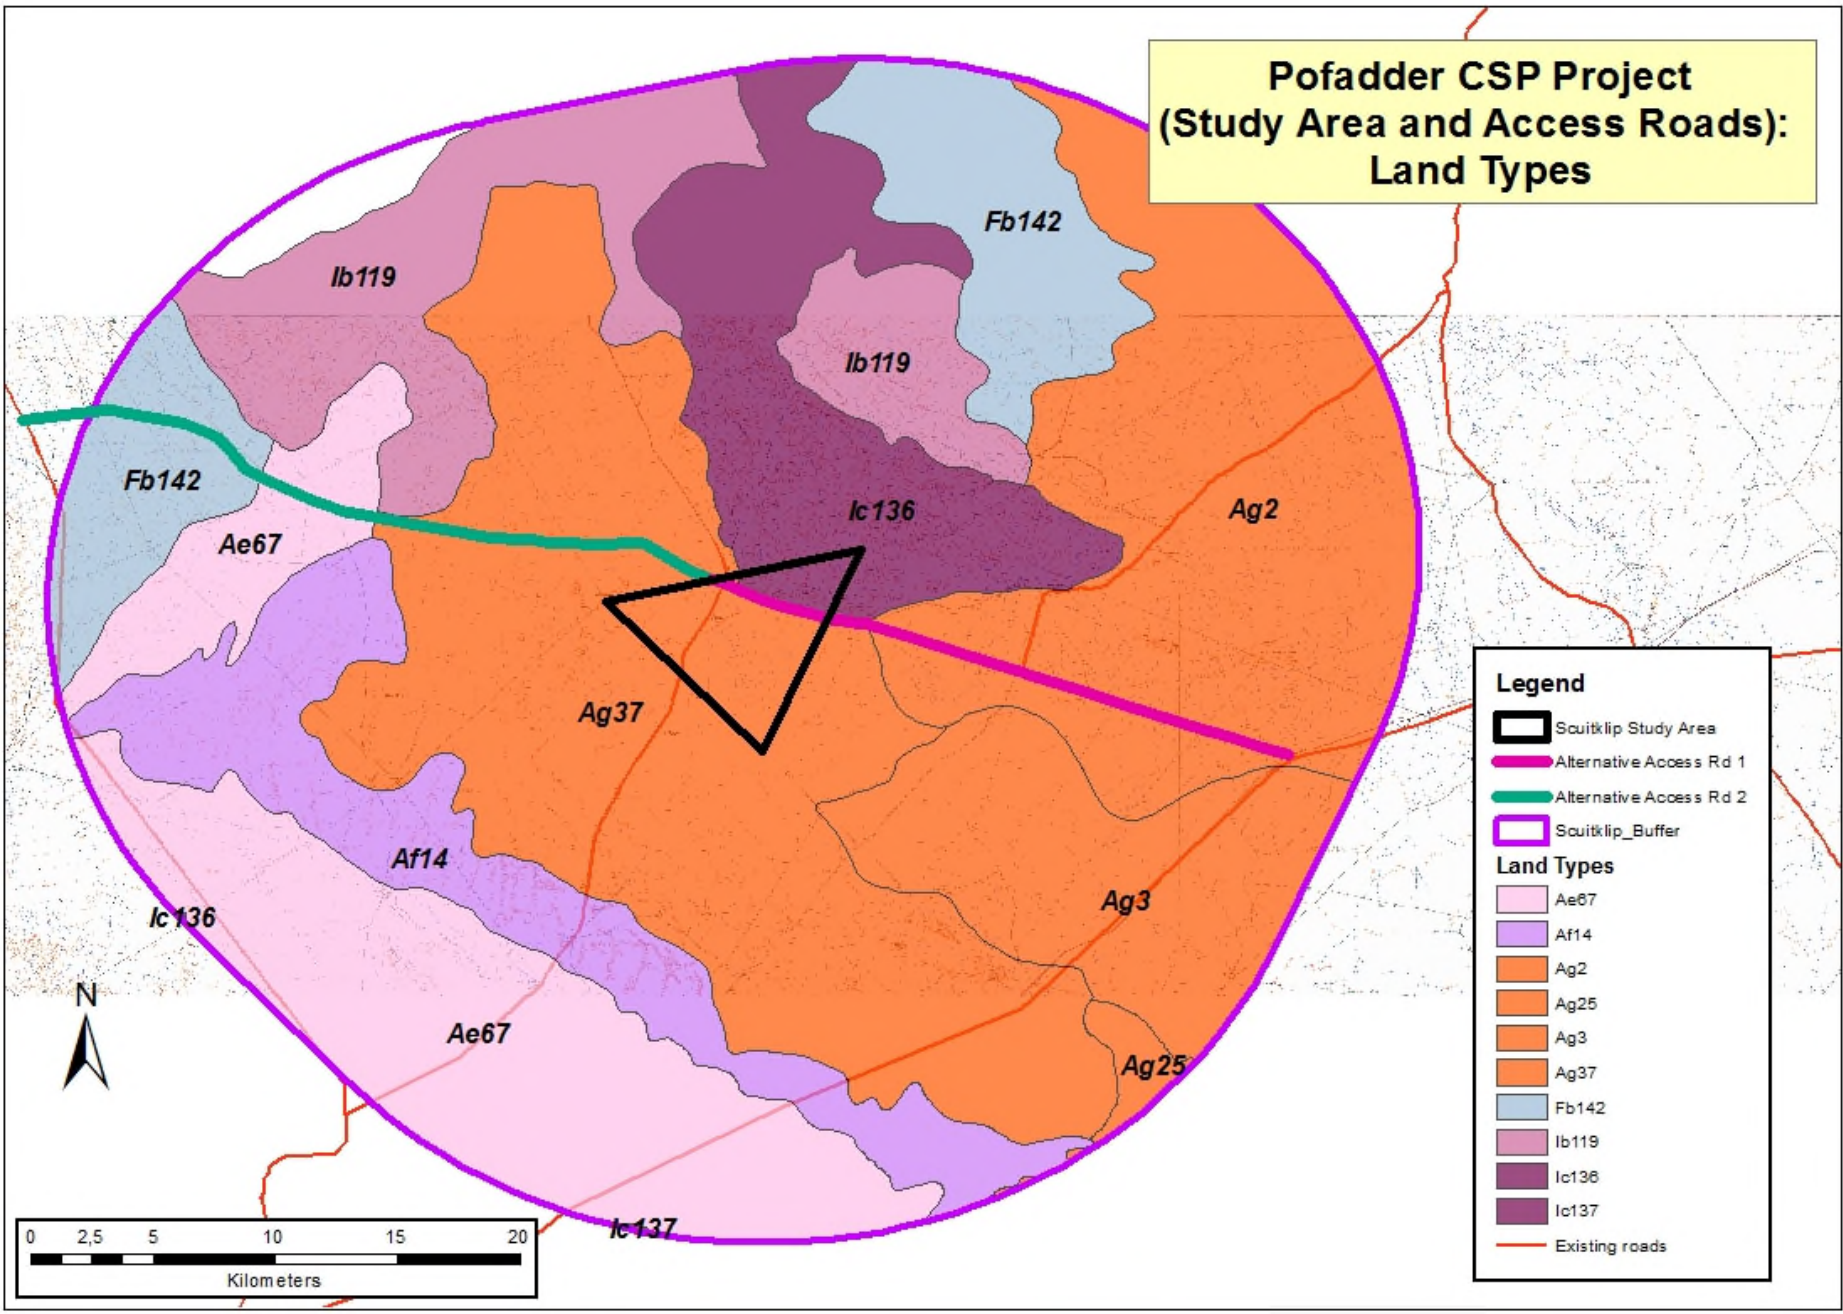
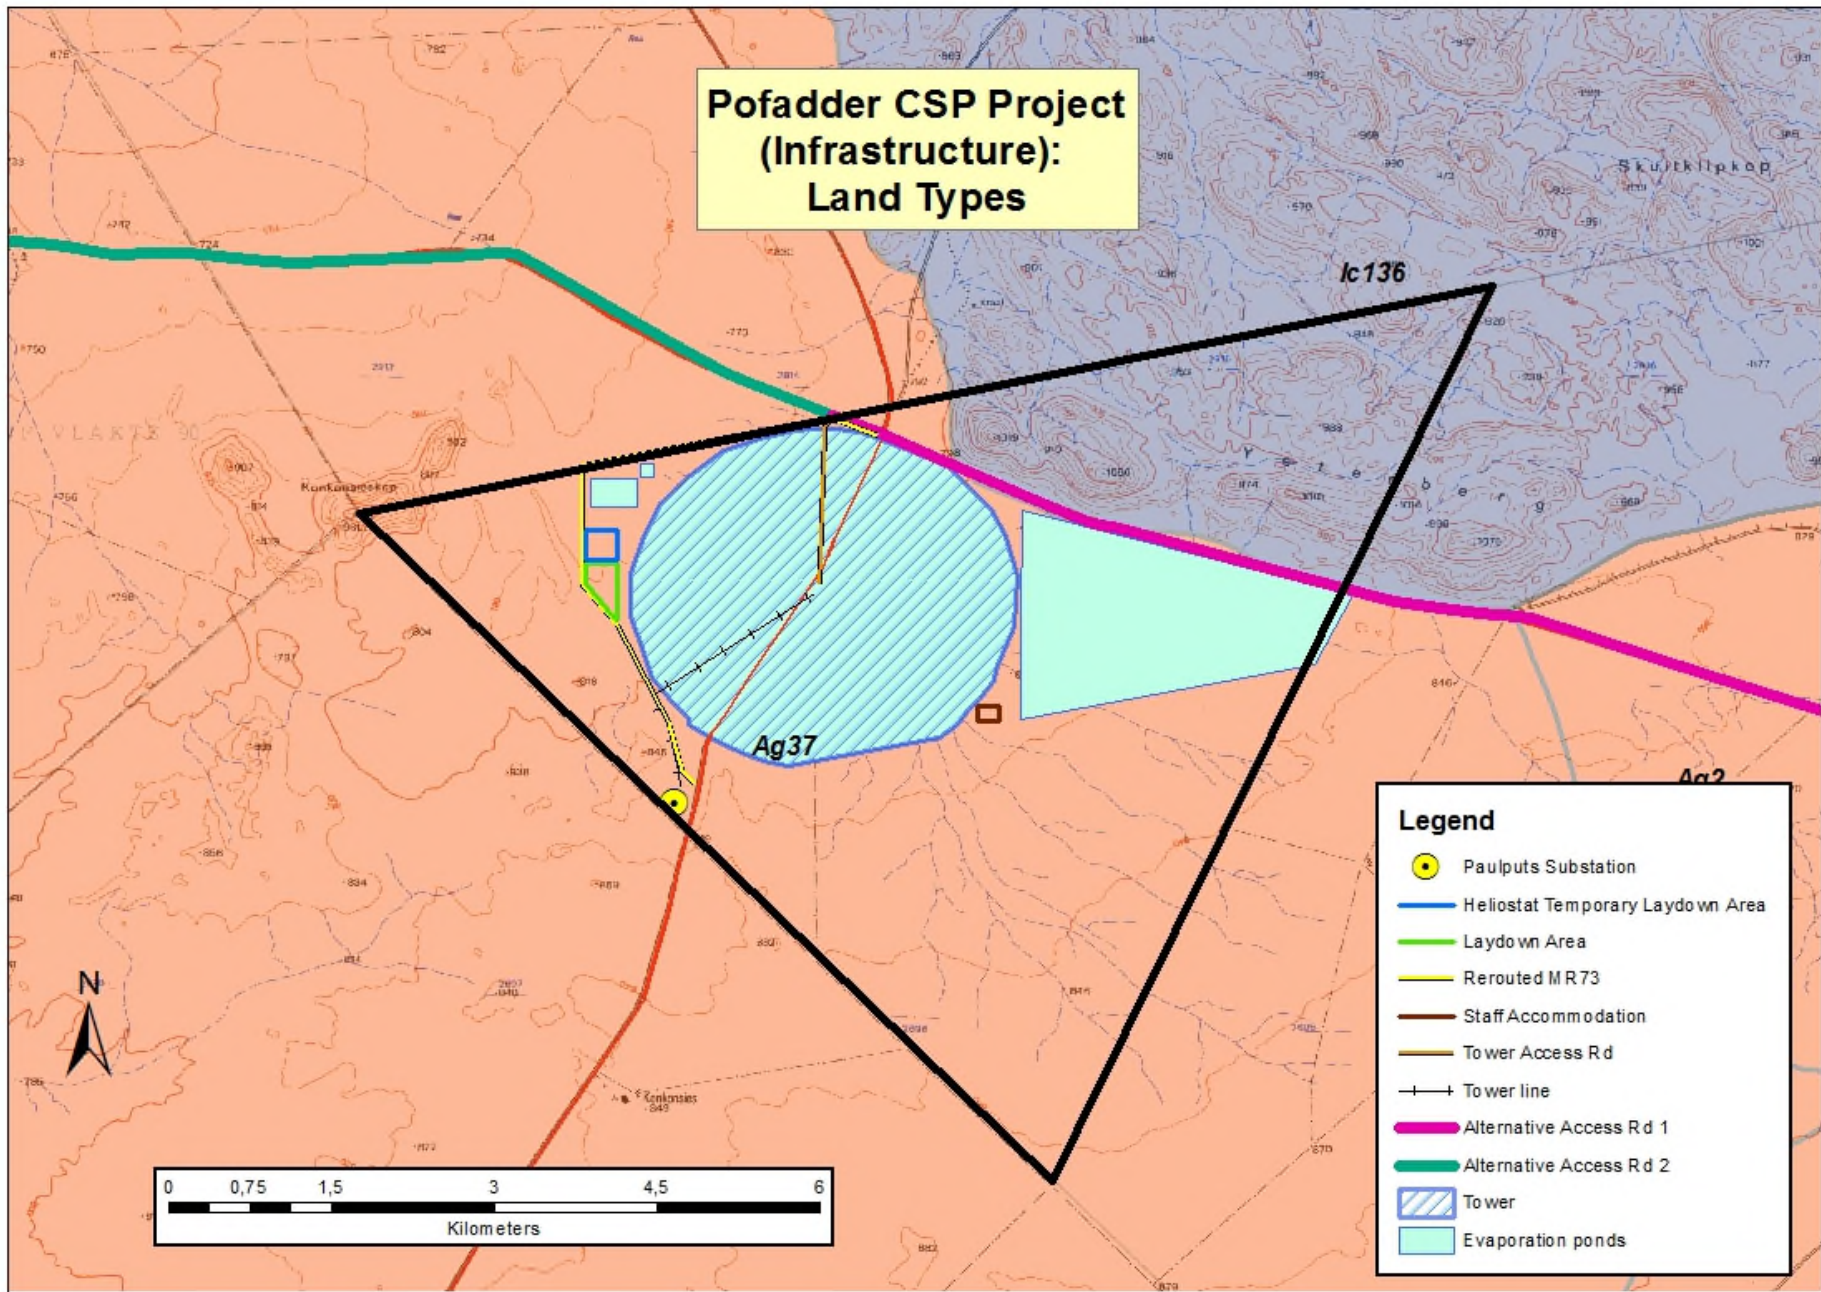
**Pofadder CSP Project
(Study Area and Access Roads):
Land Types**

Within a broad 20 km buffer area, the area under investigation (namely the Scuitklip study area and the two access road alternatives) is covered by only five land types, as shown on the map in the Appendix, namely:

- **Ae67** (Red, freely-drained soils, high base status)
- **Ag2, Ag37** (Shallow, red, freely-drained soils, high base status)
- **Fb142** (Shallow lithosols and rock, mostly calcareous)
- **Ic136** (Mostly rock, little soil)

A summary of the dominant soil characteristics of each land type is given in Table 2 below (the colours correspond to those used in the map in the Appendix).
