Impumelelo Wind Energy Facility Geotechnical Desktop Assessment

Enertrag South Africa (Pty) Ltd

WSP Group Africa (Pty) Ltd

41104073-REV1

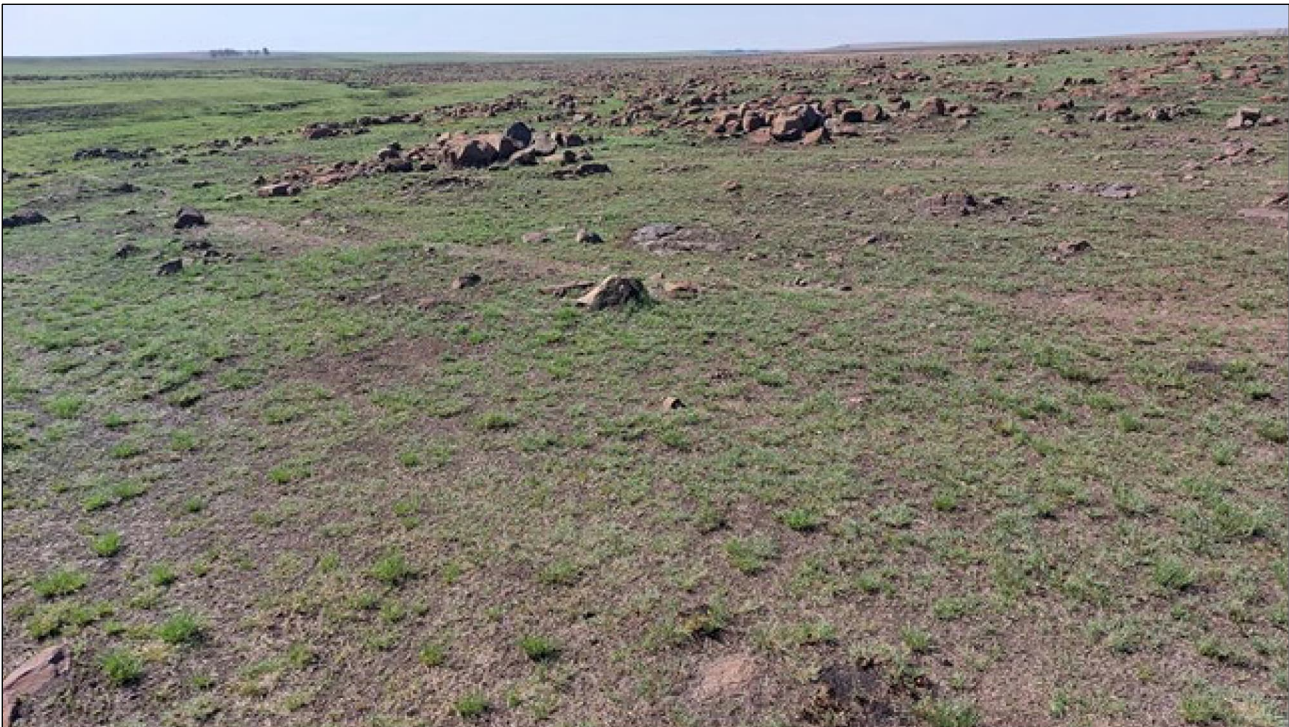
Figure 7: Shallow and surface dolerite on site

Residual doleritic clay is generally compressible and potentially expansive in the “medium to high” range. Where any structure straddles residual dolerite and a different soil type, the structure should be moved to avoid differential settlement or designed accordingly.

Dolerite rock, cobbles, boulders, gravel and sand are generally durable and are suitable for a variety of purposes. The material is commonly quarried and used as a construction material for use as concrete aggregate and road construction materials.
