# WATERCOURSE & AQUATIC ASSESSMENT

FOR THE PROPOSED EXTENSION OF THE SDANGENI ACCESS ROAD, DR  
NKOSAZANA DLAMINI ZUMA LOCAL MUNICIPALITY, SISONKE DISTRICT  
MUNICIPALITY, KWAZULU-NATAL

**DECEMBER 2020  
DRAFT REPORT**

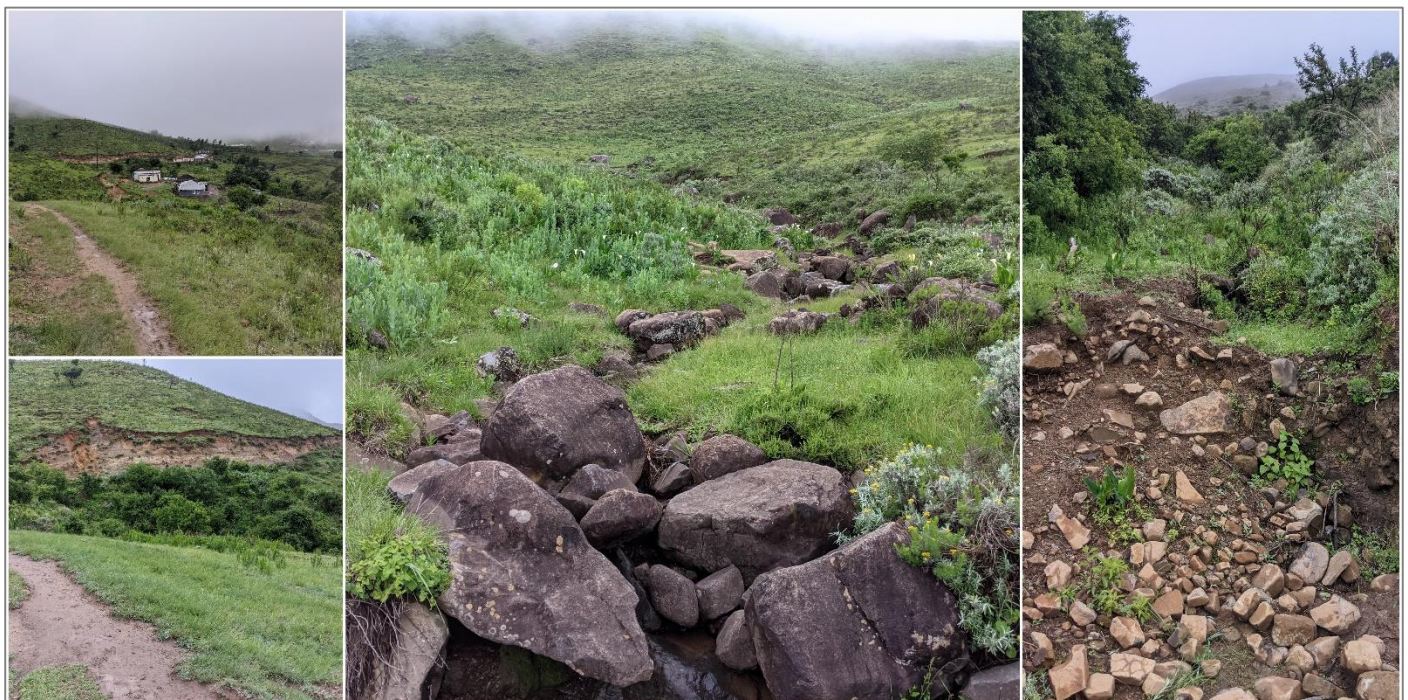
Figure 1 General setting of the road extension site

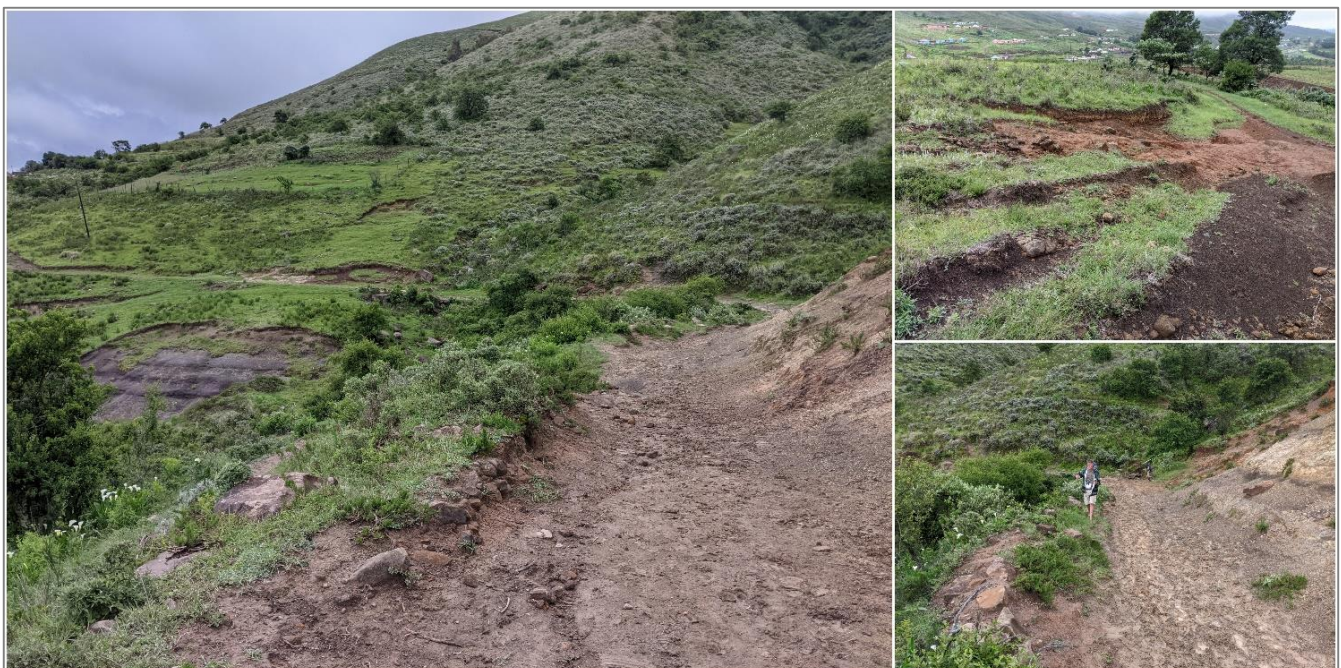
Figure 3 The site along the proposed road area

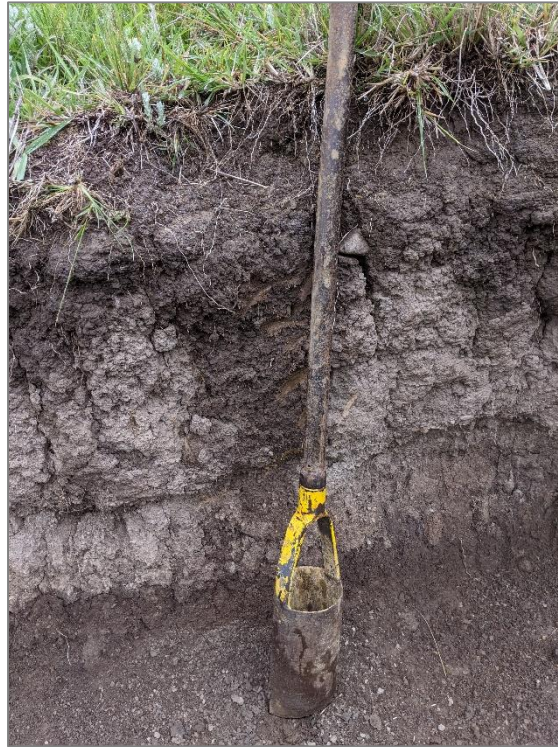
Figure 6 Soil sampling undertaken at the site

An example of the soil sampling approach is provided in Figure 6.

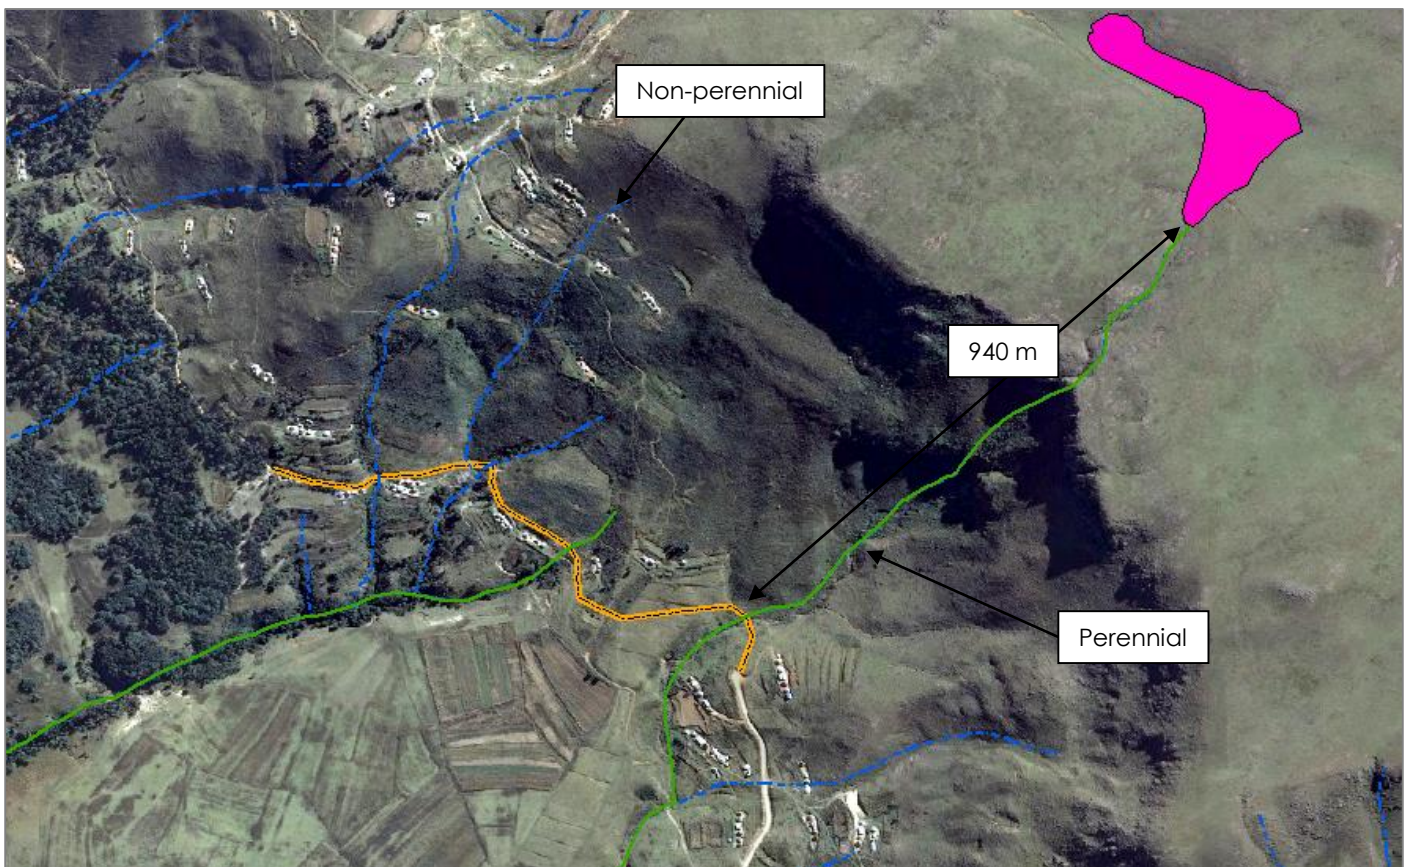
Figure 7 NFEPA wetlands (pink) within proximity to the Sdangeni road upgrade

FEPA wetlands were not identified within 500m of the study site. The nearest is a natural flat/bench wetland approximately 940 meters from the road. The layer codes for River FEPAs and associated sub-quaternary catchments, Fish Support Areas and associated sub-quaternary catchments and Upstream Management Areas.

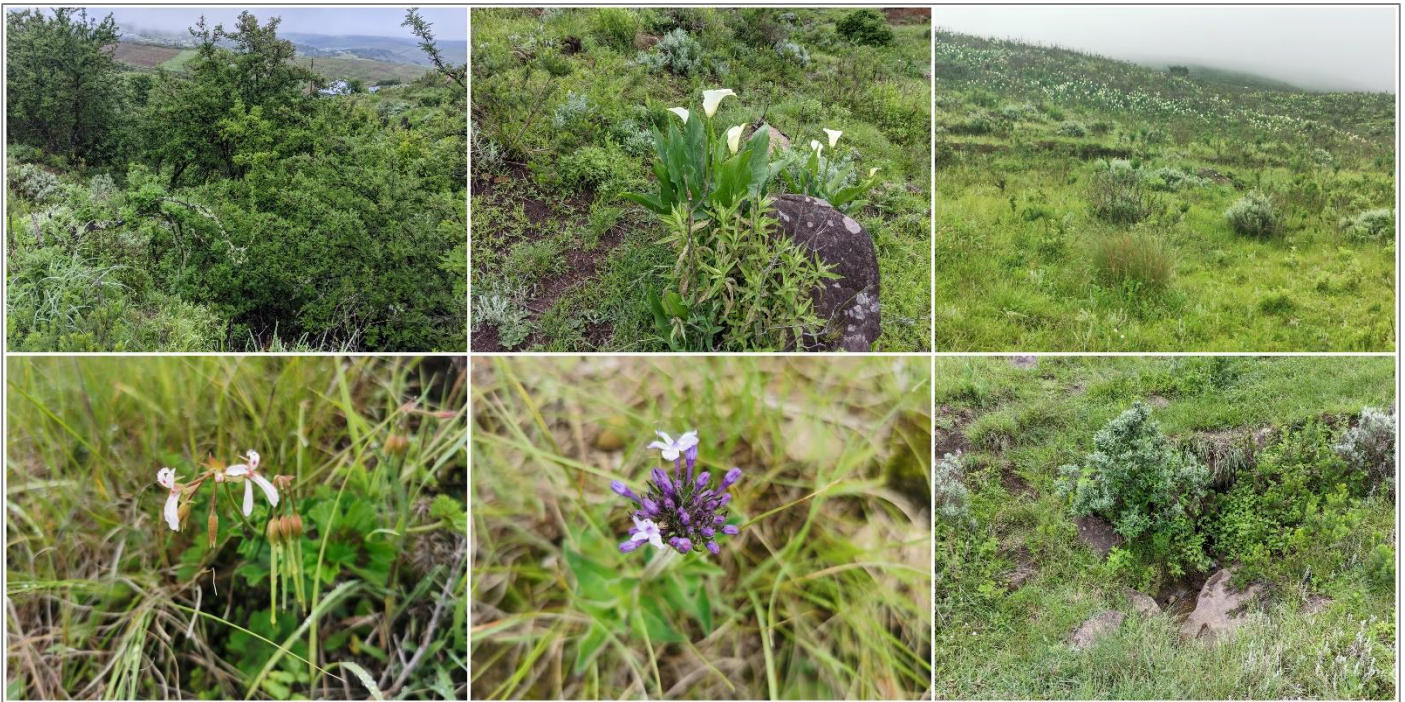
The dominant species in the riparian areas were mostly indigenous sedge with *Haleria lucida*, *Buddleja auriculata* and *Leucosidea sericea* being prevalent in patches along the drainage line. Severe erosion was observed on site, the site is at risk of future erosion due to the slope and recently transformed state. This ecosystem may hold some key species. The existing watercourse has been impacted upon by the settlement and changes in the hydrological regime have occurred.

Figure 10 Typical vegetation around the site

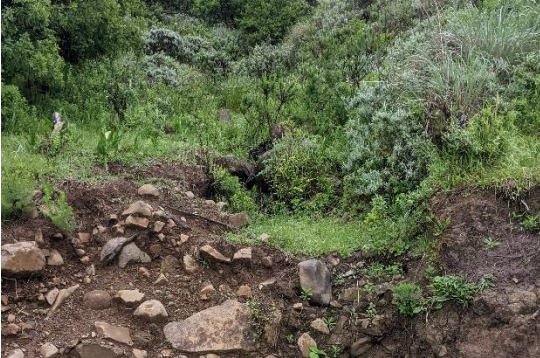
Feature	Wetland/Riparian/Artificial	Description & Vegetation	Soil Characteristics	On-site images
Drainage Line (HGM 1)	Riparian (non-perennial)	Banks of the Isongweni tributary. Dominated by small indigenous woody species. Evidence of erosion along crossing areas.	Main channel: Gray (Gleyed) Depth sampled: 0-0.2m Yellow-brown a-pedal soils Very little topsoil remaining

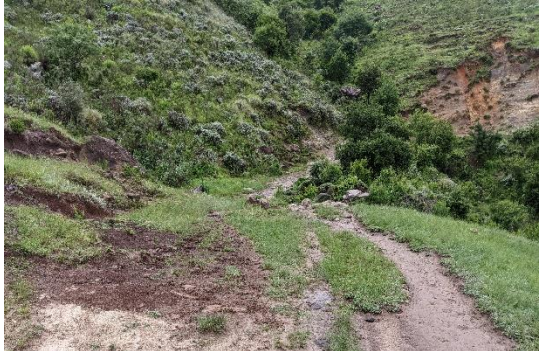
Drainage Line (HGM 2)	Riparian (non-perennial)	Banks of the Isongweni tributary. Dominated by small indigenous woody and grass species. Slight evidence of erosion along crossing areas.	Mottle % - 2-5% Hue – 7.5YR Value – 5 Chroma – 1 (Dark Gray) Depth sampled: 0-0.2m Organic matter content in the upper layer

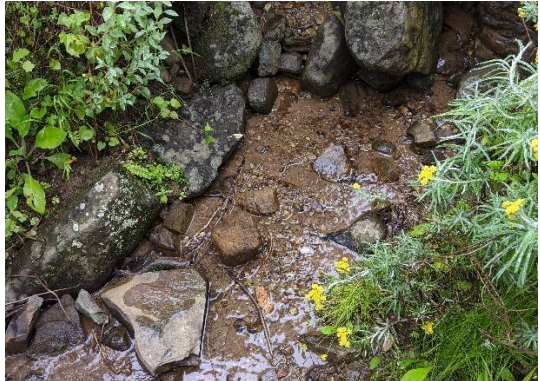
Drainage Line (HGM 3)	Riparian (perennial)	Banks of the Isongweni tributary. Dominated by larger indigenous woody species. Evidence of erosion along crossing area edges.	Main channel: Rocky, unable to sample soil.  Continual flow and aquatic life present

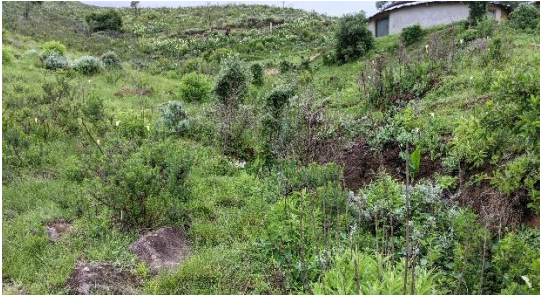
Drainage Line (HGM 4)	Riparian (non-perennial)	Banks of the Isongweni tributary. Dominated by small indigenous woody species. Evidence of erosion along crossing areas.	Main channel: Gray (Gleyed) Depth sampled: 0-0.2m Yellow-brown a-pedal soils Very little topsoil remaining

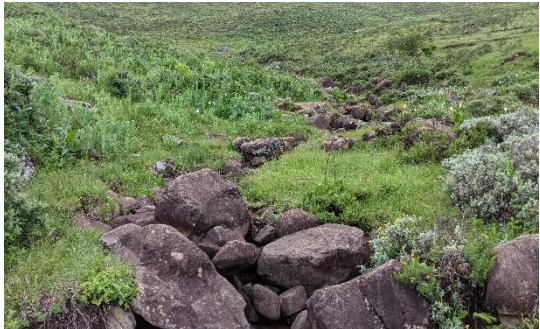
Drainage Line (HGM 5)	Riparian (perennial)	Banks of the Isongweni tributary. Dominated by small forb and grass species. This channel is in pristine condition.	Main channel: Rocky, unable to sample soil.  Continual flow and aquatic life present

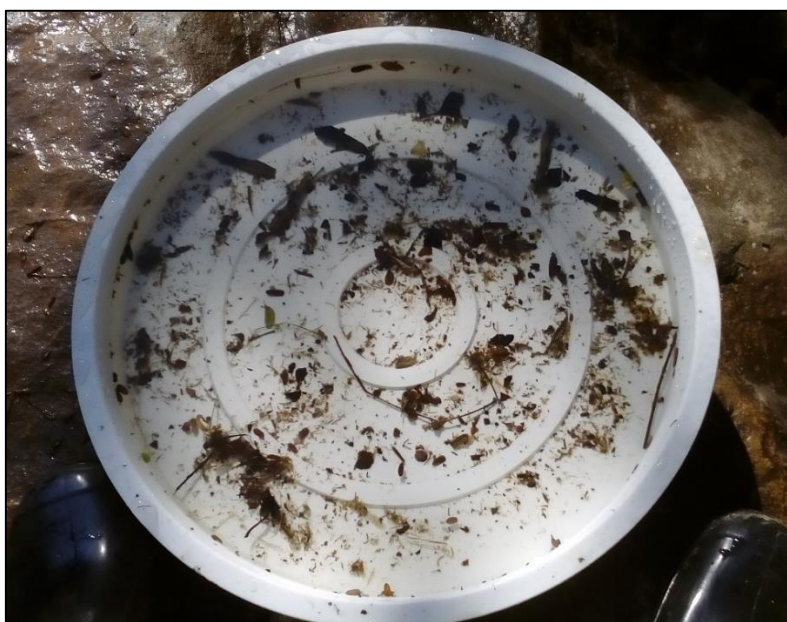
Figure 12 Sample container used to assist in identifying invertebrates

The sampling sites were located adjacent to gravel road, which is situated within low income rural area. The site was largely natural with very few observations of organic waste material / pollution on site and is currently not imposing noticeable impacts on the aquatic macro-invertebrates inhabiting the watercourse. The natural state of the watercourses is further evident with the watercourses being used for potable water, which is supported by the results of the MiniSASS assessment. Figure 12 provides an example of a typical MiniSASS sample, which was collected from all available biotopes from the stream on site. An example of the scores expected for each ecological condition, depending on the type of stream or river, is provided in Table 16. This table is used for interpreting MiniSASS data to determine the natural / modified state of the assessed watercourse in terms of their ecological health category.

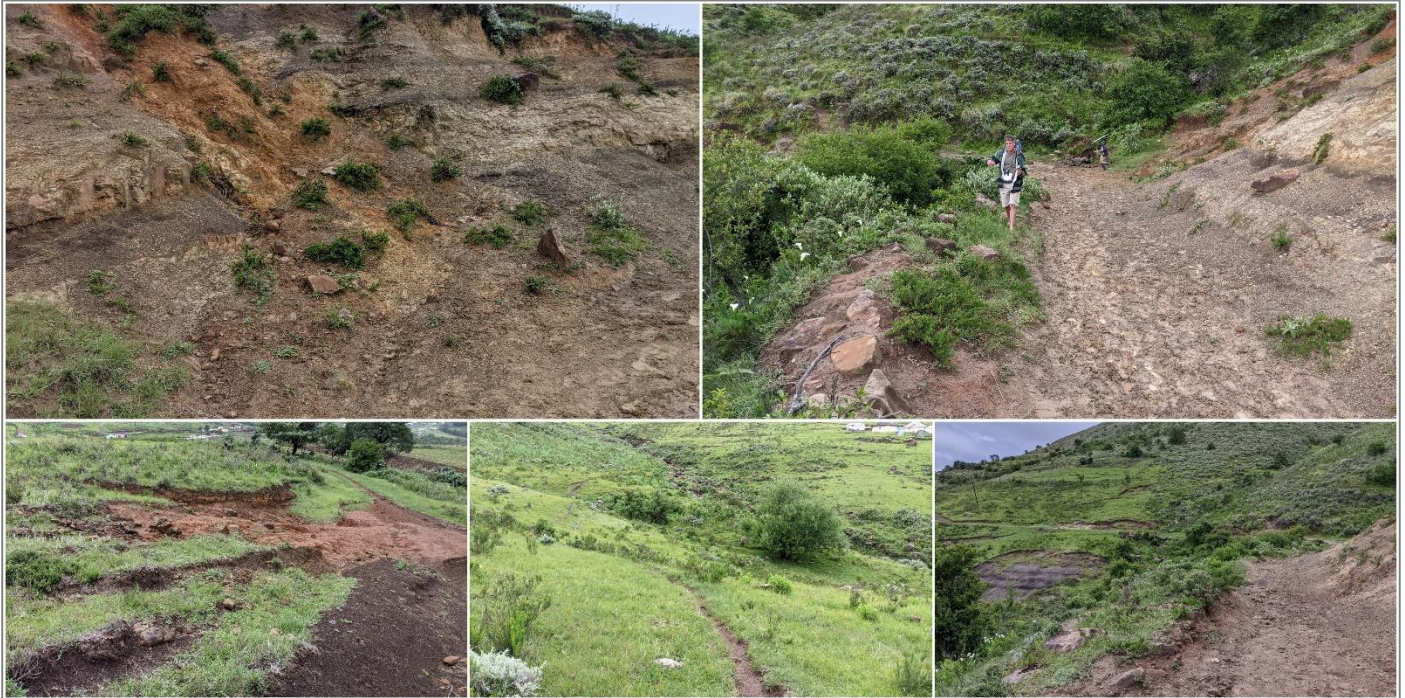
The site is in a visibly modified condition due to erosion concerns. The primary surrounding impacts are settlement encroachment and erosion. However, the riparian and wetlands systems are still intact and the households are situated away from these systems. The site was historically partially cultivated for many years. However, the wetland on site is performing much needed services to the downstream area and provide a habitat for important species.

Figure 13 Erosion present along the proposed road extension

It is recommended that the contractor stabilize banks where erosion has already occurred.
