RE: DFFE Pre-application meeting - Casteel Dam Safety Rehabilitation Project

BASIC ASSESSMENT (BA) PROCESS – DFFE PRE-APPLICATION MEETING MINUTES			
Project name	Casteel Dam Safety Rehabilitation Project		
Date & Time Meeting	25 August 2022, 09:30 – 10:20 am		
Description	DFFE pre-application meeting		
Venue	Virtual - MS Teams		
Chairperson	Marissa Botha, Naledzi Environmental Consultants (Pty) Ltd

PROPOSED CASTEEL DAM SAFETY REHABILITATION PROJECT,
FARM KASTEEL 231-JU, CASTEEL, BUSHBUCKRIDGE LOCAL
MUNICIPALITY, EHLANZENI DISTRICT, MPU

DEFF PRE-APPLICATION REFERENCE NO. 2022-08-0009

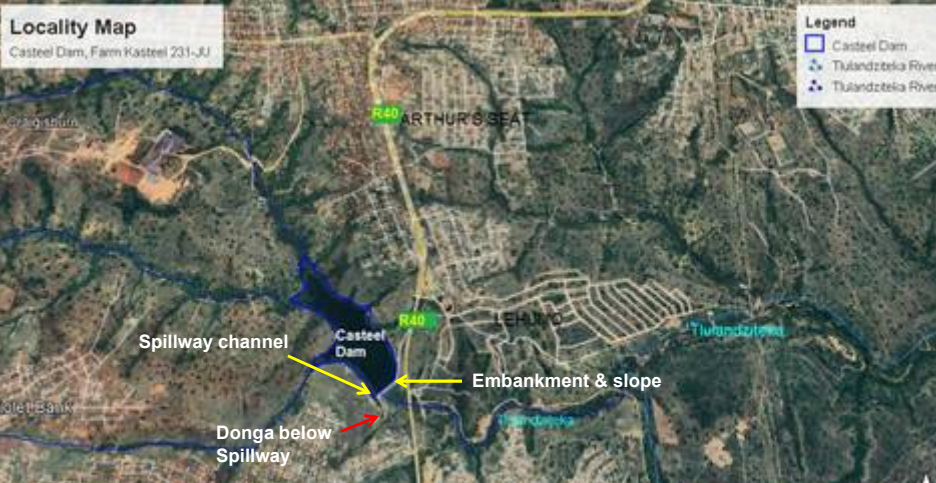
Locality Map
Casteel Dam, Farm Kasteel 231-JU

Casteel Dam	Description
Type	Medium-sized earth-fill embankment dam (Cat. II Significant Hazard Potential)
Capacity	1.18 million m3
Surface Area	16 Ha (Dam wall height 16.6m; Crest of 255m in length)
Spillway	Sharp Crested weir on right flank and outlet works (125m3/s)
Purpose	Built in 1965 to supply irrigation water to the rural community

2.2	<p>Casteel Dam is a medium-sized earth fill-embankment dam located on the Tlulanziteka River in the jurisdiction of Bushbuckridge Local Municipality 15 km north of Bushbuckridge on the farm Kasteel 231-JU between the settlements of Casteel and Arthur’s Seat next to the R 40 Bushbuckridge-Acornhoek road.</p> <p>The dam is located within the Sand River Catchment. It has a capacity of 1.18 million m³ and a surface area of 16 ha. It was built in 1965 to supply irrigation water to the rural community.</p>	
3	Scope of Works	Action

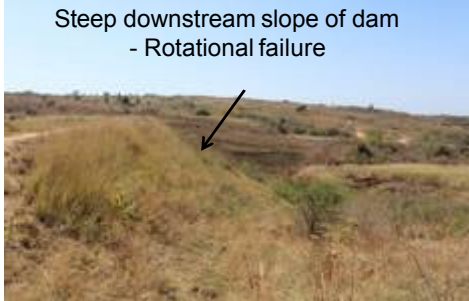
Steep downstream slope of dam
- Rotational failure

- Refurbish dam outlet works
 - Stabilise the downstream slope by flatting it
 - (i.e. add earthfill and gravel layer to downstream slope, widen embankment crest by 1m)

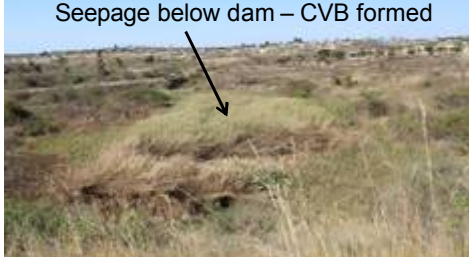
Seepage below dam – CVB formed

- (1) **28 500 m2 rehabilitation works @ main dam embankment and spillway i.e. Construct**
 - Chimney and Toe drains to intercept seepage from the dam wall (incl. collector pipes)

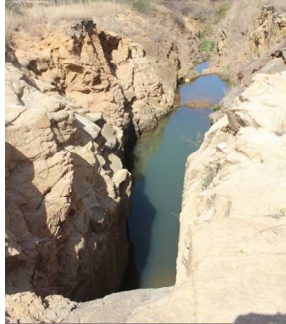
Large donga below spillway

- Slope Spillway channel to (right and left flank) to 1: 0.75
 - Line spillway using Amoflex / Geocell (erosion protection) and construct a new training wall

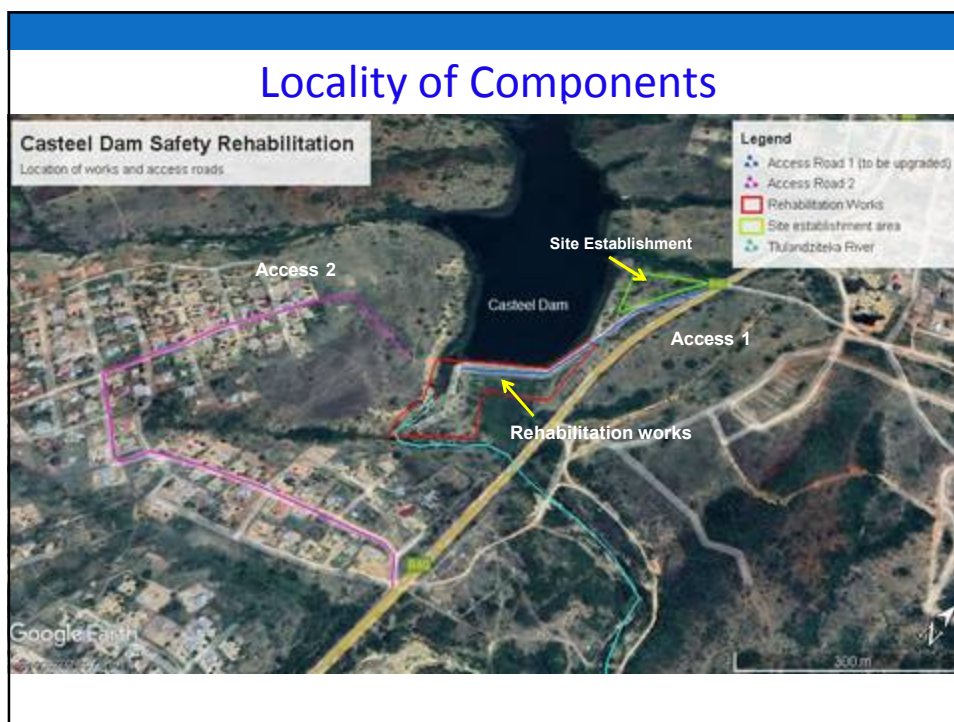
- Raising the non-overspill embankment crest by 2m to accommodate recommended maximum flood
 - (incl. raise concrete wall next to spillway to new crest level)

- Construct a paved walkway on the dam crest
- (2) **0.9 Ha Site Establishment area north-east of the dam for site offices**
- (3) **Upgrade existing gravel road from R40 to dam embankment (<1km length < 4m wide) by adding imported gravel material**

- (4) **Alternative access road also to be used during construction through Casteel settlement to access spillway section on right flank of dam.** Short 350m section of access road would need to be created to access the spillway through old fields.

3.1	<p>M Botha outlined the project scope of work and the locality of the components using presentation (see slides 8 and 9 for more details). It was explained that the DWS Chief Directorate: Construction Management proposes to undertake rehabilitation works at the original dam embankment over a twenty-four (24) month construction period. No expansion or construction of a new facility is proposed. The main rehabilitation works were outlined i.e.</p> <ol style="list-style-type: none"> 1) 28 500m² rehabilitation works at the main dam embankment and spillway (detailed components provided on slide 8); 2) 0.9 ha site establishment area northeast of the dam for site offices; 3) Upgrading of the existing gravel road from the R40 to the dam 	M Botha Naledzi

<p>embankment (less than 1km, no more than 4m wide).</p> <p>4) Use of an alternative access road during construction through Casteel settlement to access the spillway section on the right flank of the dam. A short 350m section of access road would need to be created through old fields to reach the spillway area.</p>
